Facility Overview

School District:	Wrangell Public School District
Facility:	Evergreen Elementary/Intermediary School
Inspection Date(s):	May 16-19, 2023

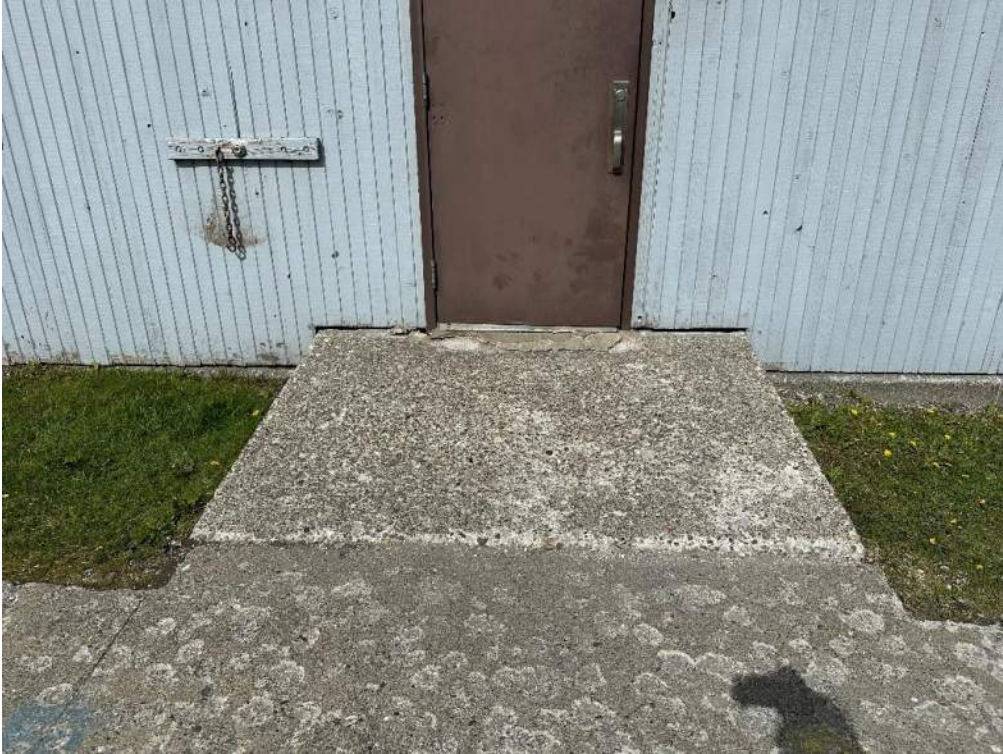
One of two concrete stoops recommended for replacement.

C-2 Priority #1 Replace two concrete stoops (9'x6' and 7'x6').

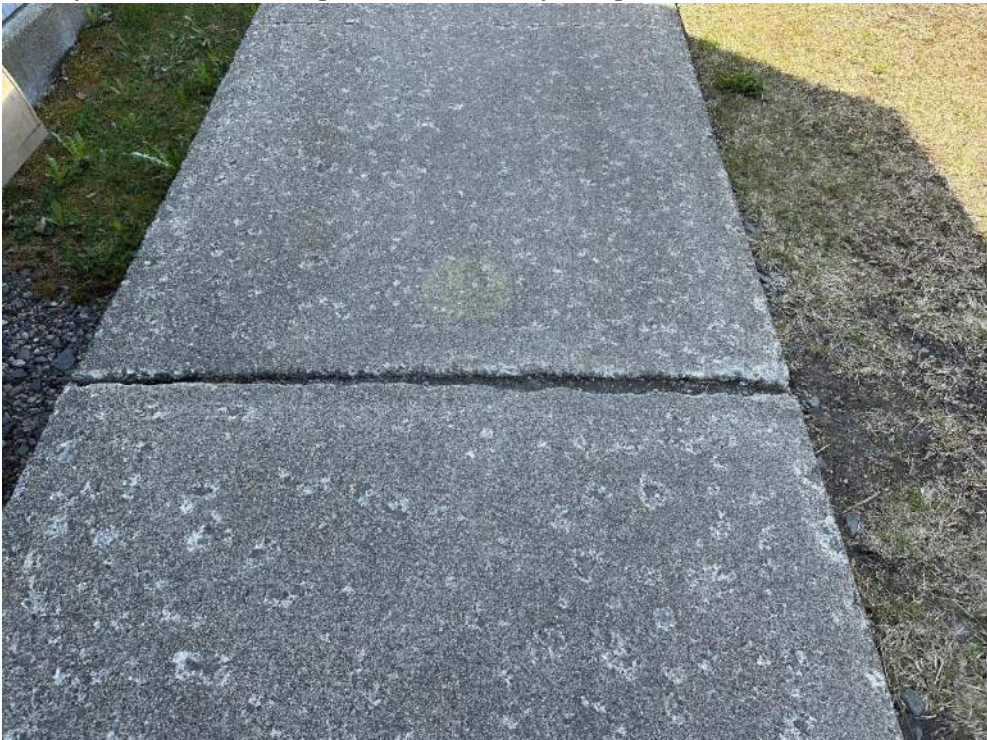
C-2 Multiple areas are not ADA-compliant for several reasons including cross or longitudinal slope, gaps or abrupt elevation changes at joints, and surface irregularities.

Large gap at joint in sidewalk on west side of building

C-2 Priority #1 Replace 137'x5' of sidewalk on west side of building.

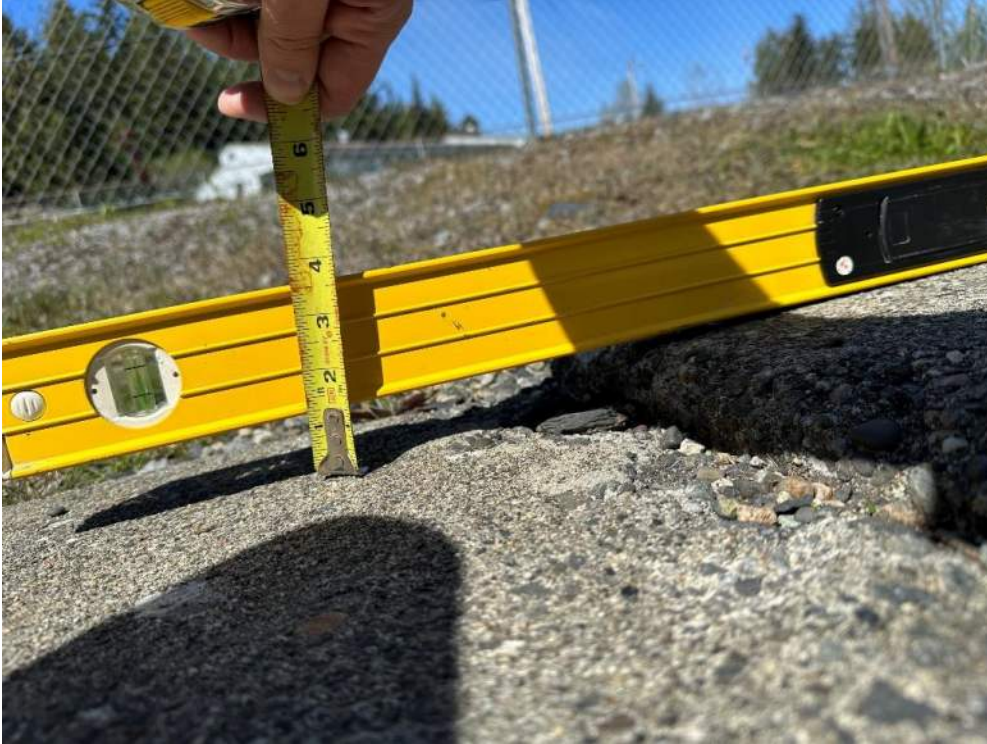
Abrupt elevation change (1.25") in sidewalk on west side of building

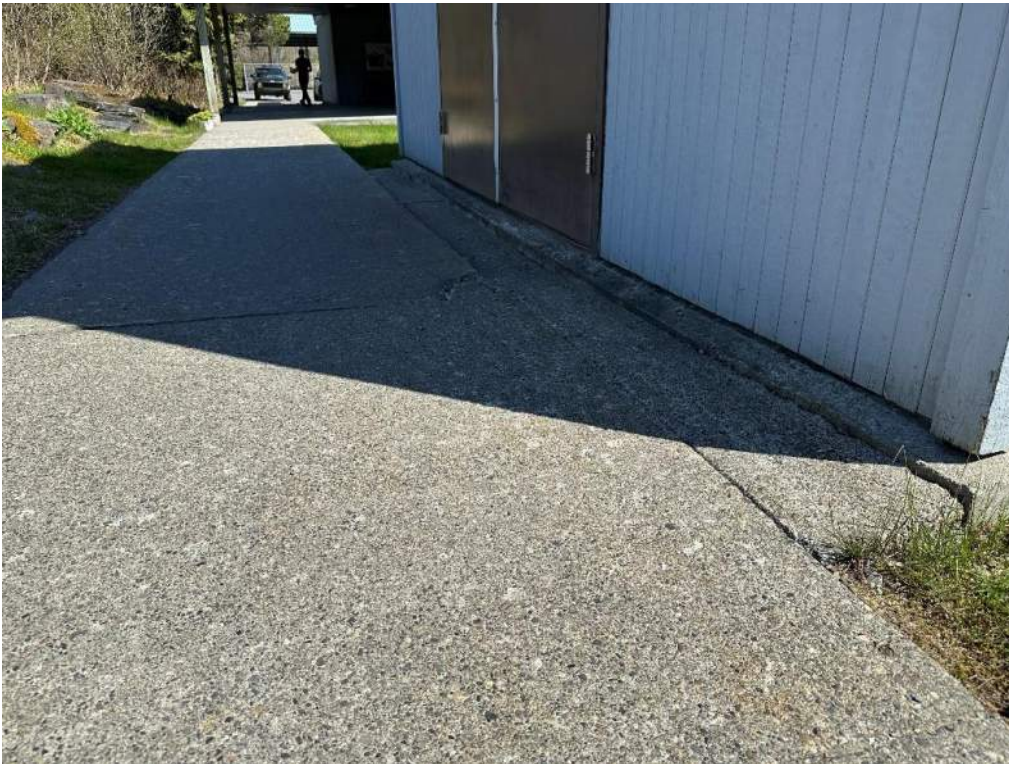
Differential settlement between sidewalk and foundations on west side of building

It is likely that weak subgrade has contributed to settlement of pedestrian surfaces. If replaced in kind, new pedestrian surfaces may continue to settle and fall out of code compliance again. It is recommended that over-excavation and backfill be considered prior to replacement.

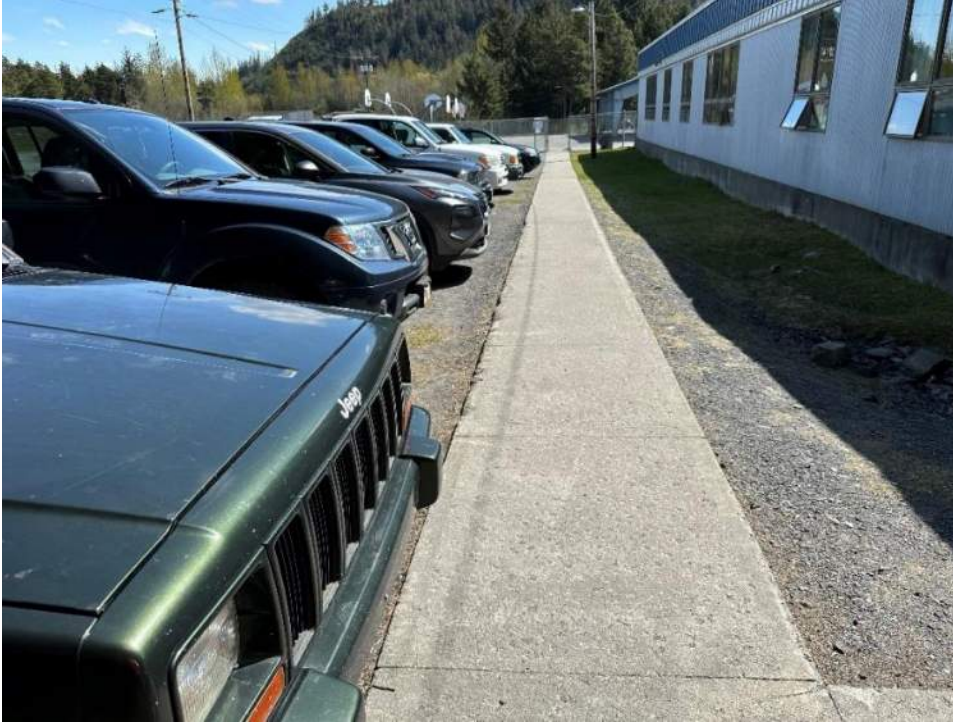
Vehicle/sidewalk conflict.

C-4 Priority #2 Replace 32'x4' of sidewalk on north side of building. (Consider replacing sidewalk in its entirety on north side of building with wider sidewalk to create adequate clear width for vehicle overhang. Alternatively, recommend installing parking bumpers to eliminate vehicle overhang).

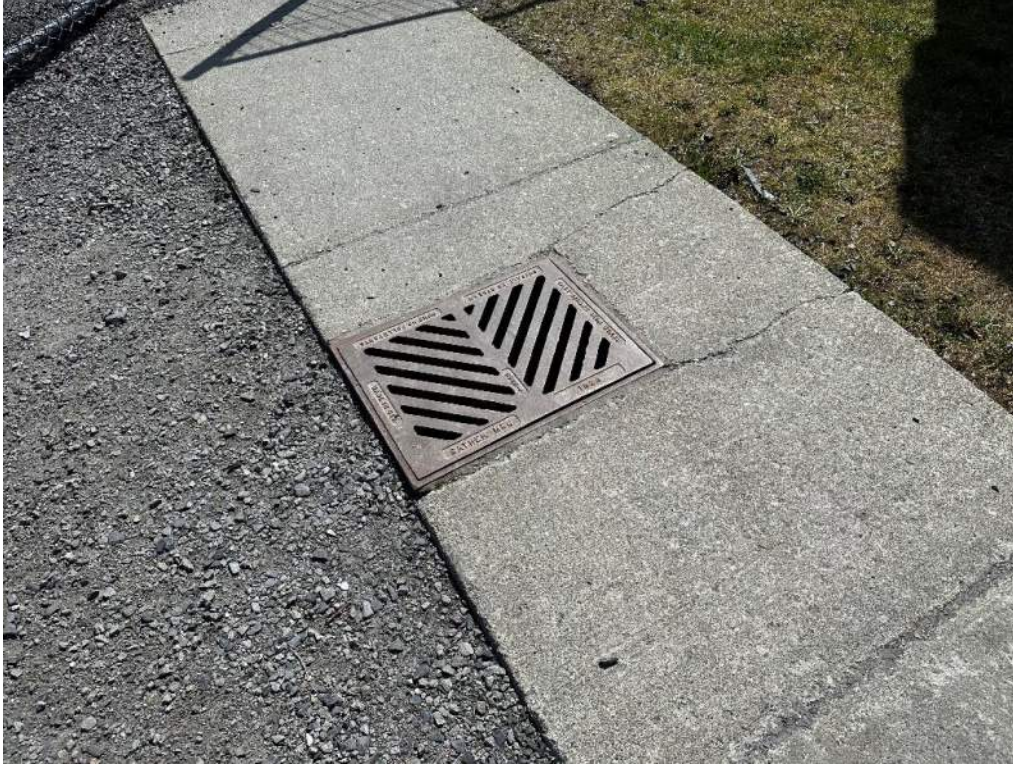
C-6 A catch basin grate located in a sidewalk is not ADA-compliant and should be rectified if the sidewalk is intended to be an accessible route.

Non-ADA grate

- C-6** Priority #1 Replace storm drain grate in sidewalk with ADA-compliant grate.
- C-7** Priority #3 Camera all storm drain pipes to assess for condition, sags, etc.
- C-8** Priority #4 Clean (3) catch basins in gravel parking area, vegetated buffer and sidewalk.
- C-9** Priority #4 Clean 60 LF of pipe upstream of playground system.
- C-10** Priority #3 Install approximately 700 LF of 4" perforated CPP perimeter foundation drain.
- C-11** Priority #4 Re-grade approximately 110 LF of vegetative buffer on north side of building to existing area drain.

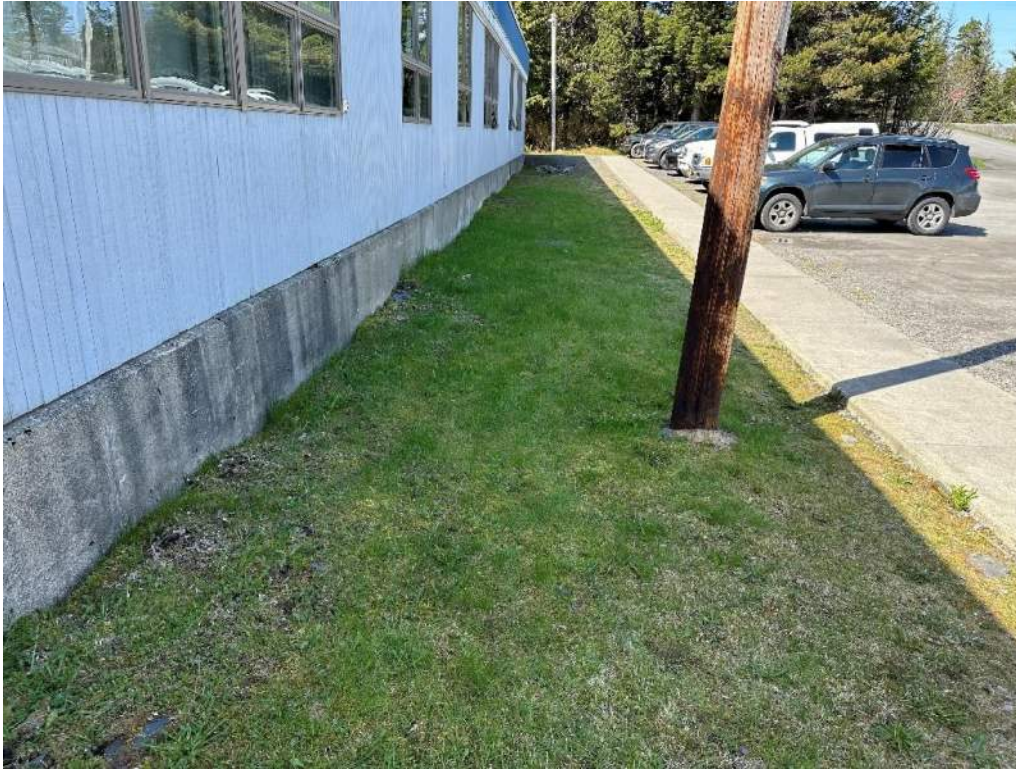
Regrade buffer

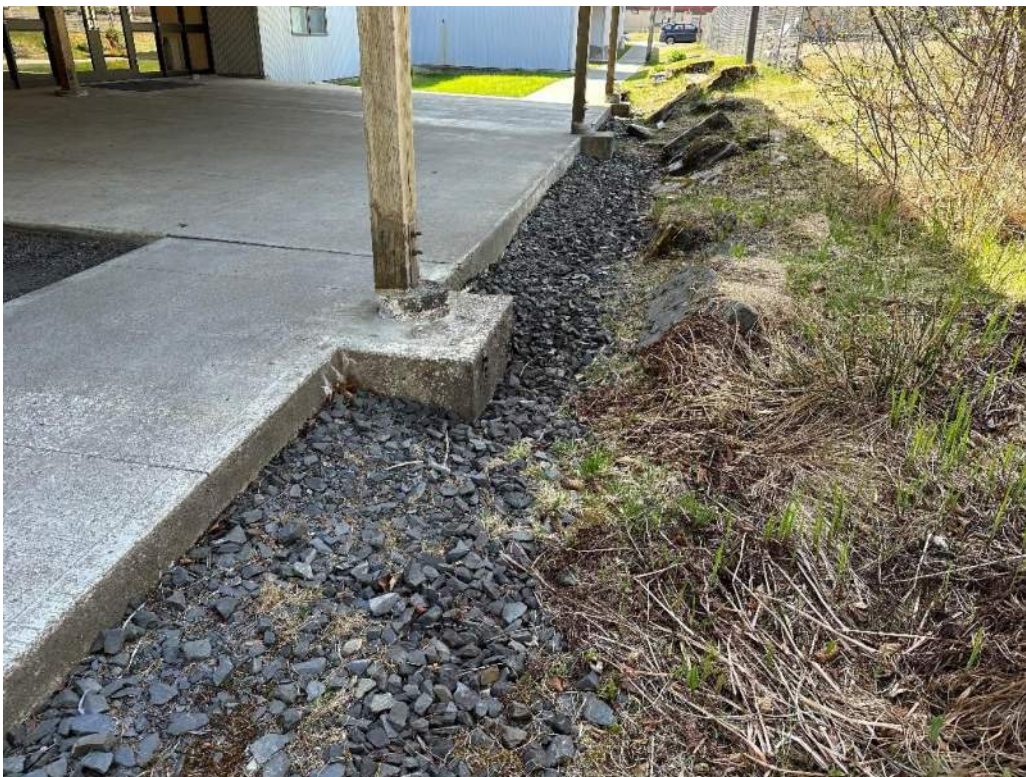
Address drainage

C-12 Priority #4 Construct swale (150 LF) and install two catch basins and 150 LF of 12" CPP pipe on west side of building, connect to existing catch basin.

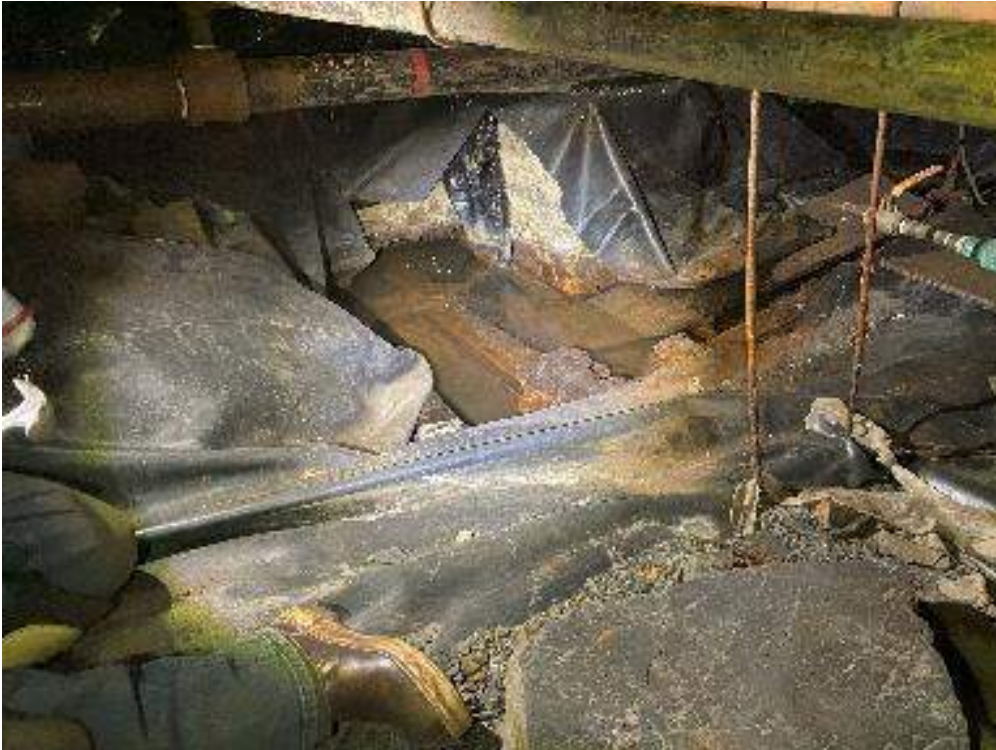
S-2: Standing water in crawl space.

Water in Crawl space (on top of Vapor Retarder)

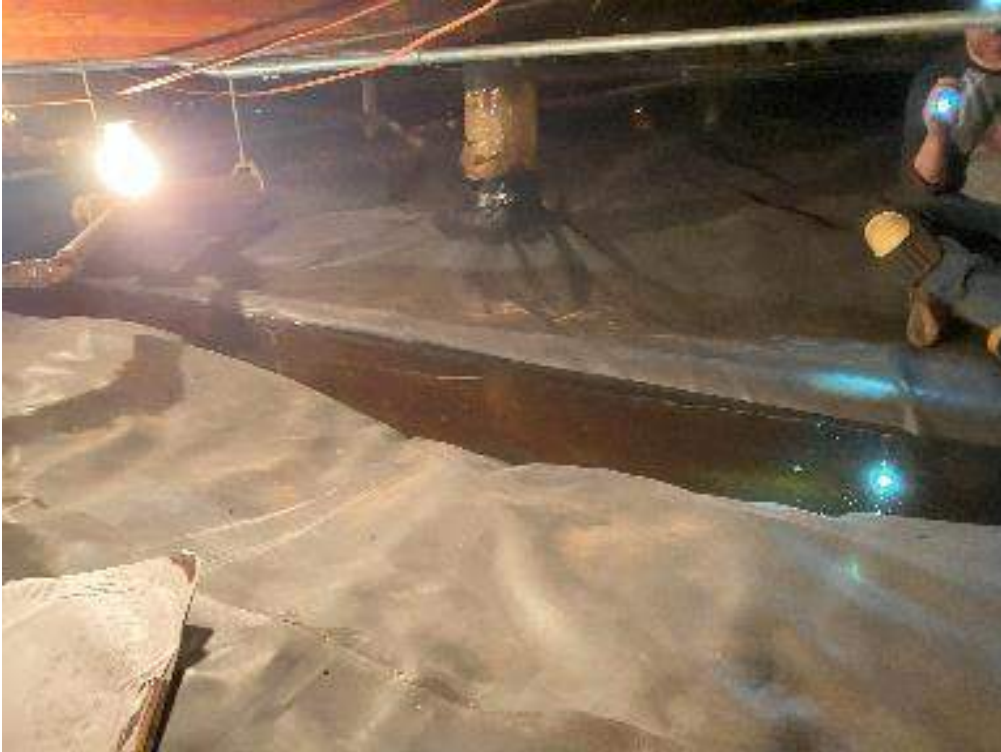
Water in Crawlspace (on top of Vapor Retarder)

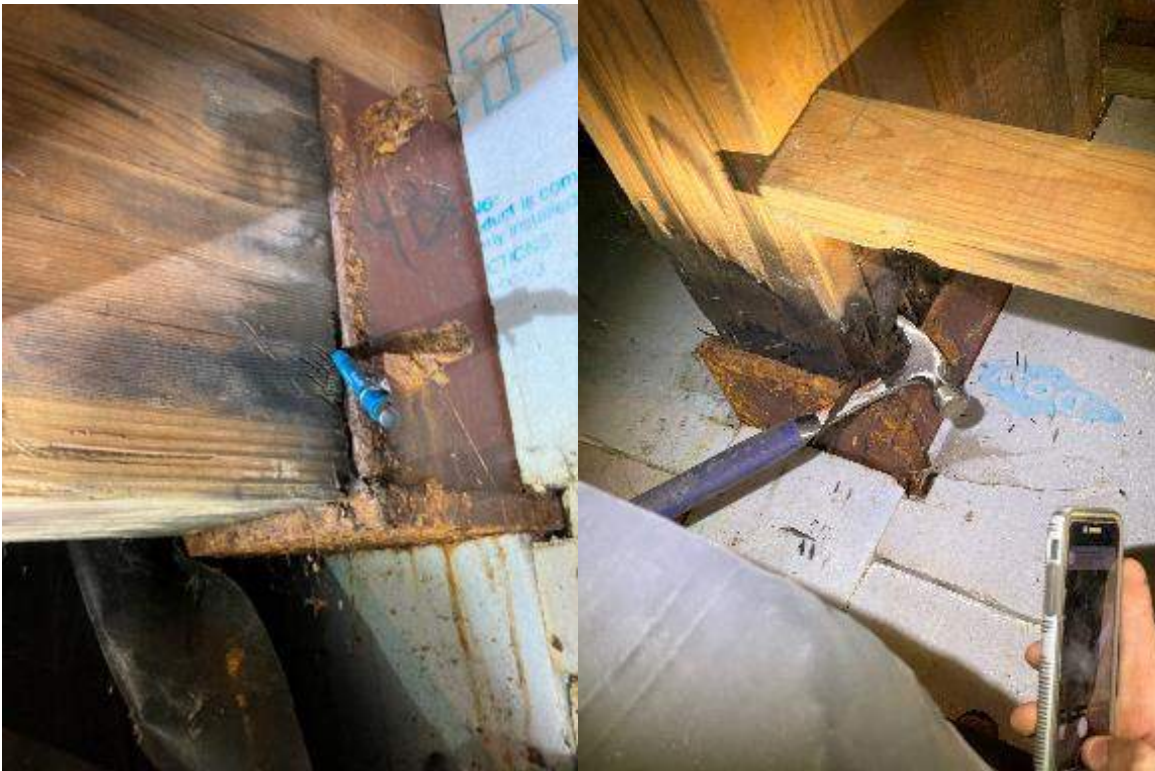
S-3: Rotten glu-lam beams at perimeter grade beam on east side of gymnasium. This was noted in four places.

Rot at beam ends

S-3: Remove end of rotten beams and provide new post and connection to pile cap below. Beams shall be shored immediately due to the extent of the rot. Priority #1

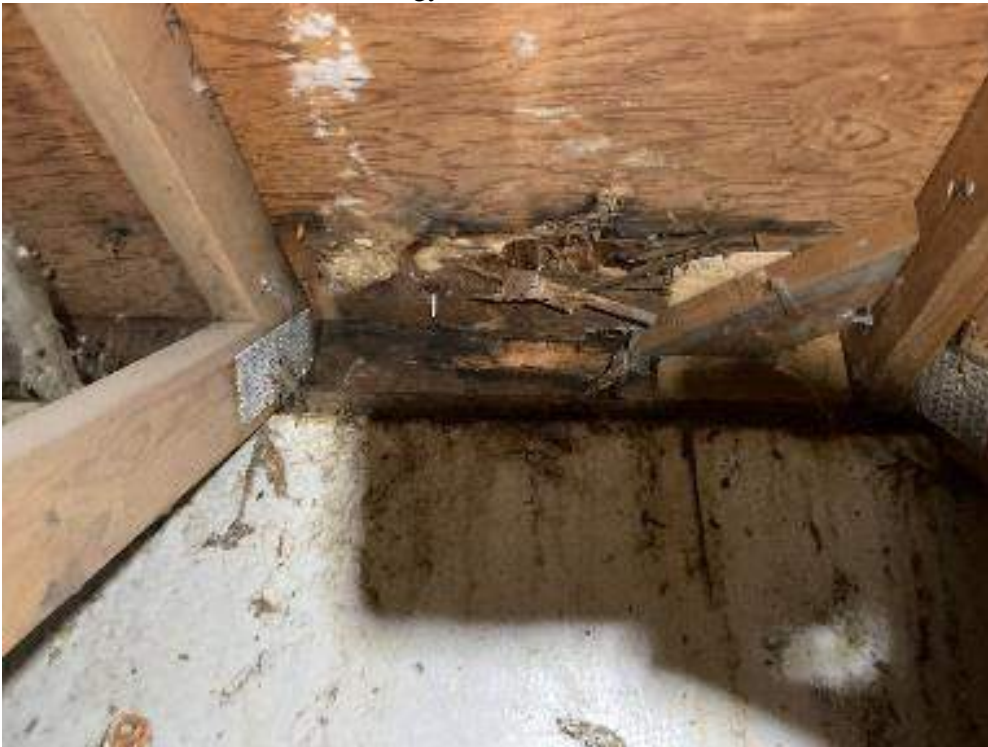
S-4: Dry rot in floor sheathing and blocking between trusses. These appear to be located under door thresholds on the south wall of the gymnasium.

Rot at sheathing, blocking.

S-4: Replace rotten sheathing and blocking. Priority #2

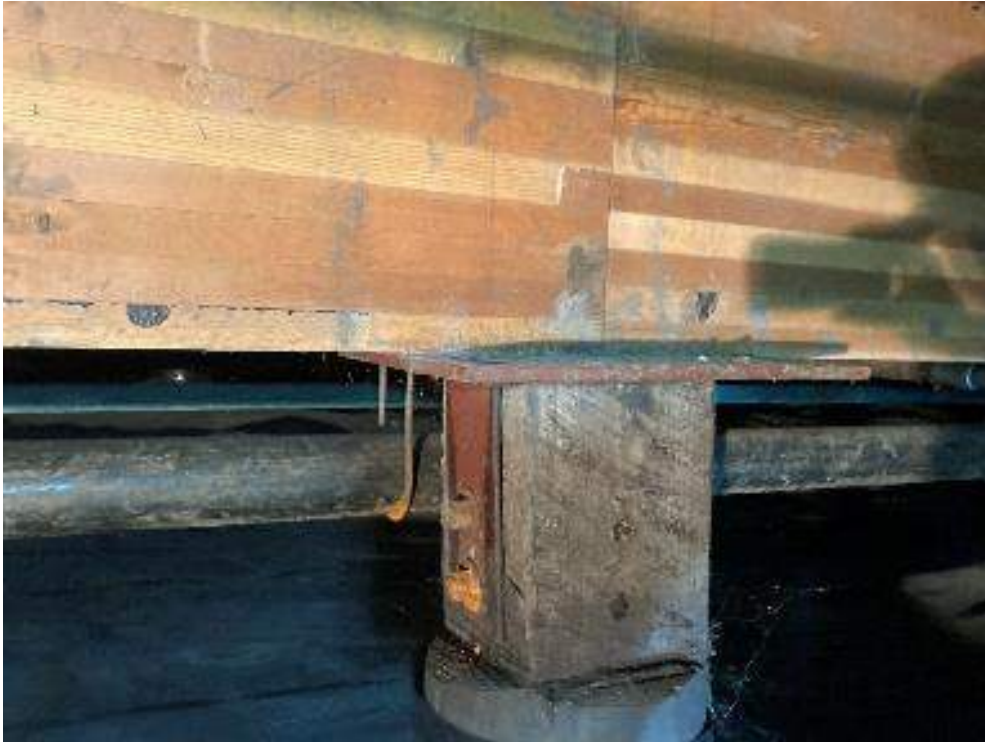
S-5: Pile to glu-lam beam connection not installed as specified.

Missing connection plate.

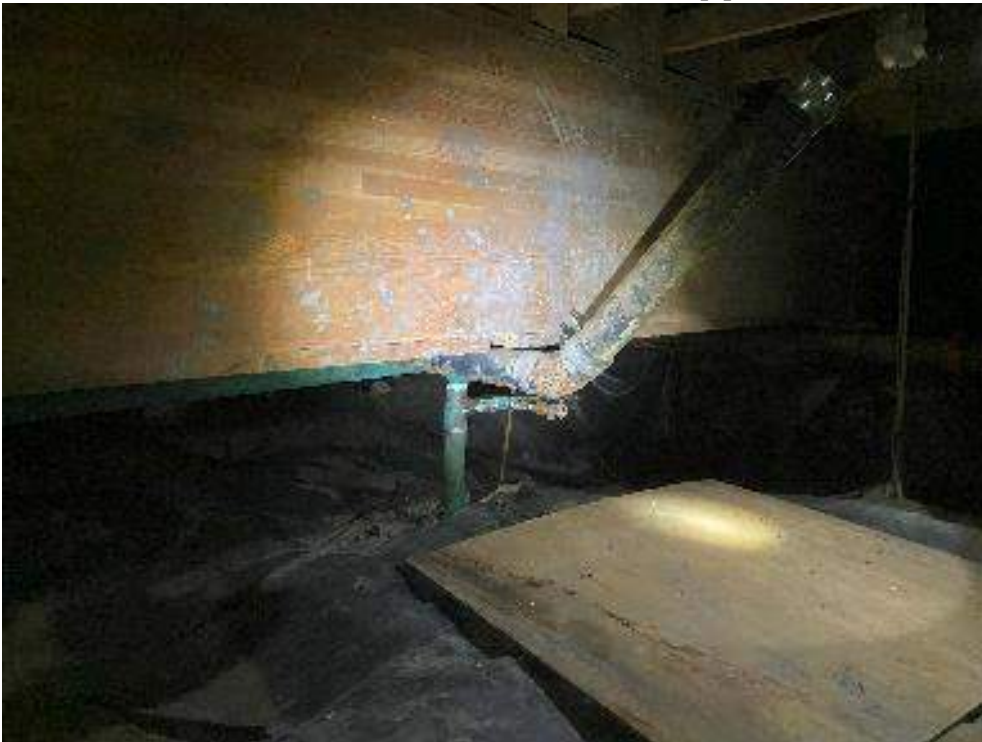
S-6: Glu-lam floor beam notched at bottom lamination for pipe.

Notched Beam

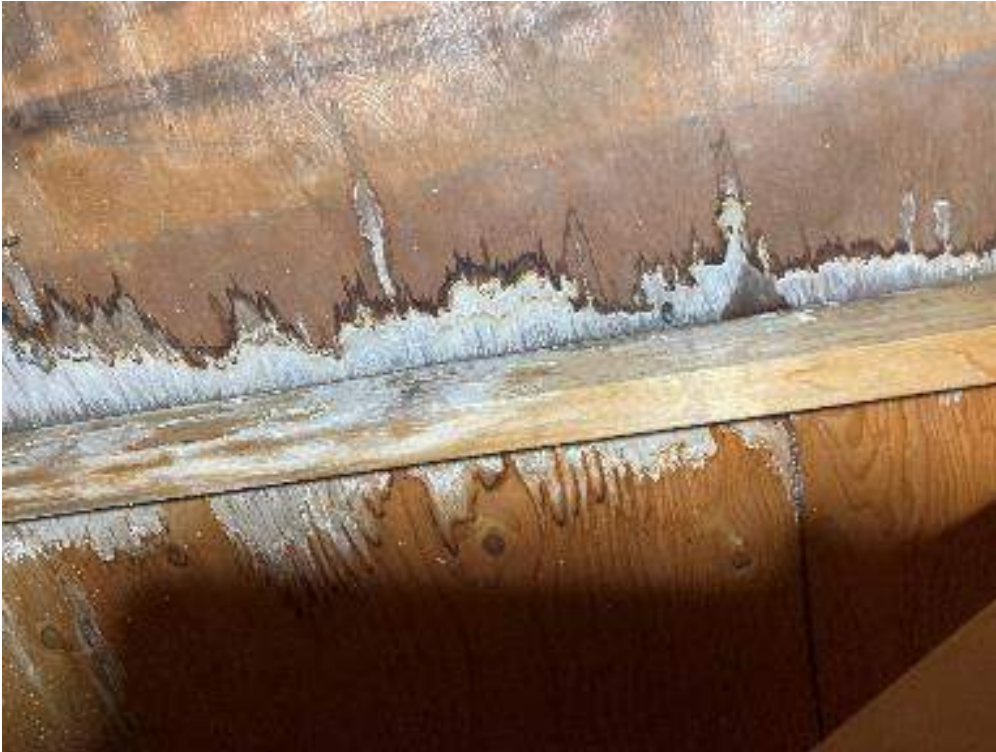
S-7: Rotten roof sheathing. While no rotten roof sheathing was observed, we assume that there may be some due to the condition of the roofing and evidence of water infiltration at underside of roof sheathing.

Water staining at roof sheathing

S-7: Replace rotten roof sheathing when roofing is replaced. Priority #1 as part of reroofing

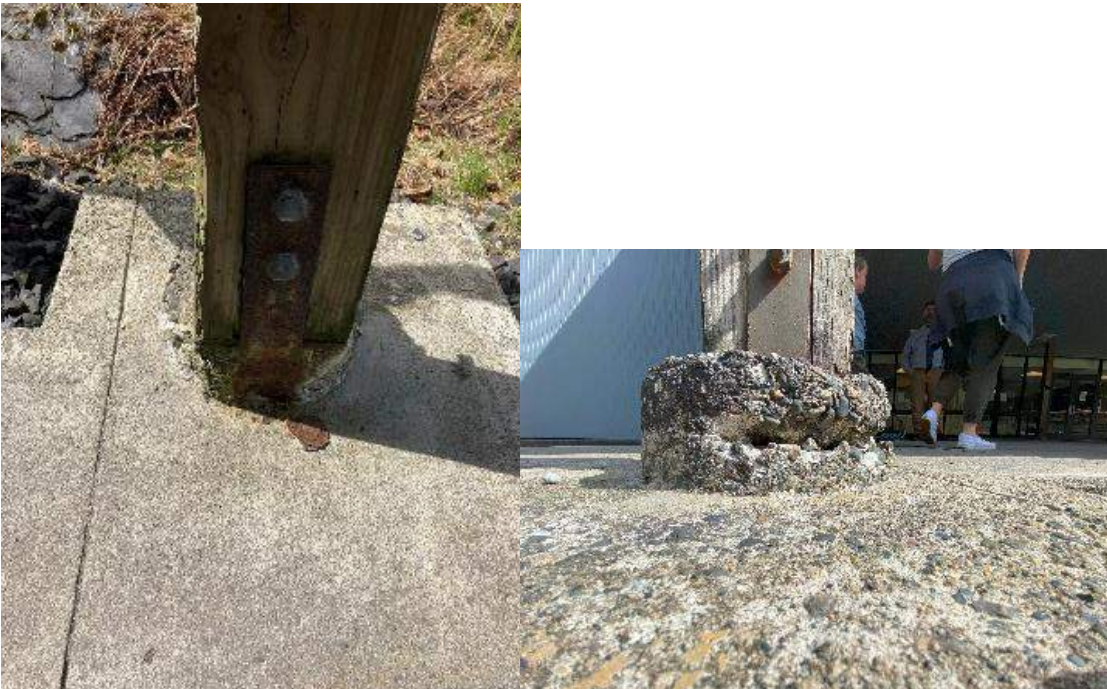
S-8: Corroded post base connections at two posts. Deterioration of concrete pier at post base.

Deteriorated post bases

S-8: Replace post base connections with hot dip galvanized connections. Remove loose concrete and patch with grout. Priority #2

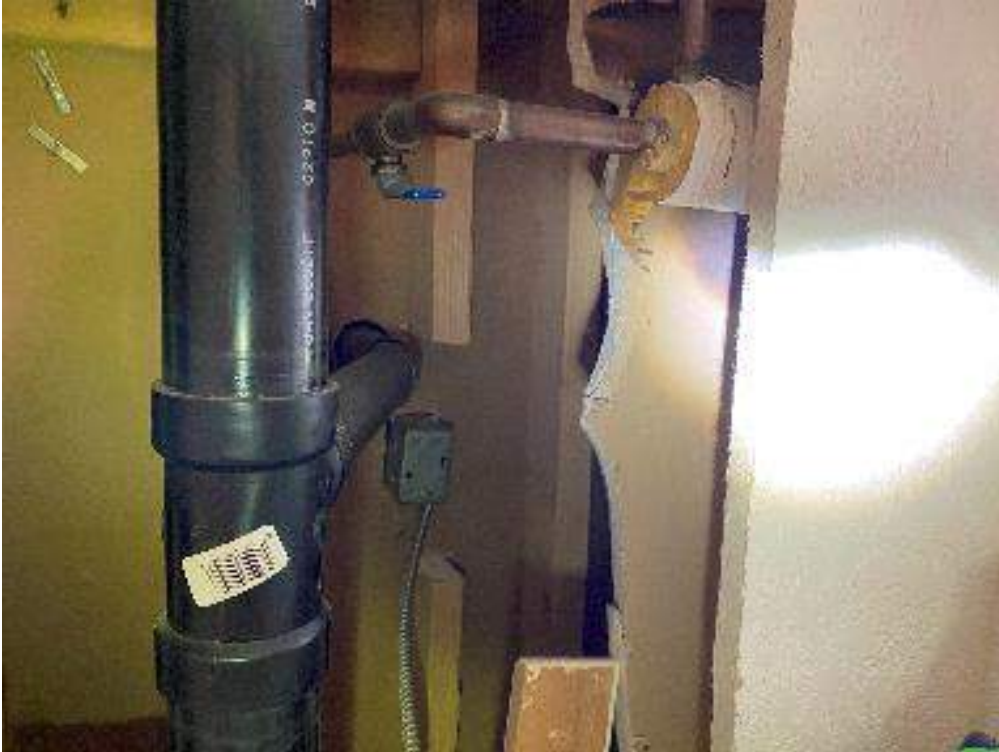
S-9: Bearing wall stud cut by electrician.

Cut structural studs.

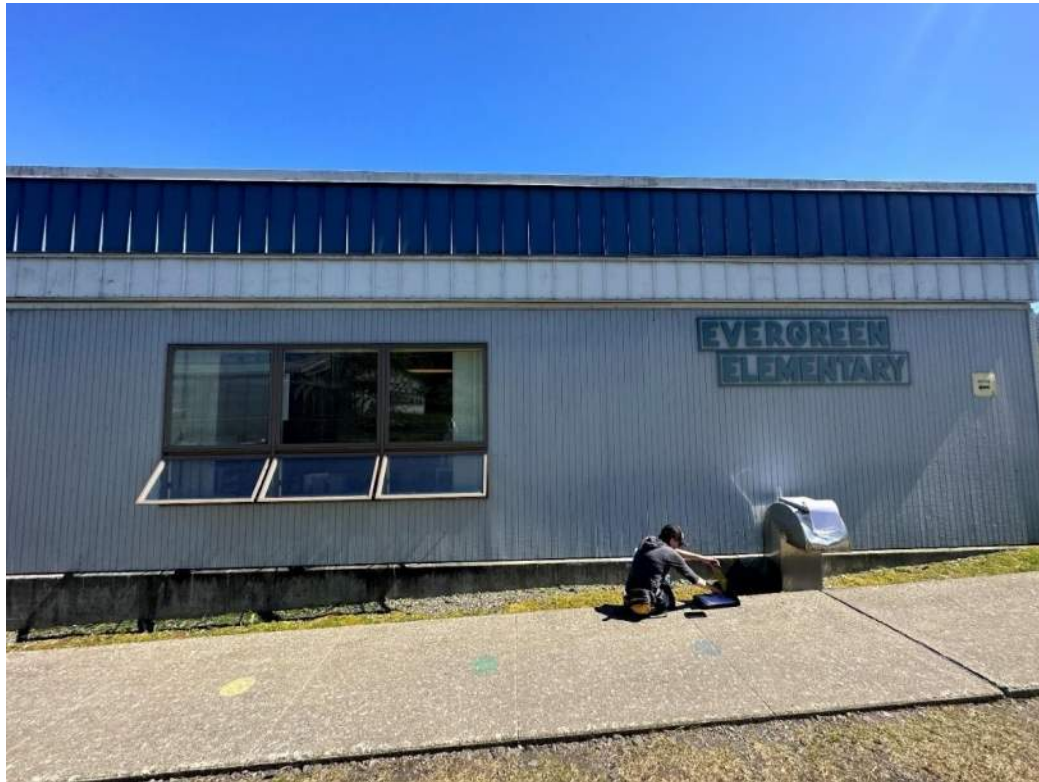
Some wood siding is compromised at bottom edges and at fenestrations where sealant joints have failed resulting in degradation at end grain. Painting is a short-term solution. Replacement with a new weather barrier and vented cavity is a long-term solution. Anticipate 1% sheathing replacement due to failure of painted wood siding as a part of any residing project. Site cast concrete base at Elementary is in good condition.

Note: Finishes on the south elevation of these buildings is in notably worse condition. Solar exposure has accelerated weathering of paint, stain, sealant and exposed substrates.

A-2: Siding: Re-seal all fenestrations, replace severely damaged material (approximately 200 sf). Repaint all siding, approximately 9,000 sf, less fenestration area. Option 1, Priority 1.

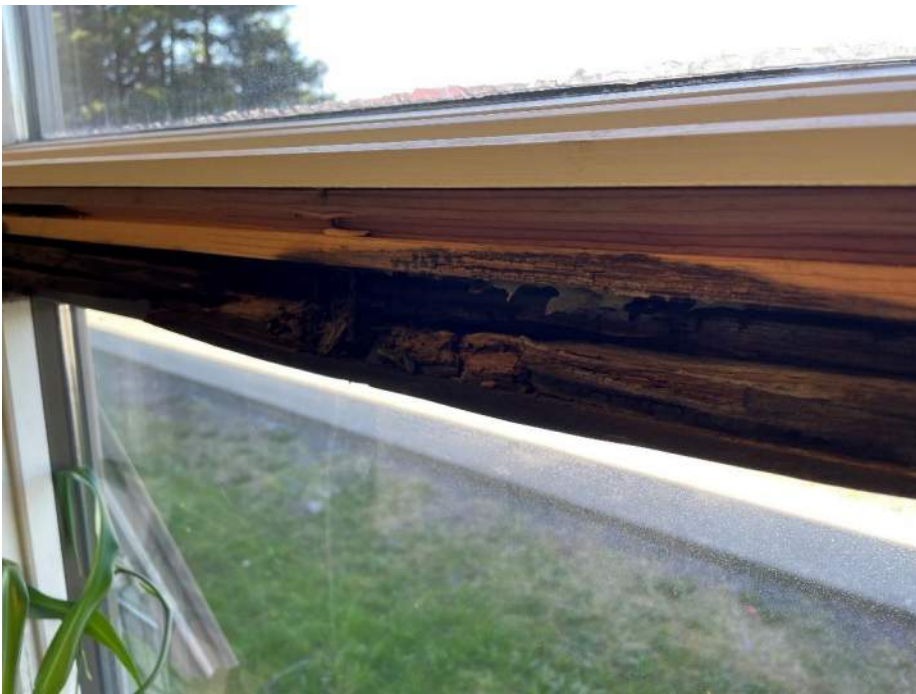
Windows in classrooms facing north have experienced severe water infiltration and exhibit rotting wood assembly. There is one broken upper fixed glass pan on the west elevation. The ½” thermal glazings are antiquated, not optimised for energy efficiency.

Rotting wood on north facing window units.

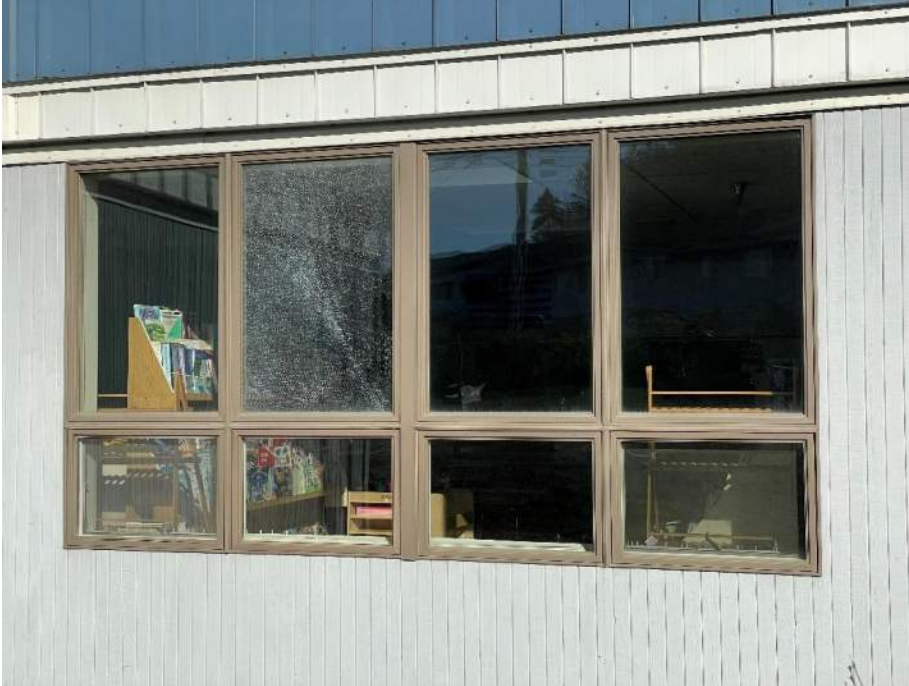
Broken glass in typical 4-modual unit, West elevation

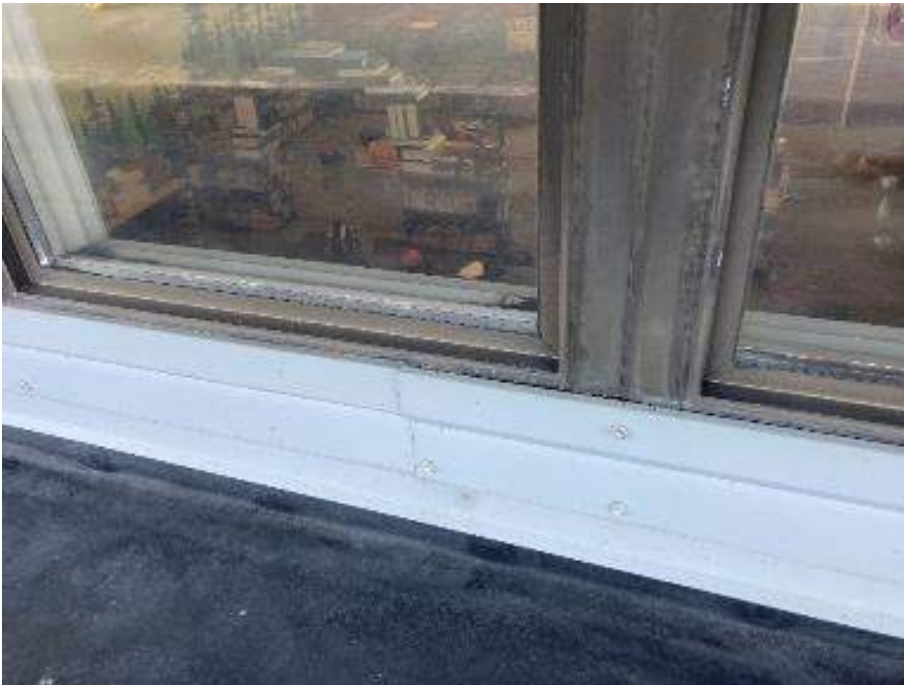
Exterior wall framing could only be visually observed above the ceilings. In locations that were visible, the wall framing was in good condition. The framing around the upper windows in the library were of particular concern as the windows did not appear to be sealed properly.

Library upper windows not properly sealed

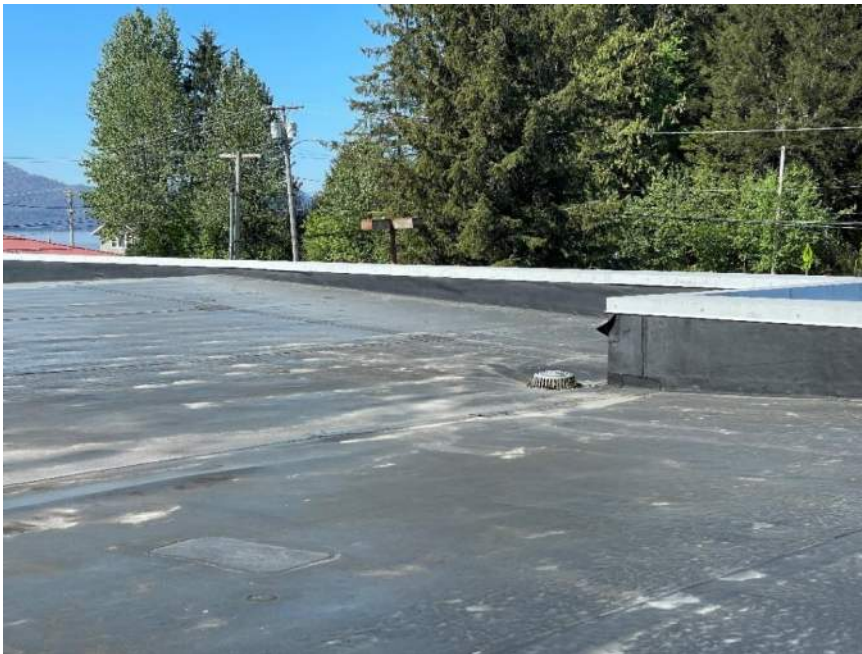
Typical condition of roof – this is area over multipurpose stage and music room.

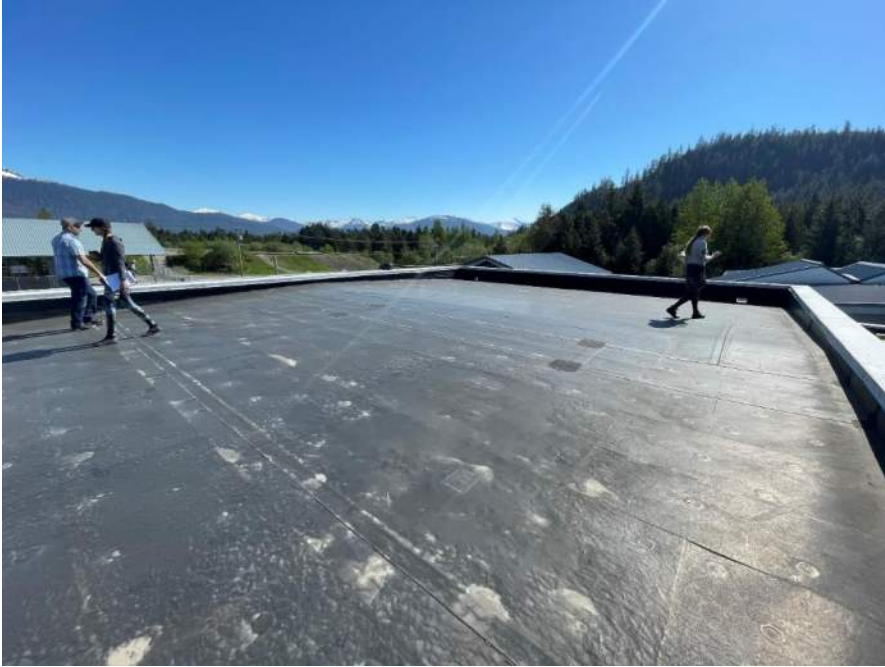
Typical condition of roof – this is area over library.

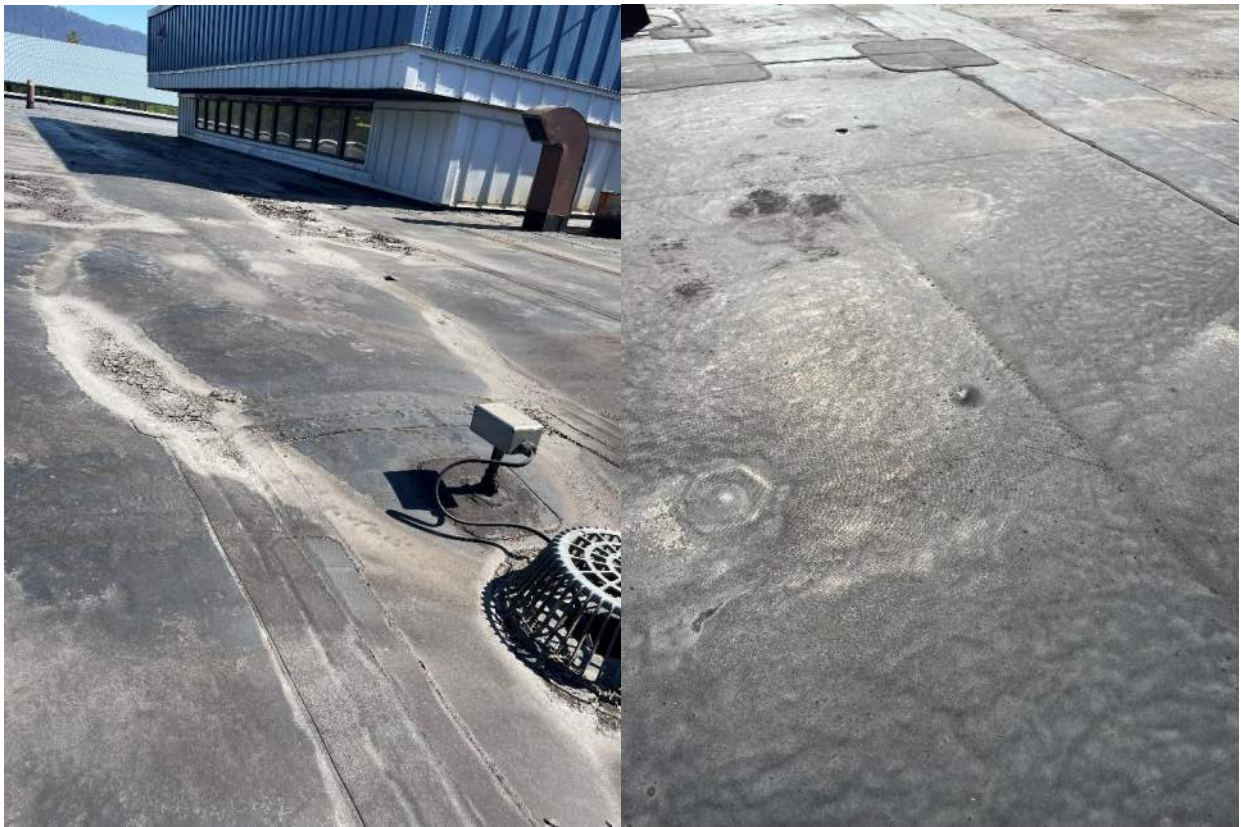
OSB “pillowing” at valley area, and debris under membrane

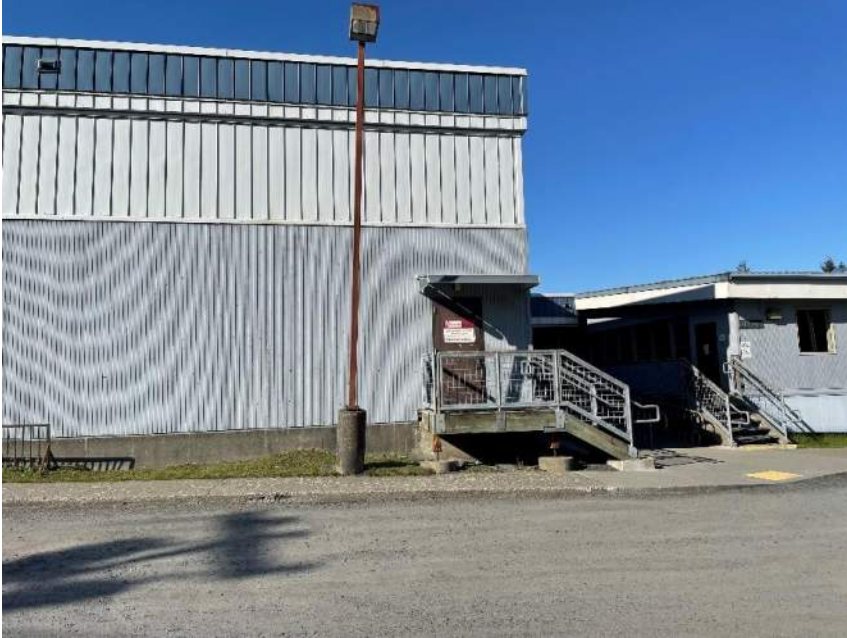
A small bolt-on canopy has been installed over the east-most multi-purpose room exterior door. It is not part of the original building system, is likely not designed for snow or wind loading.

A-12: Priority #3 Remove and replace with attached covering tht will extend to cover door, landing, and stair below. Anticipate 5' wide x 12' long, timber frame supporting metal roof assembly.

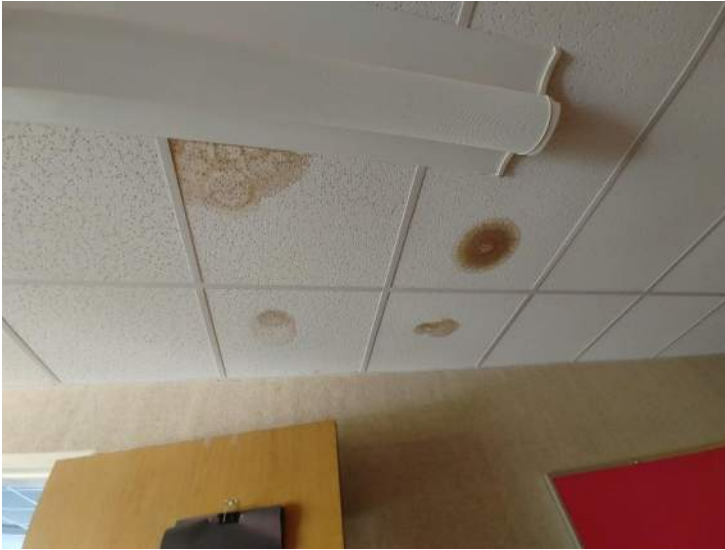
Typical ACT ceilings, with some stained tiles where roof leakage has occurred - score 4.

Water staining at ceiling tile, varies in hallways and classrooms

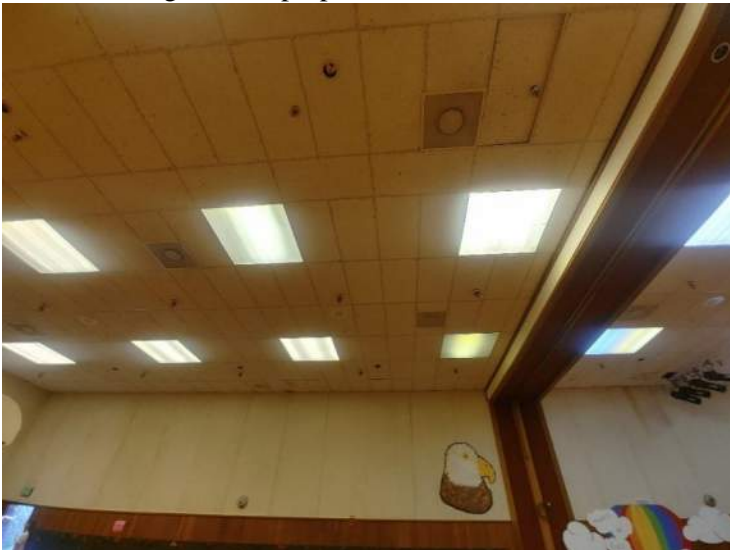
Tectum ceiling in Multipurpose room is in fair condition, needs to be repainted – score 3.

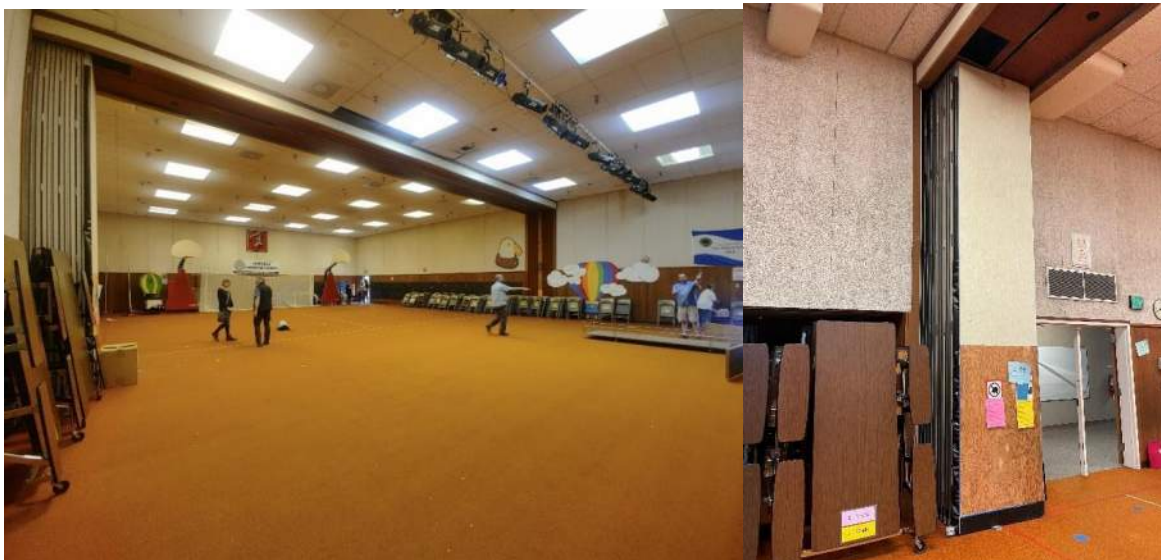
The operating cable mechanism is broken, and the system could not be extended for inspection. The panel appears to be in serviceable condition.

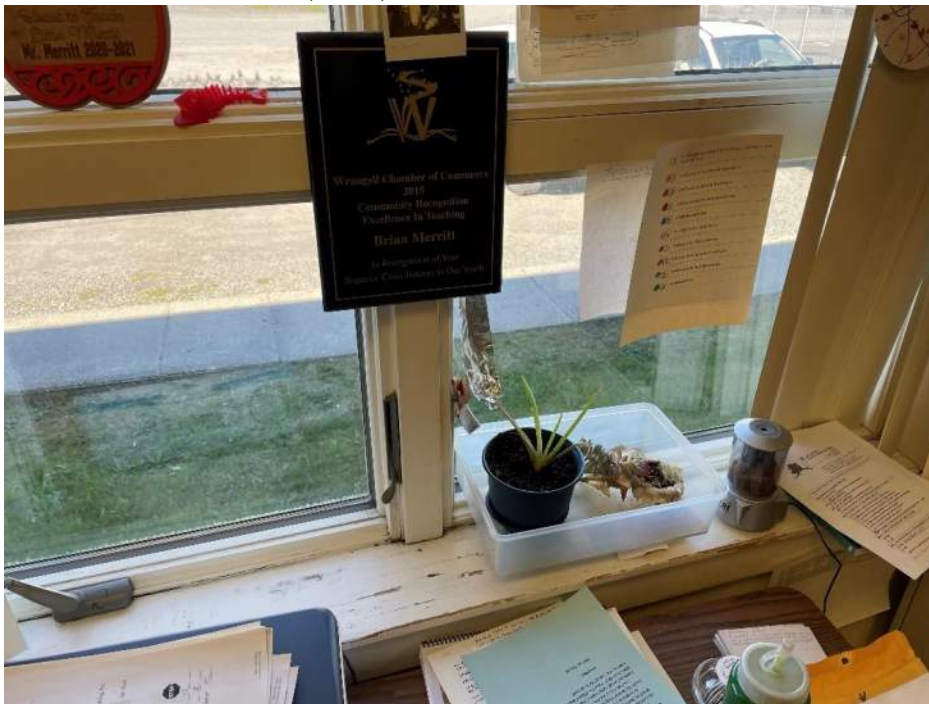
Mostly intact and operational but not functional. Operation requires sill and mullions be cleared, spaces commonly used as shelves for plants and other classroom related items that must be moved to deploy the blinds. Rapid deployment of blinds is not possible in an emergency.
