# Facility Overview

| School District: | Wrangell Public School District |
| Facility: | Stikine Middle School |
| Inspection Date(s): | May 16-19, 2023 |

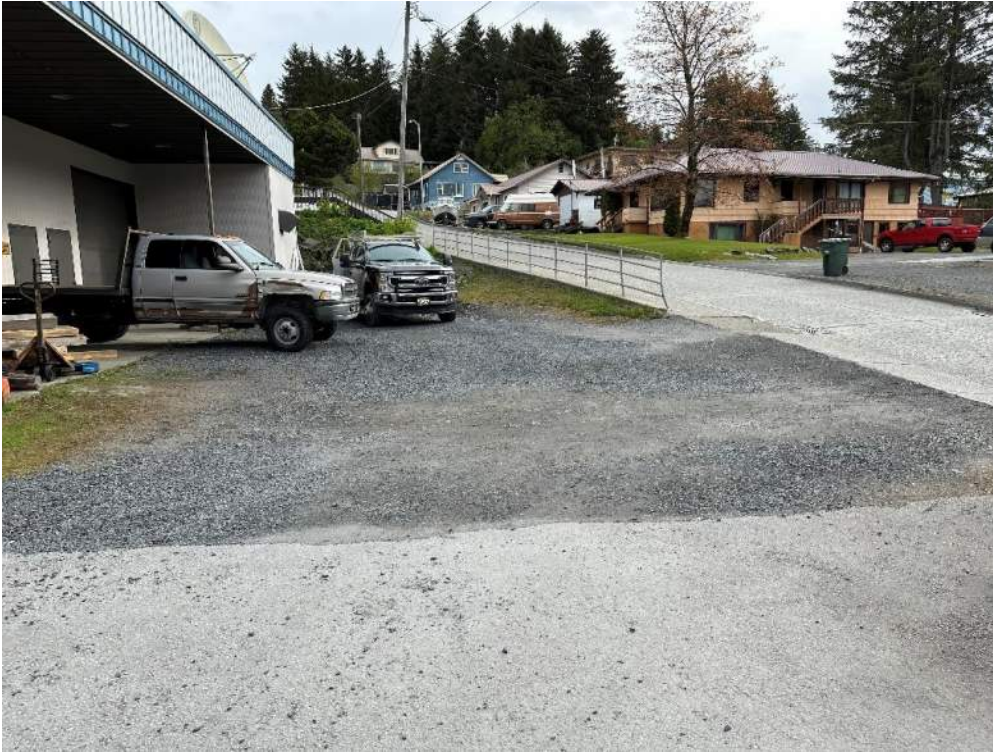
*Re-grading vocational gravel parking area at southeast end of building.*

**C-2:** Priority #3 Re-grade approximately 30'x20' of parking area with 6" of gravel. Priority #1

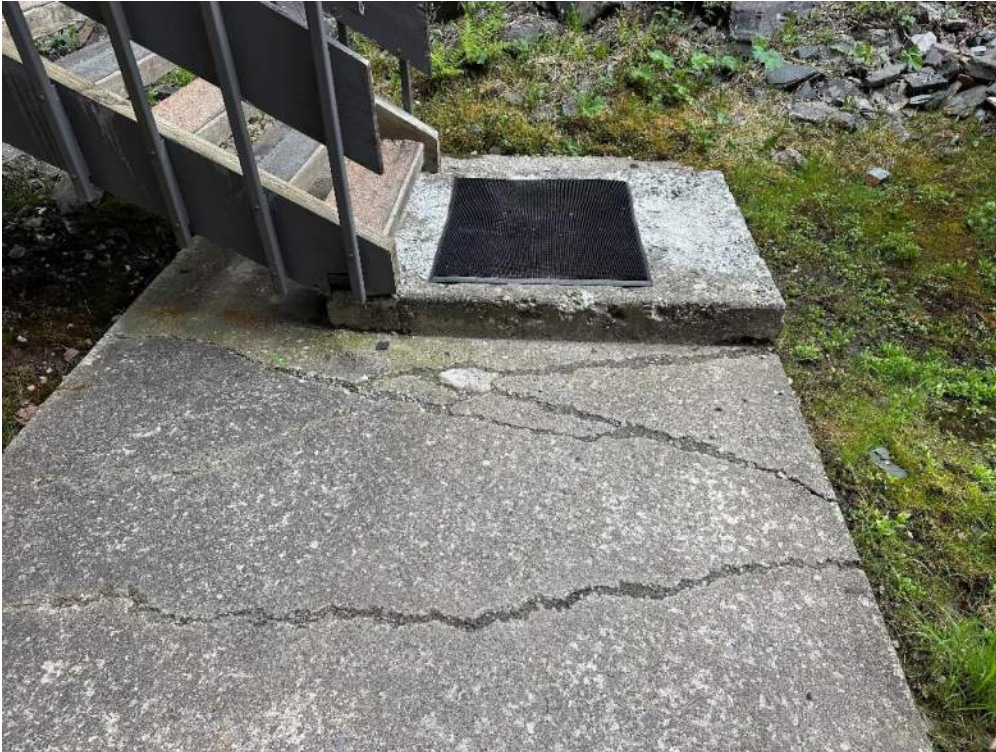
*Replace concrete apron at base of stairs leading down from breezeway*

**C-3a:** Priority #1 Replace concrete apron at base of breezeway stairs (9'x17').

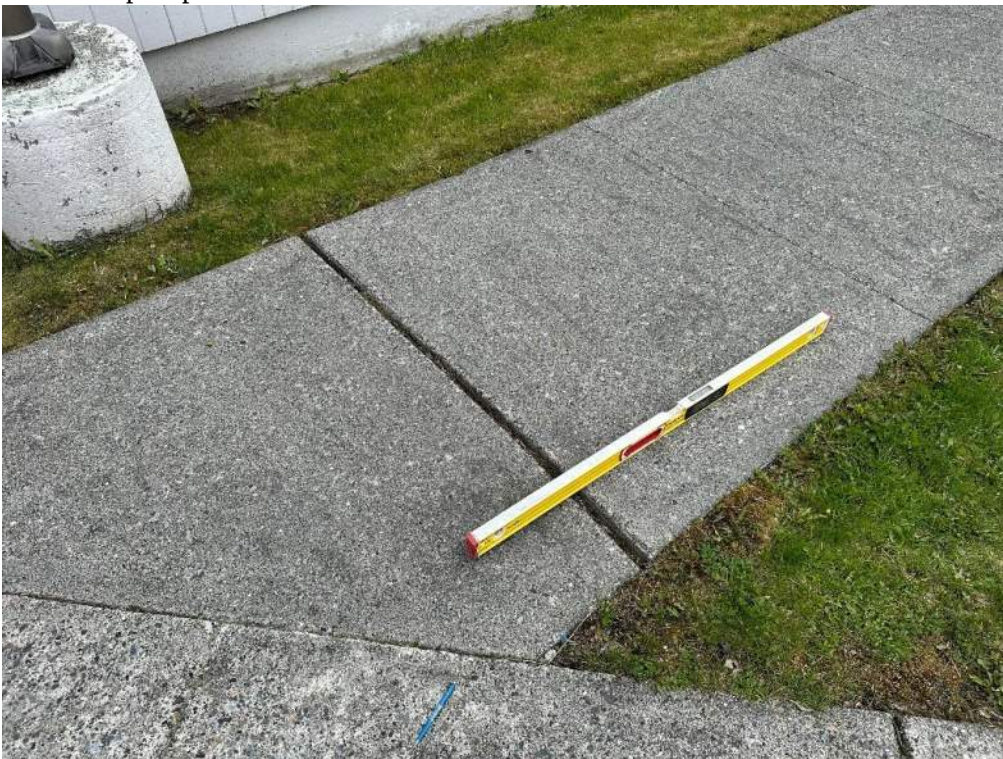
*Wide gap between panels in sidewalk on southwest side of building, top level*

**C-3b:** Priority #1 Replace 12'x5' of concrete sidewalk on southwest side of building. Alternatively, this defective sidewalk could be removed entirely as it serves no functional purpose and ends abruptly near a steep slope.

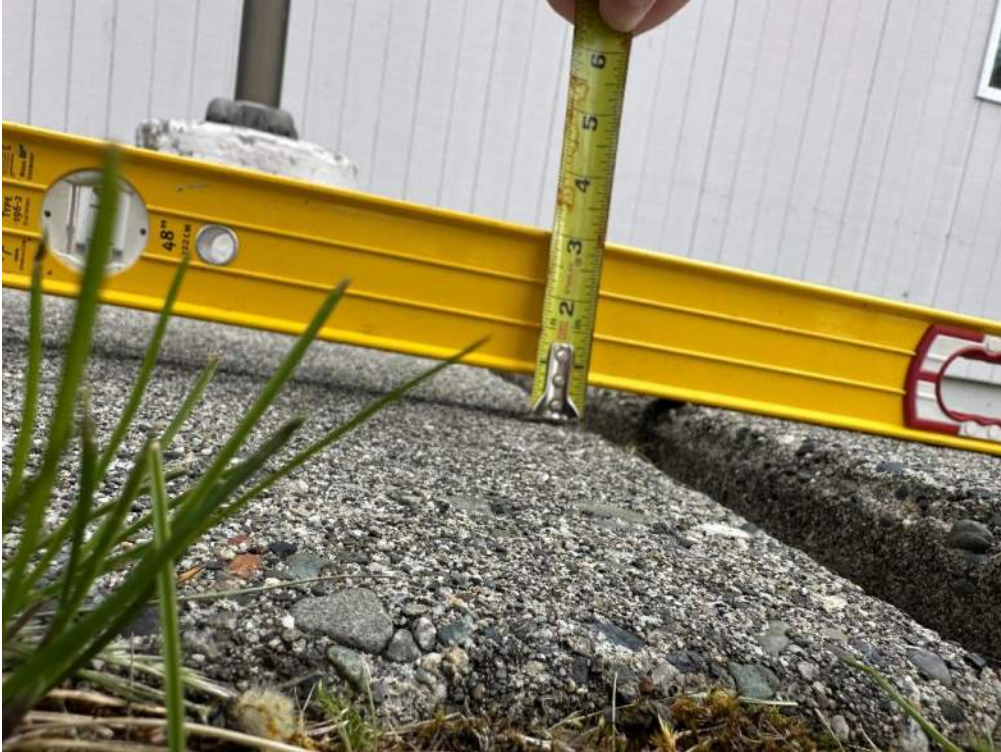
*Abrupt drop between panels in sidewalk on southwest side of building, top level*

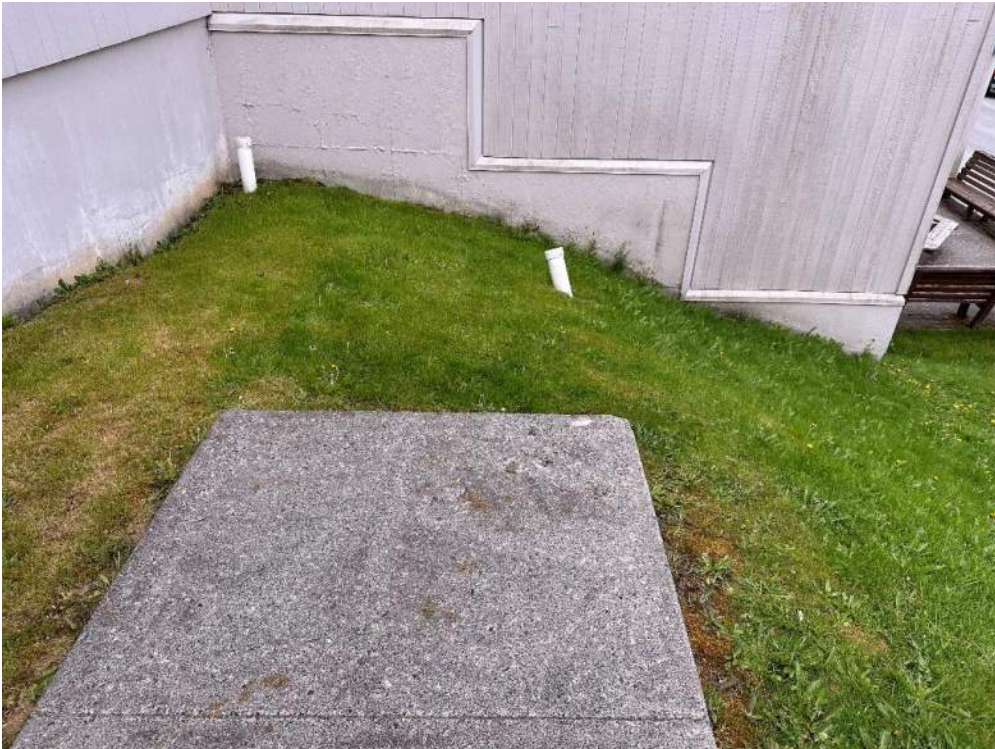
*Sidewalk on southwest side of building, top level, ends abruptly near steep slope*

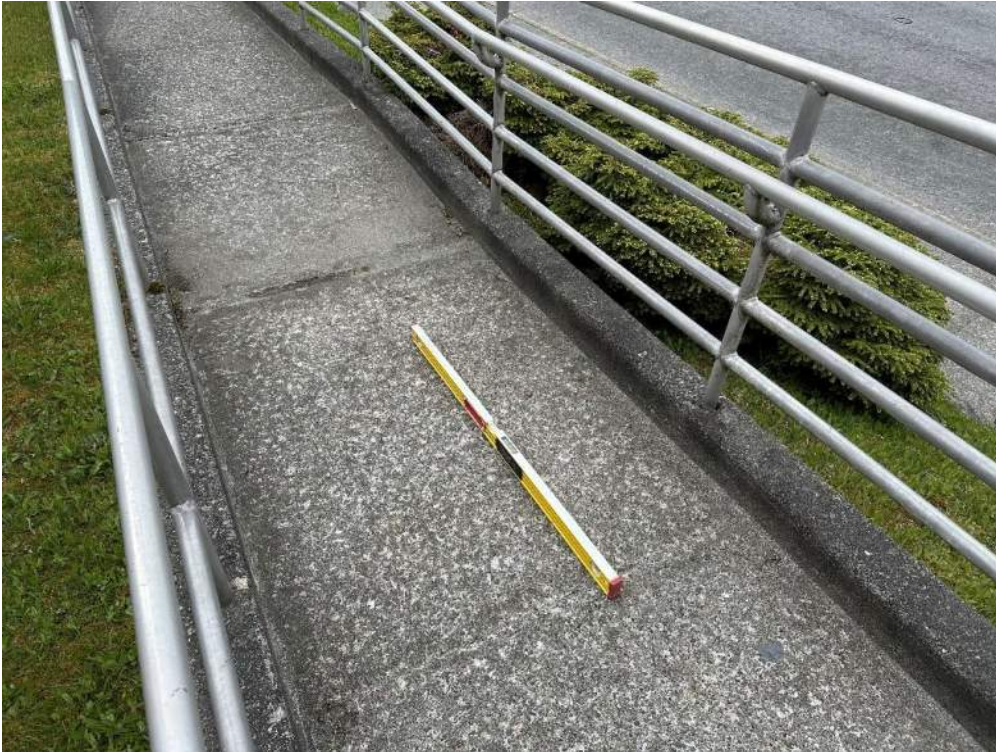
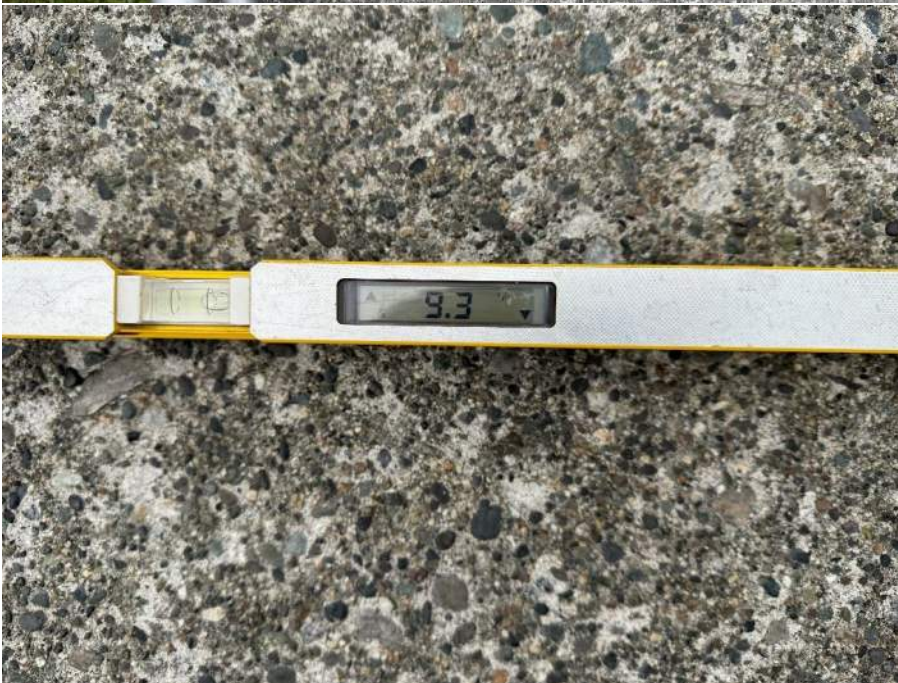
**C-6:** The concrete access ramp longitudinal slope occasionally exceeds the ADA maximum.

*Location where access ramp longitudinal slope exceeds the ADA maximum*

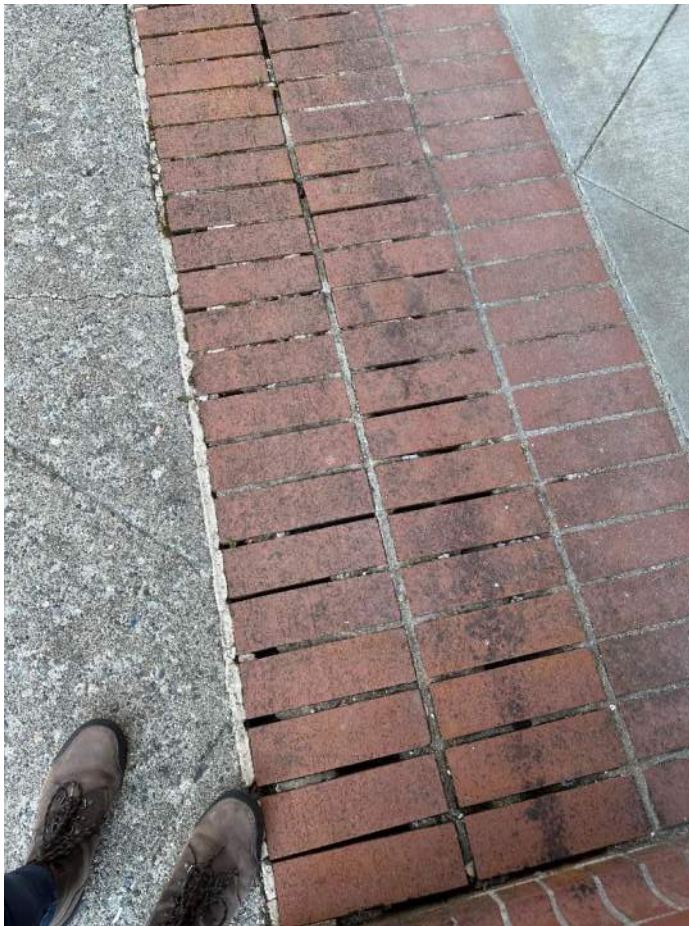
*Hardscape brick-work to be repointed.*

**A-2:** Repoint all of the grout joints at the brick pavers in the courtyard, approximately 300 sf of large format brick paver system. Priority #1

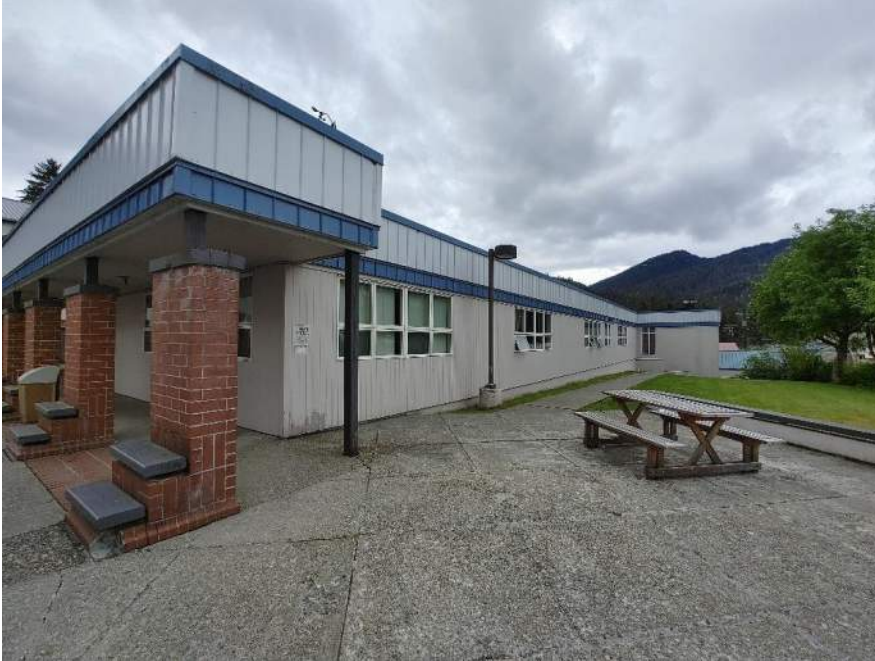
*Picnic table and timber seat walls at upper patio, southwest corner.*

**A-6:** Clean and re-stain two picnic tables and the patio seat edge (approximately 60lf.). Priority #3

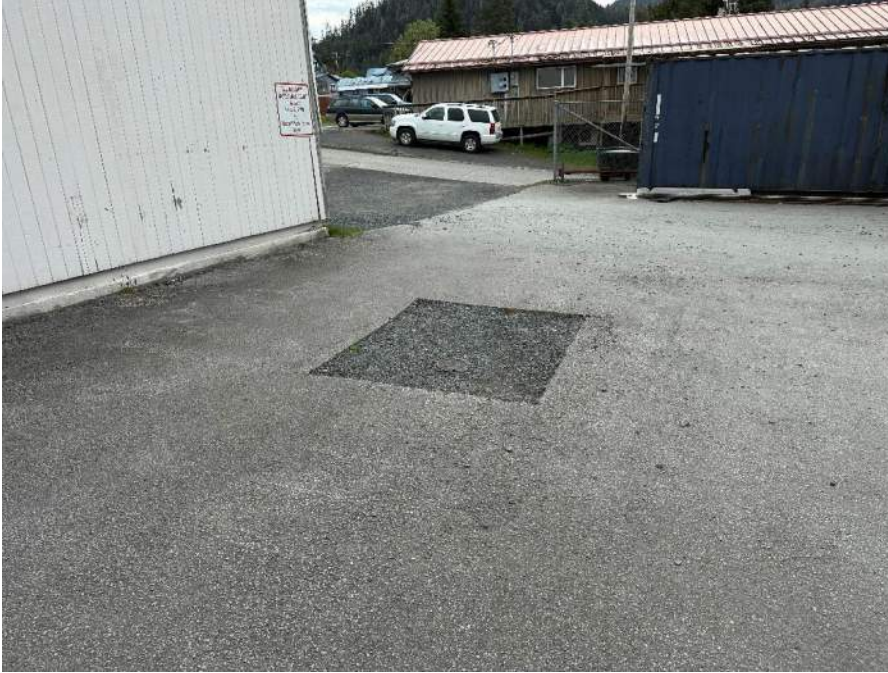
The basketball court is surfaced with ACP and is generally in good condition with the exception of several cuts made to install cleanouts.

*ACP cutouts around cleanouts*

**C-10:** Priority #1 Construct two patches at cuts around cleanouts, (1) measuring 5'x5' and (1) measuring 4'x4'. Priority #2

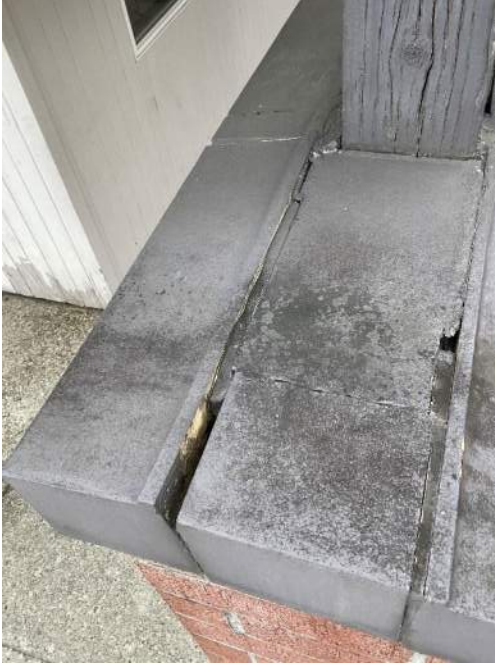
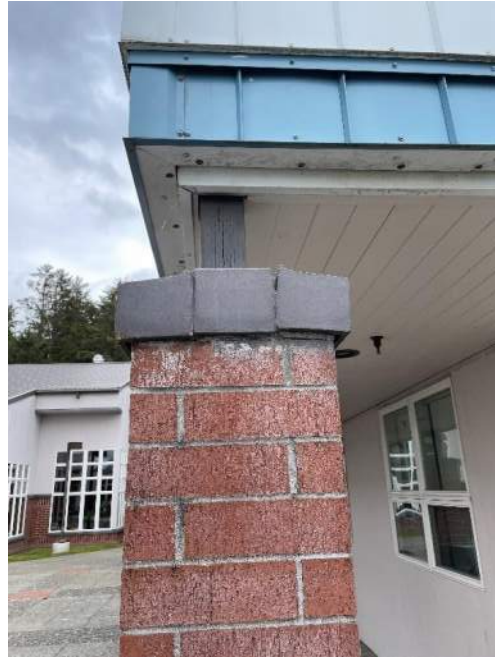
Canopies are in fair condition. The brick cladding the west canopy is in fair condition but the terracotta cap at the southwest corner is damaged.

**A-7:** Repair terracotta wall cap at indicated canopy column cover. Repair to remove and reinstall existing components with new grout, and reseal at preservative treated structural post. Priority #1

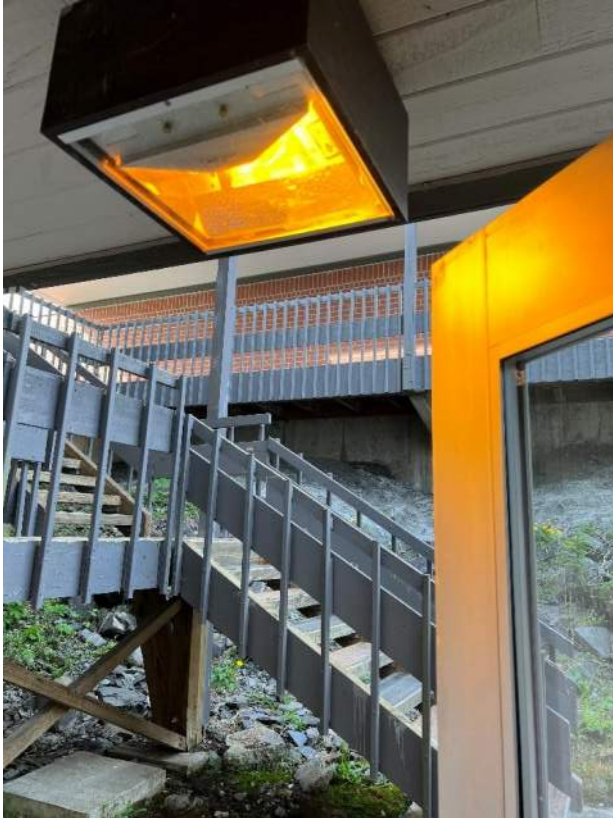
The fixtures are in poor condition.

**E-7:** Replace all exterior lighting fixtures with LED equivalent including fixture housings. Priority #2.

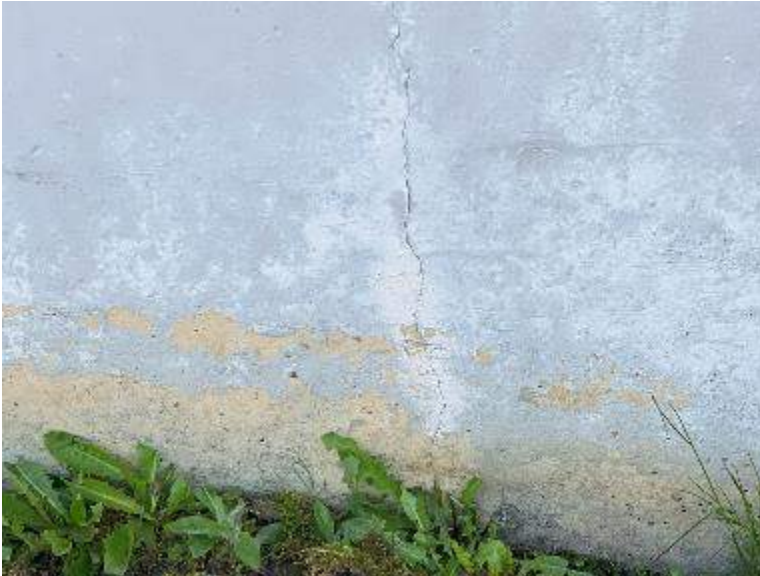
**S-1:** Cracks in the exterior walls of the concrete foundation walls.

*Crack in foundation wall*

**S-1:** Small cracks in the exterior concrete wall for the upper building. These cracks likely occurred during initial construction and are due to temperature and shrinkage. They should be monitored to ensure they are not opening or allowing water infiltration into the foundation. If the cracks are found to be expanding, cracks they should be repaired with structural epoxy. Priority #3

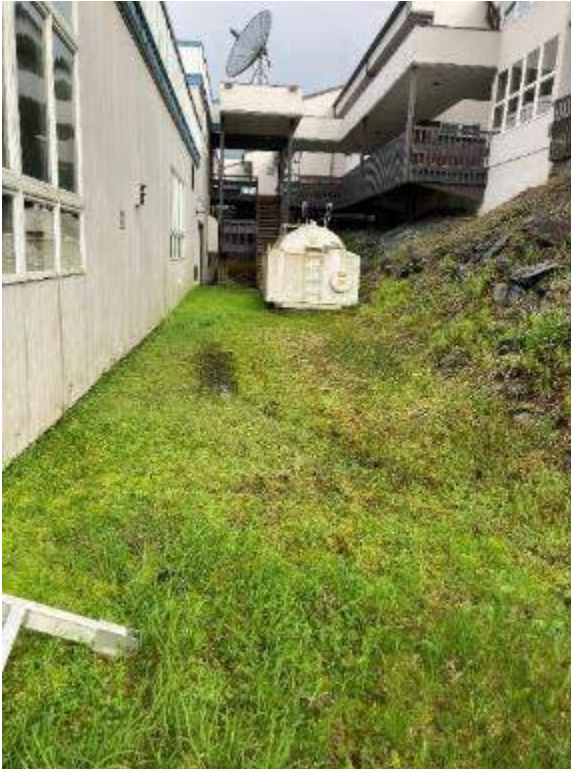
**S-3:** Standing water along the north side of the building. Priority #2

*Standing water on the north side of the building*

**S-3:** Provide drainage along the north side of the building to divert water away from the foundation and building. Priority #1

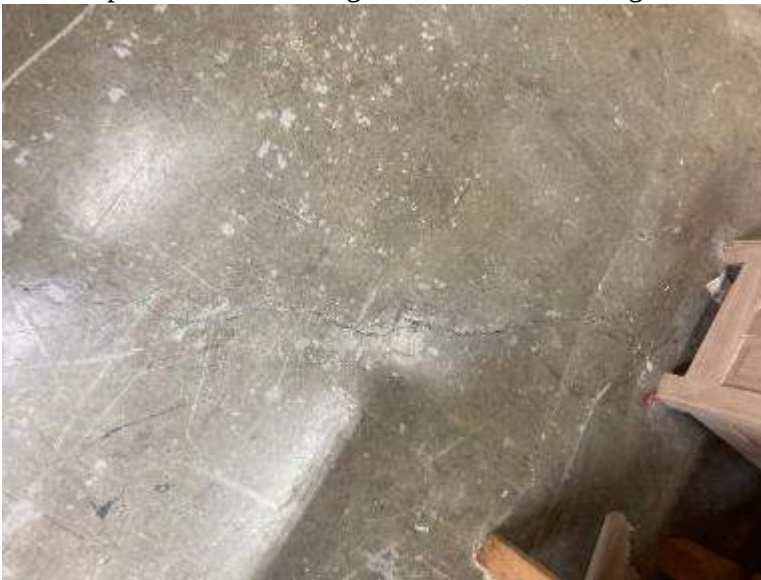
**S-4:** Temperature and shrinkage cracks in the slab on grade.

*Crack in slab-on-grade in shop*

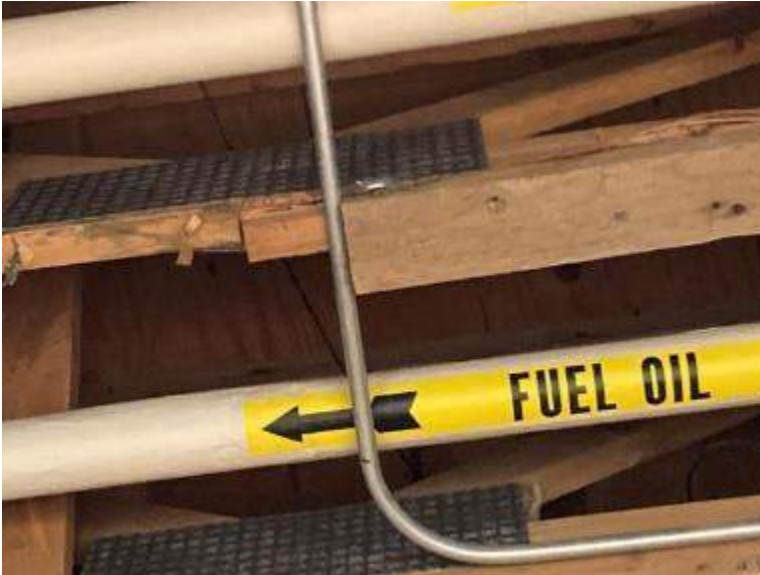
S-5: Timber truss above Snack Room 157 had damage to bottom chord. It is not clear if this happened during original construction or during a renovation.

*Damaged bottom chord of floor truss*

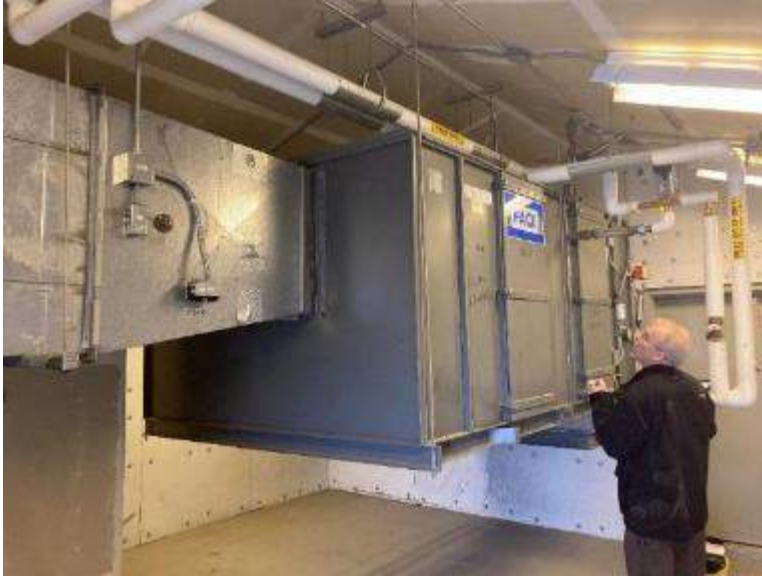
**S-6:** Mechanical unit suspended from mechanical penthouse roof structure not seismically braced.

*Suspended mechanical not seismically braced*

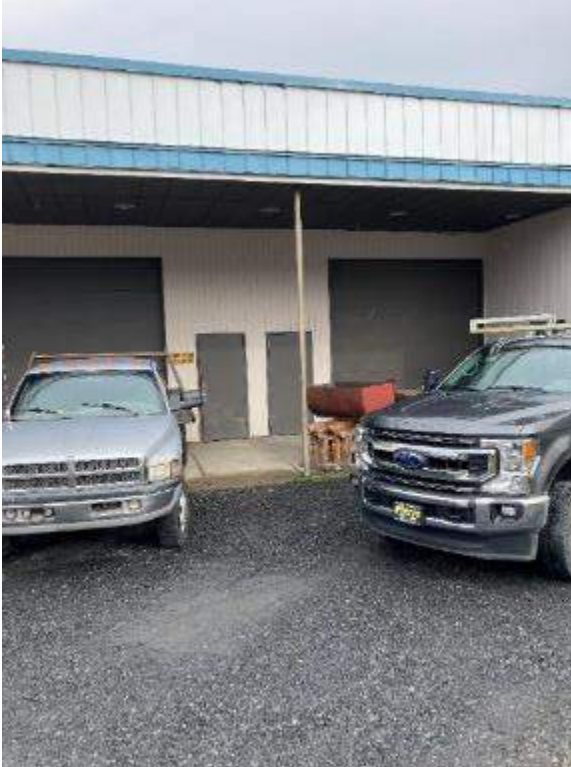
*Unprotected exterior column*

**S-8:** Typically bollards could be installed to protect the column from impact. But due to the size of the column and the proximity to vehicles, recommend the column is encased in concrete its full height. Priority #1

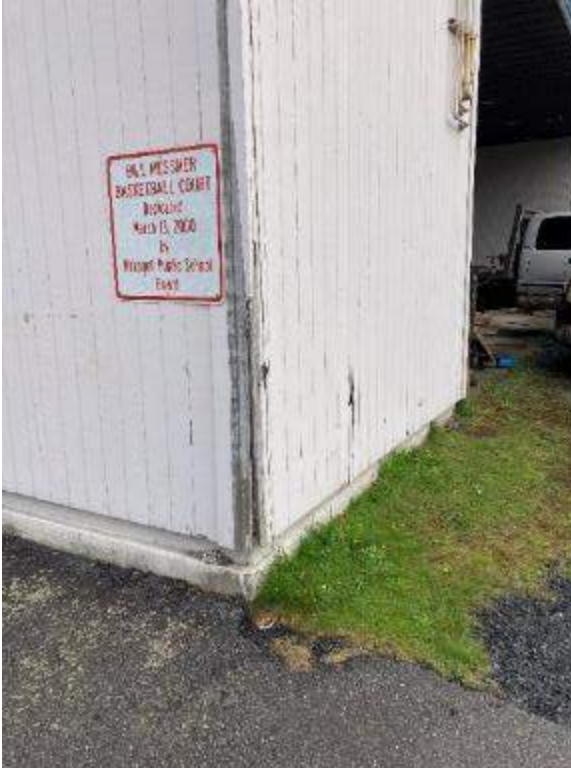
*Vehicular damage to exterior wall*

**S-9:** Install bollards in front of wall to protect the wall from impacts. Priority #1

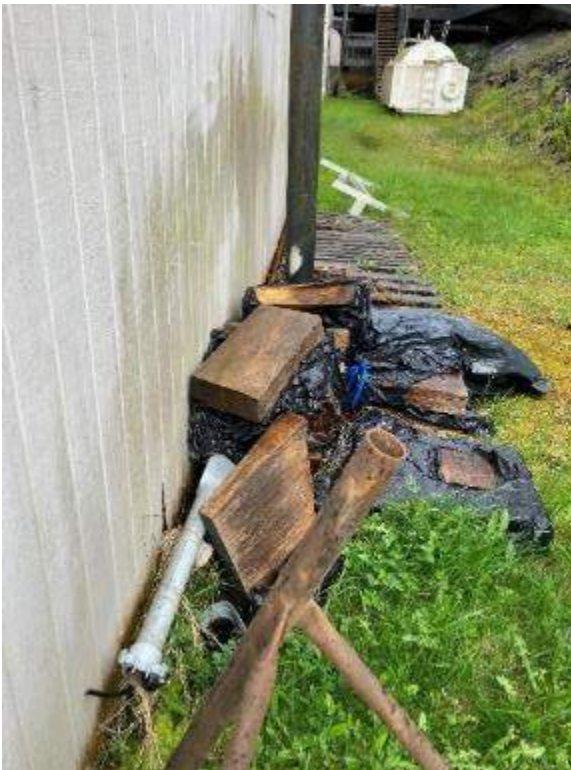
*Materials stored against exterior wall*

**S-10:** Clear material from in front of exterior wall. Priority #2

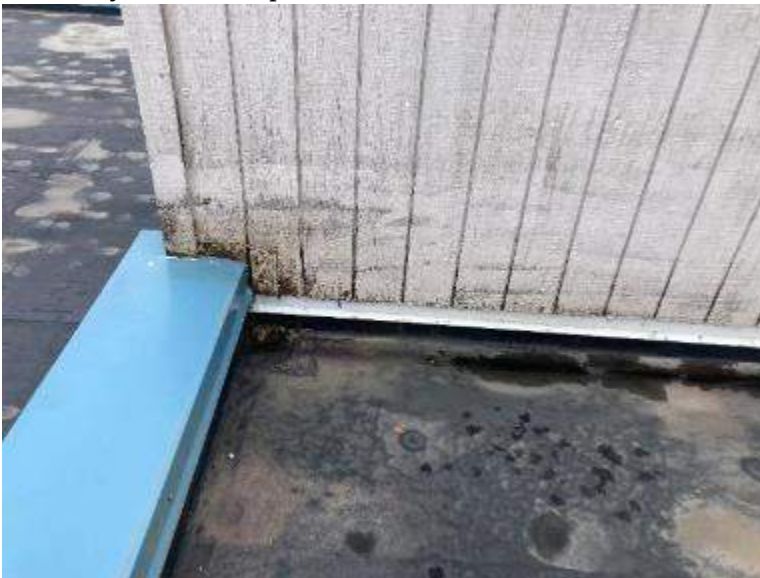
**S-11:** Exterior siding appeared to be in fair condition, but there likely is some rot in the wall sheathing and potentially the wall framing. The mechanical penthouse walls and the wall at deficiency S-10 are of particular concern.

*Rotten siding at base of mechanical penthouse wall*

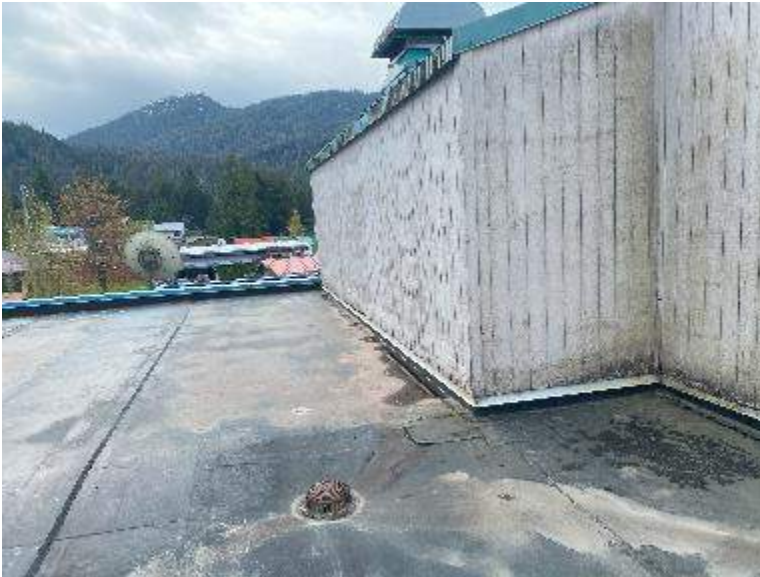
*Siding in poor condition at mechanical penthouse*

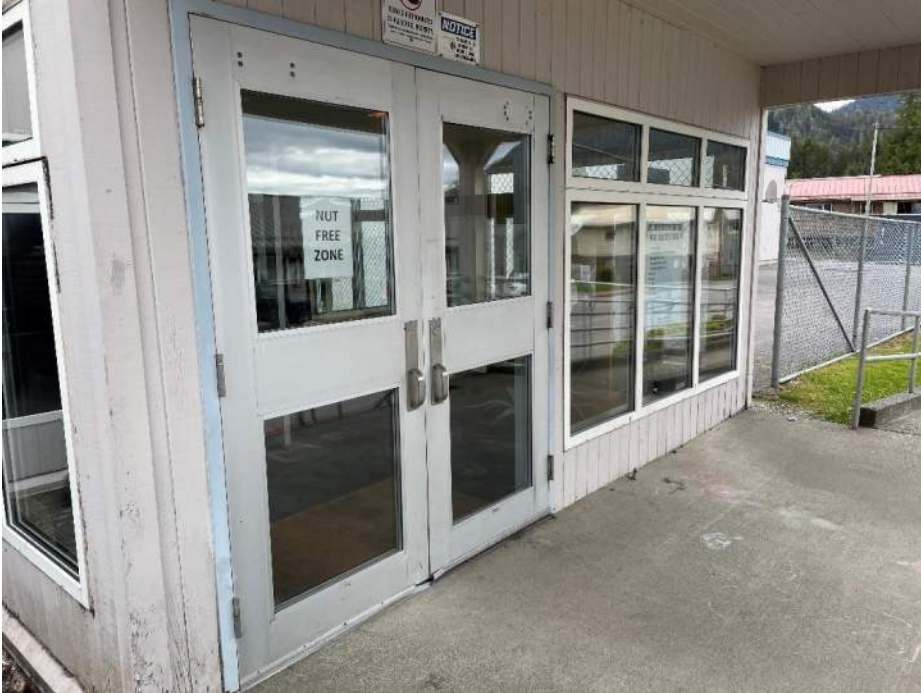
The steel frame at the aluminum entrances exhibit some corrosion at the frame and are clearly subject to harder use, and therefore exhibit greater signs of wear.

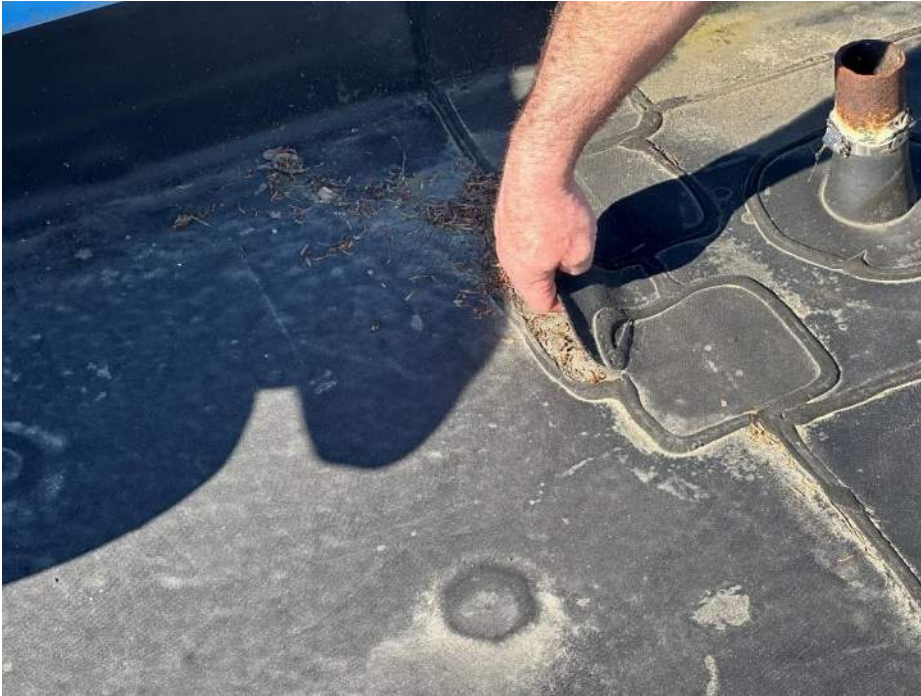
*Delaminating laps in 1995 roof.*

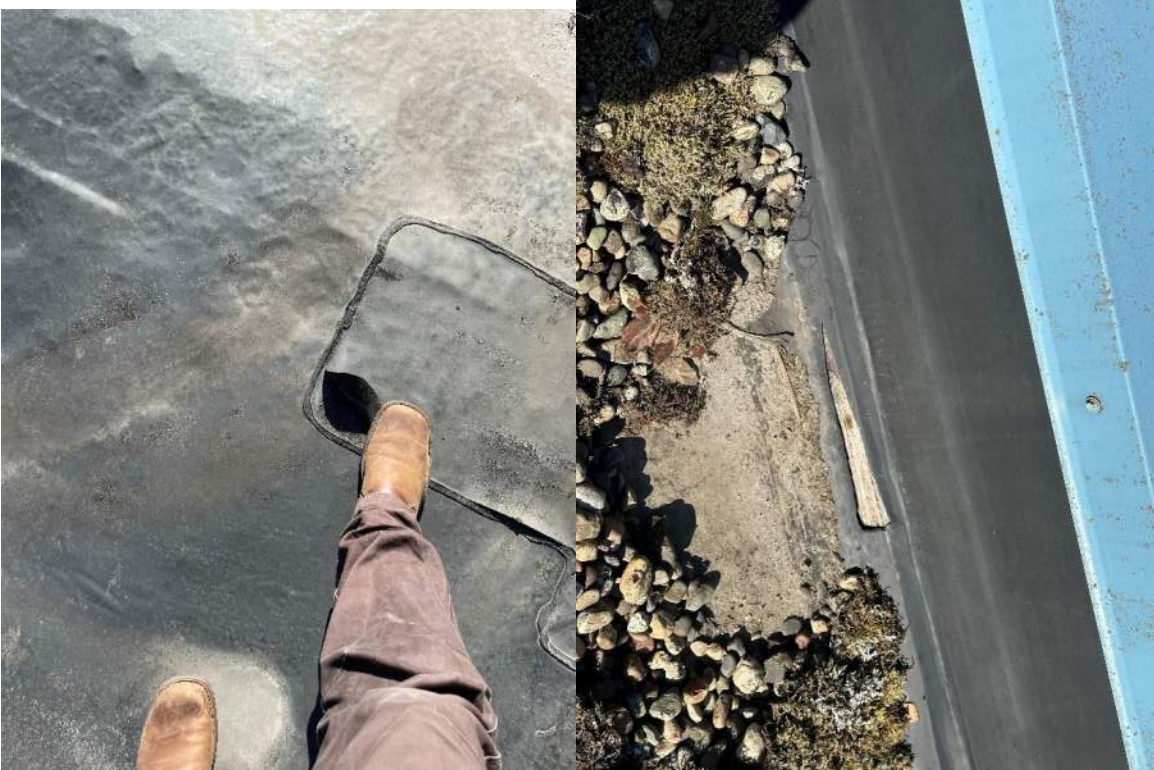
*Delam and water-swelling OSB visible*

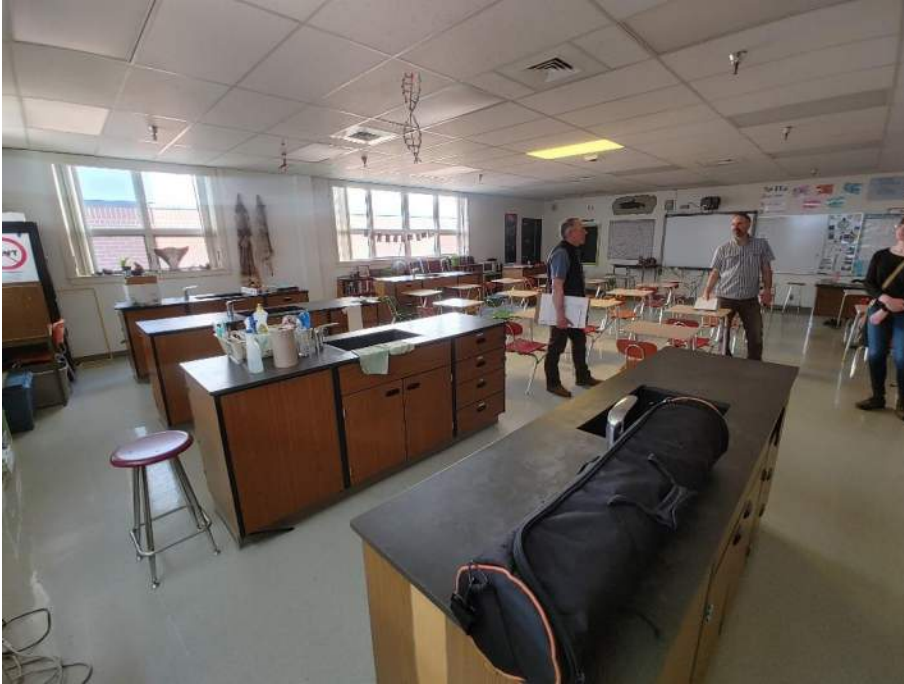
The science classroom laboratory type furnishing have undermounted sinks, the plastic laminate countertops are severely water damaged in all locations.

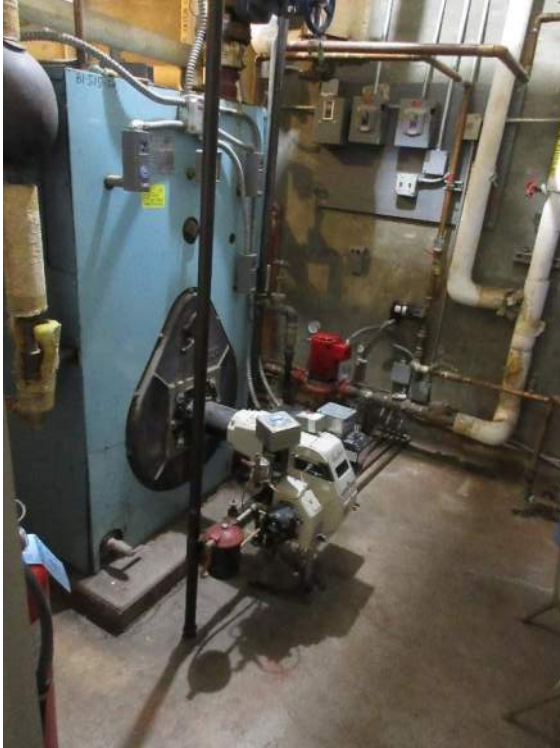
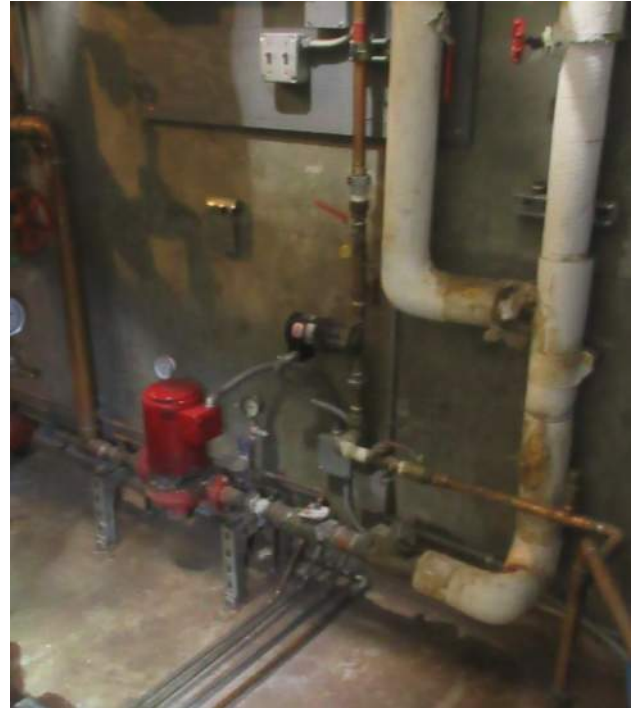
The equipment is generally in marginal to poor condition. The boiler has a leaky section.

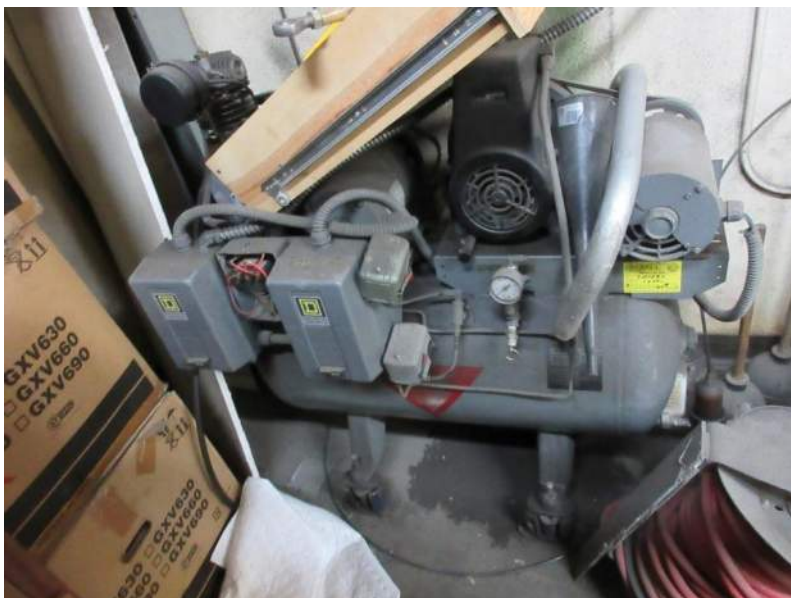
The controls air compressor system is broken and has not operated for several years. Heating for the rooms is manually adjusted by maintenance as needed on a frequent basis (generally weekly).
