Wrangell Public Safety Building Assessment

Final Report

23 February 2021

Wrangell Public Safety Building Assessments

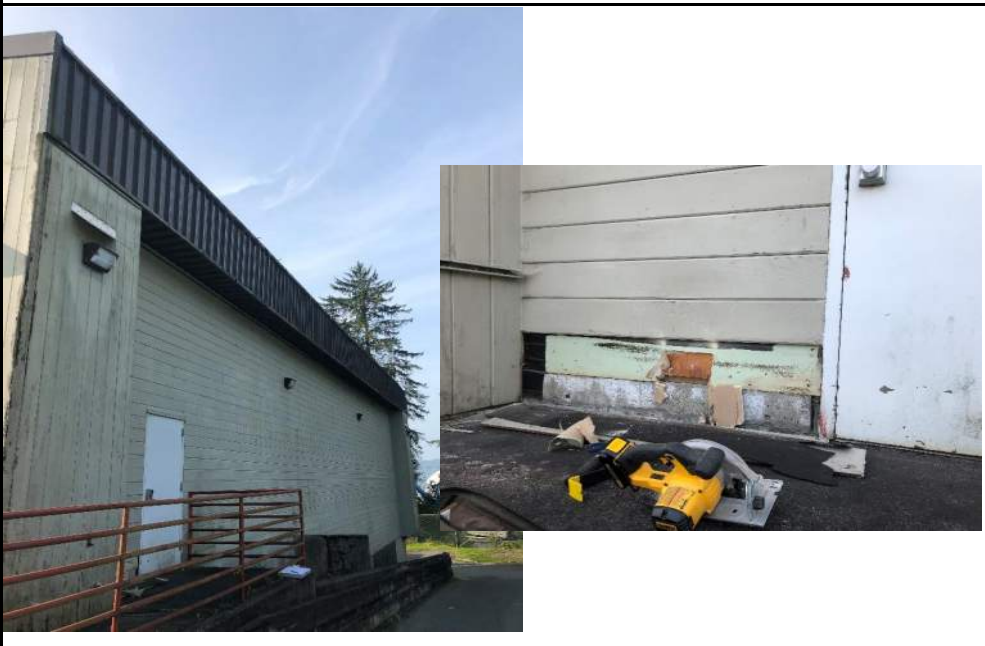
Ref.	Orientation	Observations	Quantity	Recommendations	Photos
1	North Elev.	Cupped and peeling 1x6 T&G cedar siding, solid body stain. substrate appears good at areas of selected demolition.	3307 SF	Repair structure and replace ALL siding with new Kynar coated metal panels configured as vented rainscreen over 1.5" rigid insulation and robust weather barrier.

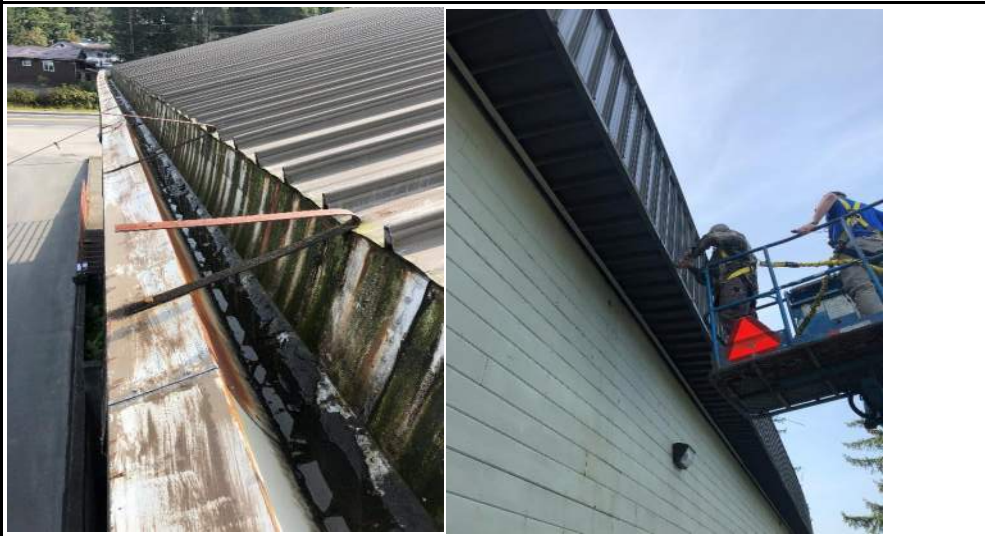
2	North Elev.	Failing gutter/soffit assembly. Structurally unstable and temporary support straps are breaking away. Soffit assembly 4' tall x 2'-6" deep, gutter integrated into top of it.	75 LF	Remove gutter and soffit assembly (wood framed, 4' tall, 2'-6" deep), reconstruct new soffit and outside gutter.

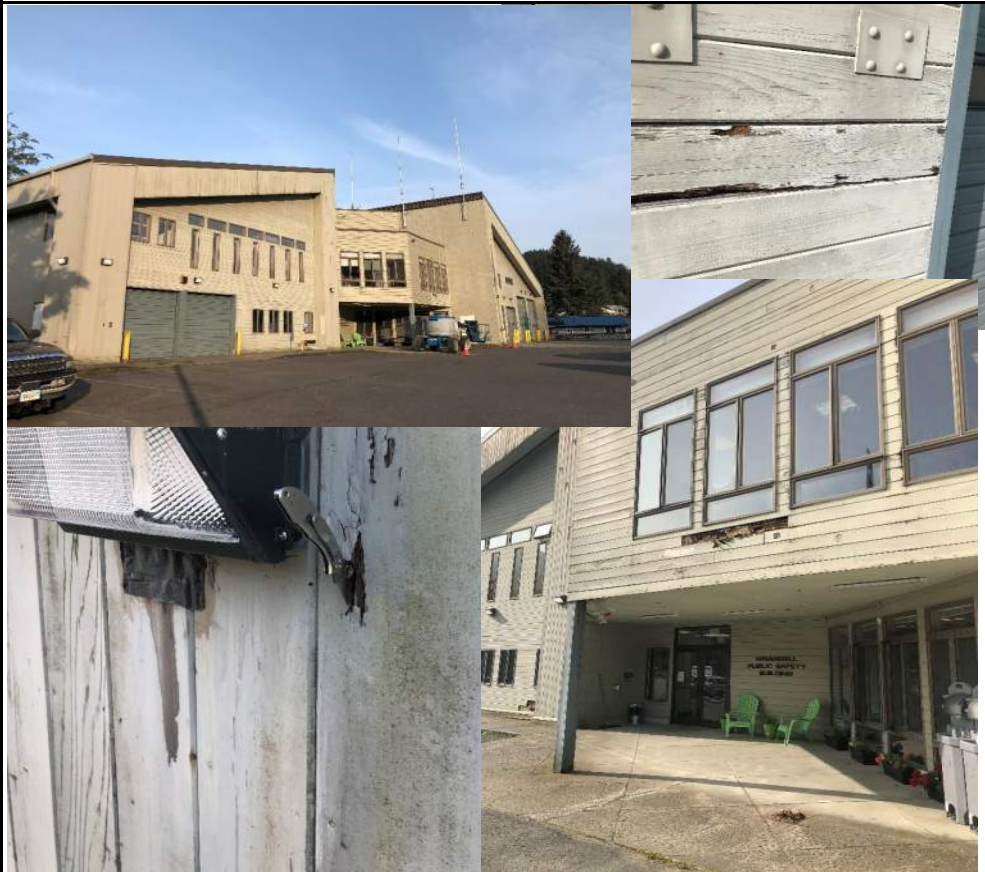
Ref.	Orientation	Observations	Quantity	Recommendations	Photos
4	East Elev.	Cupped and peeling 1x6 T&G cedar siding with solid body stain, noted areas of severe rot at substrate and siding between bay doors and above front entry.	4980 SF	Replace all siding and underlayment with new metal siding including 1.5" rigid outside insulation and weather barrier. Investigate framing, sheathing and gypsum board overlay as part of siding replacement. Repair rotten framing and sheathing where required (anticipate 15% of wall area). Repair structure and replace ALL siding with new Kynar coated metal panels configured as vented rainscreen over 1.5" rigid insulation and robust weather barrier.

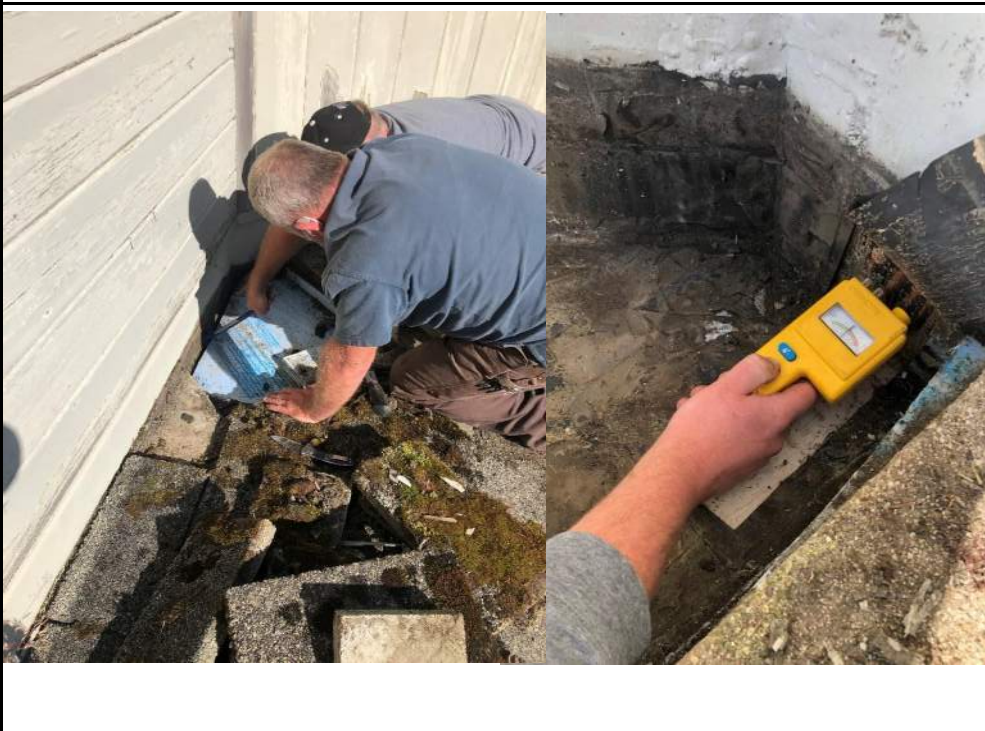
Ref.	Orientation	Observations	Quantity	Recommendations	Photos
6	South Elev.	Grid C: Cupped and peeling 1x6 T&G cedar siding with solid body stain, severely deteriorated with areas of rotten siding material.	1014 SF	Replace all siding and underlayment with new metal siding, including 1.5" rigid outside insulation and weather barrier. Investigate framing, sheathing and gypsum board overlay as part of siding replacement. Repair rotten framing and sheathing where required (anticipate 25% of wall area). investigations looked at wall and roof assembly with high moisture readings in sheathing. Repair structure and replace ALL siding with new Kynar coated metal panels configured as vented rainscreen over 1.5" rigid insulation and robust weather barrier.

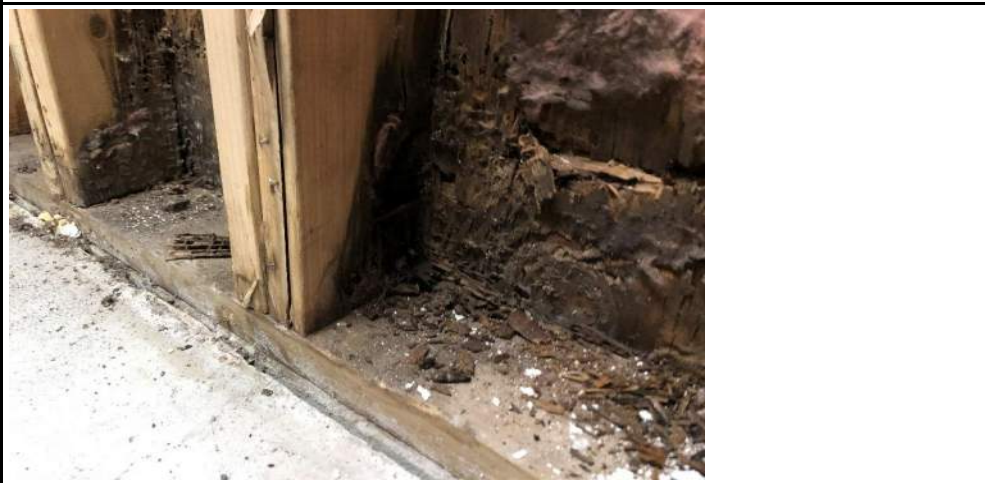
7	South Elev.	Insect infestation and severe deterioration at base of wall, police parking garage.	anticipate 60 LF damage	Will require full removal of metal siding to ascertain extent. 20 lf of lower wall identified in visit. Likely more, as well is an unvented sealed assembly with significant roof leak above. Repair structure and replace ALL siding with new Kynar coated metal panels configured as vented rainscreen over 1.5" rigid insulation and robust weather barrier.

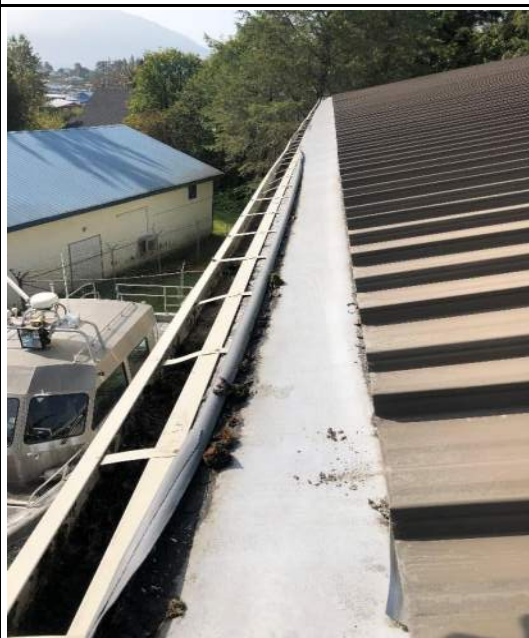
Ref.	Orientation	Observations	Quantity	Recommendations	Photos
8	South Elev.	Gutter system added in 2008 is falling apart and membrane flashing associated with that work is delaminating.	85 LF	Remove gutter and reconstruct new gutter and roof edge assembly with metal roofing panels to ensure weatherproof assembly.

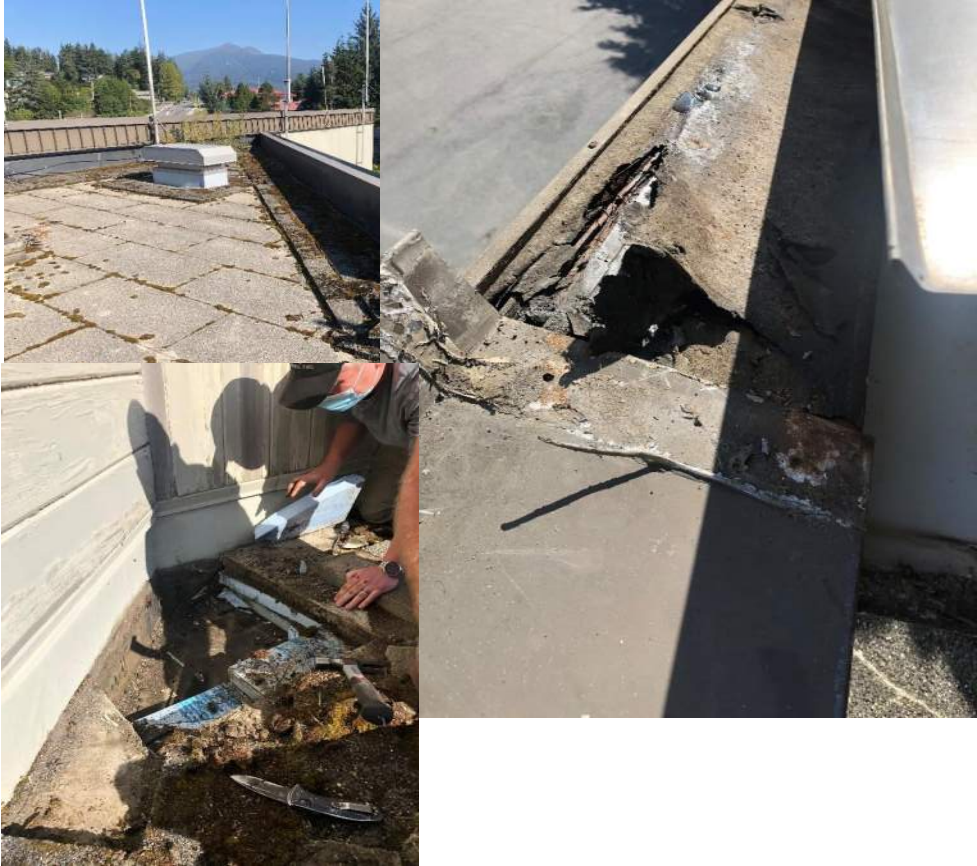
Ref.	Orientation	Observations	Quantity	Recommendations	Photos
	Flat Roof		3,300 SF	ON TWO LEVELS	
10		<p>Protected Membrane Roof assembly (PMR): 1.5" polyisocyanurate backed concrete paver and 4" XPS insulation, self ballasting, over 027 18AAHF Carlisle reinforced EPDM membrane. Slope to drain is impeded by soil and plant growth filling voids in the insulation and paver assembly. Membrane extends up but not over top of parapet under sheetmetal coping, typical. Where coping removed for inspection, parapet framing is severely deteriorated. Drainage overflow is accommodated via scuppers, which appear to leak. North side roof overflow at a failed scupper assembly is likely the primary cause of deterioration of wall, roof and floor structure below, on grid 1, between grids E and C.</p>		<p>Roof to be replaced. Remove all ballast, and insulation. remove existing roofing where required to make structural decking repairs. Patch remaining existing EPDM to serve as vapor retarder. Install R50 average tapered rigid insulation assembly, cover board and new 80-mils reinforced EPDM roof. Install new cast iron drains and install overflow drain system. Reconstruct 180 lf of parapet to 32" taller elevation (42"for OSHA). anticipate 10% roof sheathing replacement. note increase of siding area in siding quantity calculations. Lap roofing up and fully over top of parapet, sealing to weather barrier. provide new sheetmetal coping caps.</p>

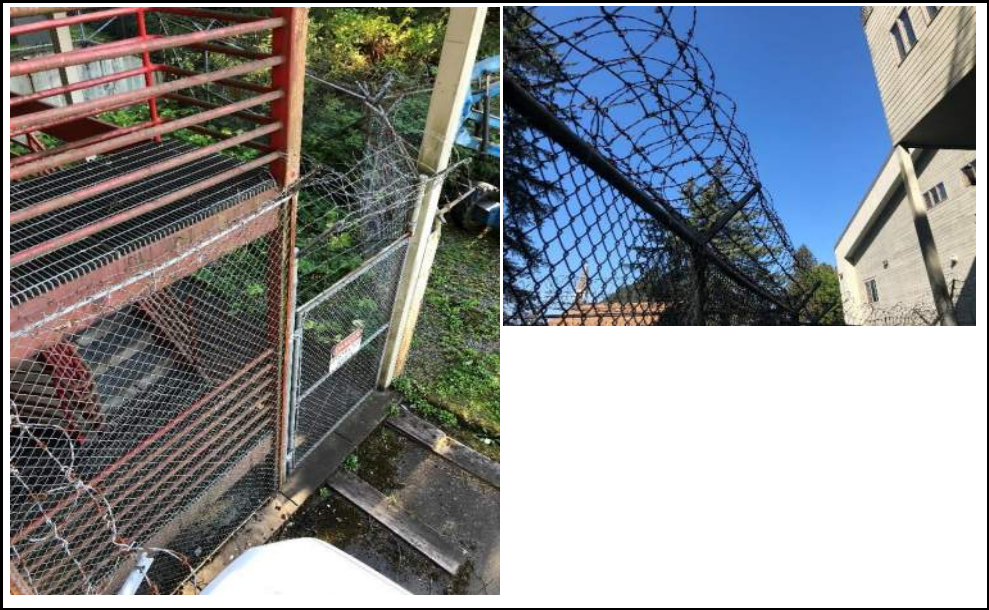
Ref.	Orientation	Observations	Quantity	Recommendations	Photos
13	Secure Recreation Yard	10' tall chainlink fence with coiled barbed wire at top, serving jail patrons. No longer in use due to minimal security confinement, however the need for this space may be mandated by law if people are being detained for extended periods of time.		Reovation to replace fencing with detention grade chain link enclosure panels full height of volumn, and enclosing access stair. Anticipate 45 LF of enclosure 24 feet tall, with one manual high security gate to exterior.

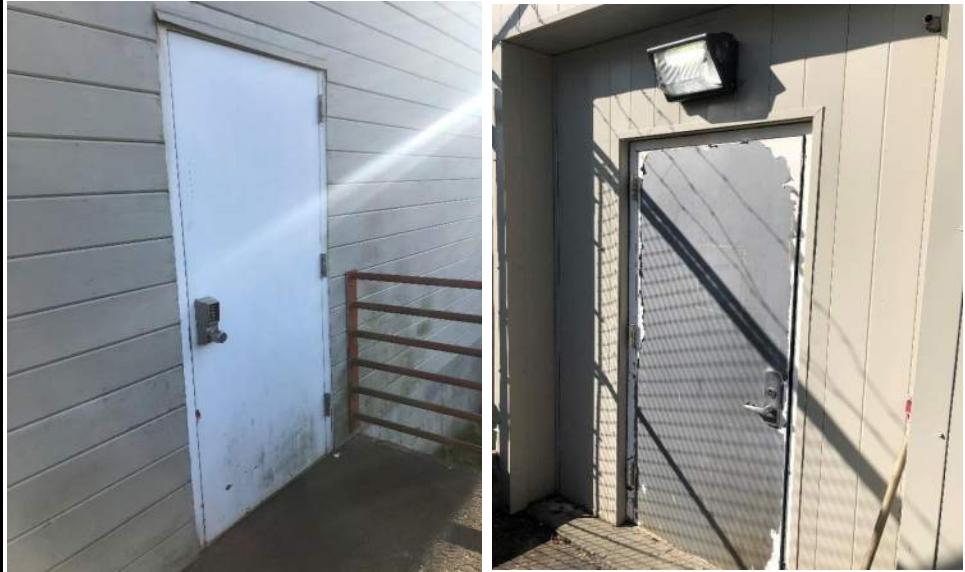
Ref.	Item	Observations	Quantity	Recommendations	Photos
1	Exterior Doors	Commercial Hollow metal, hinged	8	Hollow metal, typ. Fair to poor condition. Replace

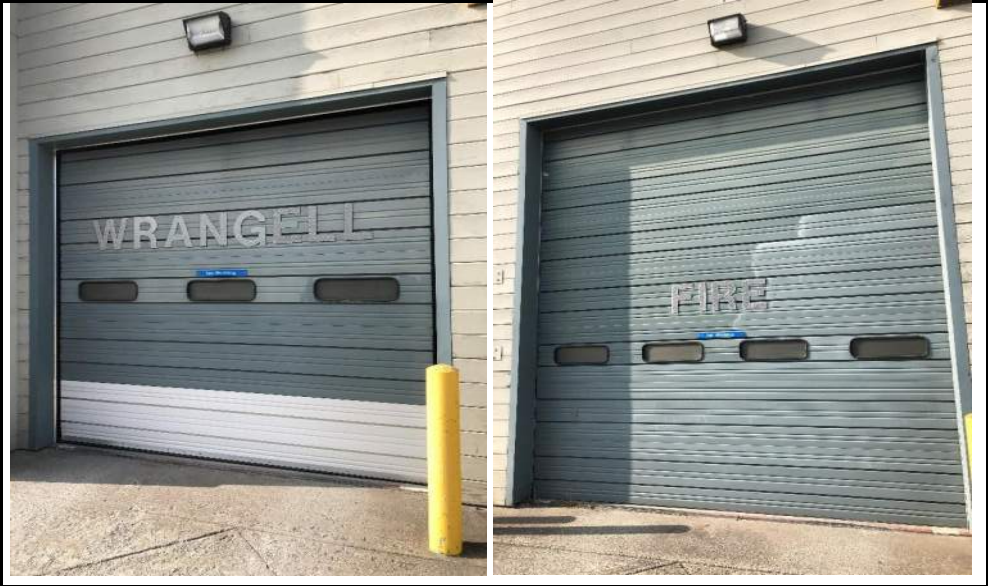
Ref.	Item	Observations	Quantity	Recommendations	Photos
3	Exterior Doors	Overhead doors - insulated section doors with motor-opperators.	6	Insulated sectional, fair condition, some dents and peeling paint, but all fully functional with electric motor operators. Replace dented panels, refinish exterior.

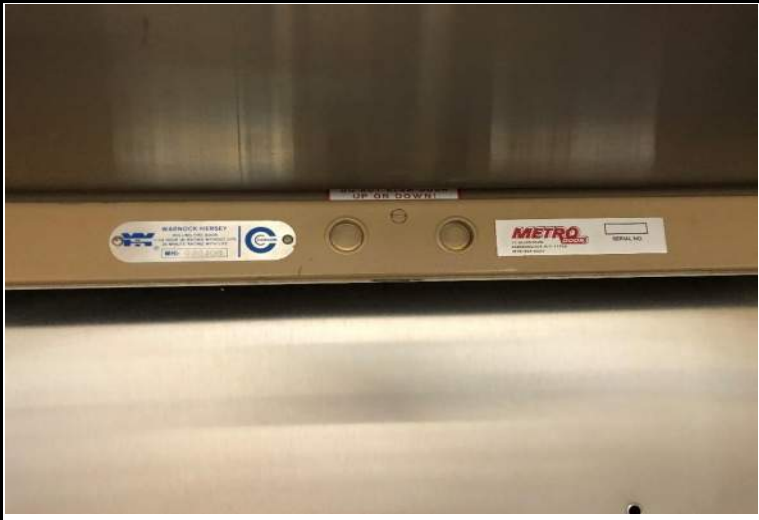
Ref.	Item	Observations	Quantity	Recommendations	Photos
7	Interior Doors	Overhead coiling counter	2	Aluminum at Jail laundry securement. Good condition.	
8	Interior Doors	Overhead coiling fire shutter	3	At elevators Automatic device not functioning, will close manually. Repair for automatic closure or replace

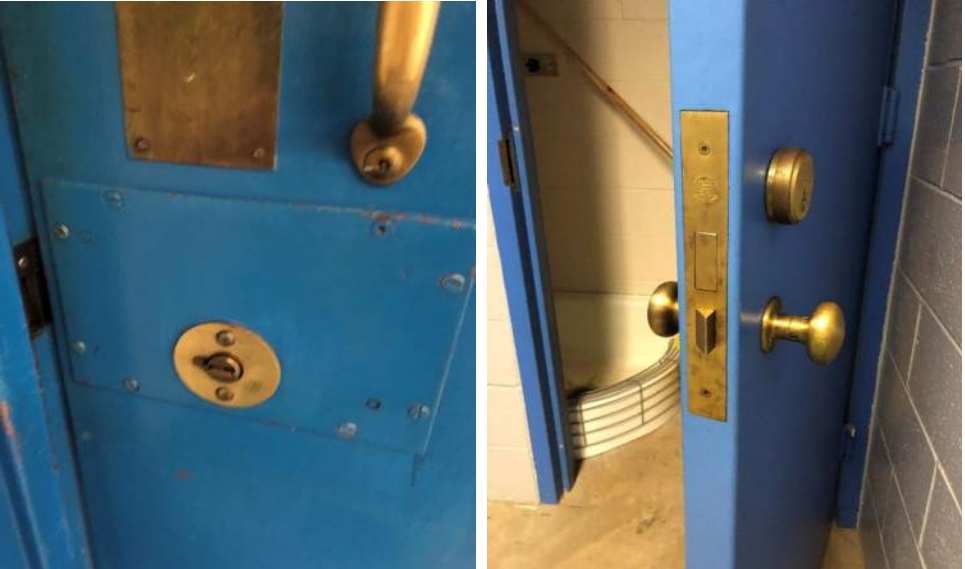
Ref.	Item	Observations	Quantity	Recommendations	Photos
13	Detention door hardware	Mechanical paracentric typical at main cell and traffic doors and access panels, one high security lock set at janitors closet. Detention pulls, push plates, strikes and receiver.		Folger Adams mortice locksets (in doors) - good condition. Bronze material and finish. Noted these doors are not electronically controlled or monitored, and therefore do not meet ACA Core Jail standards. Correct this in a renovation.

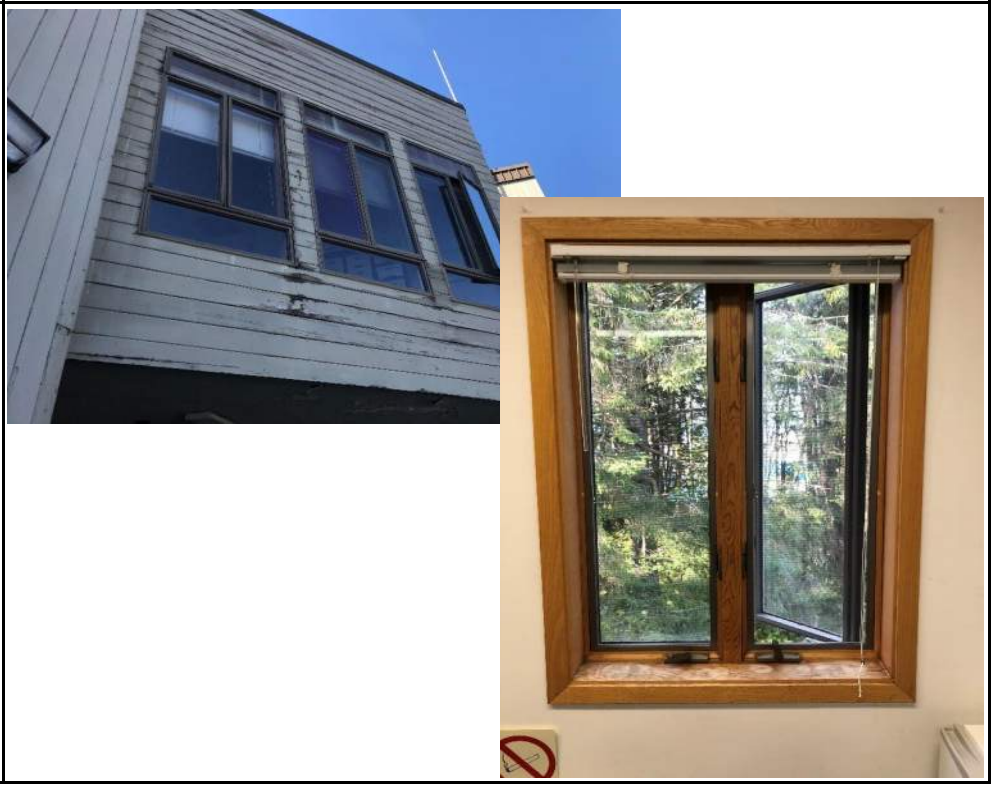
Ref.	Item	Observations	Quantity	Recommendations	Photos
19	Exterior Windows	Andersen, typ.	61	Vinyl clad wood. Mix of functional and non-functional operators. Older assemblies, poor thermal performance. One in particular at south stair well is in very poor condition.

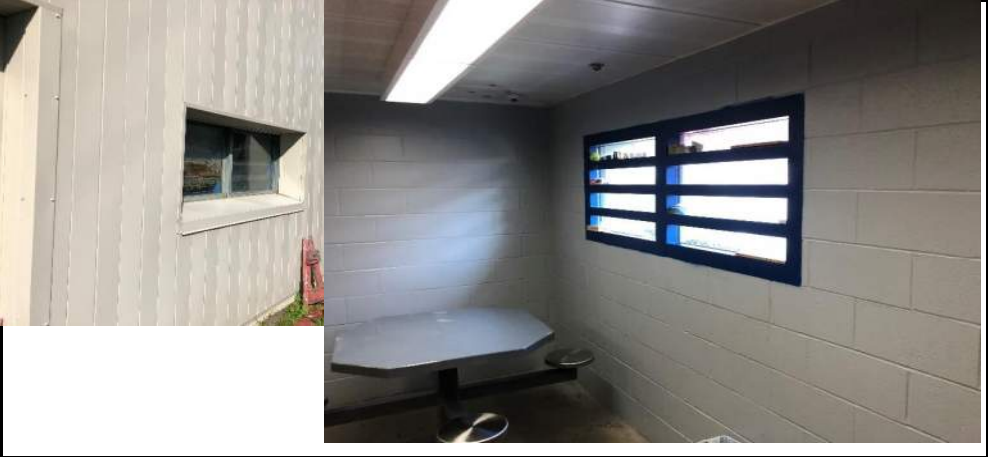
<i>Ref.</i>	<i>Item</i>	<i>Observations</i>	<i>Quantity</i>	<i>Recommendations</i>	<i>Photos</i>
22	Exterior Windows	Detention hollow metal exterior windows.	6	Fully grouted detention hollow metal frames in CMU construction, secure jail area. Overlain on outside with polycarbonate sheet for enhanced thermal. Frames and detention glazing in good conditions. Plastic exterior overlay material in fair to poor condition.

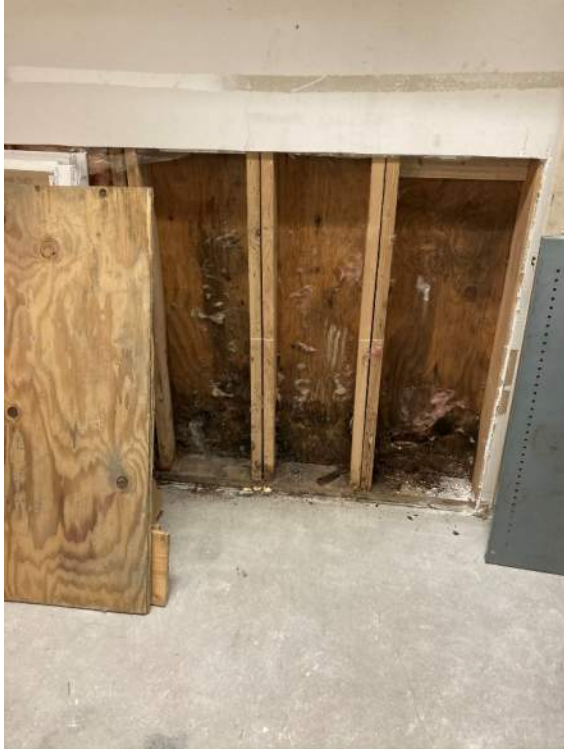
Photo 5a – Deterioration at base of exterior wall

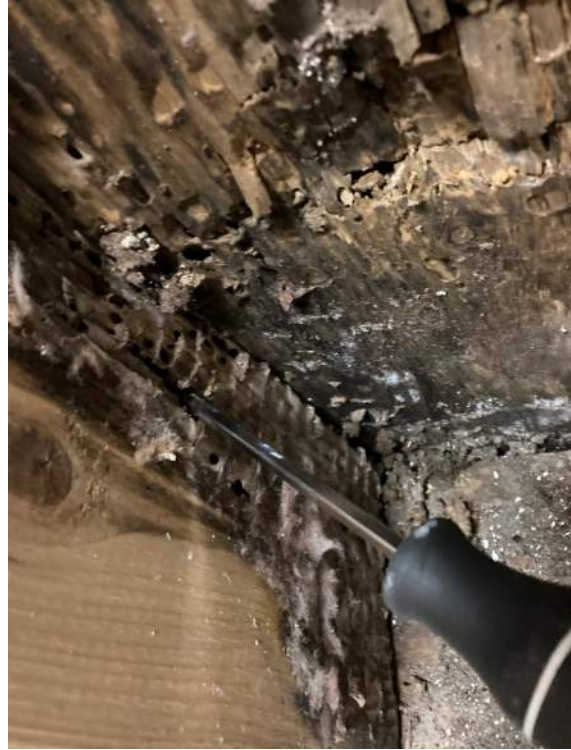
Photo 5b – Dry rot and carpenter ant damage at base of exterior wall

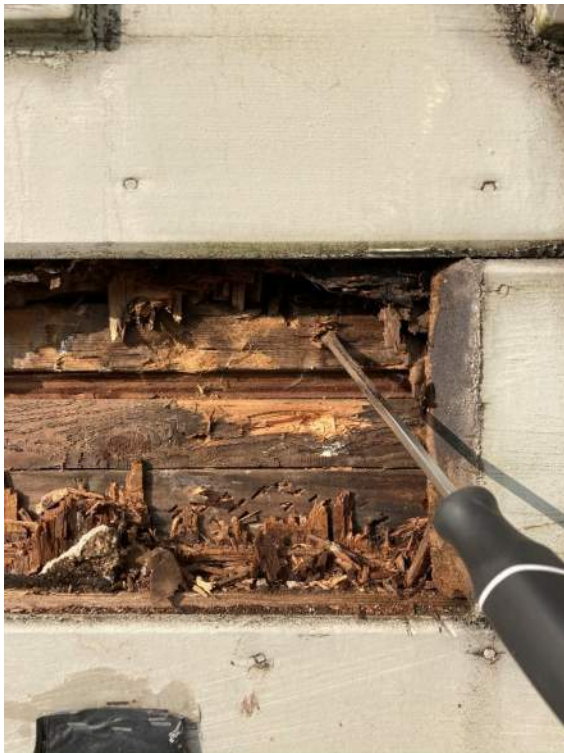
Photo 7a – Dry rot in exterior wall at Level 2 floor

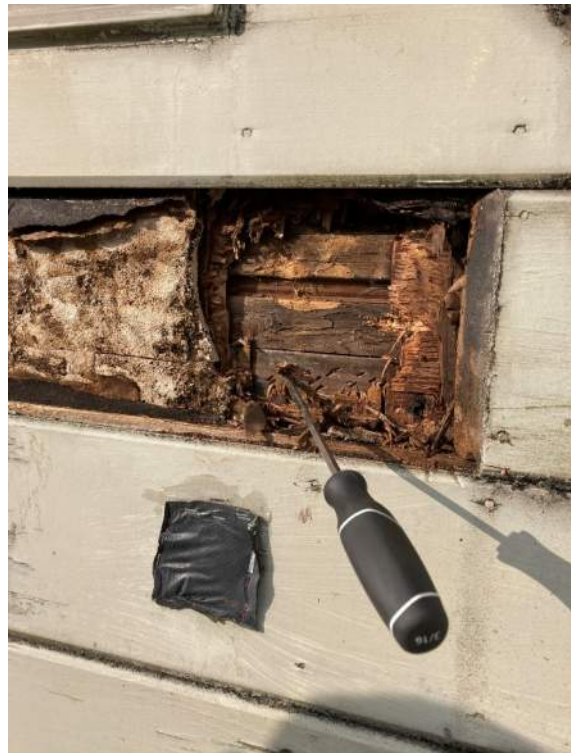
Photo 7b – Dry rot in exterior wall at Level 2 floor

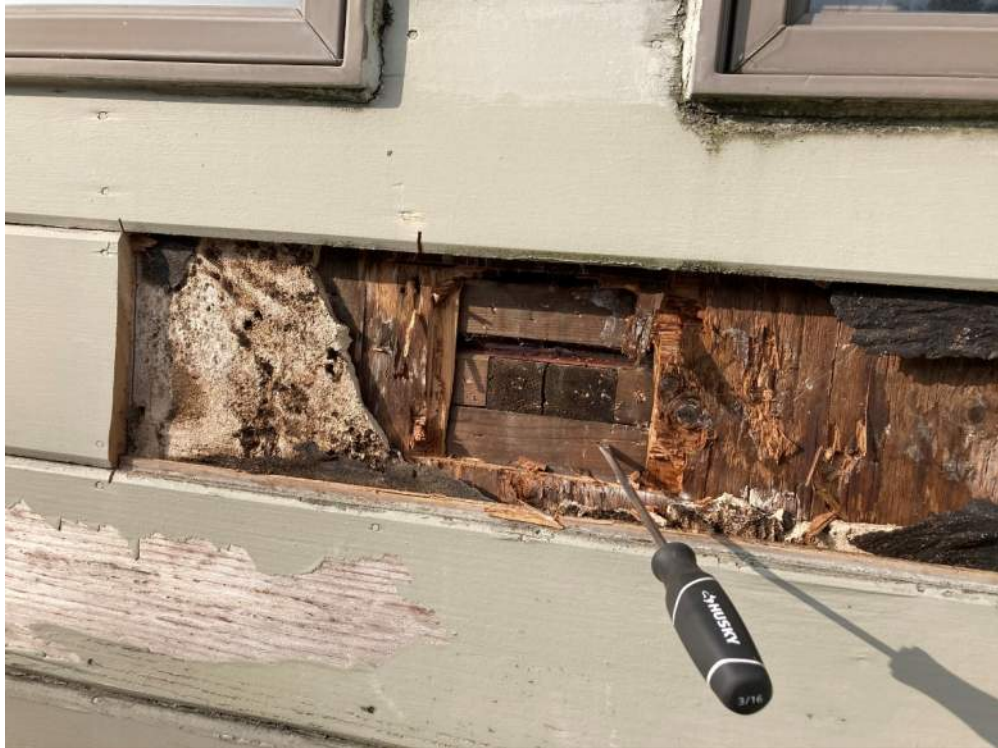
Photo 7c – Dry rot in exterior wall at Level 2 floor

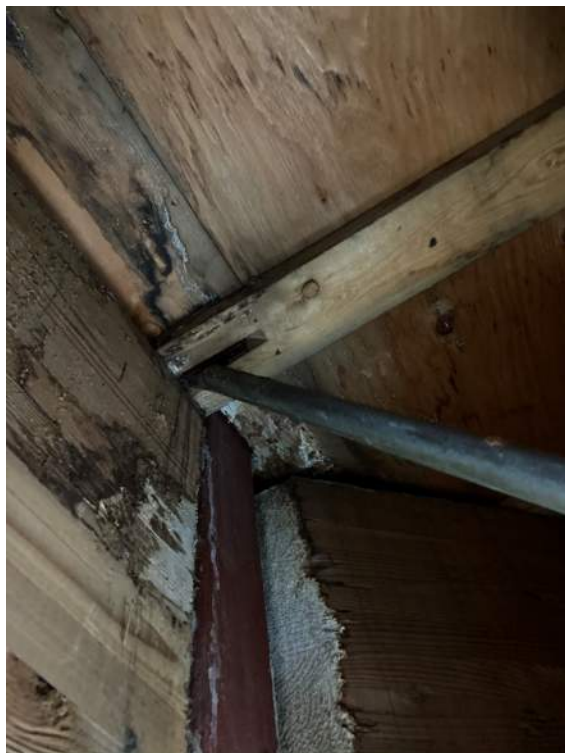
Photo 8 – Water stains on floor sheathing and glu-lam beams at exterior wall at Level 2 floor

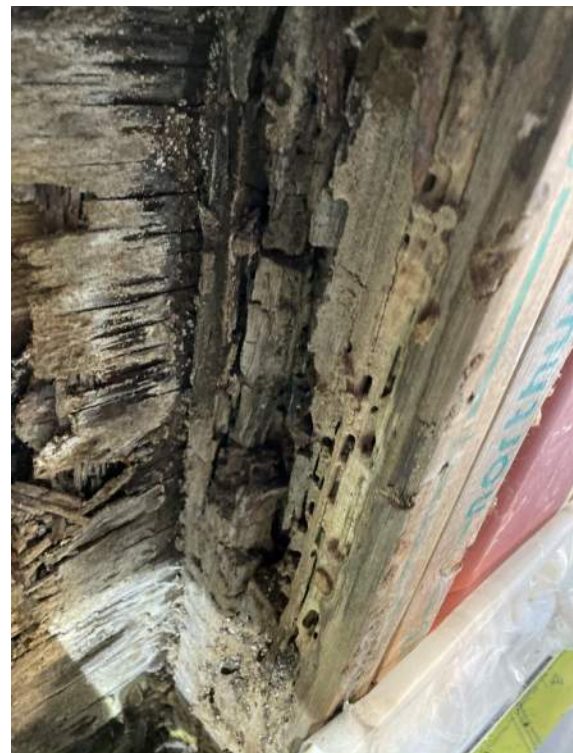
Photo 12a – Dry rot and carpenter ant damage at base of exterior wall

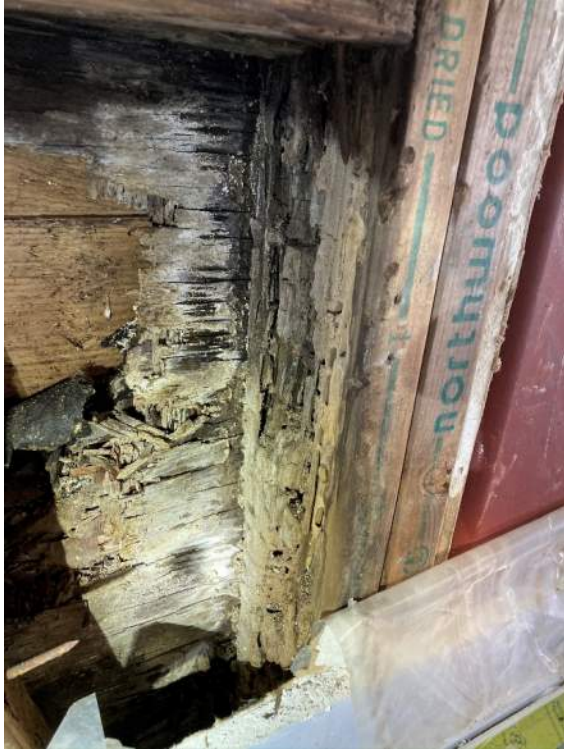
Photo 12b – Dry rot and carpenter ant damage at base of exterior wall

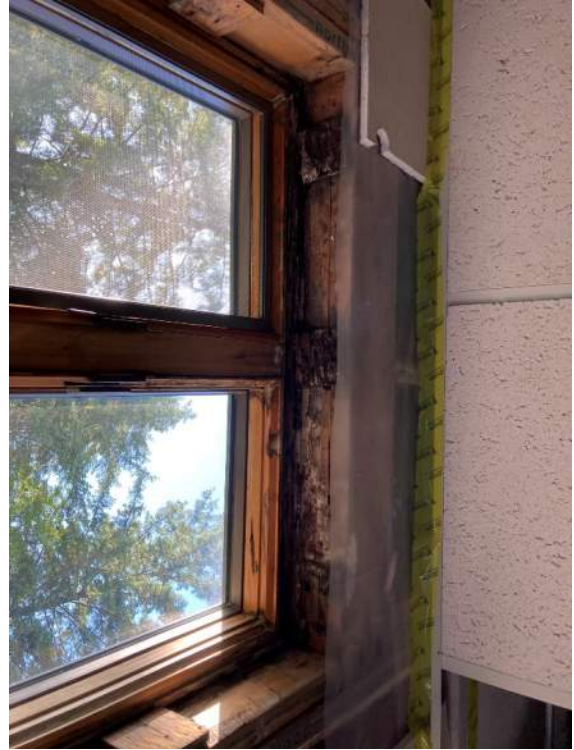
Photo 12c – Deterioration at window in exterior wall

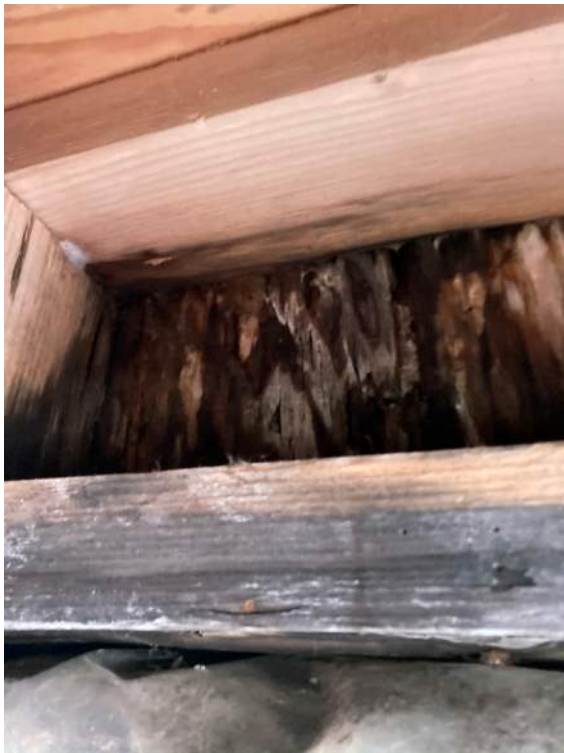
Photo 13 – Deterioration at exterior soffit at Level 2

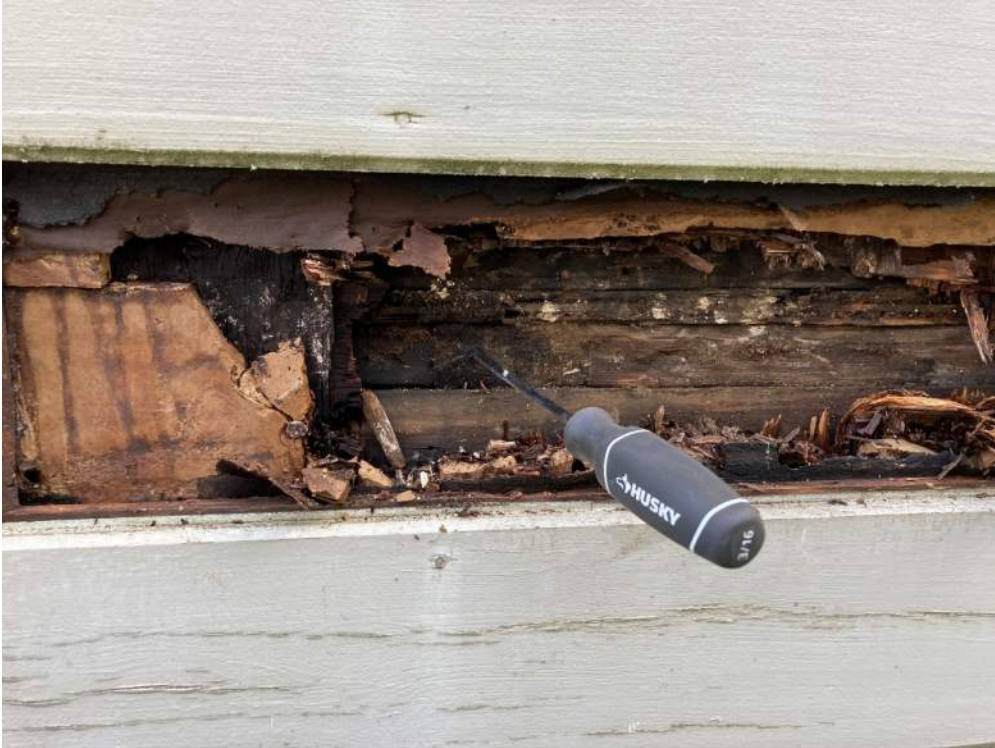
Photo 14a – Rot in exterior wall at Level 2 floor

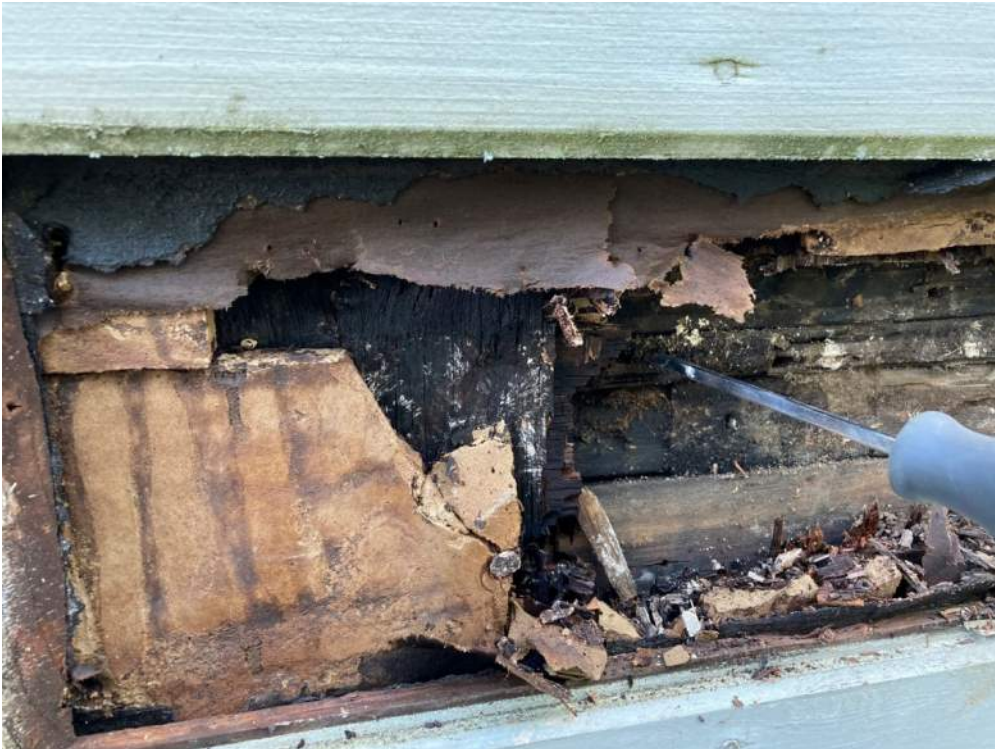
Photo 14b – Rot in exterior wall at Level 2 floor

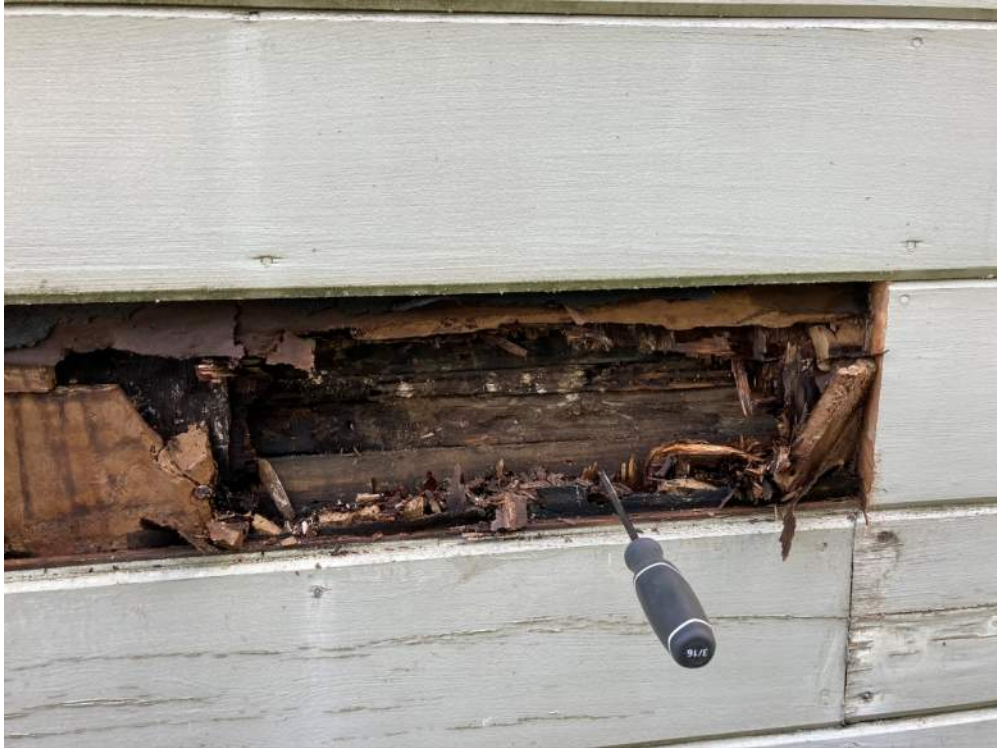
Photo 14c – Rot in exterior wall at Level 2 floor

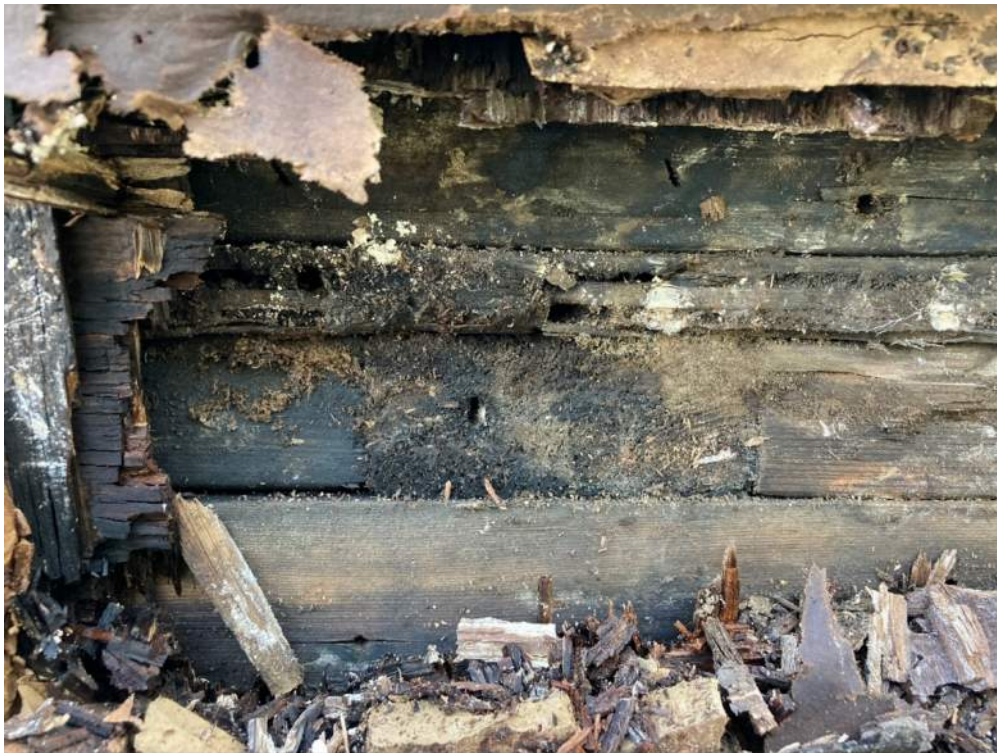
Photo 14d – Rot in exterior wall at Level 2 floor

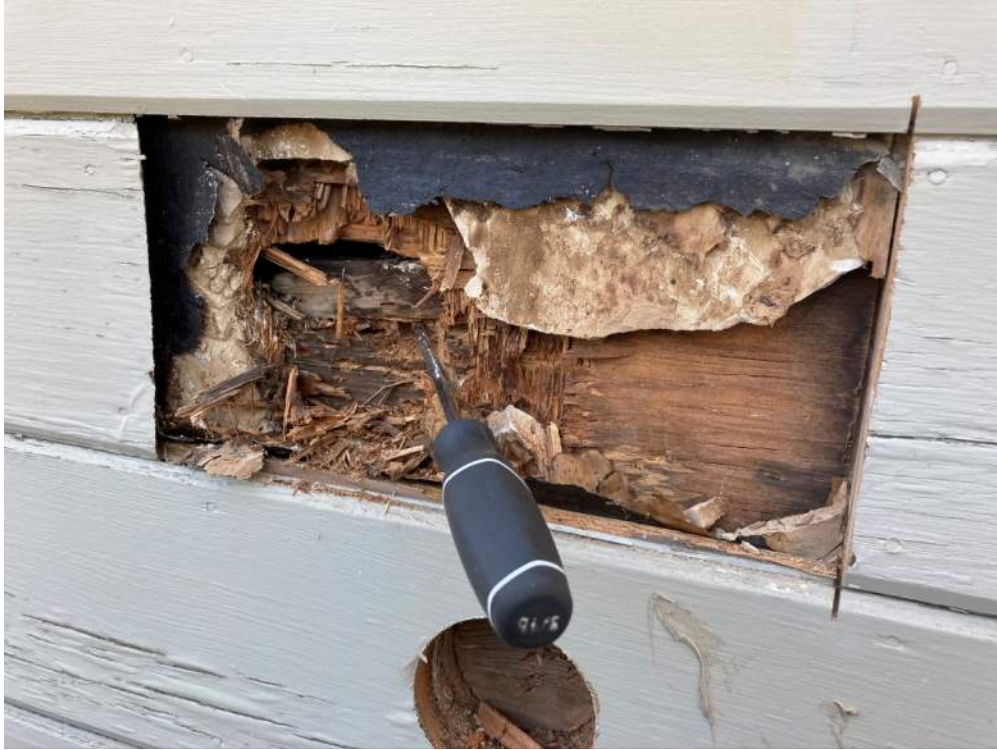
Photo 16 – Dry rot in exterior wall at roof

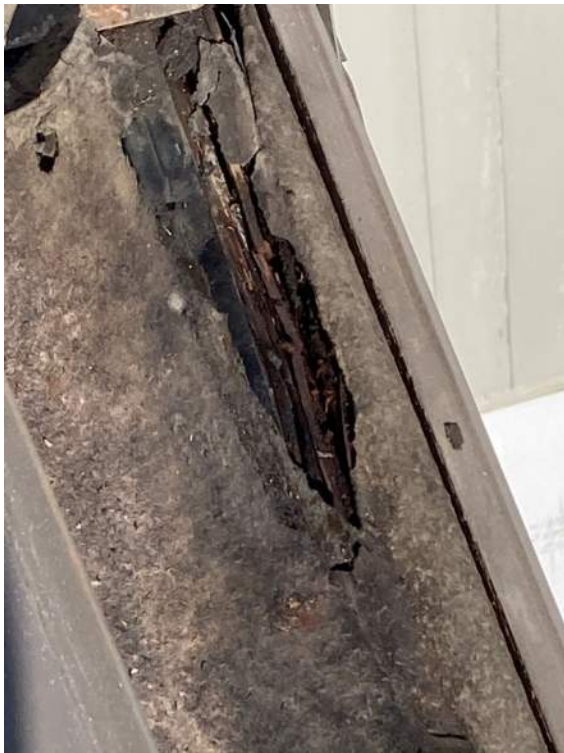
Photo 17 – Rot in exterior wall parapet

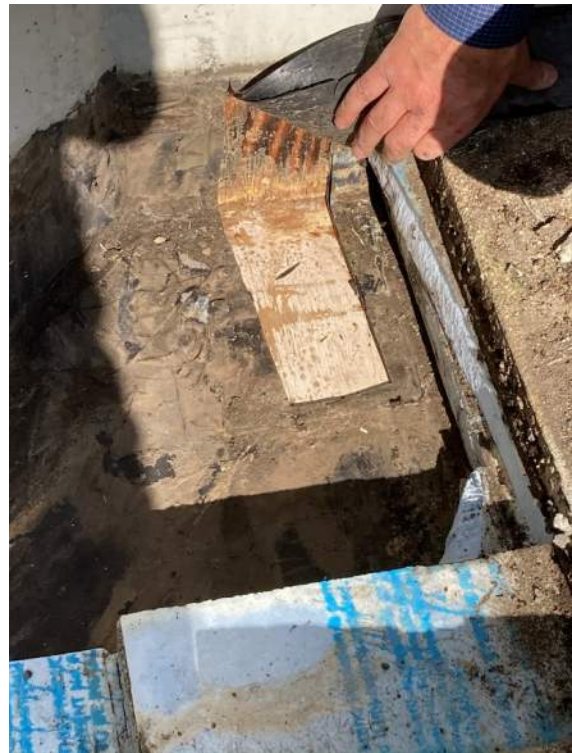
Photo 18 – Damp wall sheathing and roof plywood

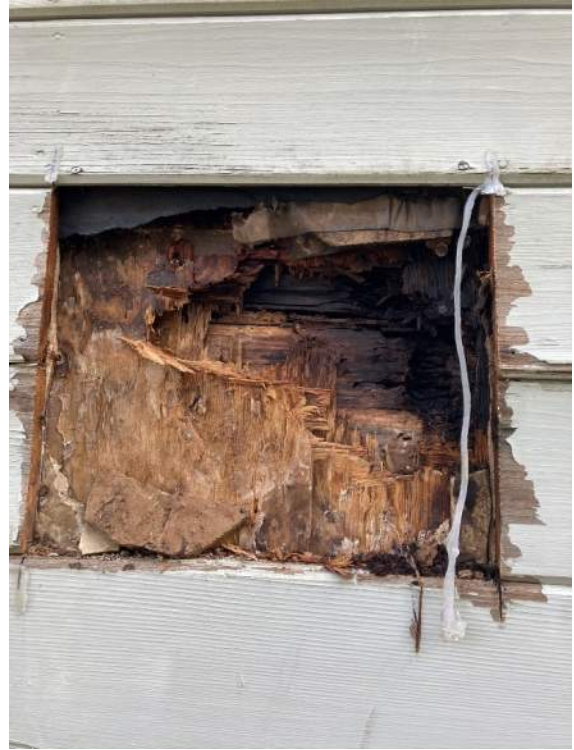
Photo 23a – Rot in exterior wall at roof

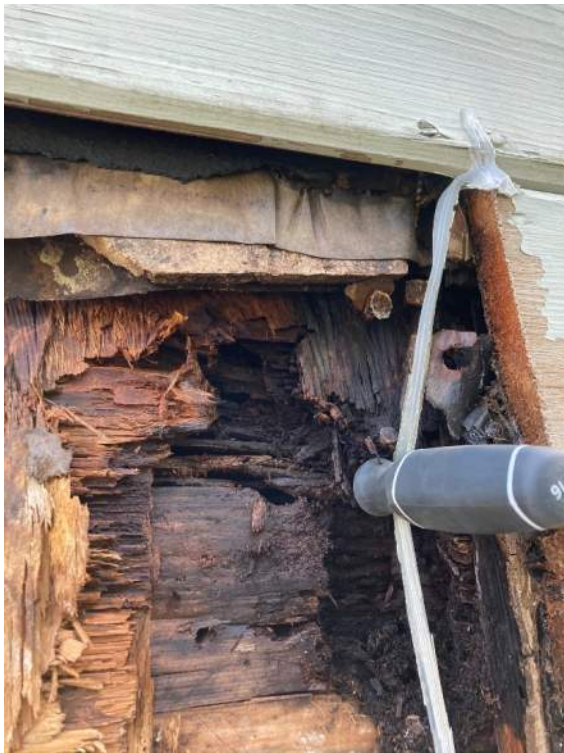
Photo 23b – Rot in exterior wall at roof

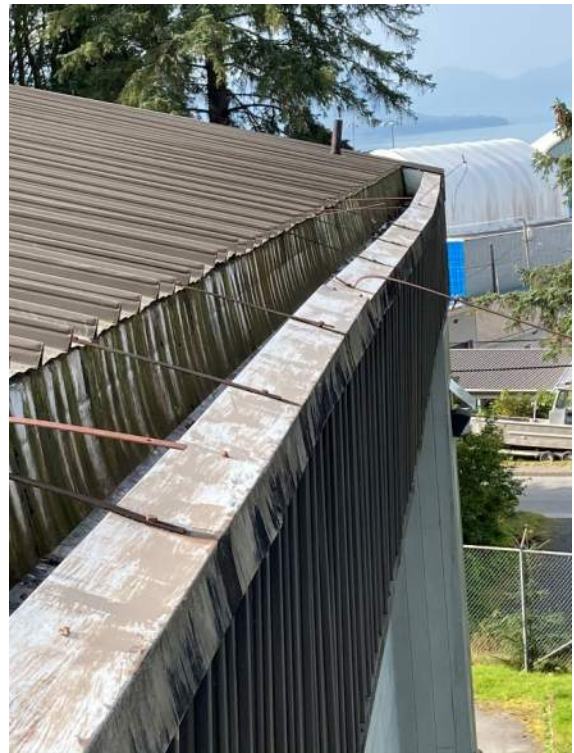
Photo 28 – Deflection of gutter and broken straps

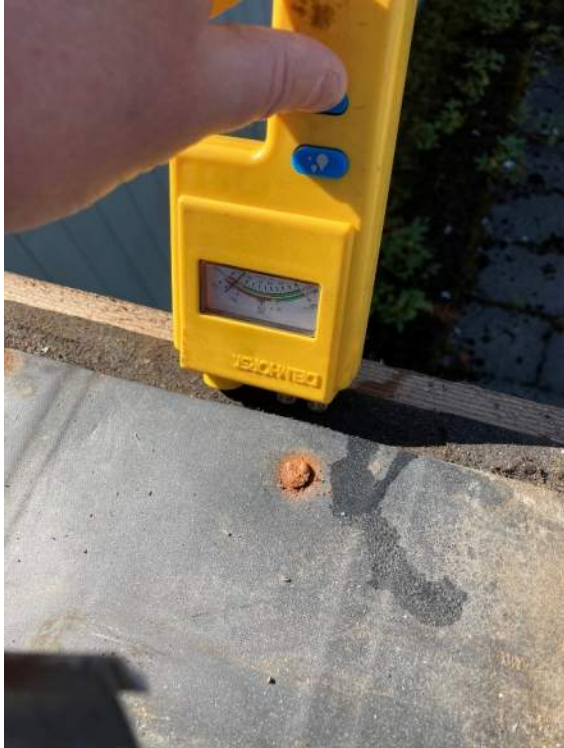
Photo 31 – Excessive moisture in exterior wall parapet
