## Design Southeast

### **Wrangell Medical Center Building Condition Survey Structural, Building Envelope and Interior Finishes (15 Pages)**

5-1-2018

## Wrangell Medical Center Building Description

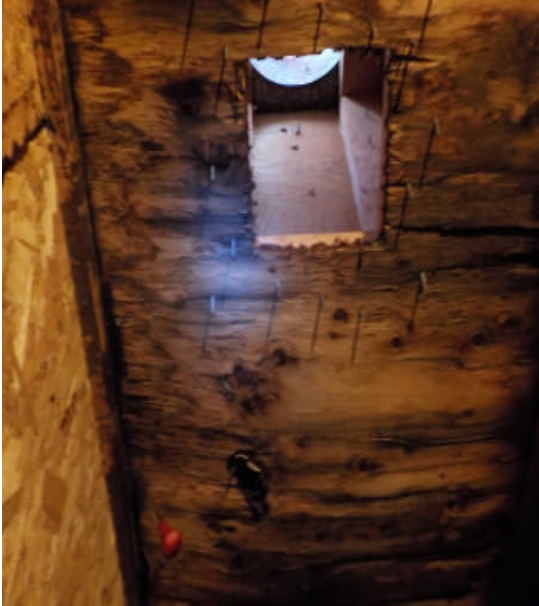
ITEM	TITLE	DESCRIPTION OF DEFICIENCY	PROPOSED CORRECTION	CODE / CRITERIA	NOTES
S01	Metal Roofing	There are (2) major roof leaks at the roof ventilation turrets and approximately (12) minor leaks throughout the metal roofing. The metal roofing was originally installed in 1988 (30 years old) and is at the end of it's useful life. The leaks at the ventilation turrets have resulted in approximately 120 sf of rotten plywood roof sheathing.	Like-kind replacement of the existing standing seam metal roofing. Replace approximately 120 sf of decayed plywood roof sheathing.	RECOMMENDATION	
S02	Seamless Metal Gutter System	Replacement is required during a reroof project.	Replace existing gutters with an new seamless metal gutter system	RECOMMENDATION	
S03	Air Handler Hoods	The existing air handler hoods are at the end of their life. The protective paint coating has failed allowing significant corrosion of the base metal to begin.	Like-kind replacement of air handler hoods.	RECOMMENDATION

Deficiency Item S01. Decayed plywood roof sheathing typical at (2) roof ventilation turrets. Nontypical condition of framing.

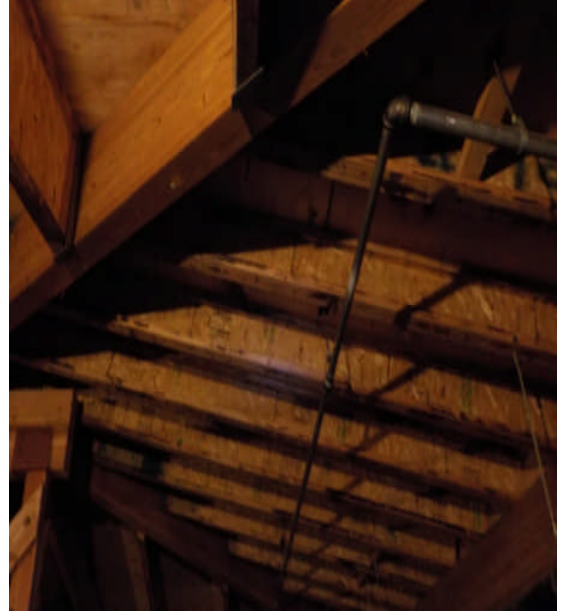
Typical structural roof framing in good condition. 1988 roof over-framing addition.

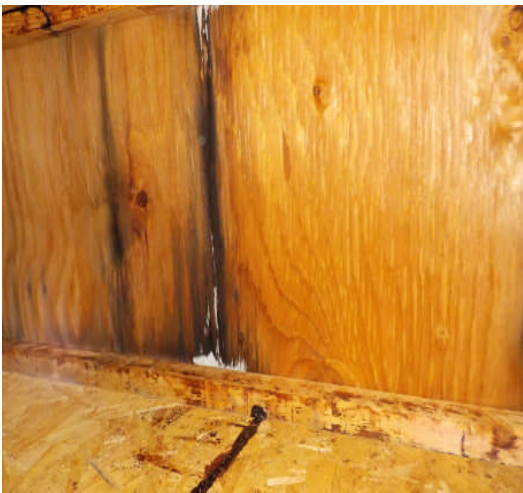
Deficiency Item S01. Minor roof leak creating moist condition for mildew growth (white).

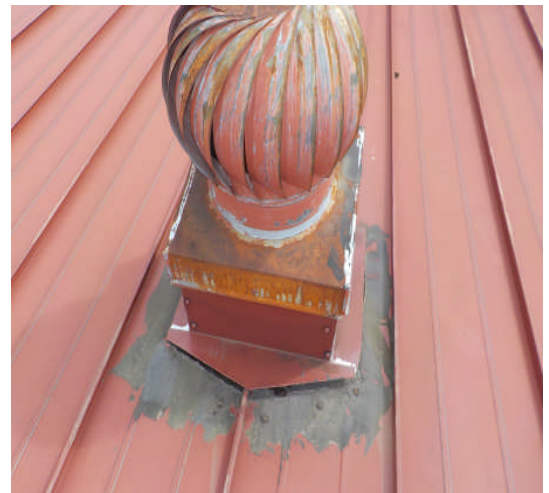
Deficiency Item S01. Example roof ventilation turret above major roof leak.

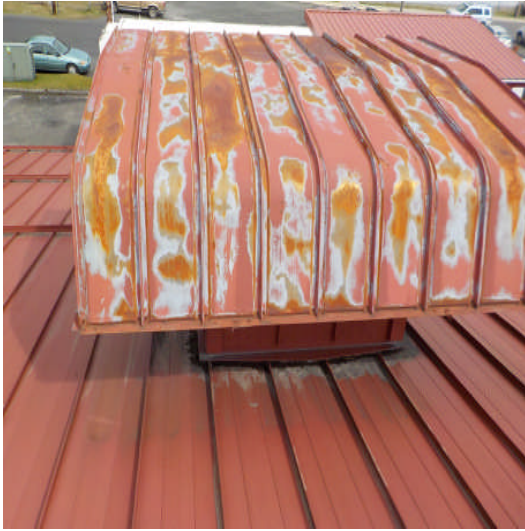
Deficiency Item S03. Air handler hood with corrosion.

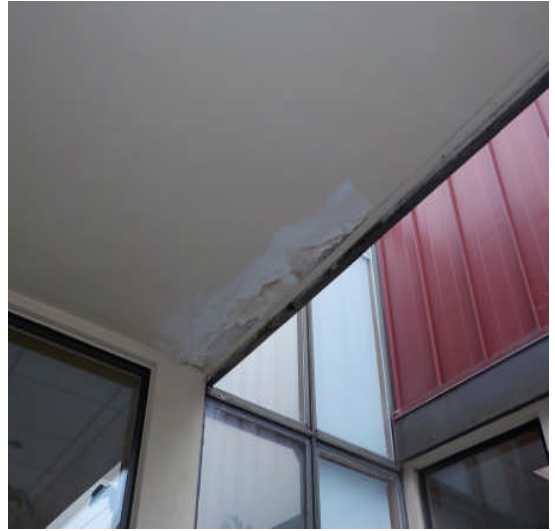
S04	Soffit sheathing	The roof eave soffit sheathing appears to consist of exterior gypsum or cementitious based sheathing. Approximately 800 sf has extensive water damage and needs replacement.	Like-kind replacement of approximately 800 sf of soffit sheathing.	RECOMMENDATION	
S05	EIFS Facia	Some sections of facia have fallen off the building and are missing.	Like-kind replacement of approximately 200 lin. ft of EIFS facia.	RECOMMENDATION

Deficiency Item S04. Example water damaged roof soffit sheathing.

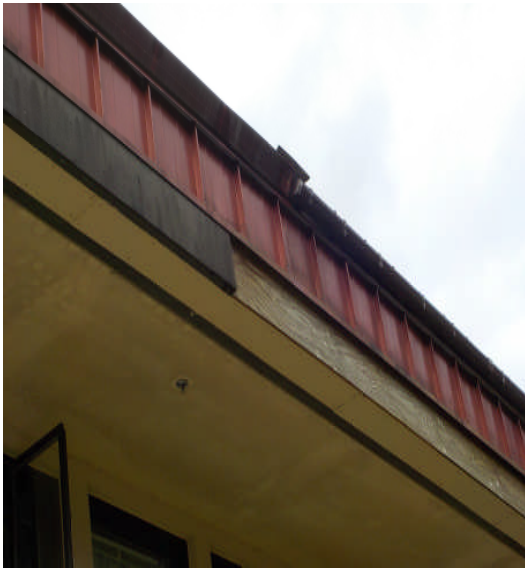
Deficiency Item S05. Missing EIFS fascia.

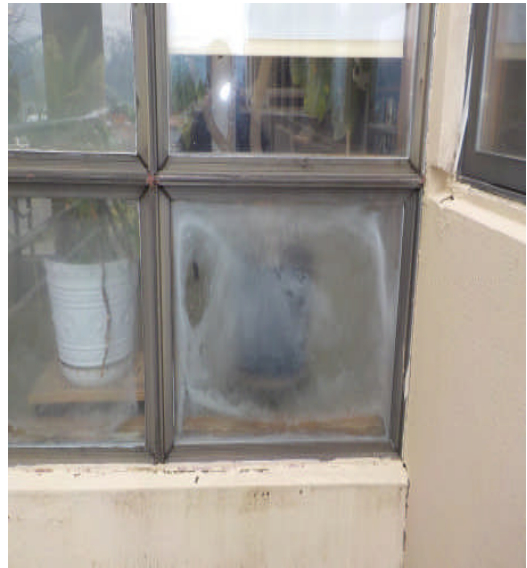
ITEM	TITLE	DESCRIPTION OF DEFICIENCY	PROPOSED CORRECTION	CODE / CRITERIA	NOTES
S06	EIFS Siding	Some sections of the exterior insulated finish system (EIFS) has damage from water infiltration, freeze-thaw or impacts.	Like-kind replacement of approximately 1,000 sf of EIFS siding.	RECOMMENDATION	
S07	Exterior Paint	The existing exterior paint finish is in fair condition. The caulking is in poor condition with some joints failing.	Paint the exterior of the building including siding, facia and underside of soffit. Remove and replace any failed caulking sealant.	RECOMMENDATION	
S08	Windows	There are at least (6) windows with either failed seals (fogging) or broken panes. Approximately (46) casement windows have malfunctioning hardware.	Replace approximately (52) windows.	RECOMMENDATION	
S09	Skylights	The (2) skylights near the main entry are in poor condition. (1) skylight has a broken pane.	Replace (2) skylights.	RECOMMENDATION

Deficiency Items S06, S07 and S08. Example damaged EIFS (freeze-thaw), fogged window, caulking sealant failure, siding in need of exterior paint

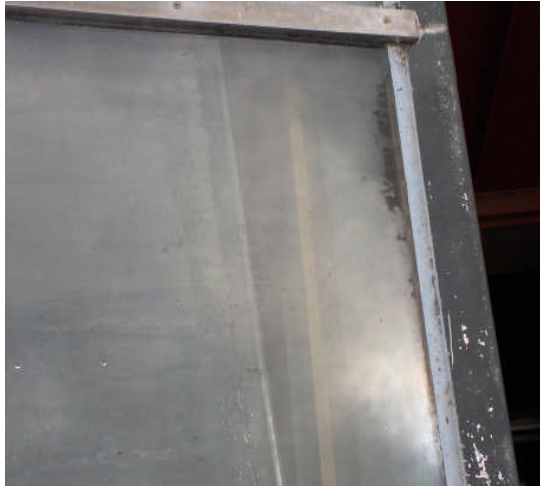
Deficiency Item S09. Broken skylight glazing.

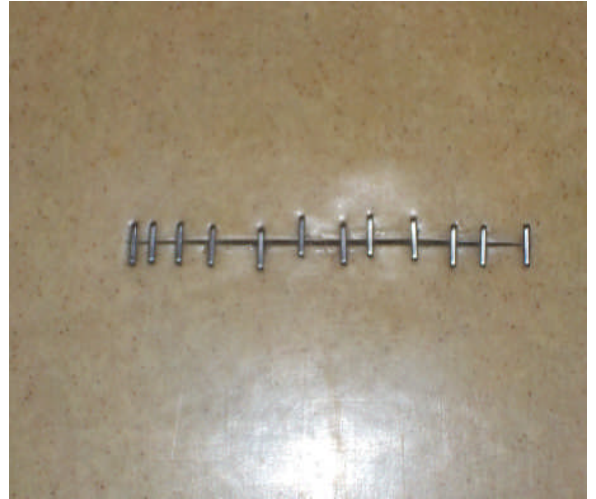
Deficiency Item S11. Example of existing vinyl flooring repair.

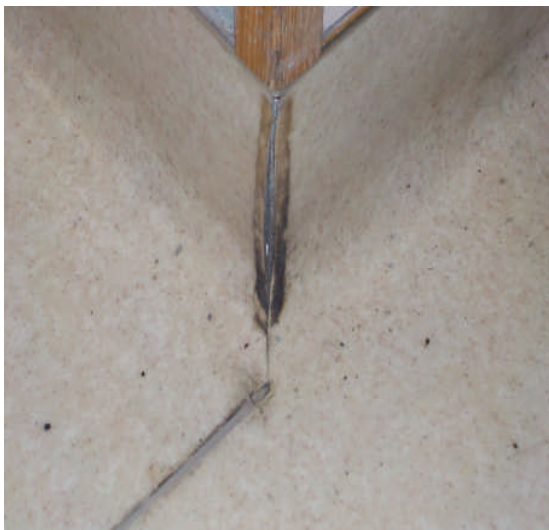
S10	Window Blinds	During the window replacement project item S08, approximately half of the window blinds will need to be temporarily removed to facilitate replacement of the new windows. The existing blinds are worn and dated, It would be more efficient to replace with new instead of reinstalling the existing blinds.	Replace the existing window blinds.	RECOMMENDATION	
S11	Flooring	Most of the flooring in the facility is worn and nearing the end of its life. A large percentage of vinyl seams have failed. There are also several patches that have been installed with staples fastened through the face of the vinyl flooring.	Replace the existing flooring	RECOMMENDATION

Deficiency Item S11. Example vinyl Flooring seam failure.

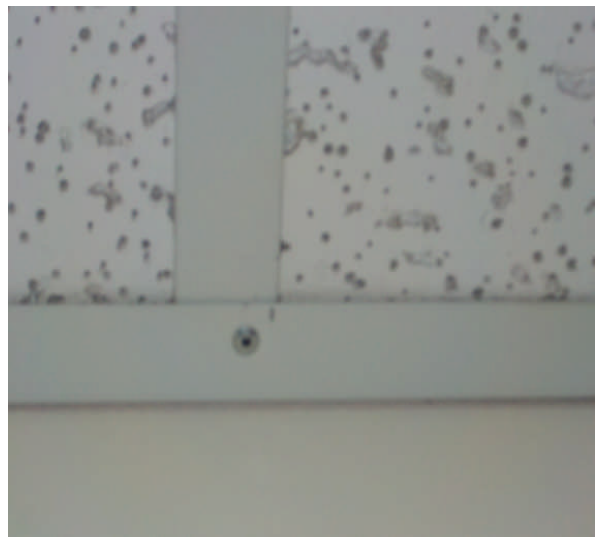
ITEM	TITLE	DESCRIPTION OF DEFICIENCY	PROPOSED CORRECTION	CODE / CRITERIA	NOTES
S12	Non-Compliant Suspended Ceiling System	Most of the existing suspended acoustic ceiling system is not constructed in such a way to meet the current seismic detailing requirements.	Replace the suspended ceilings in all rooms exceeding 144 sf.	2012 IBC, ASCE 7-10 13.5.6, ASTM E 580/E580M	
S13	Interior Paint	Interior paint finishes are in fair condition.	Paint interior walls, gypsum sheathed and adhesive tiled portions of ceiling.	RECOMMENDATION	
S14	Casework and Workstations	Casework and workstations are worn. The Formica seams and backsplash details create an infection control cleanliness issue.	Replace casework and work stations in patient care areas.	RECOMMENDATION	
S15	Elevated Exterior Deck	The deck is slightly uneven (possible settlement). The rim board is wavy when sited down. The guardrails do not meet current code. The spacing of the horizontal rails exceed 4". Connection of guardrail to deck not capable of resisting a 200 lb. load.	Rebuild and replace the existing deck framing, decking and guardrails	2012 IBC 1013.4

Deficiency Item S12. Rooms over 144 sf, metal grid runners are fastened to angle on all four sides of ceiling. Only one side shown in photo.

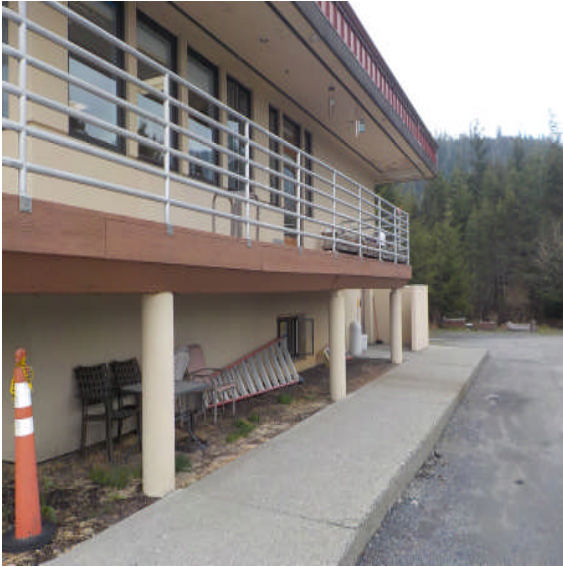
Deficiency Item S15. Note dip in deck rim board. Guardrails non-code compliant. Space between horizontal rails exceeds 4". Connection to deck not capable or resisting a force of 200 pounds.

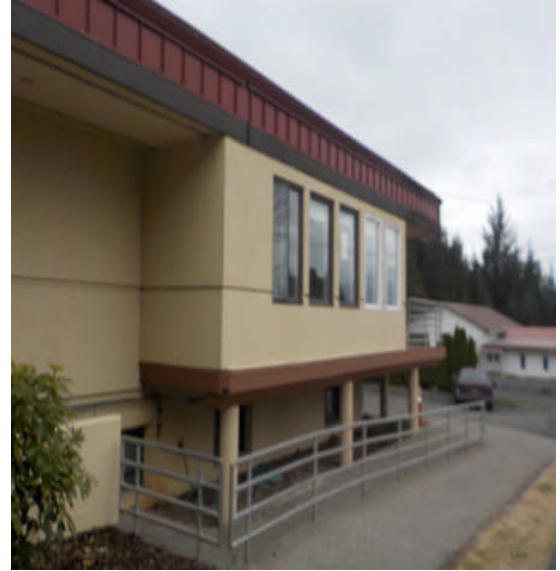
S16	Activities Room Addition	The addition bump out was added over top of an existing elevated exterior timber deck and is poorly built. The foundation piers supporting the outer perimeter wall have settled. Water runs down the exterior wall, beneath the wall sole plate saturating the floor framing.	Demo the addition back to the original perimeter wall line and infill frame the opening.	RECOMMENDATION

Deficiency Item S16. Addition bump out to activities room. Water runs down beneath the wall sole plate and runs across the floor. Foundation piers have settled.

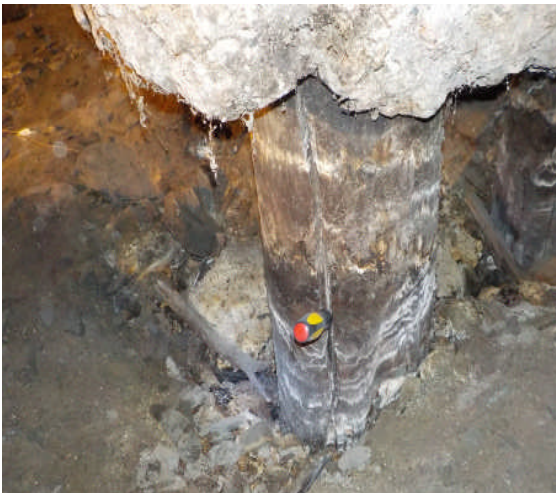
ITEM	TITLE	DESCRIPTION OF DEFICIENCY	PROPOSED CORRECTION	CODE / CRITERIA	NOTES
S17	Timber Piling	Approximately 60% of the creosote treated timber pilings were visually inspected. In addition, 20% were inspected by sounding with a metal rod and probing with an ice pick. Generally the pilings appeared to be in good condition however (1) piling with severe decay was found. Water entered the untreated center portion of this piling through large vertical checks.	<ol style="list-style-type: none"> <li>1. Repair decayed timber piling found during nondestructive visual inspection.</li> <li>2. Recommend a more thorough piling inspection using additional nondestructive testing such as ultrasound to check for additional bad pilings.</li> </ol>	RECOMMENDATION

Deficiency Item S17. Decayed creosote treated timber piling. Nontypical condition, not representative of average piling condition. Most pilings were found to be in good condition.

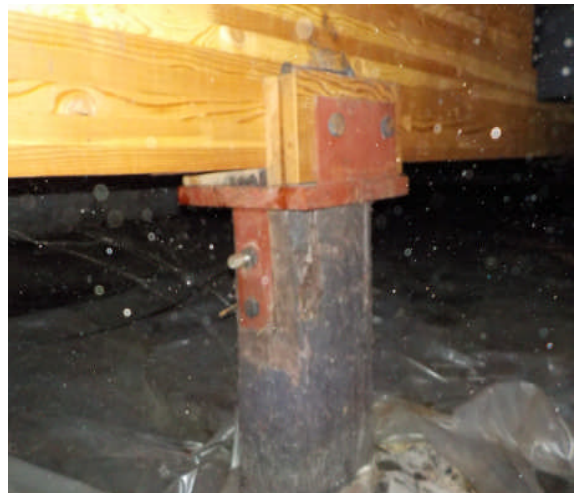
Typical creosote treated timber piling beneath 1988 addition, below emergency room. In good condition.

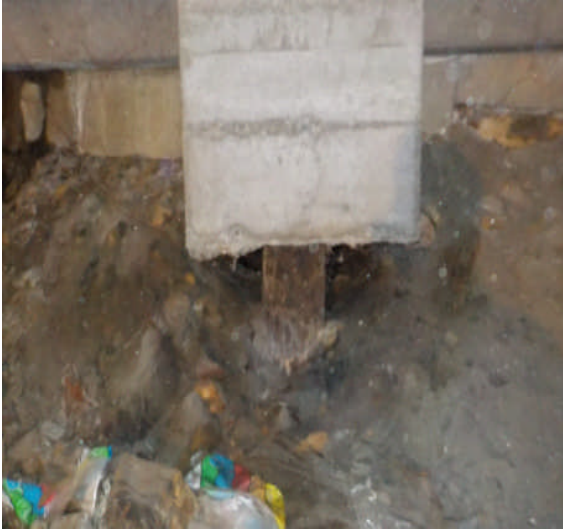
Typical creosote treated timber piling beneath 1968 Construction, beneath kitchen. In good condition. Reinforced concrete pile cap and grade beams in good condition.
