**Department of Environmental  
Conservation**

Contaminated Sites Program

Re: Decision Document: Wrangell Sawmill  
Cleanup Complete Determination

Wrangell Sawmill  
7 Mile Zimovia Highway  
Wrangell, Alaska 99929

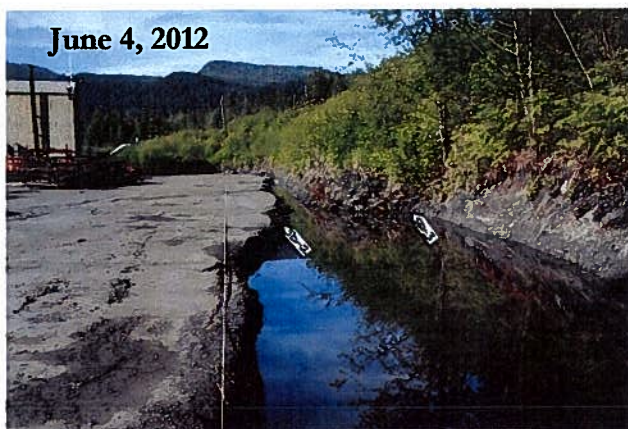
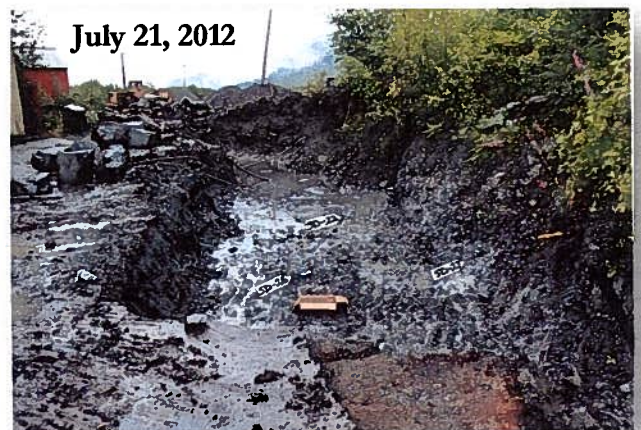
**Area #4- Shop Ditch Line and Sump:** By 6/4/12 contaminated soil and sediments had been removed from the entire 254' ditch line and the sump sediment deposits were excavated to approximately 2' depth. Confirmation samples throughout the sump and ditch line showed low levels of DRO and RRO, 28-1,400 mg/kg and 110- 1,300 mg/kg, respectively.

The excavations to the evaporation pond behind the maintenance shop exposed high RRO contaminated soil, 10,000- 14,000 mg/kg. The upper end of the ponded area had been excavated to 4' depths and by 7/1/12, confirmation samples all met DRO and RRO cleanup criteria. The excavations, however for the lower end of the pond ended with a 20' x 70' x 4' area that eventually reached a clean clay layer and cleanup criteria by 7/21/12. Laboratory analyses for DRO, RRO, RCRA-8 metals, and SVOCs met DEC cleanup levels. A total of 400 c.y. of contaminated soils were removed and stockpiled.

**Figure 3: The Shop Drainage Ditch and Shop site**

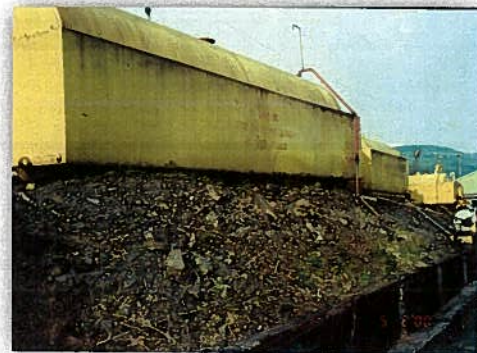
Area #5- Fuel Depot: The fuel depot bulkhead was removed on 6/4/12. Considerable diesel-contaminated soil was found and excavated to 2.5' below the concrete surface until clean soil appeared. As the excavation continued toward the gasoline tanks location, high PID readings were encountered at a depth of 4-5 feet bgs. Characterization samples showed GRO concentrations were above DEC cleanup criteria. As a result, GRO and the gasoline compounds, BTEX, were added as potential COCs for this location. Excavations continued over the course of the summer. After a July 20, 2012 site visit, DEC recommended the evaluation of SVOCs and RCRA-8 metals for this area. On 9/16/12 the final excavations took place. An additional 10'-15' section of the concrete surface was removed and soil was excavated to 12' depths. Along the embankment DRO levels were 3,900-4,400mg/kg. All other COC confirmation samples confirmed RRO, GRO, BTEX, SVOCs, and RCRA-8 metals also were below cleanup levels. Approximately, 1,090 c.y. of contaminated soil was removed for treatment.

Figure 4: Fuel Depot, circa 2000

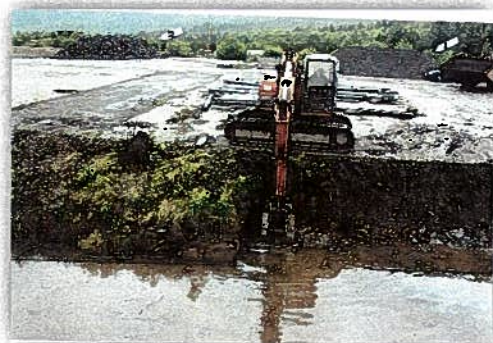
Area #6: Oil/water separator: The oil/water separator is designed for the gravity separation of hydrocarbons, petroleum products and settleable solids from water. The oil/water separator has been used at the mill to treat surface water runoff since 1992. Excavation activity began on 5/18/12 and started with the removal of all alder growth around the pond's sides. The sediment deposits on the north and south embankment were excavated to 2' depths. Characterization sampling on 6/5/12 showed that the south embankment met DRO/RRO cleanup criteria but additional excavation was needed along the north bank because RRO levels exceeded cleanup criteria. Excavations took place again on 6/29/12 and confirmation sampling resulted in DRO/RRO levels of 25 mg/kg-750 mg/kg and 130mg/kg- 3,600mg/kg, respectively. SVOCs and RCRA-8 metals were evaluated and were below DEC cleanup criteria. An estimated 115 c.y. of contaminated soil and sediments were removed and stockpiled for treatment.

Figure 5: 6/30/12 excavation of oil/water separator

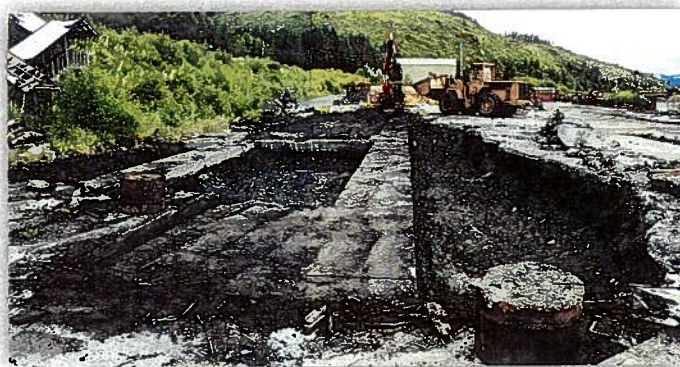
**Area #9- Green Chain/Sorter Line:** Black stained sawdust and gravel were noticed on 5/19/12. Exploratory sampling found high DRO/RRO levels that lead to the start of a series of excavations that began on 6/29/12. A long 4'-wide concrete foundation structure<sup>1</sup> was uncovered and excavations were made on both sides of the foundation at 2-4'-depths until clean appearing soils were found. The foundation was identified as the former Sorter Line and paralleled the Green Chain Line, refer to Figure 6. The extent of the excavation continued 150' south of the starting point until clean soil was found. To the northeast, greasy-blue contaminated soil was excavated around the foundation and completely uncovered by the end of the day of 6/30/12. Characterization samples found contaminated sections of DRO and RRO well above DEC cleanup criteria. Substantial excavation had taken place in this area and sample results still showed contaminated soil remained. Excavations continued on

**Figure 6: Looking south along the former green chain line area on 6/29/12. Excavations exposed 4'-wide foundations which later were discovered to be the former hydraulic-powered 'action pack'**

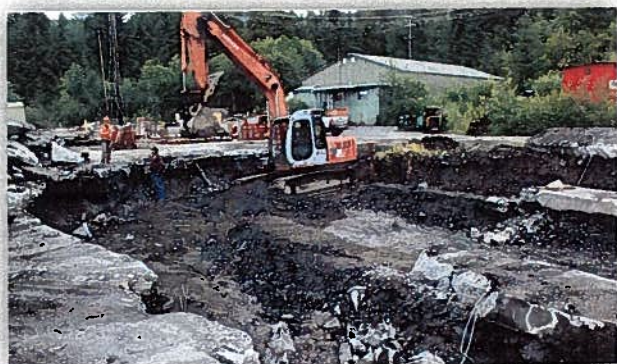
**Figure 7: View on 7/20/12- looking toward the north end of the green chain/ sorter line after the former 'action pack' foundation had been removed for continued excavation of contaminated soil**

7/20/12 and removed the middle portion of the foundation structure and an additional 25' of the concrete foundation's north end. On 8/20/12, two areas of contaminated soil were removed in the north end-- the northwest corner and embankment and north of the sorter foundation. Confirmation samples found the bottom northwest corner met cleanup criteria, however the embankment still had RRO levels of 9,700 mg/kg. The last two excavations of 2012 took place on 9/15 and 10/25/2012. The 9/15/12 excavation removed an additional 2'-3' of contaminated soil just north of the sorter foundation. RRO levels along the southwest corner were above cleanup criteria. The northwest embankment, required the removal of a 5' x 20' x 3'

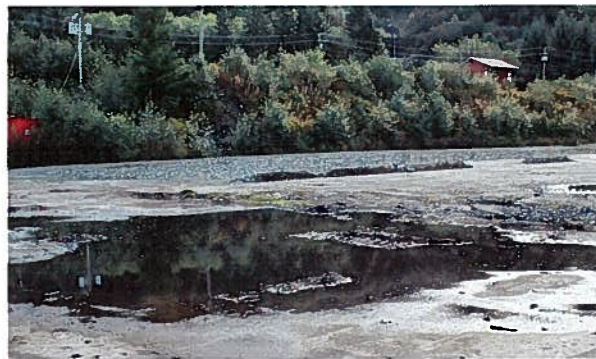
By the end of 2012, approximately 860 c.y. of contaminated soil had been removed from the Green Chain/Sorter Line area for bioremediation treatment. The majority of the area met DEC cleanup criteria with the exception of a small pocket in the northwest corner embankment, to be removed during the spring 2013 excavations.

**Figure 8: 9/18/13 view of the former Green Chain/ Sorter line- now backfilled**

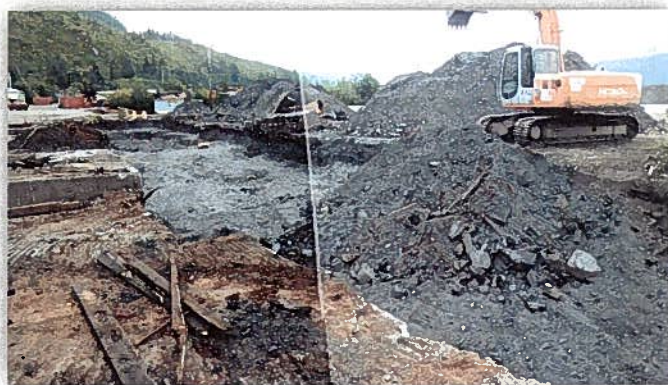
Area #10-The Cherry Pickers: The former cherry picker consisted of four hydraulically operated cranes on concrete blocks that removed and sorted sawed lumber from a long chain grate that came out of the sawmill building. After black stained soil and gravels were noticed, SMS hand-dug shallow excavations that confirmed the presence of petroleum contaminated soil. DEC included the Cherry Picker Site in the September letter based on this new found contaminated area.

**Figure 9: View on 8/21/12 looking toward the south-end of the former cherry picker line.**

The series of excavations began on 8/20/12, starting at the south-end of the former cherry picker line that opened up an area approximately 2'x4'x50'. A characterization sample taken at a 1' depth had a high DRO level of 26,000 mg/kg thus prompting the continued excavation activities. By the time excavations reached the north end, a 188'-long excavation had been overseen by SMS. Confirmation samples showed that four areas

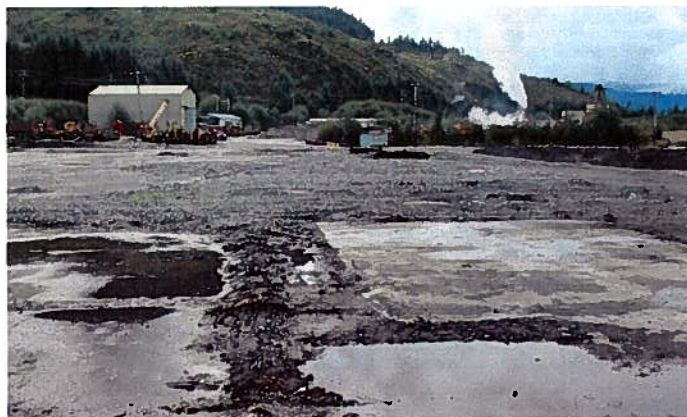
**Figure 10: 9/18/13 view of the former Cherry Picker Line- Now backfilled**

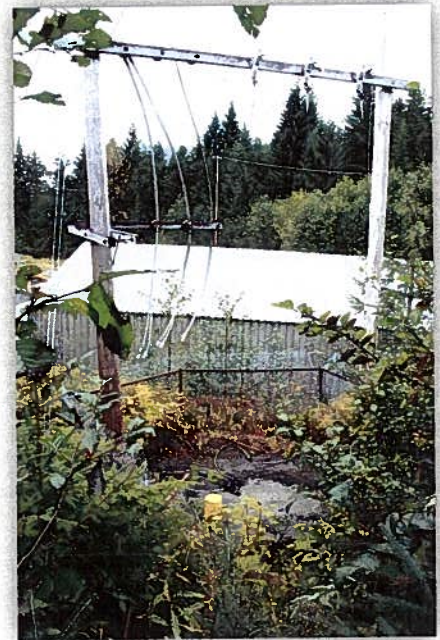
**Figure 11: City-Tie  
Transformer Pad**

Area #11- City-Tie Transformer site: Four 8"- 12"-deep soil samples were taken along the periphery of the existing concrete foundation block that remained at the former city-tie transformer site. The exploratory samples showed two upgradient DRO levels of 19,000 mg/kg and 33,000 mg/kg and RRO levels of 8,200 mg/kg; the latter which was just below DEC cleanup criteria. The samples downgradient of the pad had very low DRO/RRO levels meeting cleanup levels. Excavations began on 10/26/12 along the south side and downslope of the transformer pad. Gray blue soil was removed to a 5'- depth bgs when clean looking muskeg soil was reached. Characterization samples showed DRO/RRO levels were elevated above regulatory compliance at 1.5 below ground surface (bgs). Pockets of contaminated soil found below the transformer pad's south side keep this site from meeting cleanup compliance in 2012. This contamination was addressed in 2013.

**3.a. City-Tie Transformer Site - April 30, 2013:** The thick brush along the southwest corner was cleared on 4/40/13. The pockets of contamination that remained were located and excavated. A layer of 3-4' of contaminated soil was removed along and under the concrete pad together with an area about fifteen feet away which was excavated to 4'-6'-depths until clean muskeg soil appeared. Nine confirmation samples were taken. Unexpectedly high DRO levels were encountered and the decision to excavate the area further was made and expected to continue the next morning.

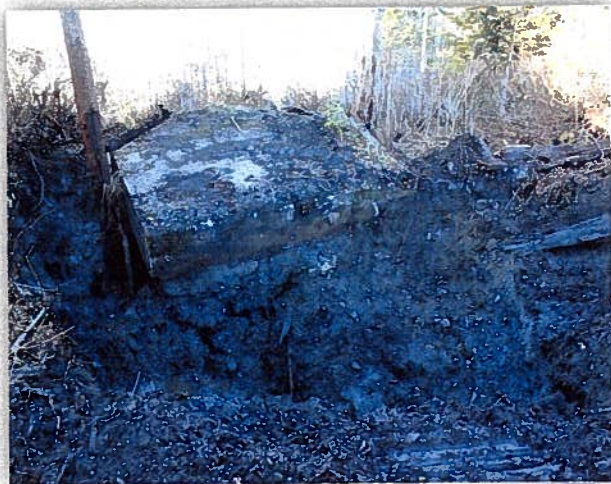
**Figure 12: The 10/26/12 view of the city-tie  
transformer site excavation**

**3.b. Buried Oil Tank Removal- May 1-3, 2013:** Continuing from the previous day's excavation, suspicious grayish soil with a diesel odor was encountered at the lower end of the city-tie transformer excavation and were identified for removal. Almost immediately into the excavations, the top of an unknown buried oil tank was discovered and punctured by the backhoe. Diesel began to flow but was quickly contained. The contents of the tank were slowly siphoned out, most of which was water. On 5/3/13, the tank was removed and revealed obvious contaminated soil. The soil was excavated to a depth of 6" below the tank and 1.5' along the east side of the footprint. In addition, the area of the confirmation sample site at the City-Tie Transformer site that did not meet cleanup criteria from the 4/30/13 work was also removed.

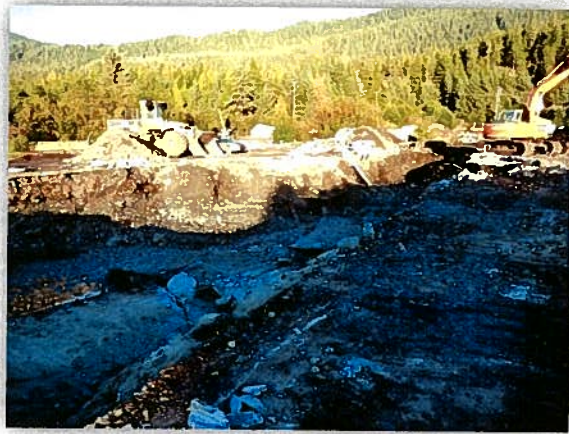
**Figure 14: July 2013 view of the extensive excavations that completed the cleanup of this area**

**1.a. Log Barker Site- April 30, 2013:** Excavations resumed on 4/30/13 with removal of the top concrete surface to the northwest corner embankment and the underlying 3' of fill. The embankment was excavated back 12' and down to a depth of 7' bgs until the visual signs of the contaminant layer were reduced. Confirmation samples showed DRO/RRO levels were 760- 5,600 mg/kg and 250 -900 mg/kg, respectively. 35-40 c.y. of contaminated soil was removed for treatment. The area near the north embankment floor removed 5 c.y. of contaminated soil. Two confirmation samples indicated cleanup criteria were met in this location. When the excavations along the ramp sidewall took place, the wood-&-pile sidewall partially collapsed and had to be removed. Approximately 10-15 c.y. of soil were removed for bioremediation and DRO/RRO confirmation samples were 83 mg/kg and 150 mg/kg, respectively.

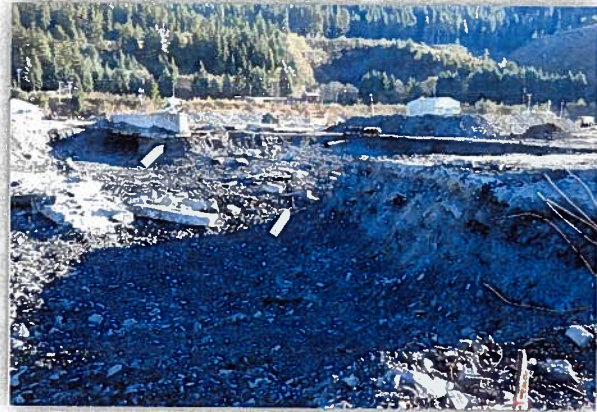
Area #12- Log Barker Area: The former barker area is located along the northwest corner of the mill site facility. All operating equipment had been removed by 2012 leaving only the two earth-filled log loading ramps. The 9/14/2012 exploratory excavations found contaminated soil within 1' bgs of the surface. A characterization sample taken 2.5' bgs had DRO/RRO levels of 10,000 mg/kg and 17,000 mg/kg located under the south log conveyor. Excavations extended eastward to 9'-depths and 143' of the original starting point. DRO/RRO cleanup criteria were met along the north

**Figure 13: The 10/24/12 view of the log barker area. Arrow in the back shows the log knockout structure and lower arrow indicates the point of origin.**

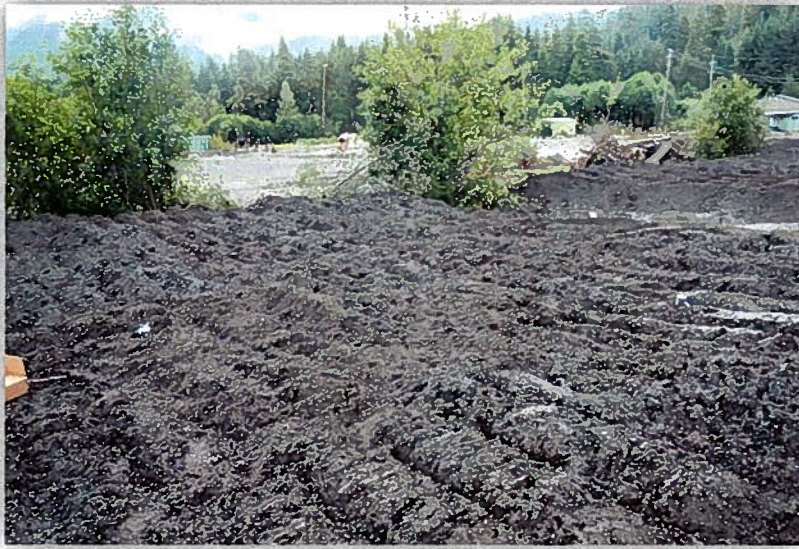
**Figure 16: July 23 view showing the northeast corner of Biocell #3, where B3-5 and B3-6 were taken to determine current conditions**

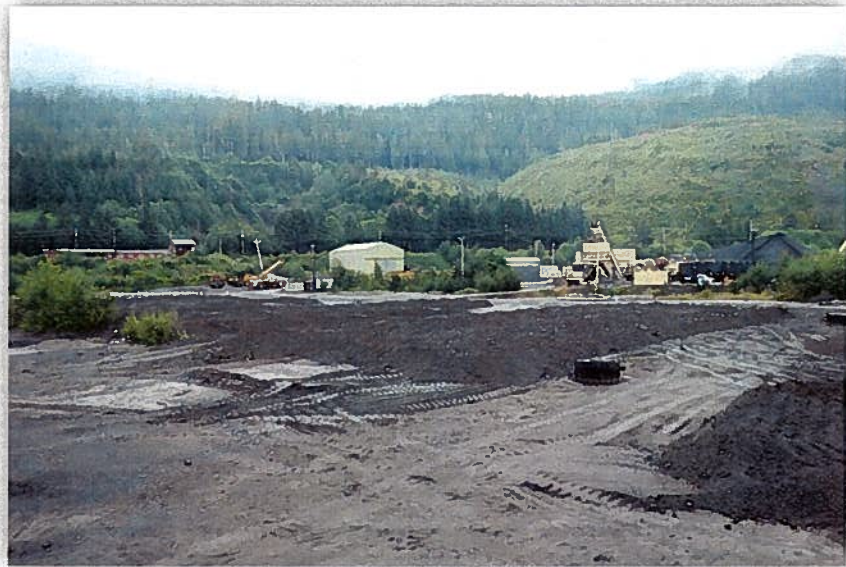
**Figure 17: July 23 view showing 4 of the 5 Biocells that have been turned and tilled**
