WRANGELL BARGE RAMP CONDITION ASSESSMENT

March 2011

PND 102077.01

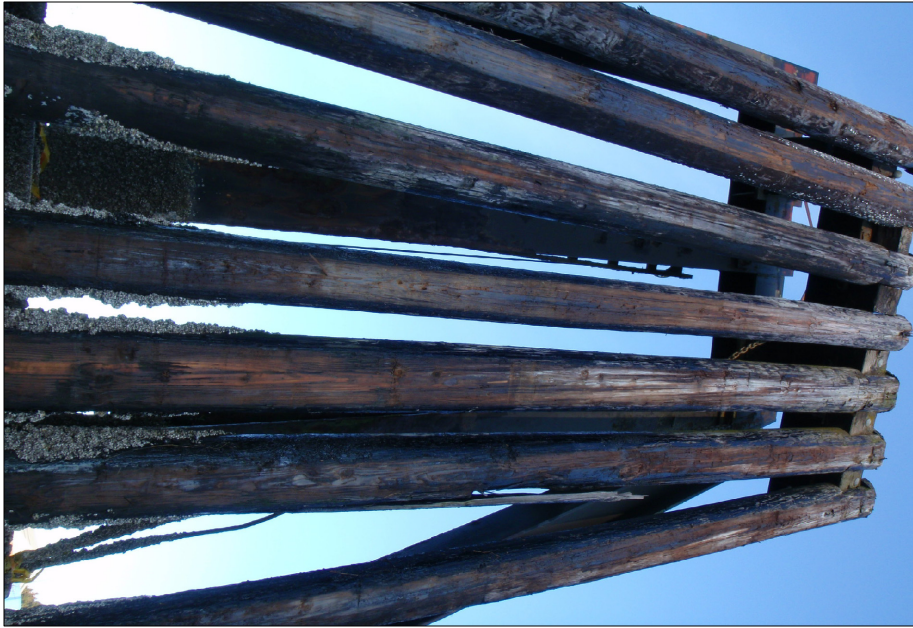
Displaced fender piles at Dolphin "D".

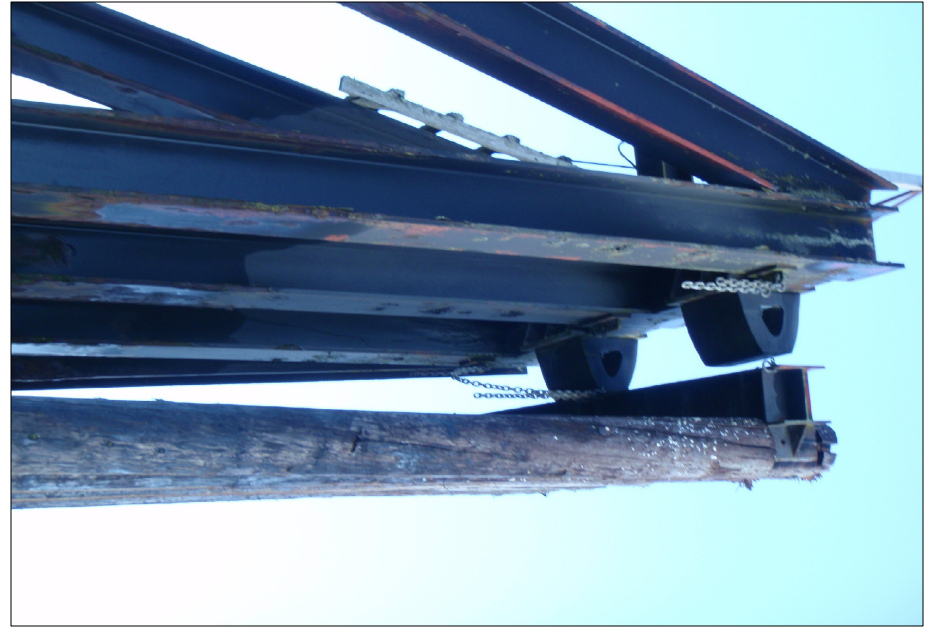
Broken stay chains at Dolphin "D".

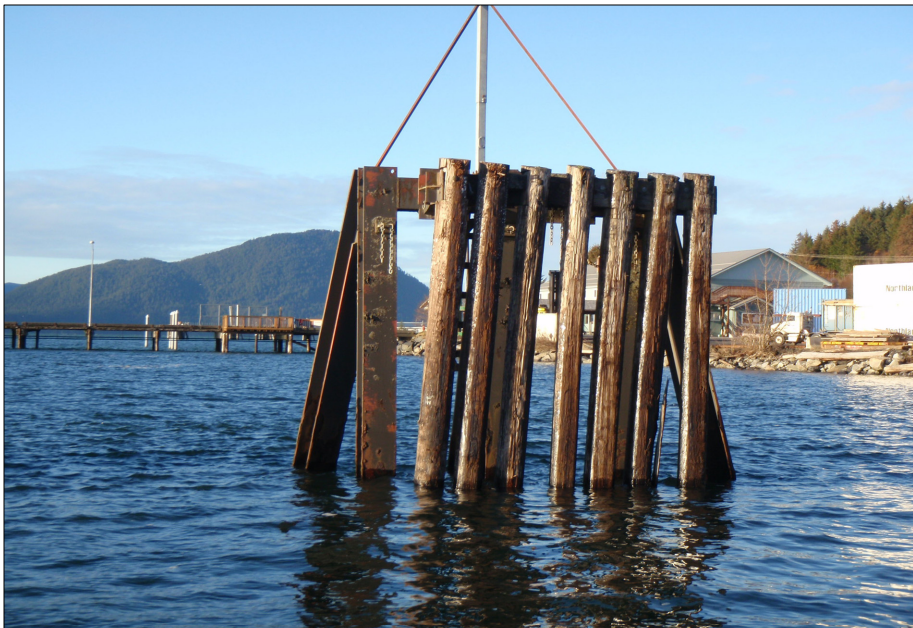
Displaced fender piles at Dolphin "D", looking north.

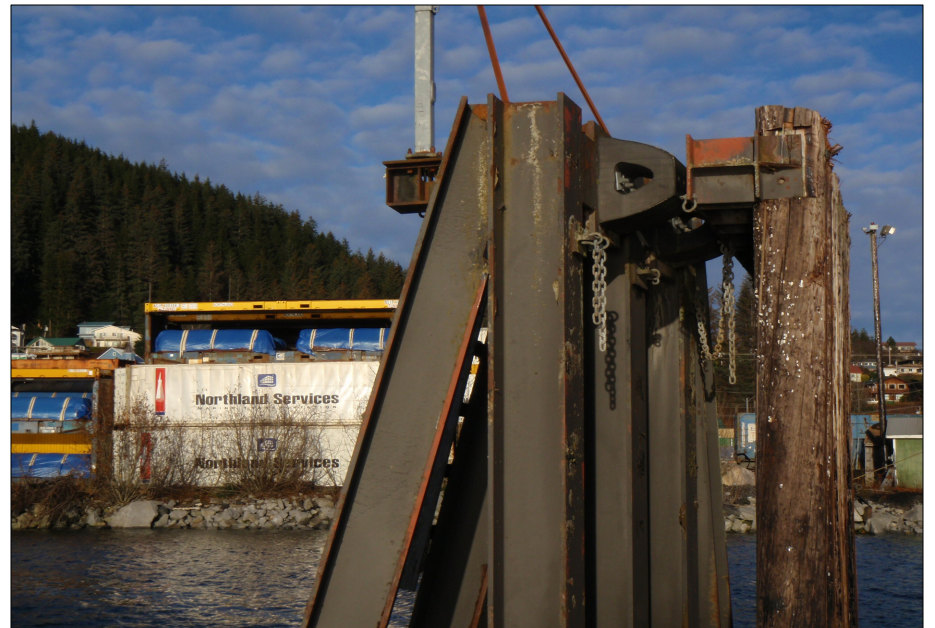
Broken stay chains at Dolphin "D".

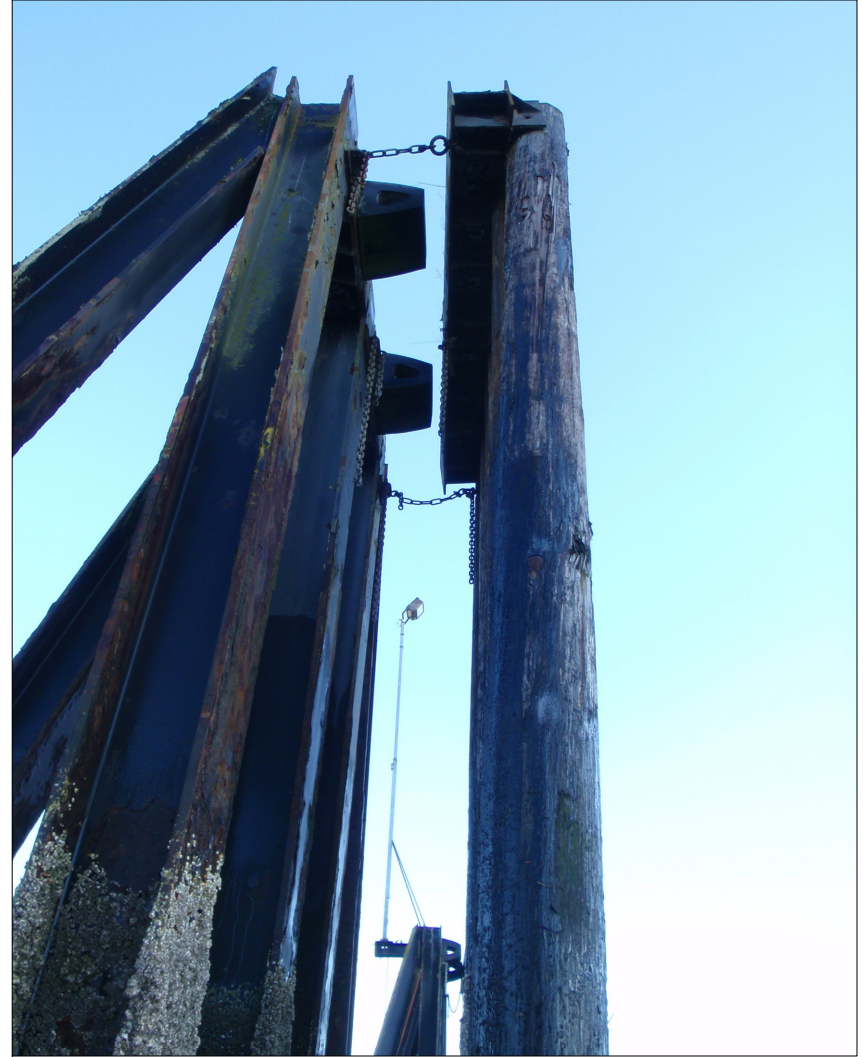
Broken stay chains at Dolphin "C".

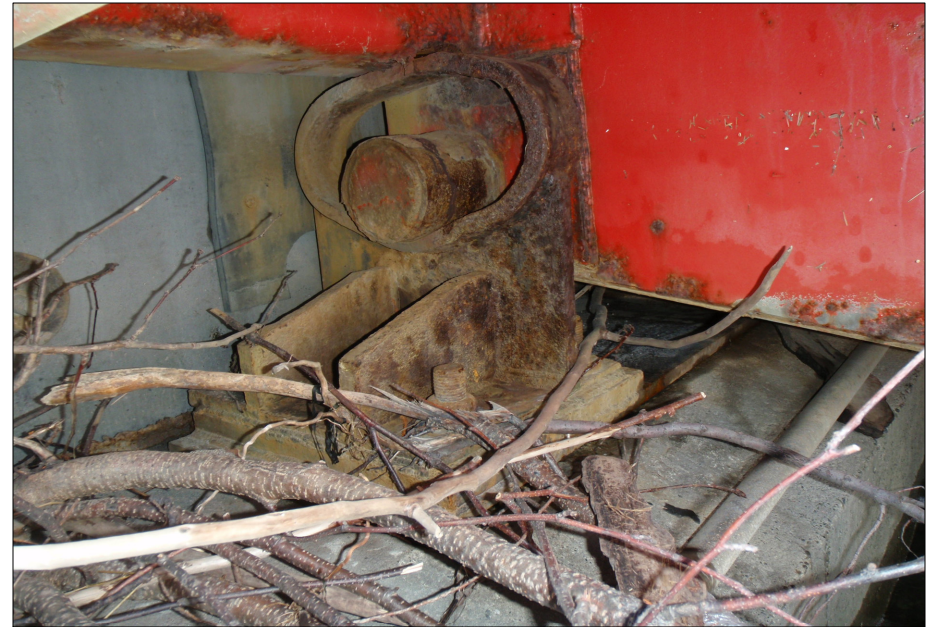
- Abutment - The steel bridge bearing assemblies are still structurally adequate; however, the protective paint coating is in poor condition. The north bearing assembly has significant mechanical wear such that the bridge sets approximately an inch lower on the north side. Minor erosion exists along the base of the concrete abutment's front face.

North bearing assembly, debris and worn steel; coating failure on all steel components.

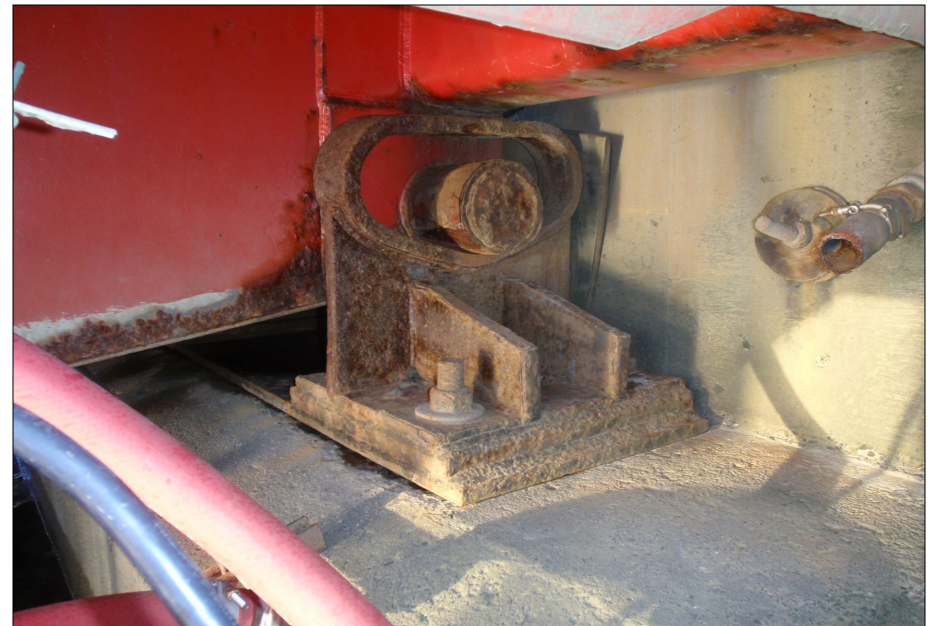
South bearing assembly; coating failure on all steel components.

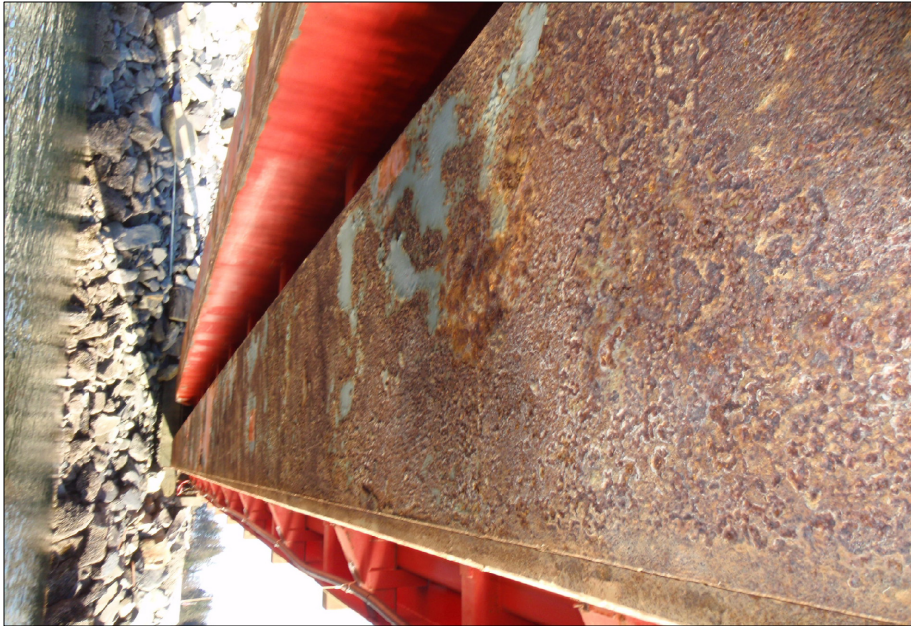
Ramp box-girder bottom flange corrosion.

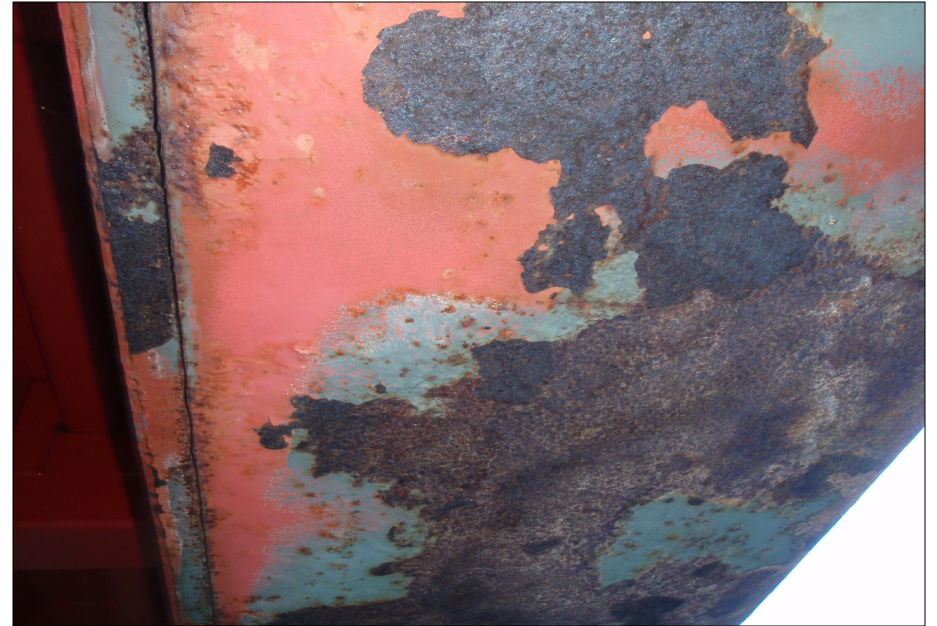
Typical coating failure/corrosion of girder bottom flange.

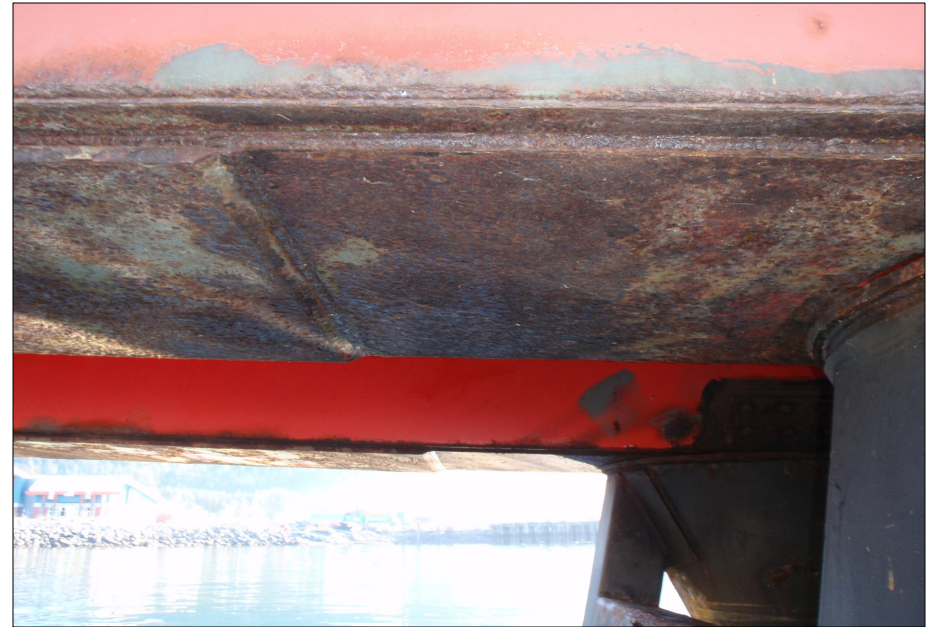
Typical minor corrosion of ramp girder bottom flange.

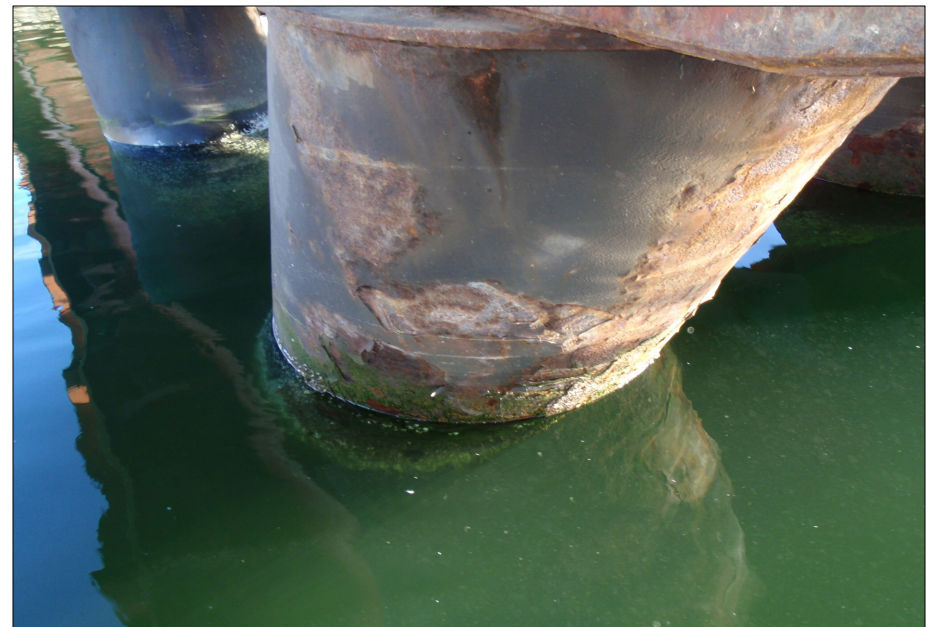
Typical coating failing/minor corrosion of ramp tank support strut.

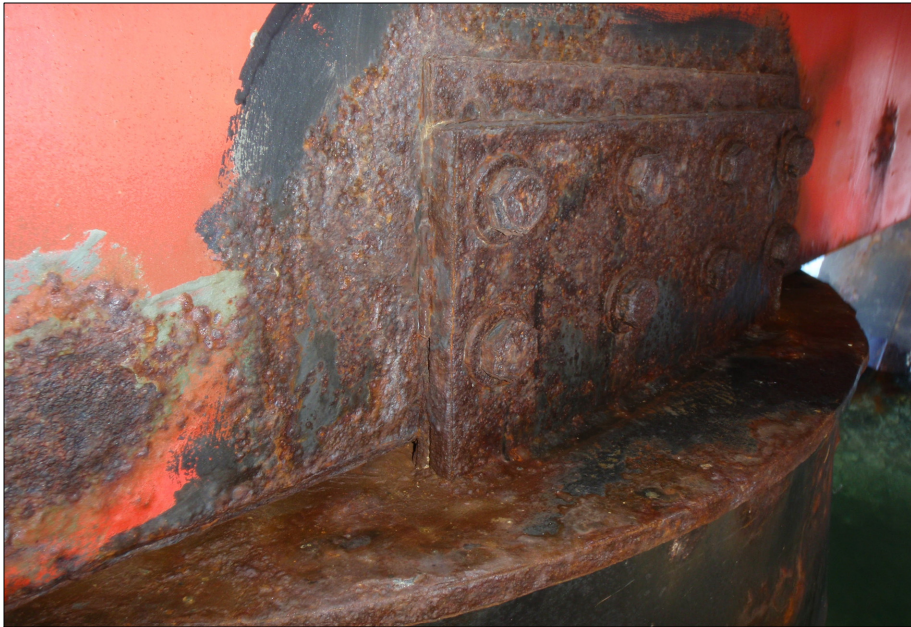
Coating failure/corrosion at ramp/support tank connection assemblies.

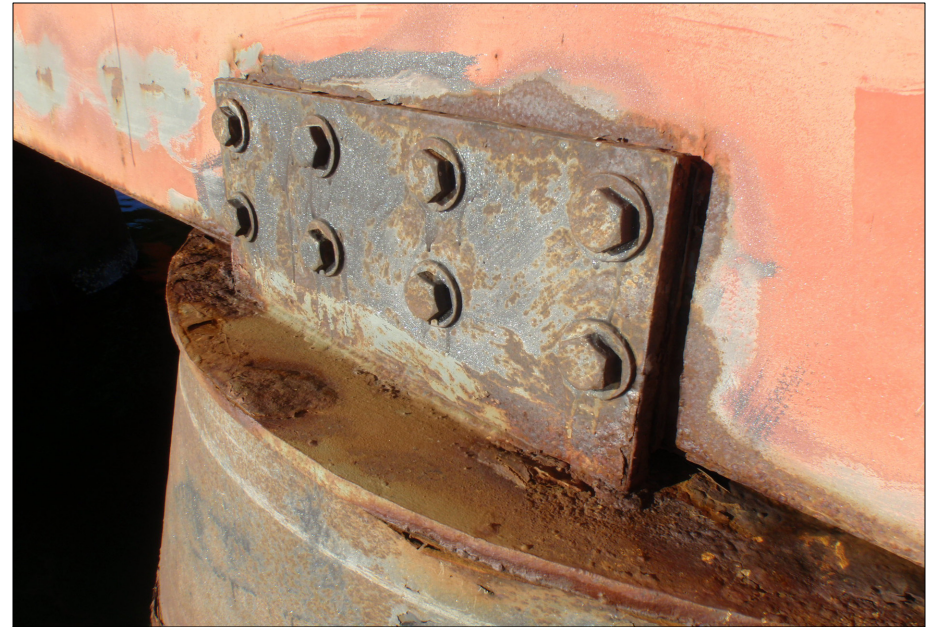
Coating failure/corrosion at ramp/support tank connection assemblies.

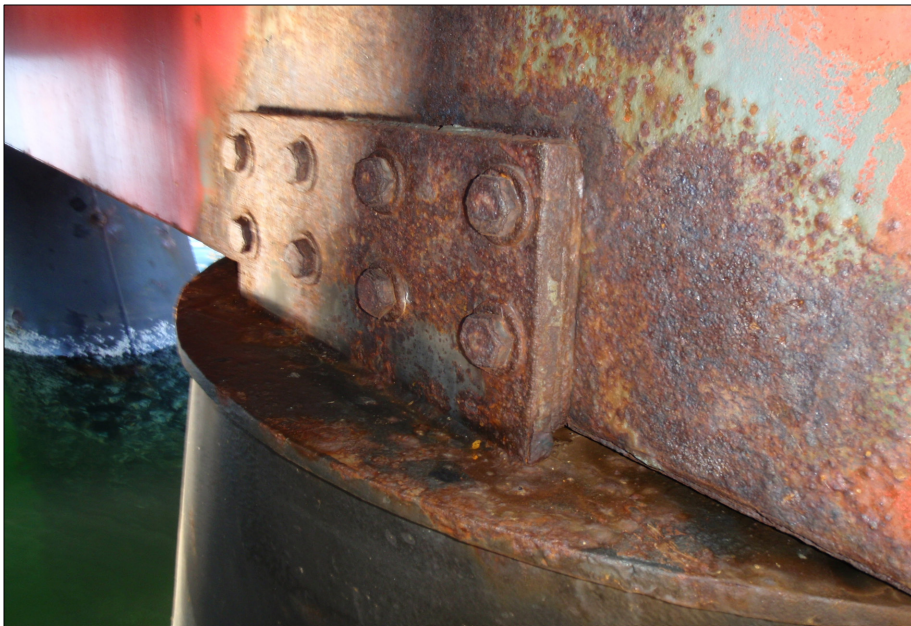
Coating failure/corrosion at ramp/support tank connection assemblies.

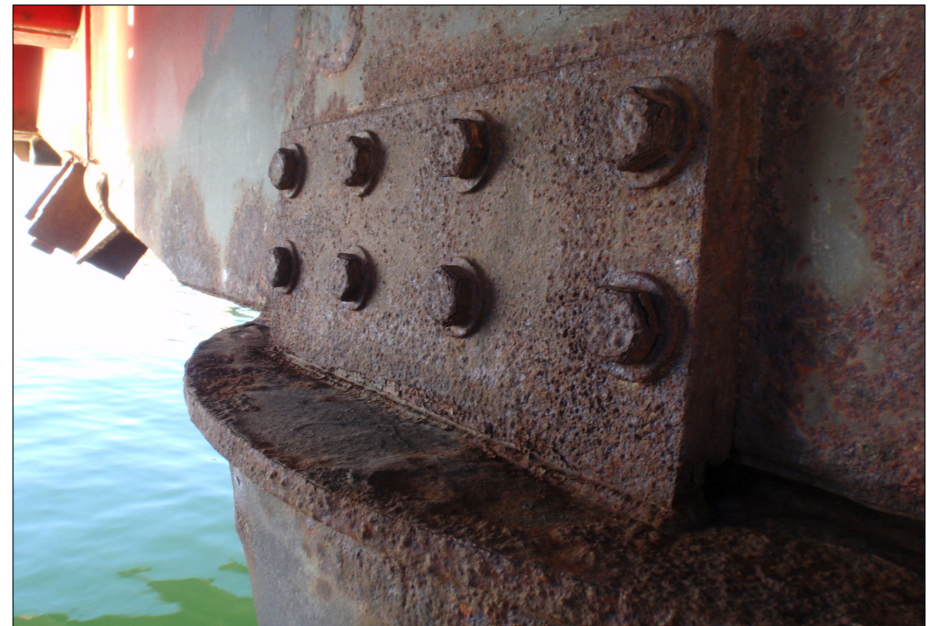
Coating failure/corrosion at ramp/support tank connection assemblies.

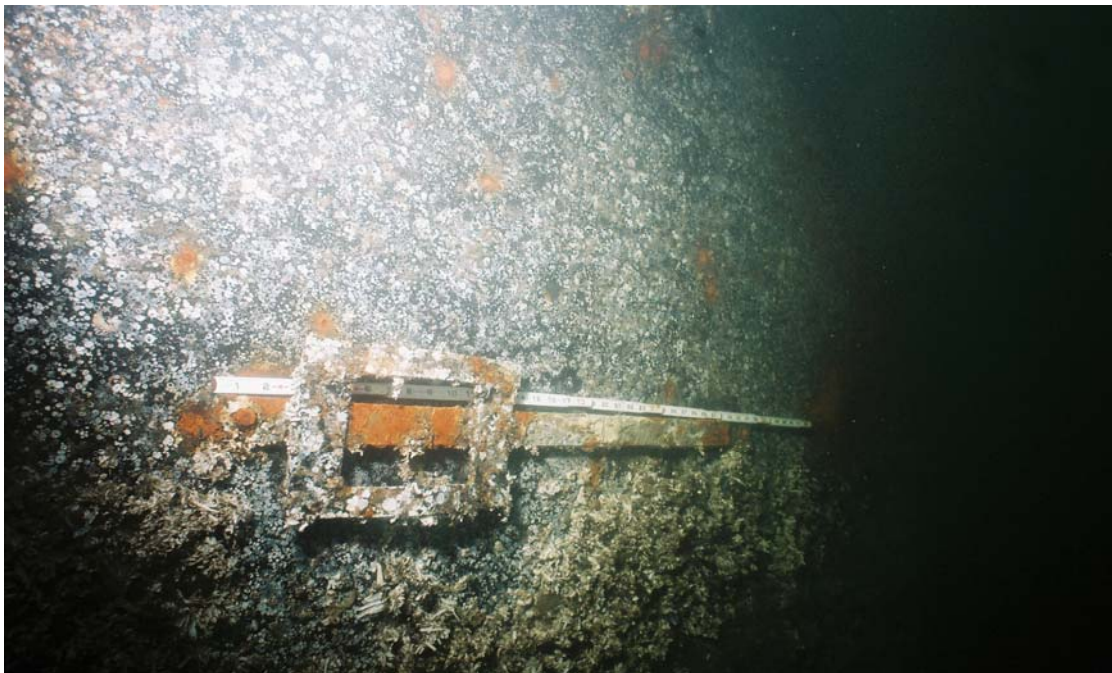
PHOTO No. 6: Floatation Pontoon Cathodic Protection Anode Bracket – Investigation of the Floatation Tanks noted this anode bracket on the north end of the larger 9 ft. diameter tank. Note the ruler lying along the top of the anode attachment bracket. The anode has been completely consumed.

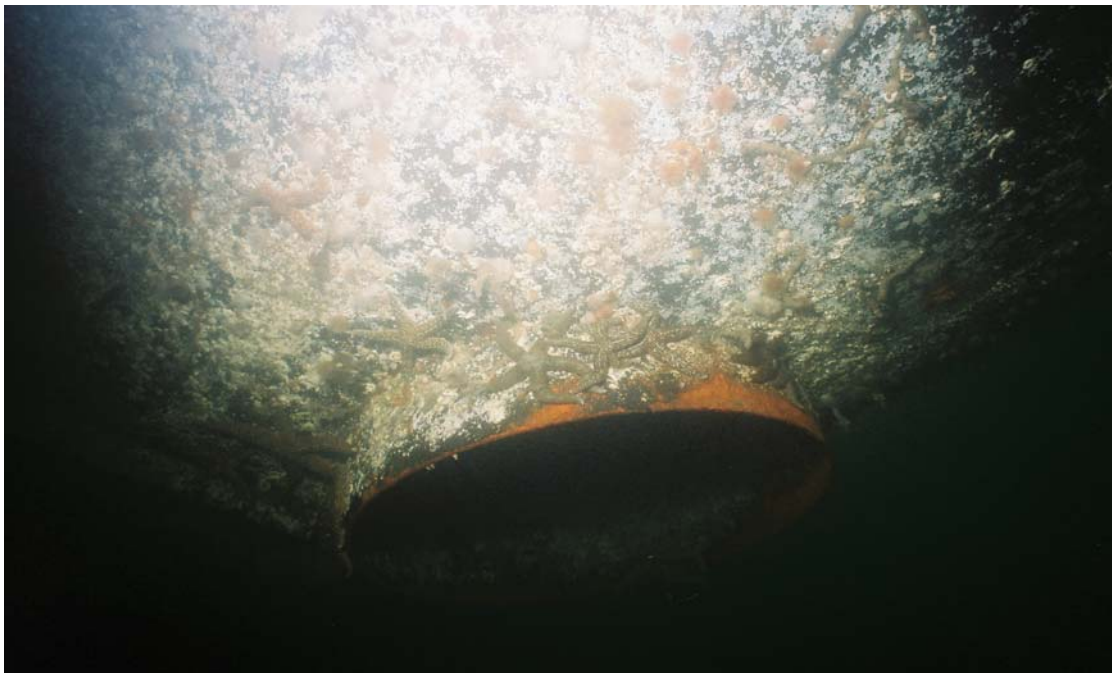
PHOTO No. 8: Floatation Tank Exhaust Port – Note the coating deterioration and minor surface corrosion on the bottom of one of the three exhaust ports located on the bottom of the 9 ft. diameter tank. Also note the good condition of the coating on the bottom of the tank.

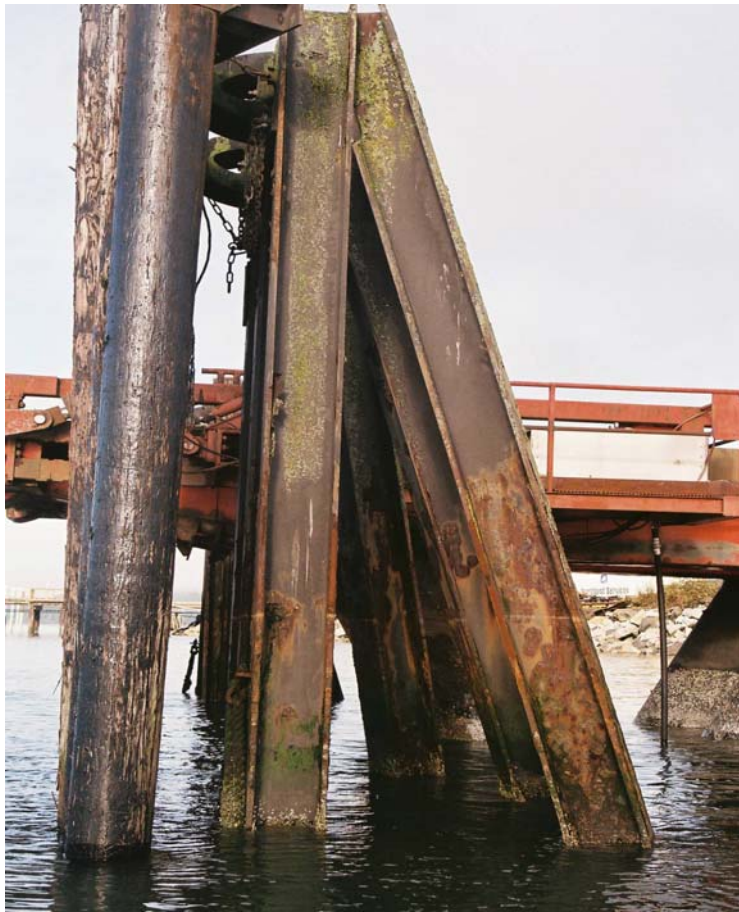
PHOTO No. 11: Breasting Dolphin F – Note the good condition of the epoxy coating at the tops of the piles and the localized coating deterioration in the splash zone. Overall these piles have been estimated to retain 75% of their coating in the combined top and splash zone.

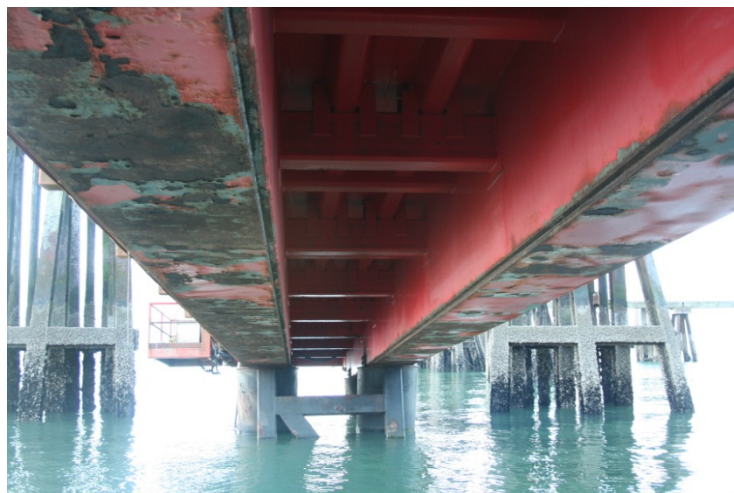
Figure 3 - coating failure along the barge ramp girder soffits

exception of the bottom of the two supporting girders that run the length of the ramp.
