**Department of Environmental
Conservation**

Re: Decision Document: Wrangell Sawmill
Cleanup Complete Determination

Wrangell Sawmill
7 Mile Zimovia Highway
Wrangell, Alaska 99929

File No: 1529.38.022
Hazard ID: 25786

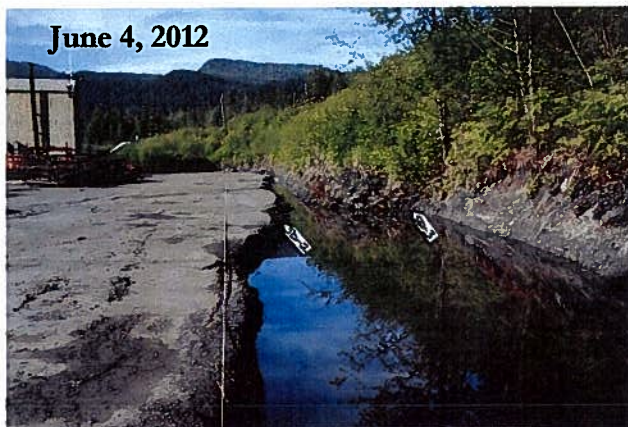
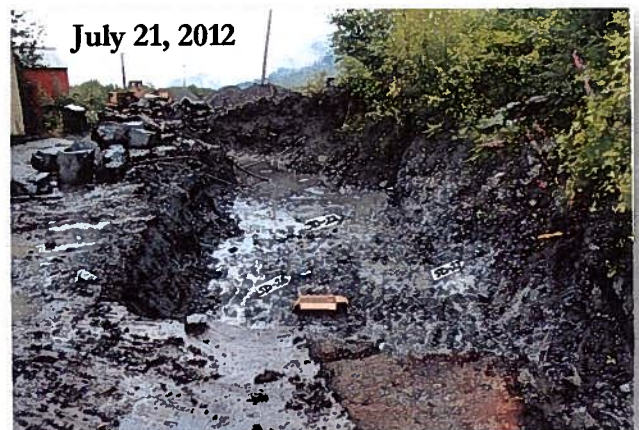
Figure 3: The Shop Drainage Ditch and Shop site

Area #4- Shop Ditch Line and Sump: By 6/4/12 contaminated soil and sediments had been removed from the entire 254' ditch line and the sump sediment deposits were excavated to approximately 2' depth. Confirmation samples throughout the sump and ditch line showed low levels of DRO and RRO, 28-1,400 mg/kg and 110- 1,300 mg/kg, respectively.

The excavations to the evaporation pond behind the maintenance shop exposed high RRO contaminated soil, 10,000- 14,000 mg/kg. The upper end of the ponded area had been excavated to 4' depths and by 7/1/12, confirmation samples all met DRO and RRO cleanup criteria. The excavations, however for the lower end of the pond ended with a 20' x 70' x 4' area that eventually reached a clean clay layer and cleanup criteria by 7/21/12. Laboratory analyses for DRO, RRO, RCRA-8 metals, and SVOCs met DEC cleanup levels. A total of 400 c.y. of contaminated soils were removed and stockpiled.

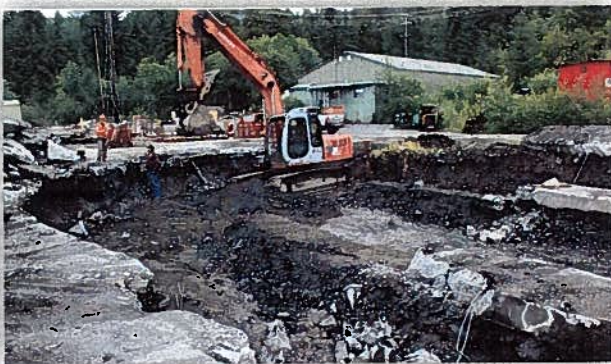
Figure 7: View on 7/20/12- looking toward the north end of the green chain/ sorter line after the former 'action pack' foundation had been removed for continued excavation of contaminated soil

7/20/12 and removed the middle portion of the foundation structure and an additional 25' of the concrete foundation's north end. On 8/20/12, two areas of contaminated soil were removed in the north end-- the northwest corner and embankment and north of the sorter foundation. Confirmation samples found the bottom northwest corner met cleanup criteria, however the embankment still had RRO levels of 9,700 mg/kg. The last two excavations of 2012 took place on 9/15 and 10/25/2012. The 9/15/12 excavation removed an additional 2'-3' of contaminated soil just north of the sorter foundation. RRO levels along the southwest corner were above cleanup criteria. The northwest embankment, required the removal of a 5' x 20' x 3'

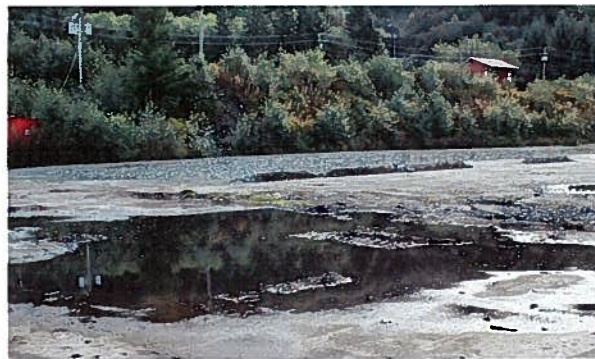
By the end of 2012, approximately 860 c.y. of contaminated soil had been removed from the Green Chain/Sorter Line area for bioremediation treatment. The majority of the area met DEC cleanup criteria with the exception of a small pocket in the northwest corner embankment, to be removed during the spring 2013 excavations.

Figure 8: 9/18/13 view of the former Green Chain/Sorter line- now backfilled

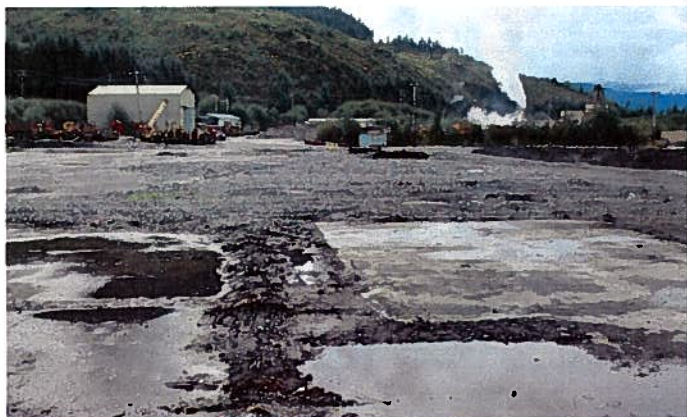
Figure 10: 9/18/13 view of the former Cherry Picker Line- Now backfilled

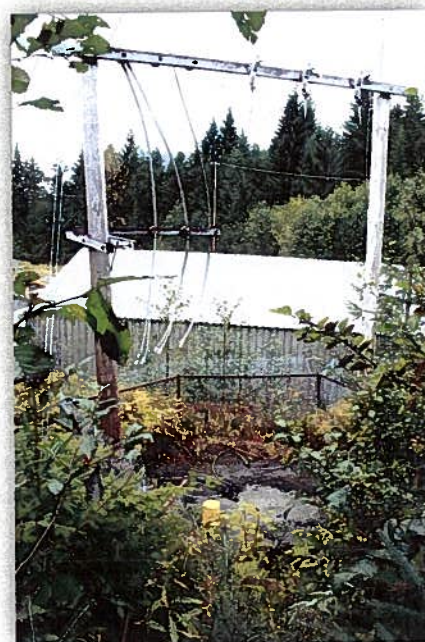
Figure 11: City-Tie Transformer Pad

Area #11- City-Tie Transformer site: Four 8"- 12"-deep soil samples were taken along the periphery of the existing concrete foundation block that remained at the former city-tie transformer site. The exploratory samples showed two upgradient DRO levels of 19,000 mg/kg and 33,000 mg/kg and RRO levels of 8,200 mg/kg; the latter which was just below DEC cleanup criteria. The samples downgradient of the pad had very low DRO/RRO levels meeting cleanup levels. Excavations began on 10/26/12 along the south side and downslope of the transformer pad. Gray blue soil was removed to a 5'- depth bgs when clean looking muskeg soil was reached. Characterization samples showed DRO/RRO levels were elevated above regulatory compliance at 1.5 below ground surface (bgs). Pockets of contaminated soil found below the transformer pad's south side keep this site from meeting cleanup compliance in 2012. This contamination was addressed in 2013.

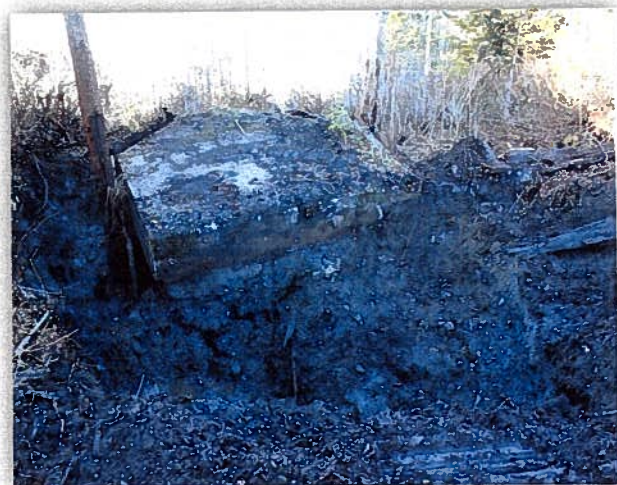
Figure 12: The 10/26/12 view of the city-tie transformer site excavation

3.a. City-Tie Transformer Site - April 30, 2013: The thick brush along the southwest corner was cleared on 4/40/13. The pockets of contamination that remained were located and excavated. A layer of 3-4' of contaminated soil was removed along and under the concrete pad together with an area about fifteen feet away which was excavated to 4'-6'-depths until clean muskeg soil appeared. Nine confirmation samples were taken. Unexpectedly high DRO levels were encountered and the decision to excavate the area further was made and expected to continue the next morning.

3.b. Buried Oil Tank Removal- May 1-3, 2013: Continuing from the previous day's excavation, suspicious grayish soil with a diesel odor was encountered at the lower end of the city-tie transformer excavation and were identified for removal. Almost immediately into the excavations, the top of an unknown buried oil tank was discovered and punctured by the backhoe. Diesel began to flow but was quickly contained. The contents of the tank were slowly siphoned out, most of which was water. On 5/3/13, the tank was removed and revealed obvious contaminated soil. The soil was excavated to a depth of 6" below the tank and 1.5' along the east side of the footprint. In addition, the area of the confirmation sample site at the City-Tie Transformer site that did not meet cleanup criteria from the 4/30/13 work was also removed.

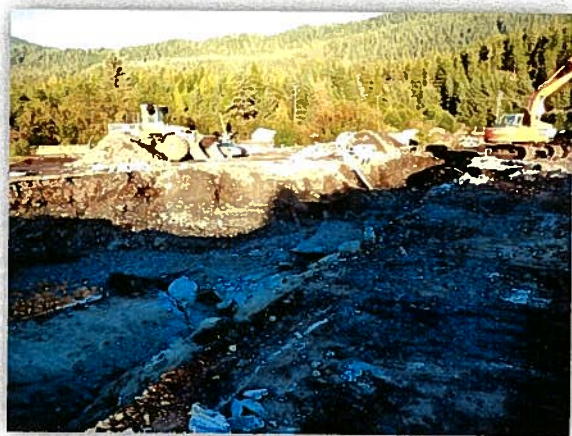
Figure 14: July 2013 view of the extensive excavations that completed the cleanup of this area

embankment and excavation bottom. Substantial contamination remained along the west and south embankments guiding the excavations throughout September. By the time excavations had ceased for the year, the excavation area had enlarged to 160'-wide by up to 210'-long. Three areas remained that required additional excavation in 2013 to meet DEC cleanup criteria.

1.a. Log Barker Site- April 30, 2013: Excavations resumed on 4/30/13 with removal of the top concrete surface to the northwest corner embankment and the underlying 3' of fill. The embankment was excavated back 12' and down to a depth of 7' bgs until the visual signs of the contaminant layer were reduced. Confirmation samples showed DRO/RRO levels were 760- 5,600 mg/kg and 250 -900 mg/kg, respectively. 35-40 c.y. of contaminated soil was removed for treatment. The area near the north embankment floor removed 5 c.y. of contaminated soil. Two confirmation samples indicated cleanup criteria were met in this location. When the excavations along the ramp sidewall took place, the wood-&-pile sidewall partially collapsed and had to be removed. Approximately 10-15 c.y. of soil were removed for bioremediation and DRO/RRO confirmation samples were 83 mg/kg and 150 mg/kg, respectively.

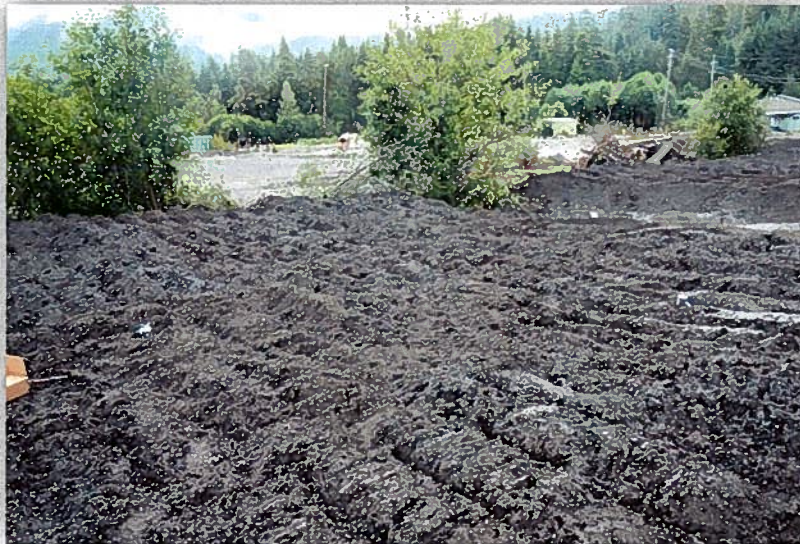
Figure 16: July 23 view showing the northeast corner of Biocell #3, where B3-5 and B3-6 were taken to determine current conditions

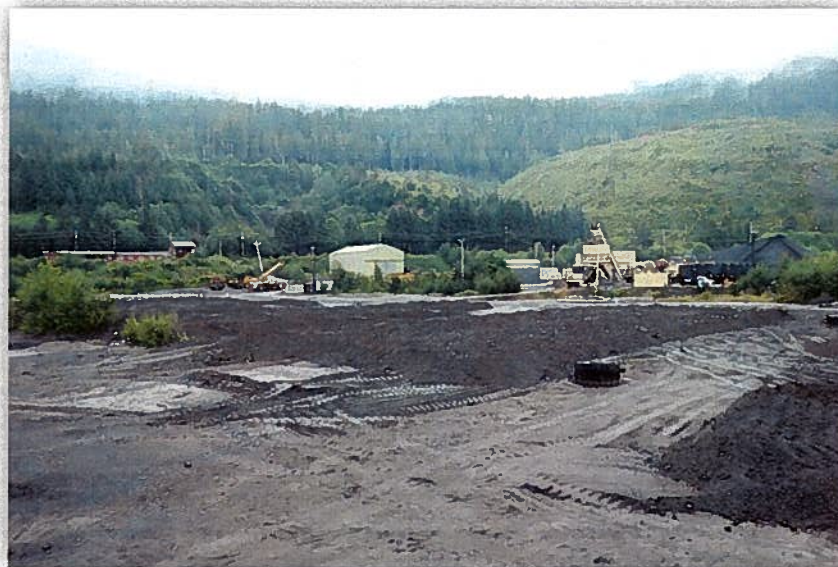
tilled by Silver Bay Logging staff at least three times from June – August 2013. SMS inspected the biocells multiple times throughout the summer and took three analytical samples from Biocell #1 at 8”-10” depths. Again, all samples were below cleanup criteria. By September 2013, the biocell layout had increased from four to five cells with a soil thickness ranging from 24”-32”. Confirmation sampling for the 5 biocells took place on 9/17-18/2013. A total of 111 samples were collected. The following tables, figures and digital images present the sampling results, data on volumes, and the locations and configuration of the cells. The final mean soil concentrations at the 95th upper confidence limit (UCL) are listed in Table 2. The final concentrations met the DRO (8,250 mg/kg) and RRO (8,300 mg/kg) cleanup levels for the site.

Figure 17: July 23 view showing 4 of the 5 Biocells that have been turned and tilled
