Marine Infrastructure Site Visit Report

Date of Site Visit:	April 14 & 15, 2016	Project Name:	Wrangell Site Assessment
Date of Report:	06/09/2016	Project No.:	1508.15
Reported by:	Craig Funston	Client:	MFA
Location:	Wrangell, AK		
Weather:	Overcast, 60° F		
Present at Site:	Craig Funston; RPS Stacy Frost; BMI	Distribution:	MFA

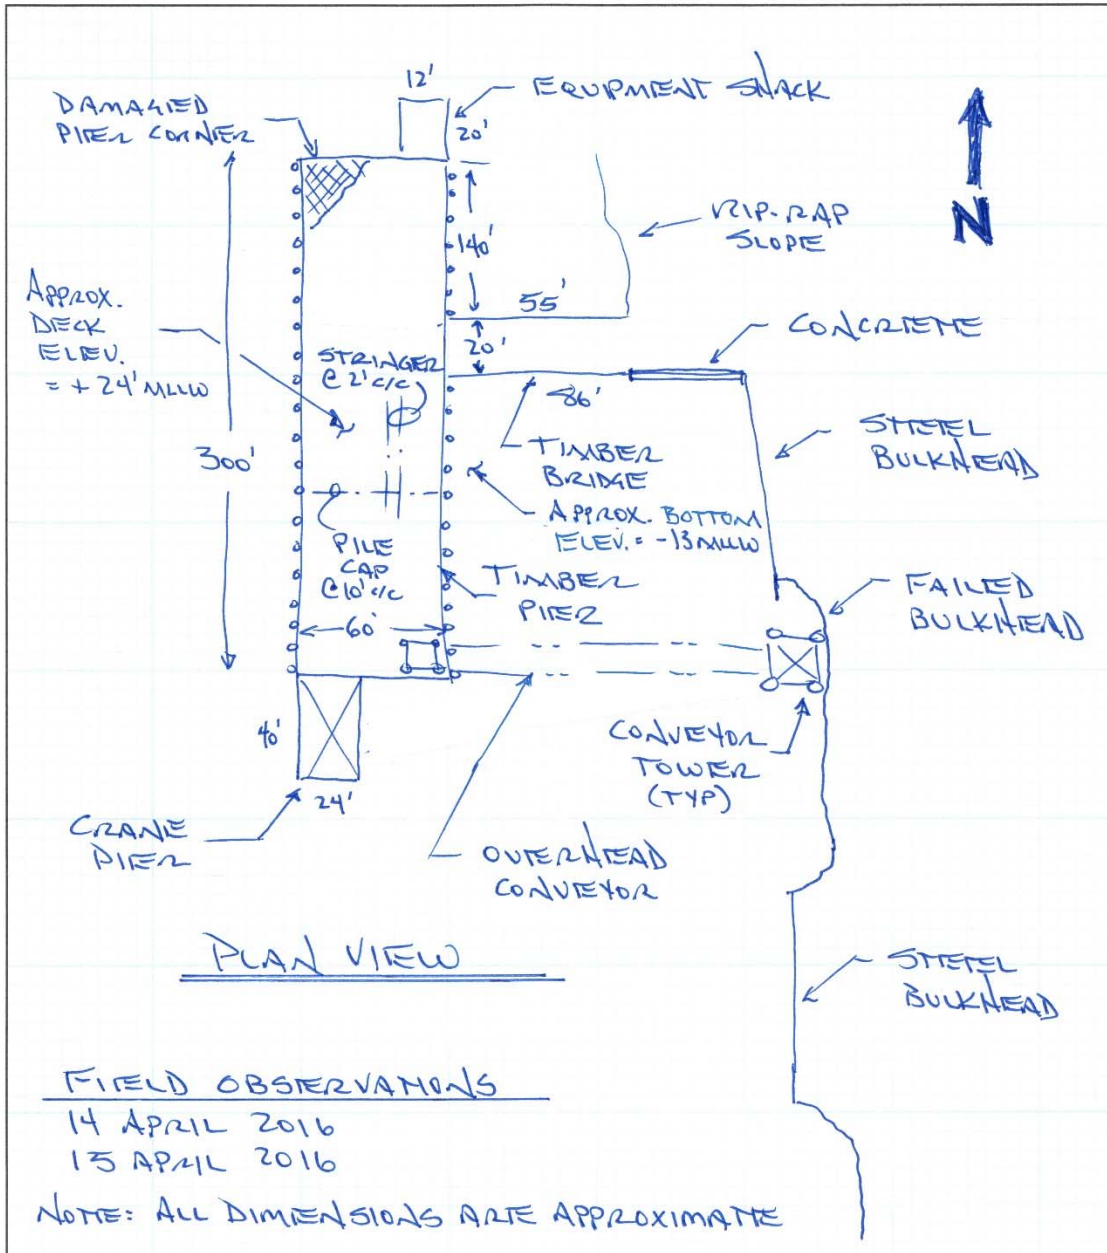
Figure 1 – Site plan

1. The northern pier is approximately 300' x 60' and is arranged parallel with the shoreline. A general layout sketch is shown in Figure 1. The pier is of treated timber construction typical for the region.

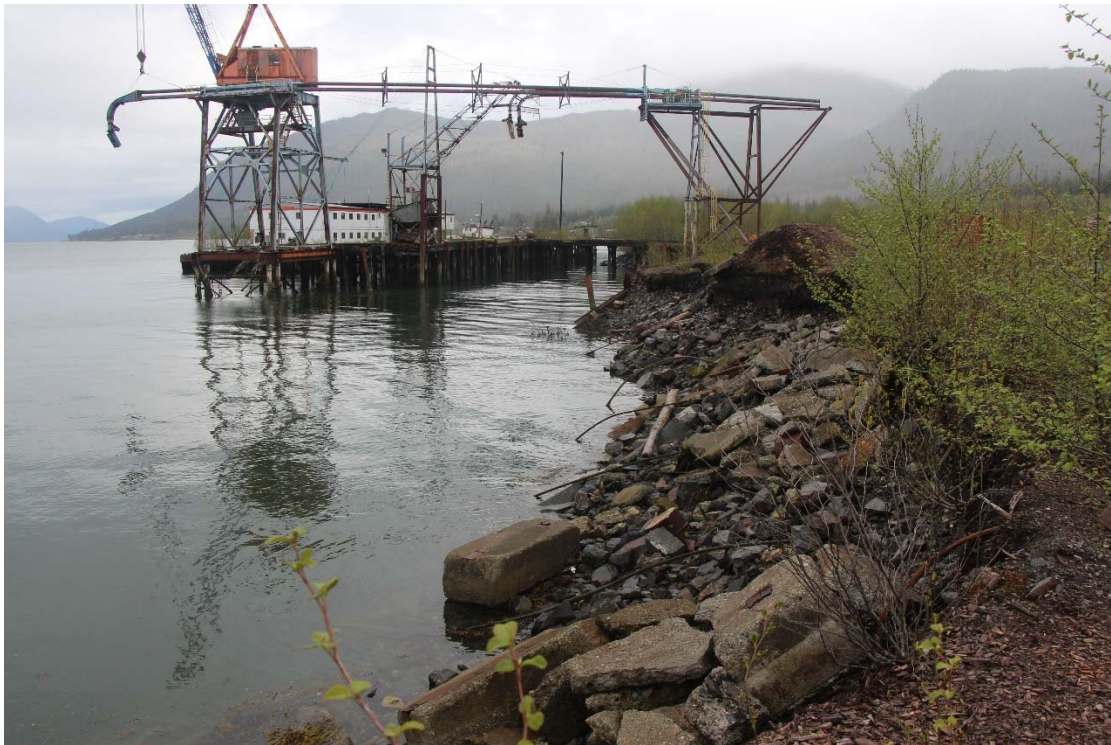
2. The pier is supported by creosote treated timber piles with butt diameters of approximately 12 to 14 inches. In general, the piles appear to be in fair condition. Probing with a pick was conducted at the waterline on a limited number of piles to check for borers or decay and all tested piles appeared to be sound. No probing was performed at the deck level due to lack of access. Physical damage was observed at a number of piles, and much of the cross-bracing, that is likely due to impacts from floating debris during storms.

Photo 1 – Timber Pier (looking north)

5. This pier appears to be in fair enough condition to allow rehabilitation and re-use. Removal of the entire wearing surface as well as an unknown amount of the structural deck will be required. Additionally, replacement of a portion of the stringers, pile caps, and piles will be required in areas of physical damage or decay. Extensive replacement and enhancement of bracing will be needed.

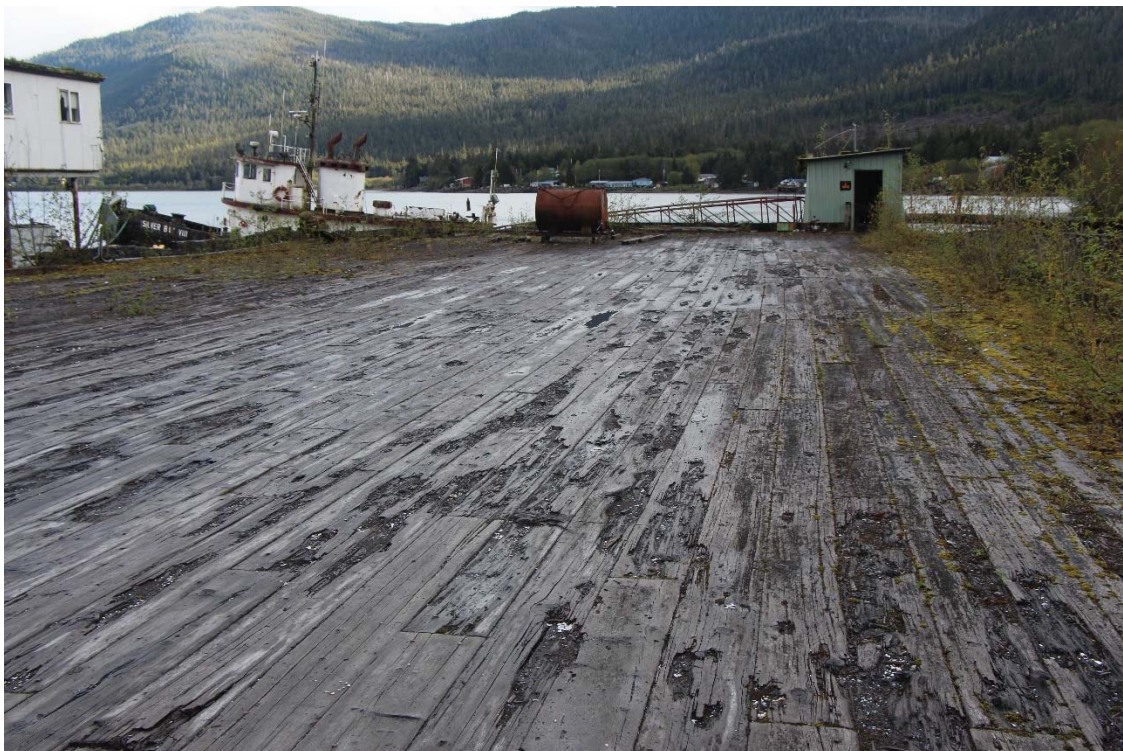
3. The northwest corner of the pier appears to have been impacted by vessels and is sagging significantly.
4. The timber deck consists of 3" x 12" planks laid as a wearing surface over 4" x 12" structural planks. The deck is supported by a grid of 4 x 12 stringers and 12 x 12 pile caps. The wearing surface is heavily decayed and in some locations is supporting plant growth. The condition of the structural planks, stringers and pile caps was not able to be physically assessed due to lack of access. Visually these structural elements appeared to be in reasonable shape.

Photo 2 – Timber Pier Deck (looking north)

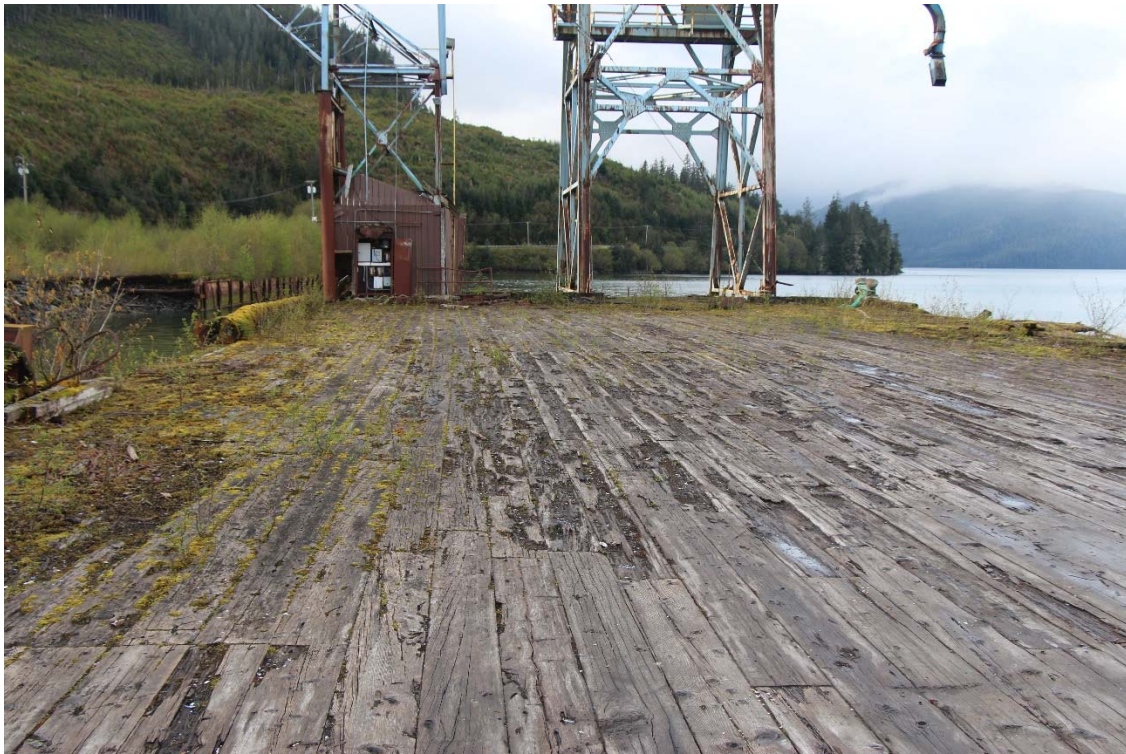
Photo 3 – Timber Pier Deck (looking south)

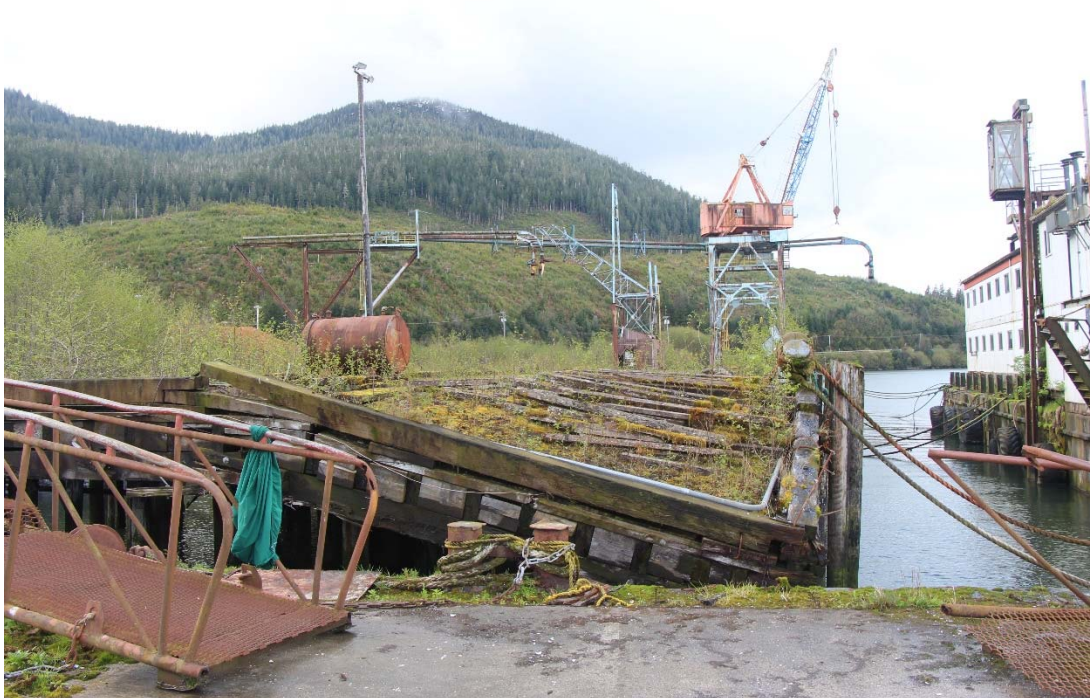
Photo 4 – Damage at North End of Timber Pier

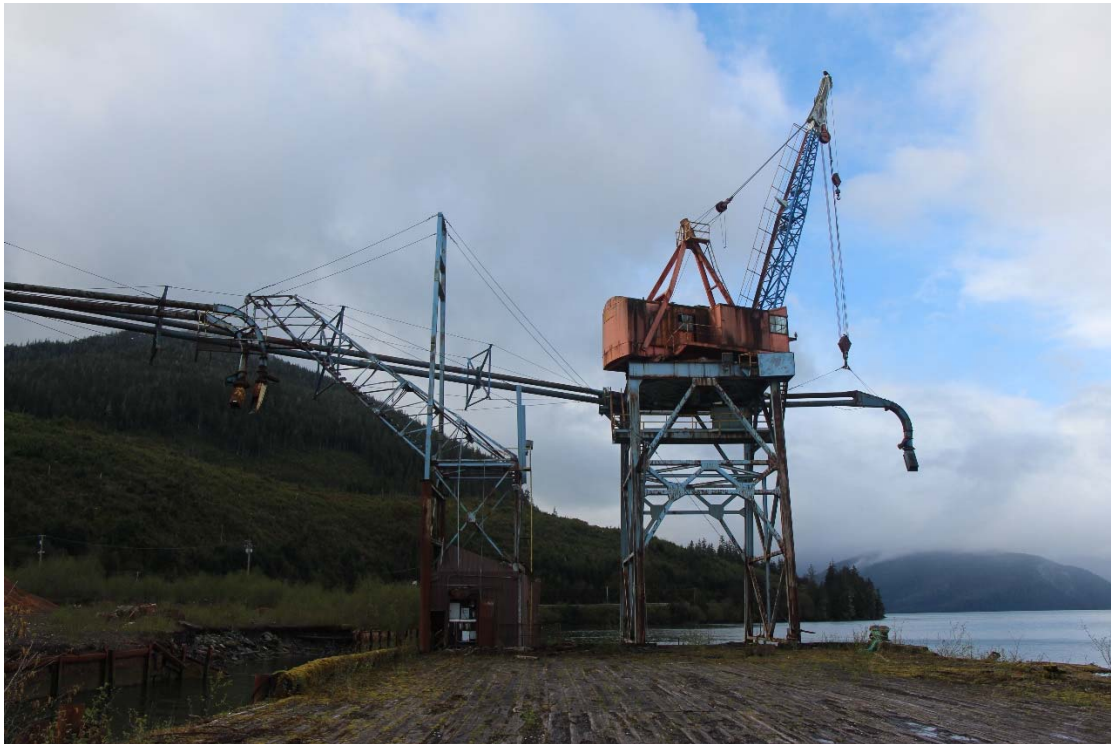
Photo 5 –Tower Crane and Conveyor Support

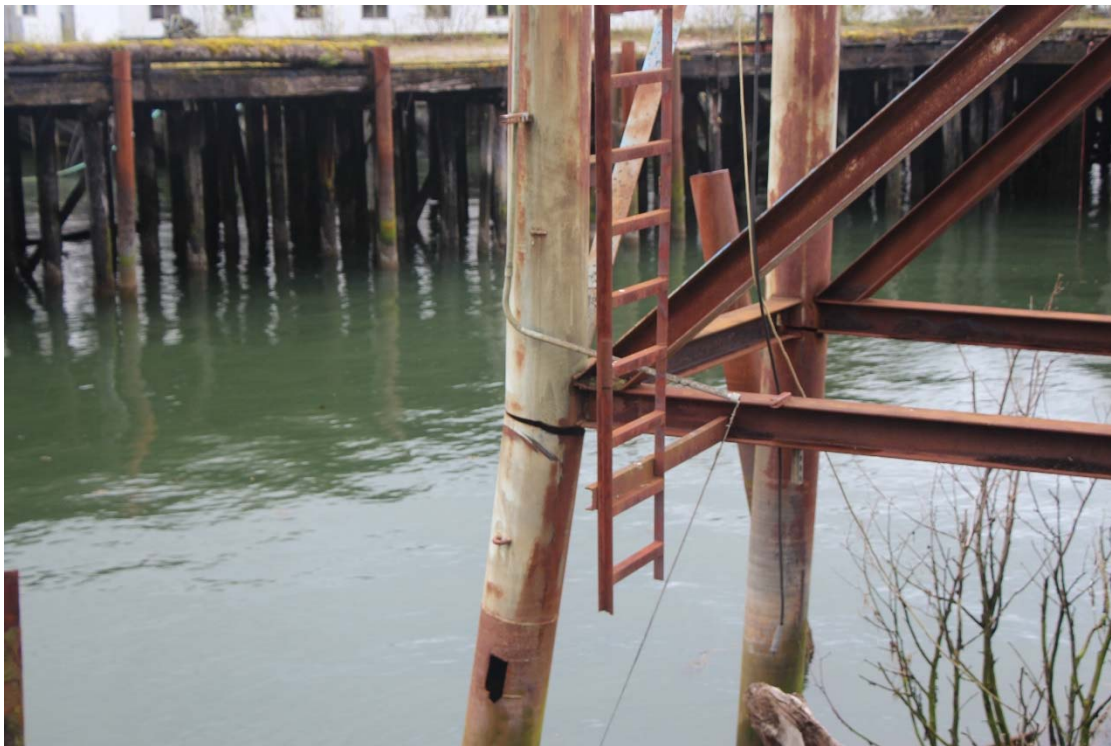
1. An overhead conveyer located at the south end of the pier spans between the shore and the North Pier. The conveyer is supported by steel towers at each end. The shore tower is significantly damaged near the base, with large tears and deflections in the columns. The conveyer system and towers will need to be demolished and removed from the site prior to any re-use of the pier.

Photo 5 – Failed Column at Shore-side Conveyor Tower

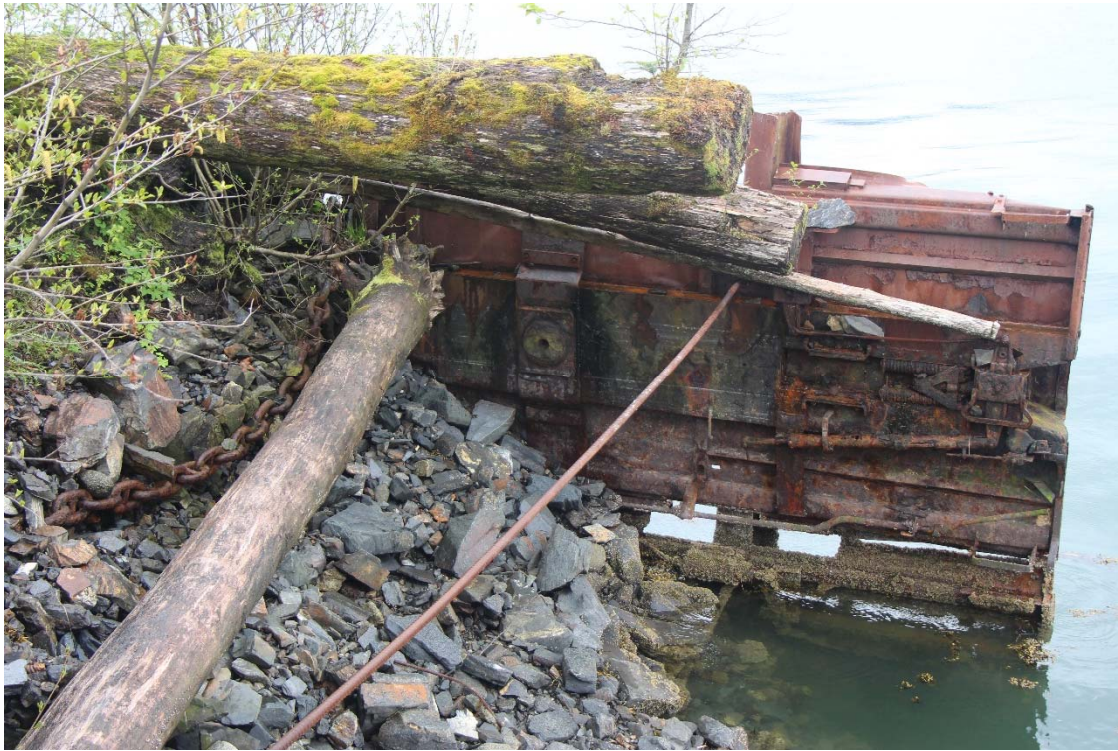
1. Approximately 650 ft. of steel bulkhead extending south from near the midpoint of the pier was constructed sometime after 1992. This bulkhead appears to be constructed of the bottom portions of railcars stood on edge, spanning between steel wide-flange piles. The piles are tied back to buried anchors with steel thread-bars (Dywidag). This bulkhead is severely corroded and has failed over a significant portion of its length.

Photo 6 – Railroad Car Bulkhead

2. The bulkhead will need to be completely replaced if a vertical face at the waterline is needed for future functions. It may be possible to drive a sheet pile type bulkhead just offshore from the existing bulkhead to reduce demolition efforts, however, more study of permit restrictions and costs is needed to prepare a plan for bulkhead restoration.

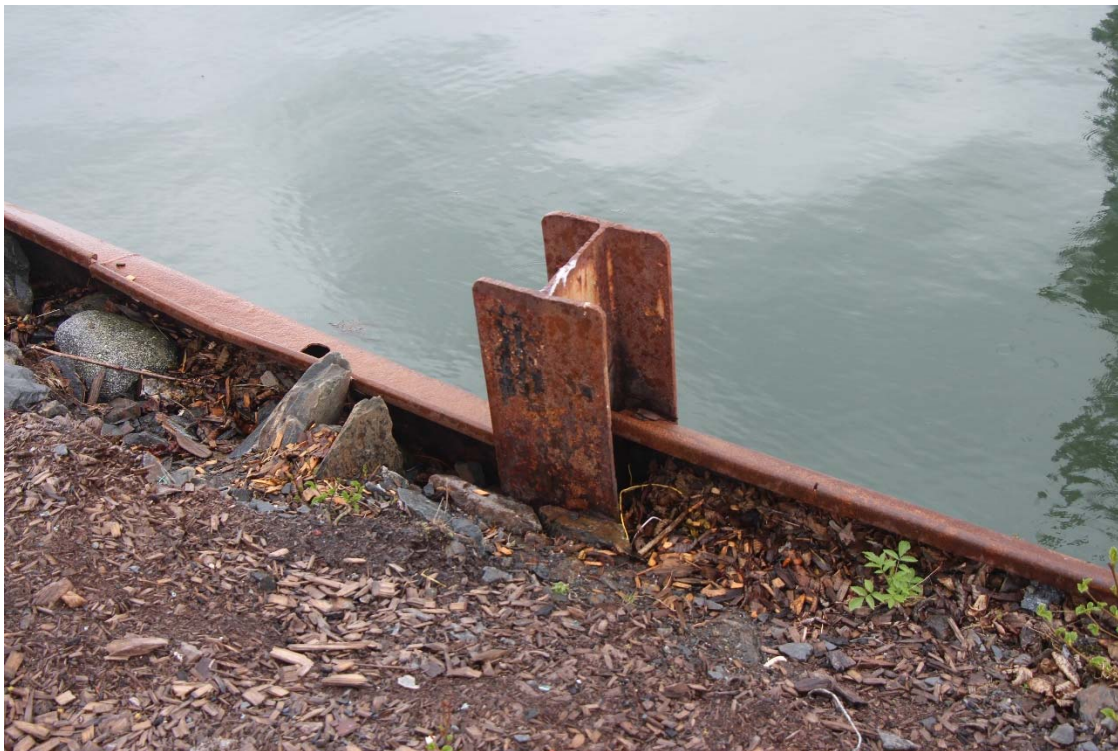
Photo 7 – H-Pile at Railroad Car Bulkhead
