**CITY OF WRANGELL
HARBOR CONDITION STUDY
OF
RELIANCE HARBOR
INNER HARBOR
STANDARD OIL FLOAT
FISH & GAME FLOAT**

**Prepared By:
Peratrovich, Nottingham and Drage, Inc.
3220 Hospital Drive, Suite 200
Juneau, Alaska 99801**

1994

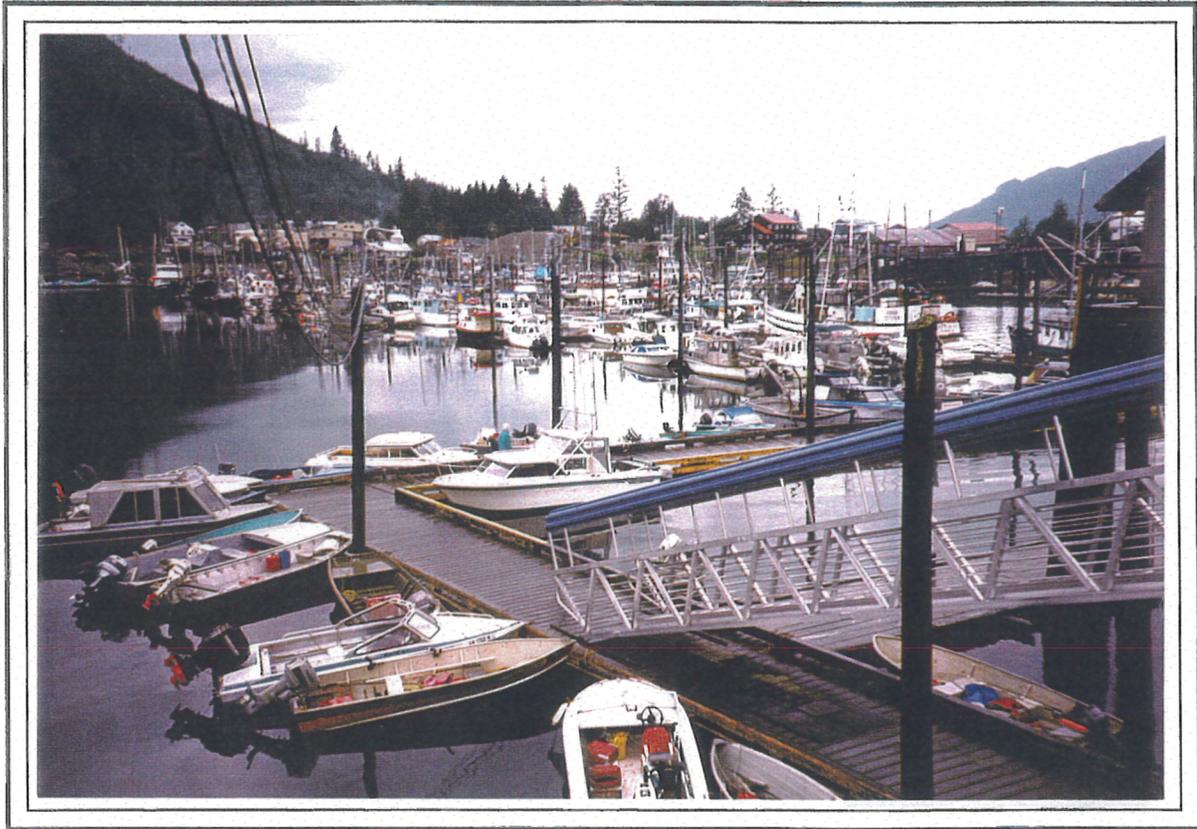
Photo 3.1 - Reliance Harbor

Reliance harbor was originally built using all timber construction. The float system consists of 2 main floats, constructed in 1962, and 5 finger floats and 22 stall floats constructed in 1975. An electrical system was added in 1977 (Photo 3.1).

The Reliance Harbor gangway is a new aluminum gangway and is in good condition (Photo 3.1). The top hinge connection is not galvanized and should be replaced. The gangway guide rail on the gangway landing float should be adjusted so that the gangway lands squarely on the rail. This will prevent the gangway rails from wearing excessively. These rails should be lubricated with waterproof grease twice a year in order to prevent unnecessary wear. A transition plate should be provided at the base of the gangway as well for safety reasons.

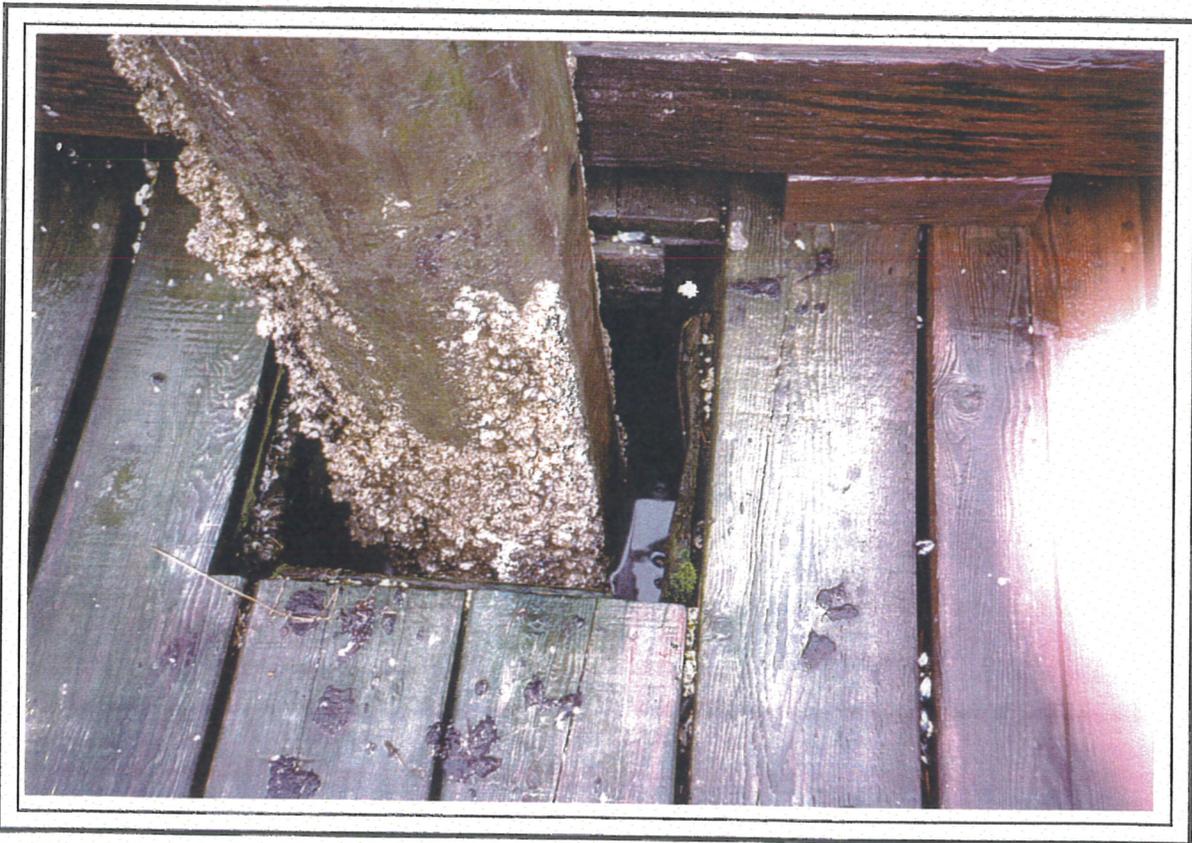
Photo 3.2 - Timber Pile Blockout

Except for one location, the timber pile block-outs in these floats are in good condition. The iron bark wear courses were in good shape considering their time in service (Photo 3.2). The one blockout that is damaged should be repaired accordingly to prevent the pile from wearing into adjacent structural members.

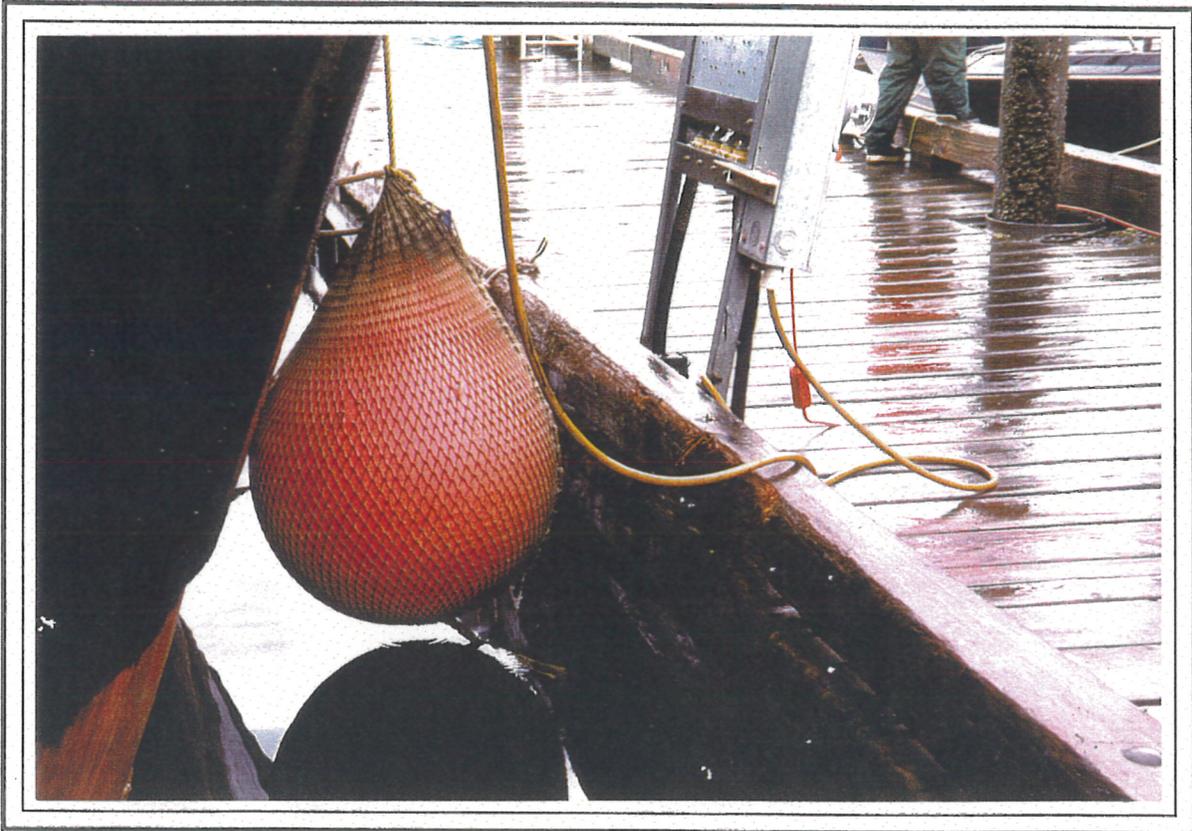
Photo 3.3 - Bullrail Wear

The bullrail and cleats in this harbor are in good condition. One or two areas of bullrail are worn from many years of service, but are still sound (Photo 3.3). There are some bullrail supports missing as well. In these areas with substantial wear, the bullrail has worn enough to allow the vessels to make contact with the dock structure. These areas should be repaired to prevent further damage to the float structure.

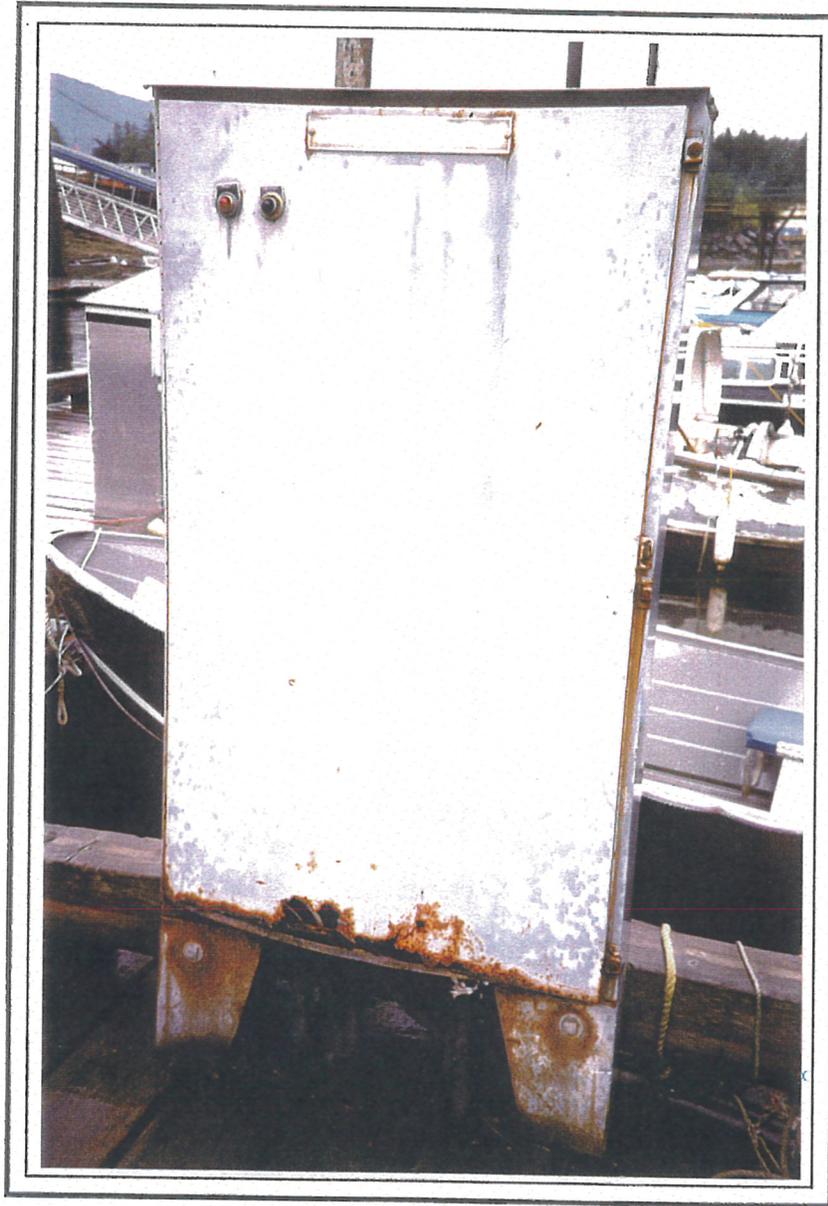
Photo 3.4 - Damaged Electrical Panel

The water system on this dock seems to be in good operating condition, although it was not tested during below freezing conditions. The electrical system appeared to be in good operating condition as well. This system should be inspected by a qualified electrical engineer to determine it's actual condition. Some of the electrical panels were rusted through and allowing water to come into contact with electrical components (Photo 3.4). These should be replaced.

3.8 Utilities				
Replace Electrical Box	Stall 186	1 ea.	\$ 2,500	\$ 2,500
3.9 Fire Safety				
Fire Extinguisher, 100' Hose w/ Cabinet (installed)	Main Floats	8 ea.	\$ 1,000	\$ 8,000
Signs	Existing Fire Extinguisher	3 ea.	\$ 50	\$ 150
Standpipes (installed)	All locations	11 ea.	\$ 500	\$ 5,500
15% Construction Contingency				\$ 4,400
<i>Estimated Repair Costs</i>				\$ 39,000

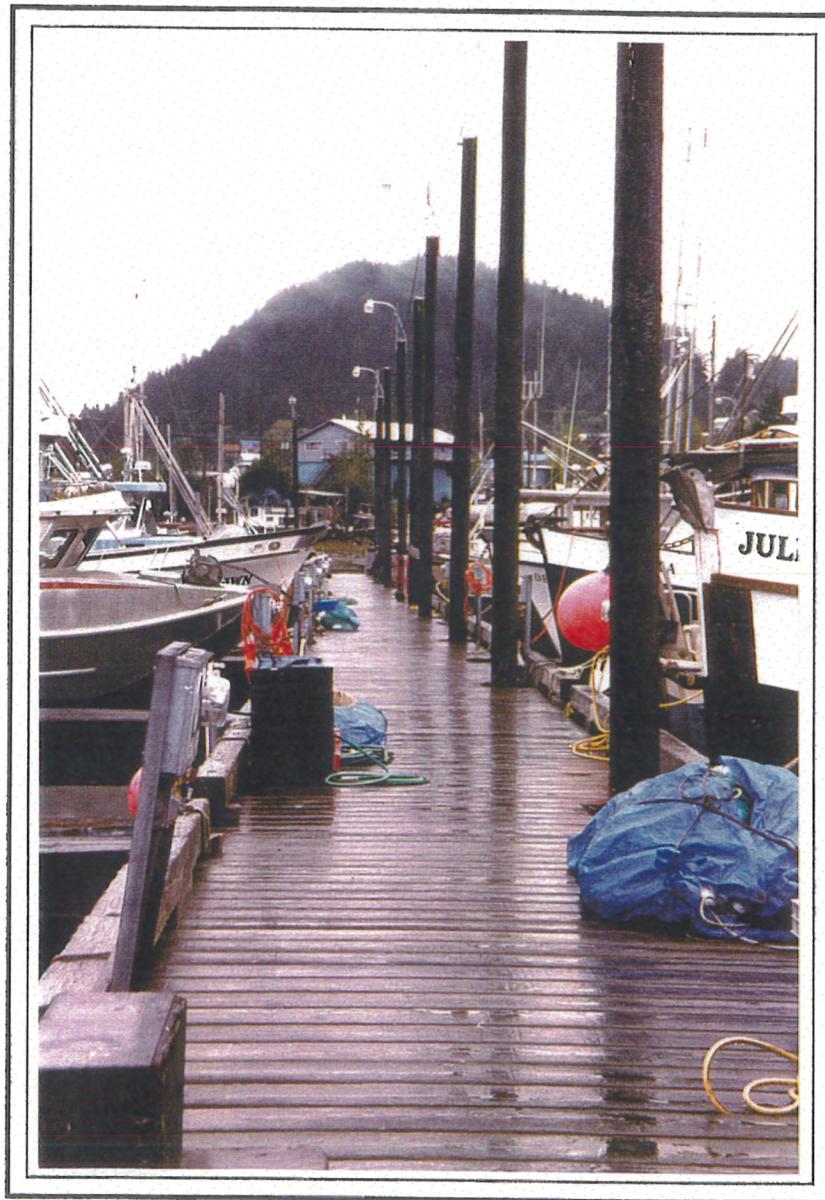
Photo 4.1 - Inner Harbor

The Inner Harbor float system is in good condition (Photo 4.1). Similar to Reliance Harbor, the main floats are relatively old (37 years) and exhibit the usual wear and tear associated with long term use. The location of the float system away from any kind of wave action has contributed significantly to it's longevity. However, some design details we find standard today were not considered at the time these floats were designed and therefore they are not up to "standard" in that respect.

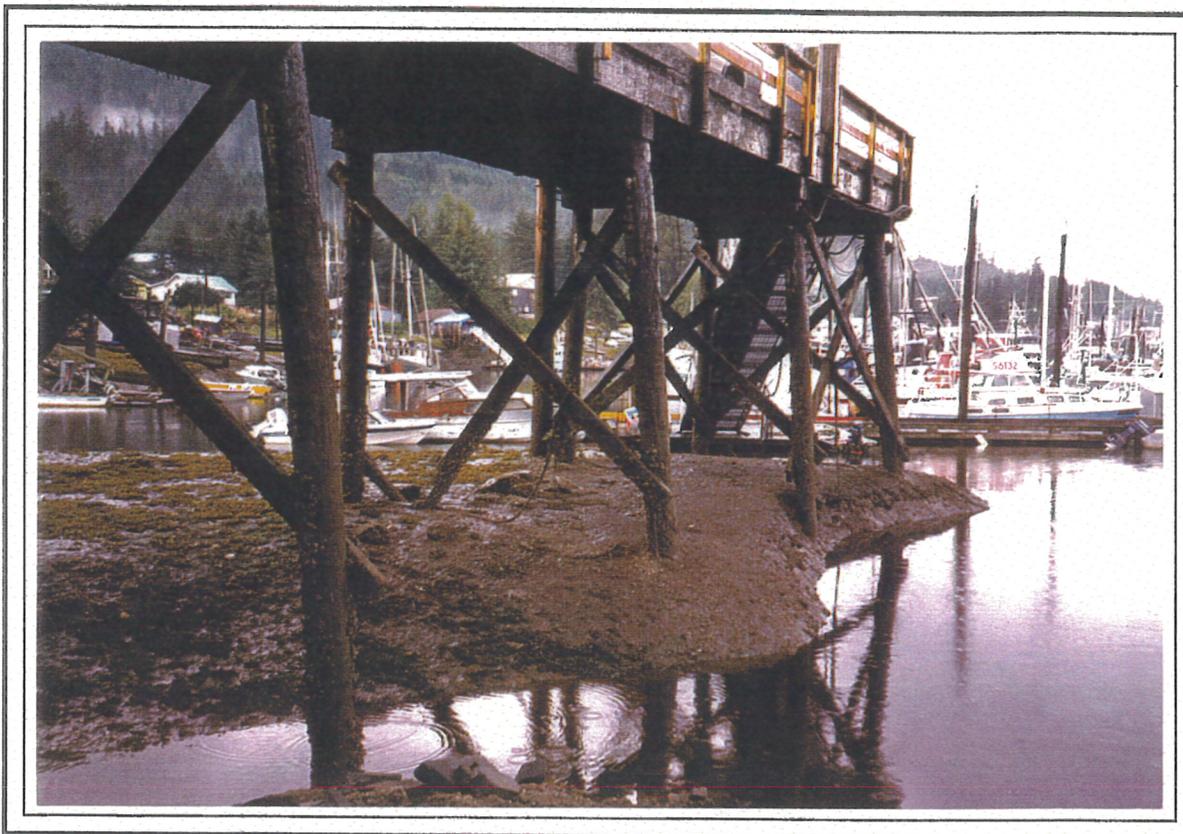
Photo 4.2 - Damaged Cross Bracing

The approach dock that connects the parking area with the gangway and float system is in fair condition. Several cross bracing members are broken in the dock sub-structure (Photo 4.2) and an adjacent drainage stream is undermining a support pile (Photo 4.3). This cross bracing should be replaced and a small amount of rip-rap fill should be added to the drainage side of the approach dock to prevent the flow from further undermining the support pile. The timber backwall is damaged (Photo 4.4). The gangway needs a transition plate at the bottom to eliminate a tripping point. Also, handrail extensions should be installed at the top of the gangway for safety reasons.

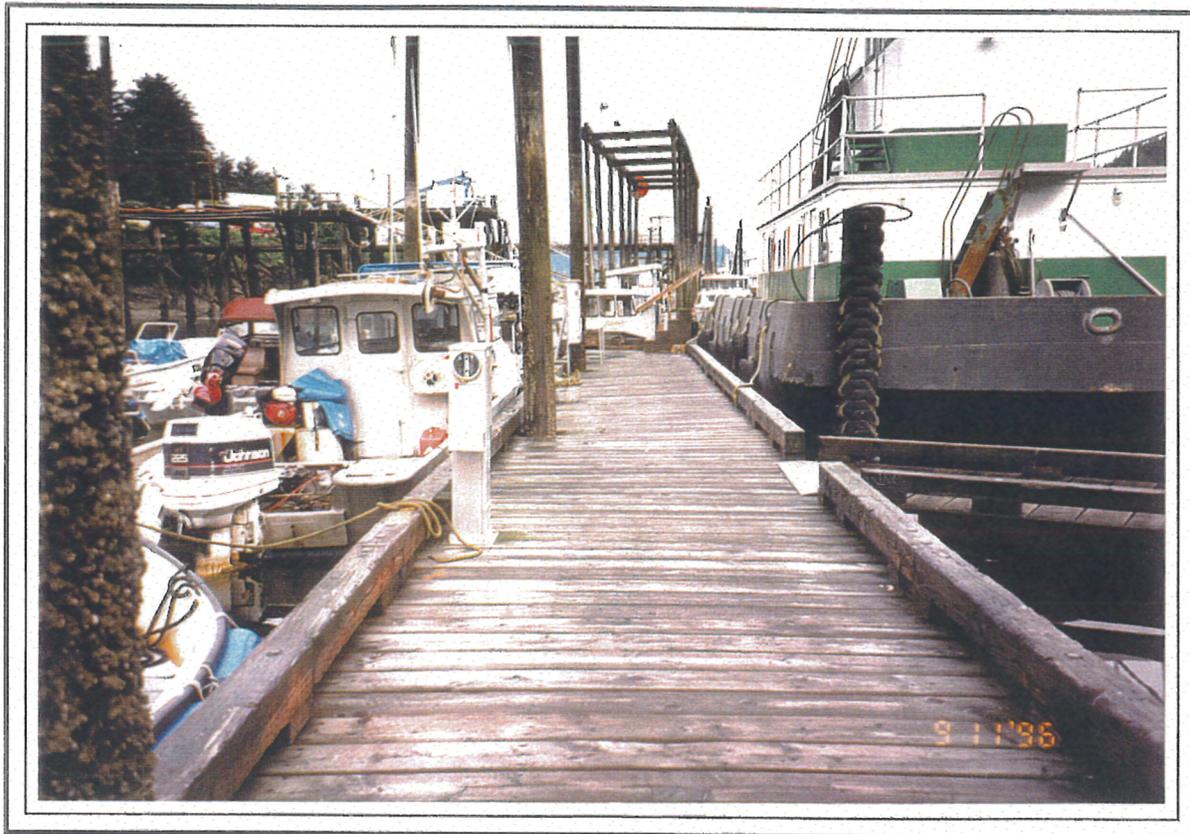
Photo 5.1 - Standard Oil Float

The Standard Oil Float was constructed in 1962 to replace an existing log float system. The harbor received a new electrical system in 1985, a new gangway in 1988, and some new finger floats in 1995. All of these floats are timber construction (Photo 5.1).

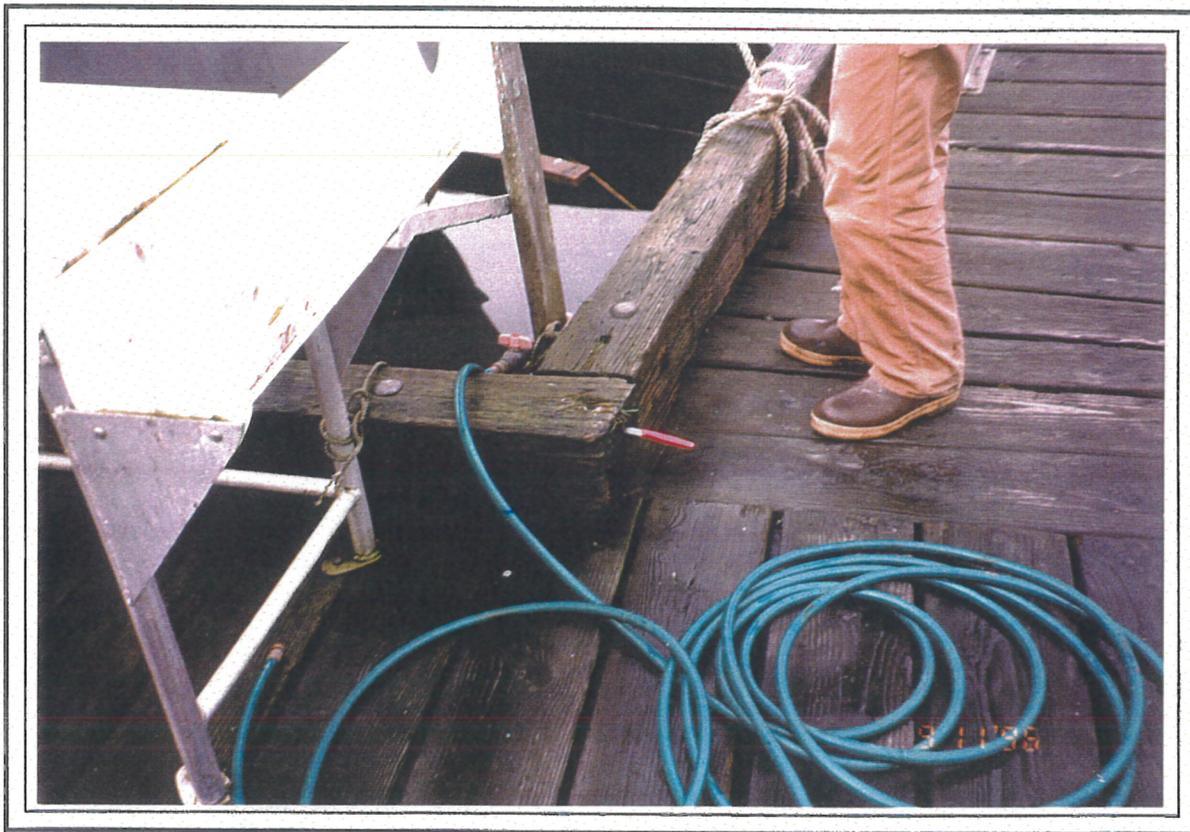
Photo 5.2 - Typical Timber Rot

The Standard Oil float is in fair condition. A good portion of the timber in the original floats has advanced algae growth and weathering (Photo 5.2). The decking and bullrails are checked and cracked in many places, and the timber pile blockouts in the original floats need rehabilitation. This is evidence that the timber pressure treatment has met or exceeded its design life.

The pressure treatment on most of the timber members in this float system has exceeded its design life. The wood is rotten in places and the decking is checking and splitting (Photo's 5.2, 5.3). None of the decking was removed to perform a thorough inspection of the float sub-structure. As these timber members crack even more, rot and decay will occur at an accelerated rate. We recommend that this float system be considered for replacement in the next five to ten years.

The bullrail on the original floats is showing signs of long term wear and rot (Photo's 5.2, 5.7). The pressure treatment has obviously exceeded its design life. The bullrail present on the new stall floats is all in good condition. All of the cleats on this float are in good condition.

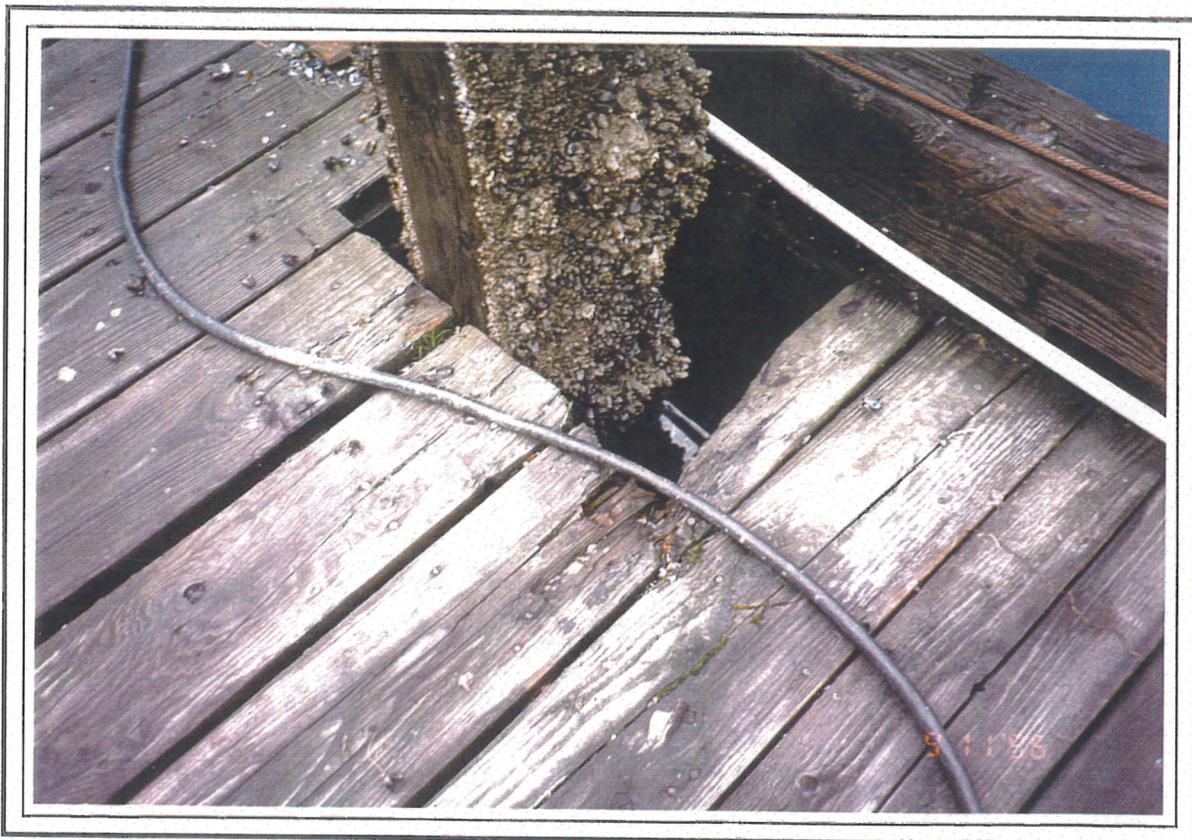
Photo 5.3 - Rotten and Damaged Decking

The timber piles and timber pile blockouts are showing signs of rot and wear (Photo's 5.3, 5.6). Separation of the outer annular rings, evidence of marine borer invasion, is appearing on many of the anchor piles. Although no rot or soft wood was found in these areas, no wood core samples were taken of these piles to determine the extent of the marine borer invasion, if any. Some pile wear was observed. The timber pile blockouts should be re-built with new wear courses to prevent the piles from wearing into critical structural members within the floats.

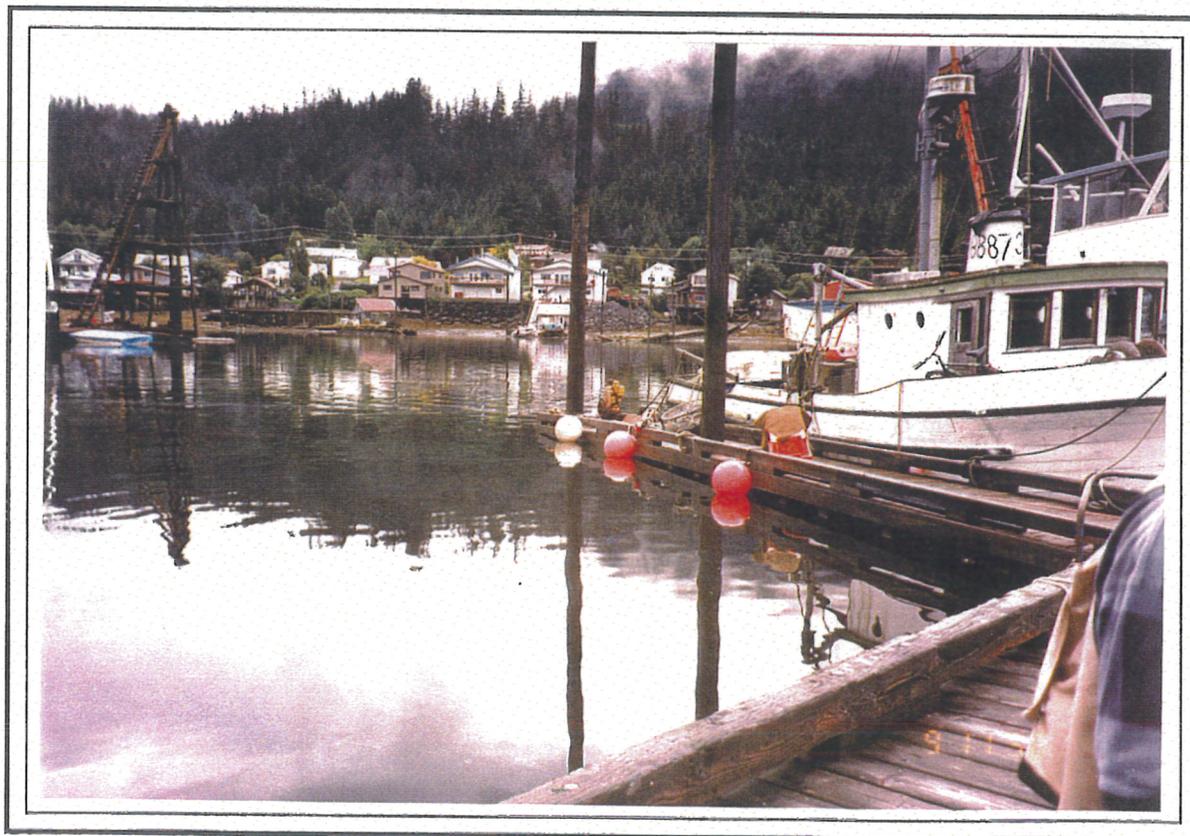
Photo 5.4 - Poor Floatation

The floatation has deteriorated in four of the five recently installed finger floats. After discussion with the Harbormaster, it was learned that there was a long term fuel leak on shore uphill from these floats. Polystyrene floatation material deteriorates in the presence of fuels or petroleum products. Fuel present on the water surface could have deteriorated the polystyrene floatation billets in these floats, resulting in low freeboard and listing. Additional floatation should be added to these finger floats to prevent the damage that will occur to the float to float connections (Photo's 5.4, 5.5).

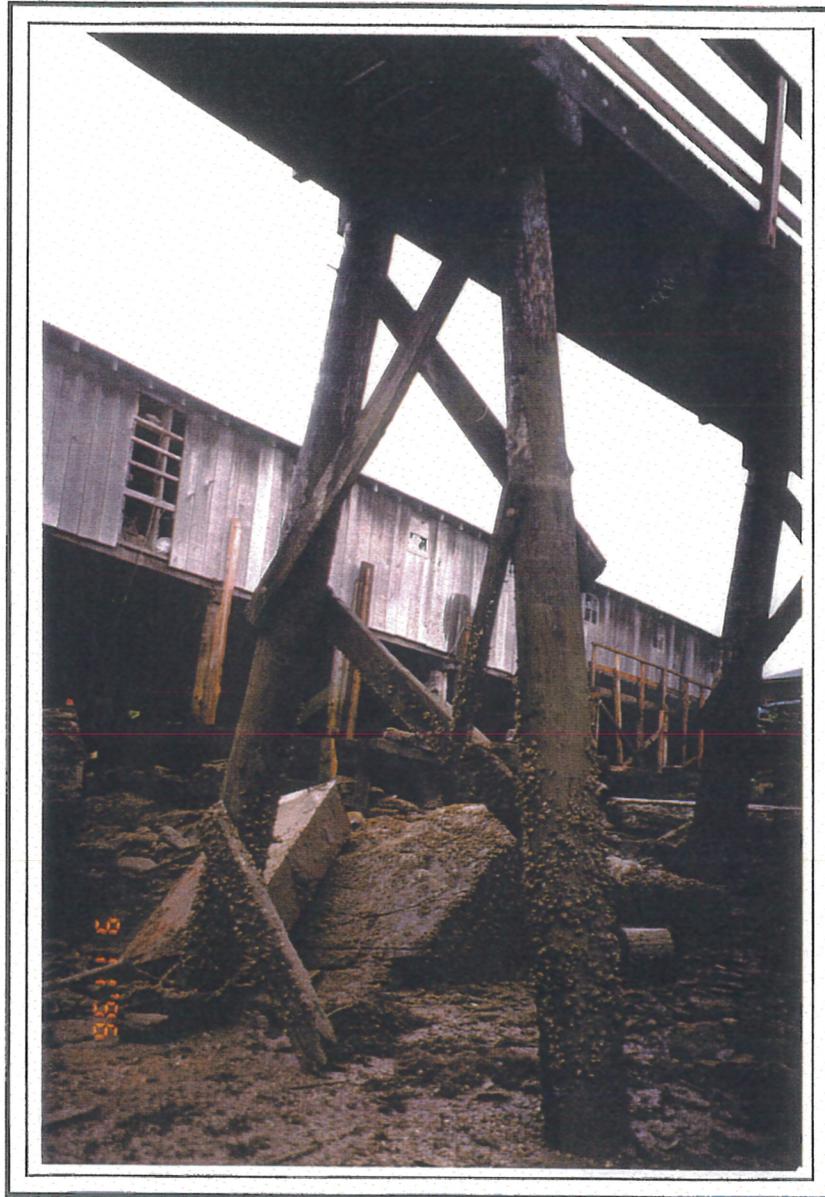
Photo 5.8 - Damaged Cross Bracing

The approach dock that leads from Peninsula Street to the Standard Oil Float is in fair condition, although some items need attention. The cross bracing that is intended to add lateral resistance to the support piles is broken in many places. These members should be restored to provide the approach dock with lateral resistance (Photo 5.8, 5.11). The butt end of one support pile is visible above the ground surface (Photo 5.9). The power poles are attached with ½-inch diameter bare steel rod. We do not feel that this is an adequate connection for this application (Photo 5.10). A portion of the handrail is broken and should be replaced for safety reasons.

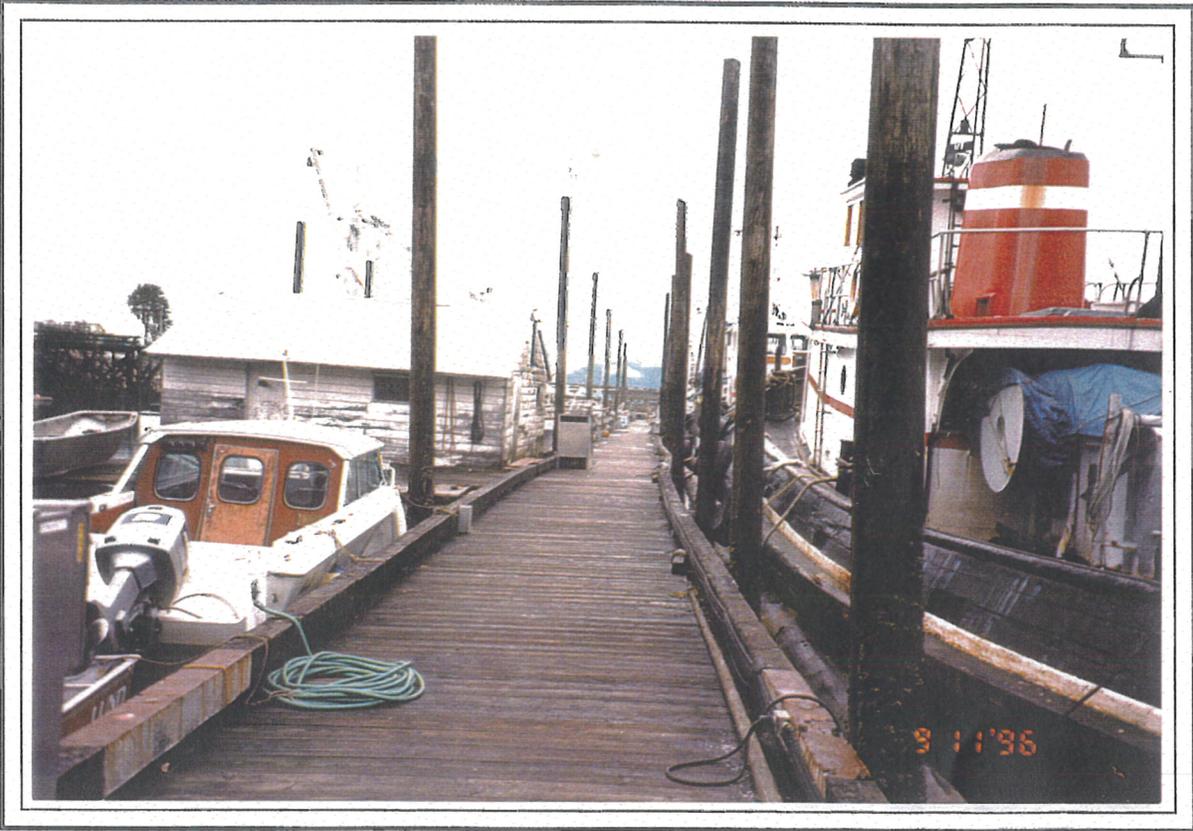
Photo 6.1 - Warped Main Float

The main Fish and Game Float is in fair to poor condition. Factors contributing to this are old construction, large vessels and wave action. The galvanized coating on most of the older steel hardware is gone. The floats have been damaged and warped by moorage of large tug boats, pile block outs are badly worn or missing and the timber pressure treatment has reached or exceeded it's service life. The newer portions of the float system are in fair condition.

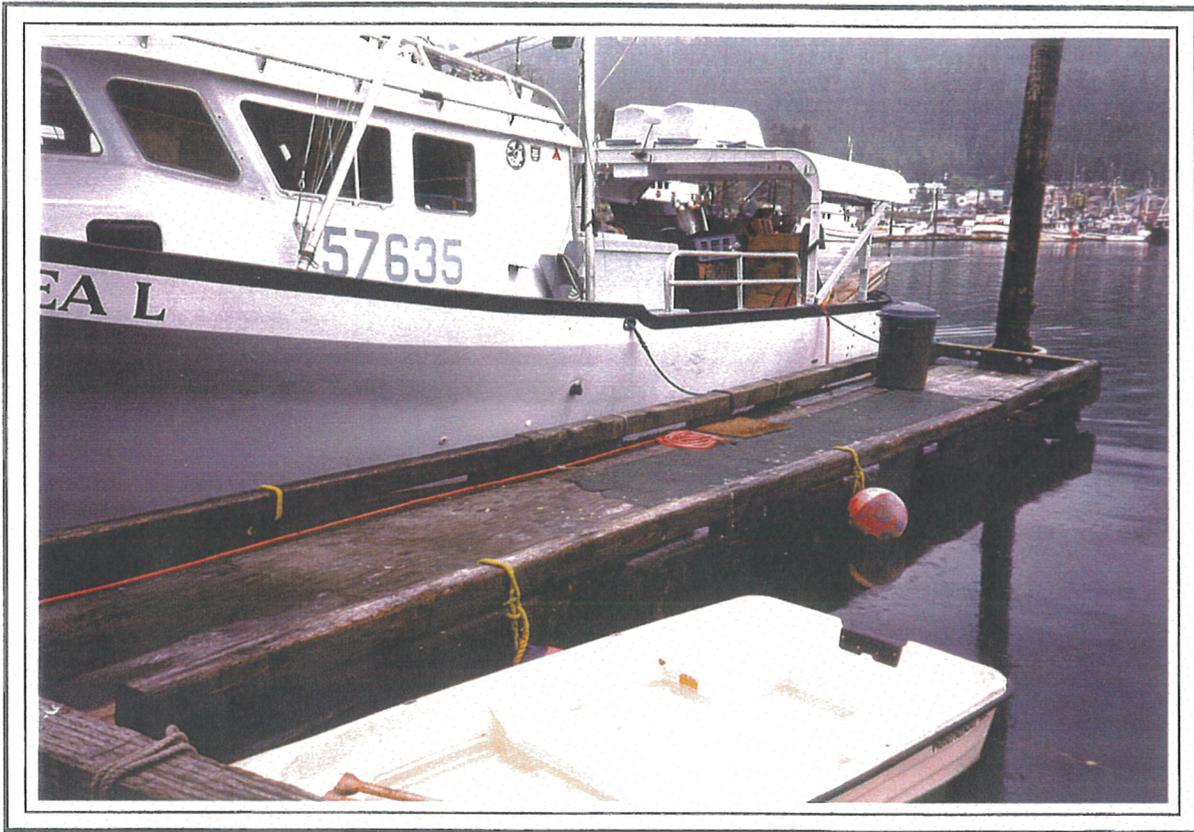
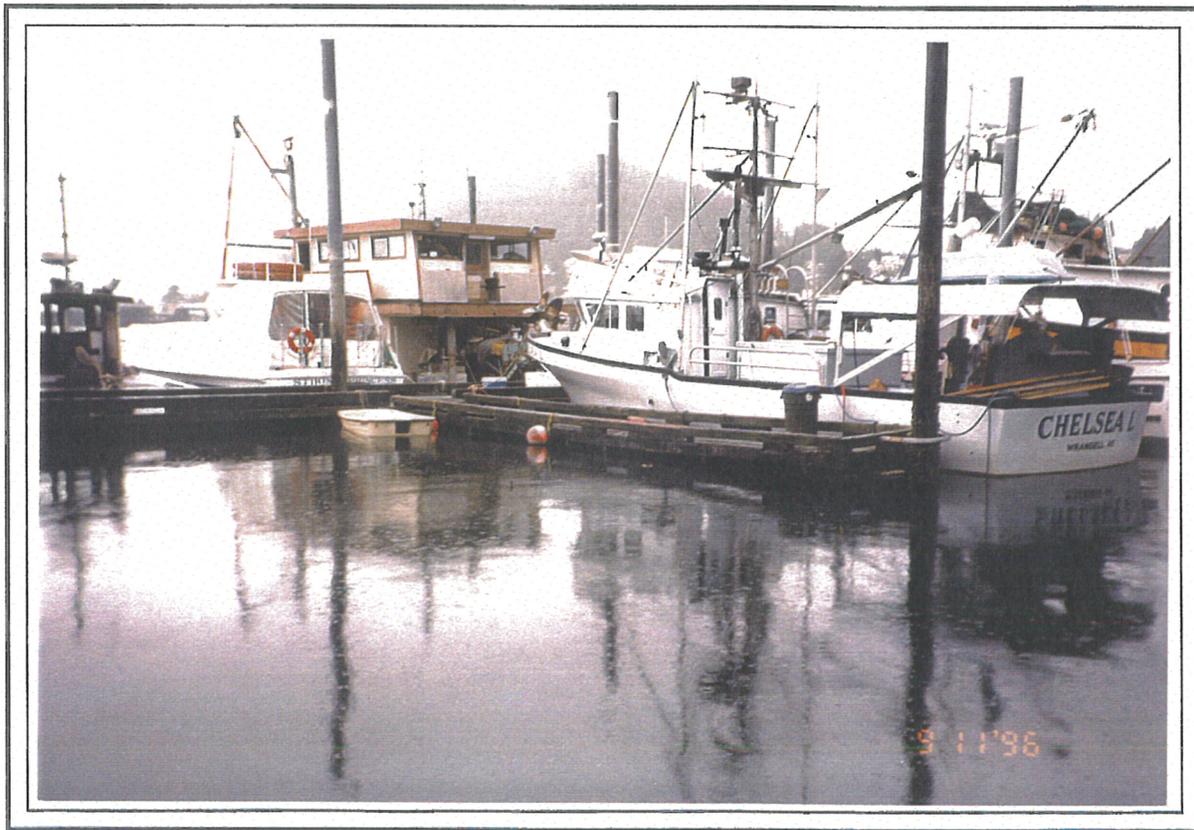
The main structural components of the older float structure are nearing the end of their design life. The structure itself has been warped and the main connections between these components have experienced creep due to excessive loading from large vessels and wave action from vessel traffic (Photo 6.1). Some sections of rubstrip are missing or are broken, as well as some structural members. These items should be repaired or replaced. The decking on the older floats has significant algae growth and checking (Photo 6.2). The 38 foot finger float, stalls 257A and 257B, is an old float with structural damage. The decking has been overlaid with plywood and the float structure is warped. This is evidence of structural damage to the float stringers (Photo's 6.3, 6.4).

Photo 6.3 - Damaged Float

Photo 6.4 - Damaged Float

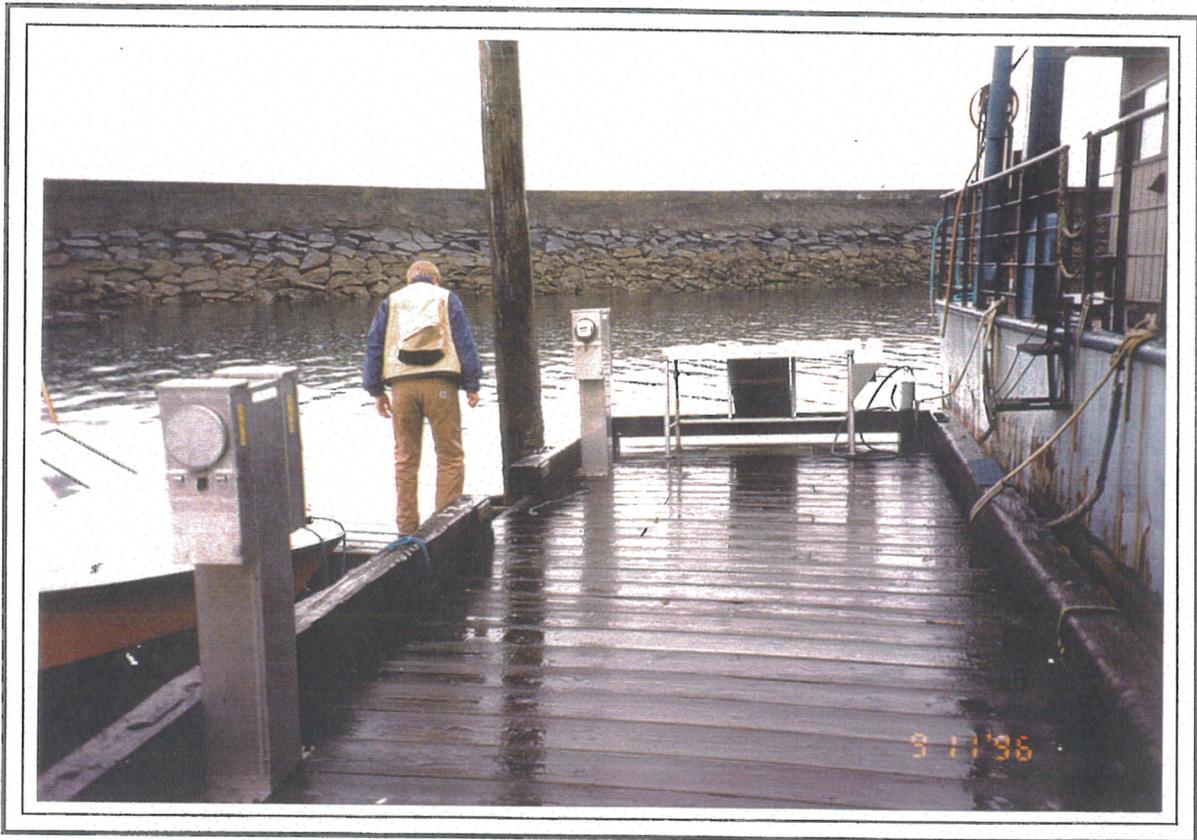
Photo 6.5 - Poor Floatation

The flootation on the main dock is still in good condition except for the gangway landing area and the extreme north end of the main float (Photo 6.5). Flootation is poor in many of the smaller finger floats. This is evidenced by low freeboard and excessive stress to the float-to-float connections (Photo 6.6).

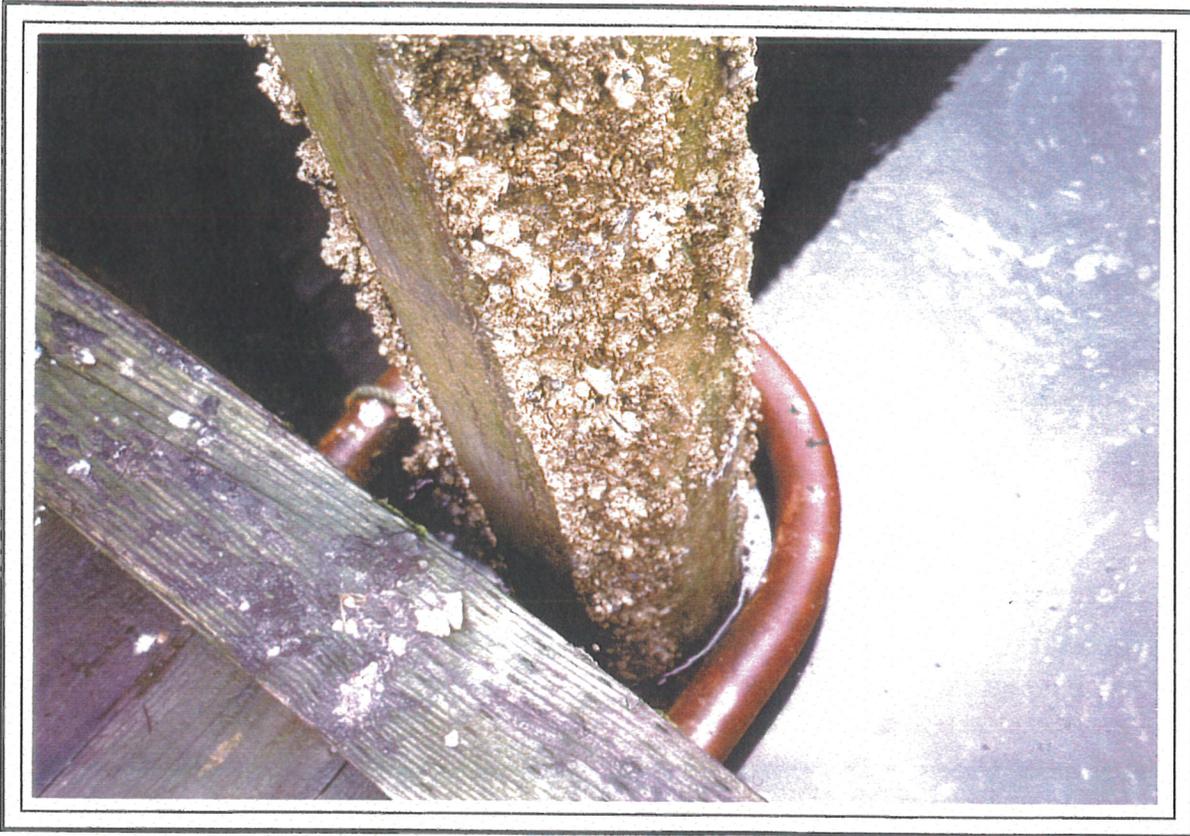
Photo 6.7 - Pile Wear

The timber and steel piles in this harbor are in fair condition. The timber piling has abraded and worn in places from long term use (Photo 6.7). Minor surface checking is visible and could be evidence of marine borer invasion. No core samples were taken to prove or disprove this. Several timber pile blockouts are completely worn away or missing altogether and the piles are wearing into the float structure (Photos 6.8, 6.9). These blockouts should be repaired as soon as possible to prevent further damage to the float structure. The damaged portions of the float structure in these areas should be repaired as well. Many of the steel pile hoops have lost all of their galvanizing protection and should be replaced (Photo 6.10). Along the portion of the main float where large vessels are moored, a makeshift camel log / fender pile system has been installed (Photo 6.11). The float to which these fender piles are breasting is not adequate for this type of loading. We would recommend a heavy duty float to replace the existing float in this area.

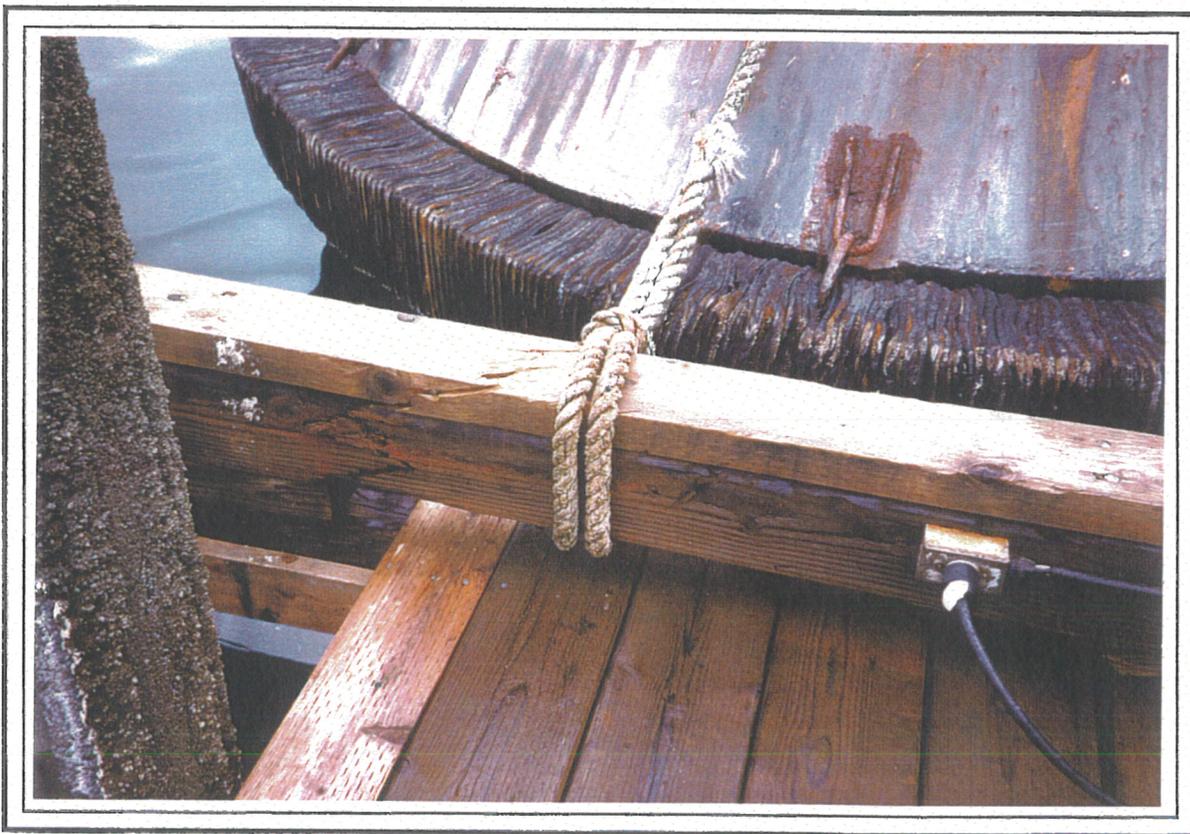
Photo 6.12 - Damaged Bullrail

The bullrail on the older portions of the main floats is broken in a few spots (Photo 6.12), some of the scupper blocks are missing, the pressure treatment has reached it's design life in many places. Most of the bullrail damage is seen where large vessels have attached mooring lines (Photo 6.13). The existing cleats in this harbor are in good condition.
