# WRANGELL BARGE RAMP CONDITION ASSESSMENT

Prepared for:  
City and Borough of Wrangell  
Department of Public Works & Capital Projects  
P.O. Box 531  
Wrangell, Alaska 99929

March 2011

Re: Wrangell Barge Ramp Condition Assessment

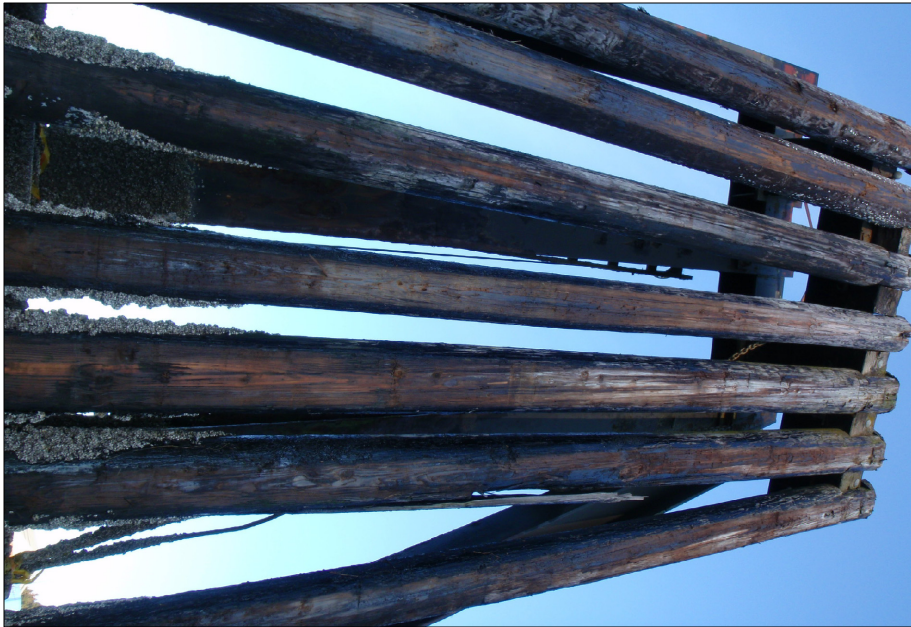
Displaced fender piles at Dolphin "D".

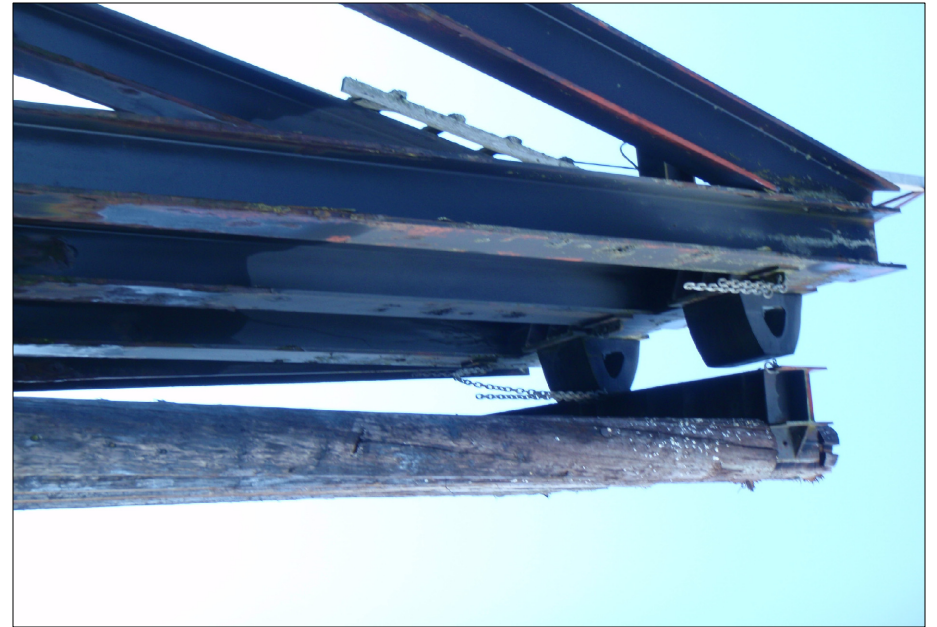
Broken stay chains at Dolphin "D".

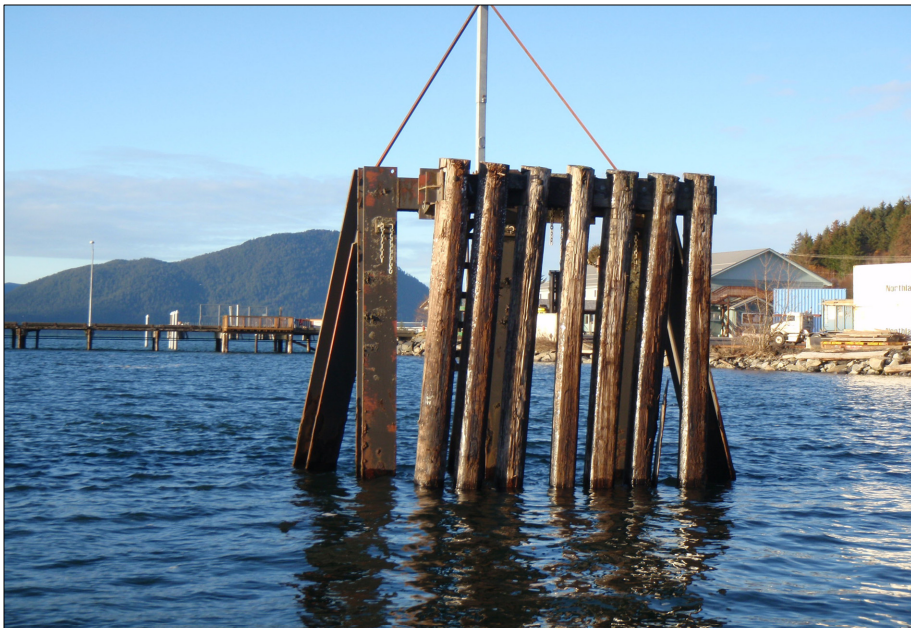
Displaced fender piles at Dolphin "D", looking north.

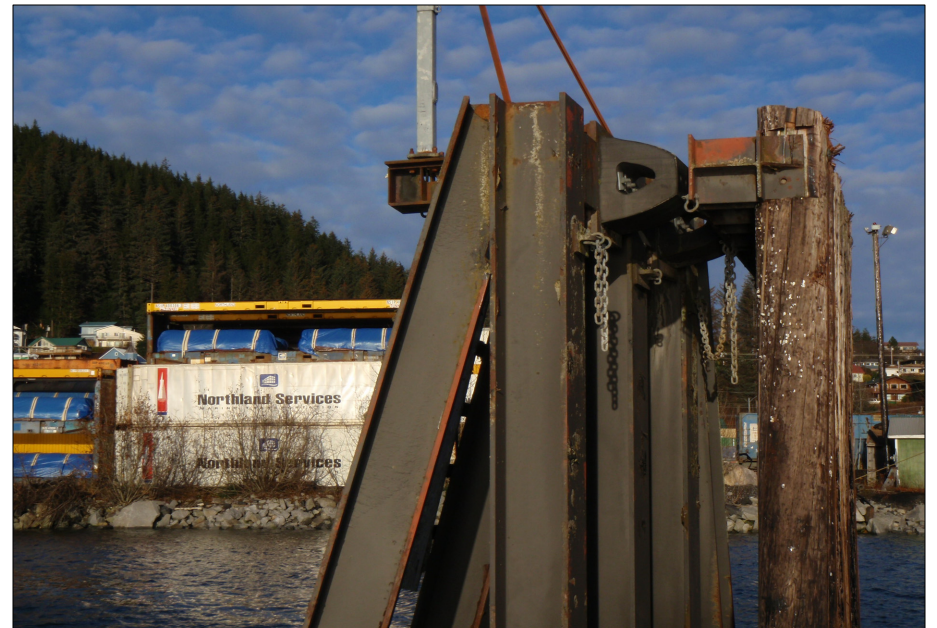
Broken stay chains at Dolphin "D".

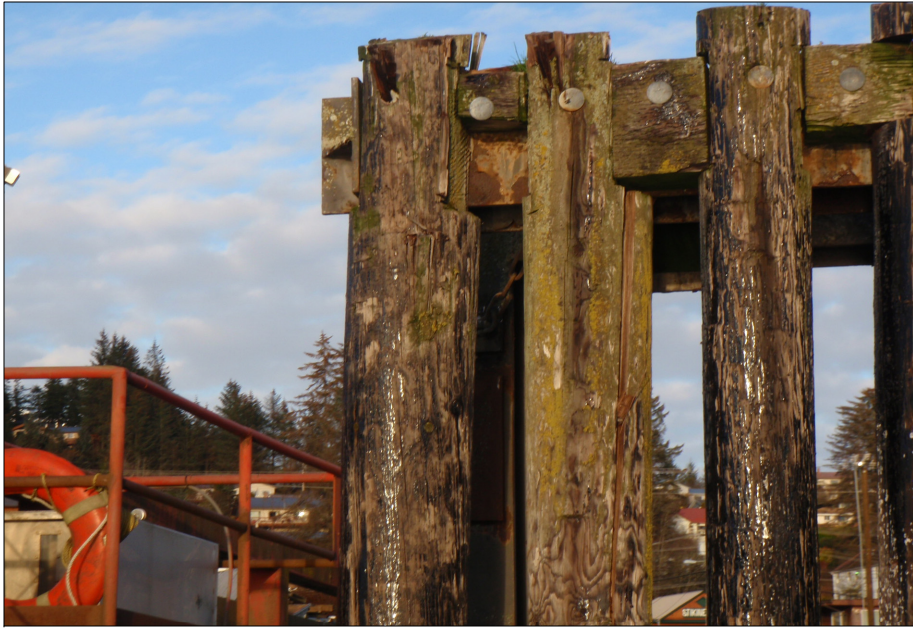
Broken fender pile at Dolphin "F".

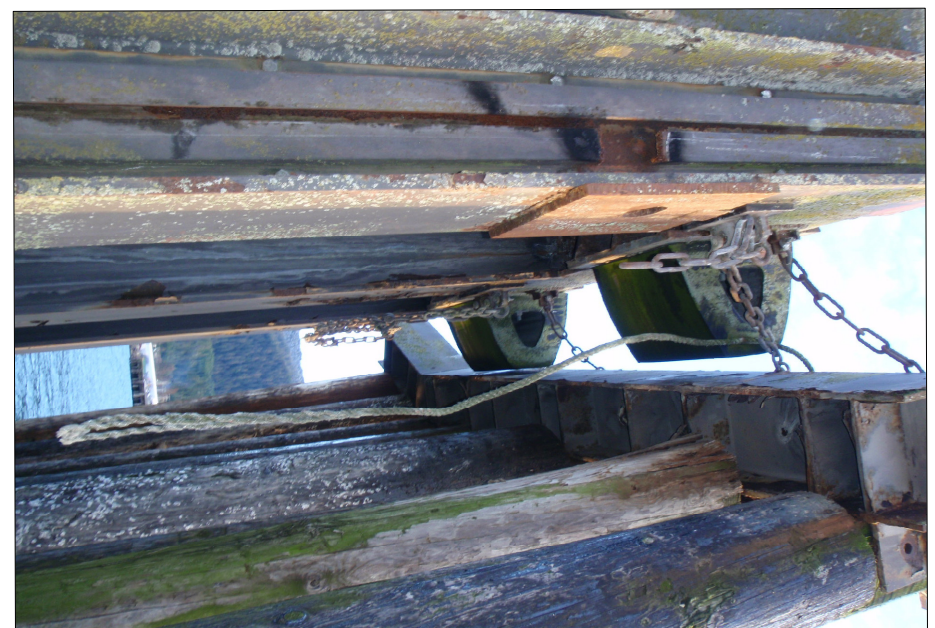
Broken stay chains at Dolphin "F".

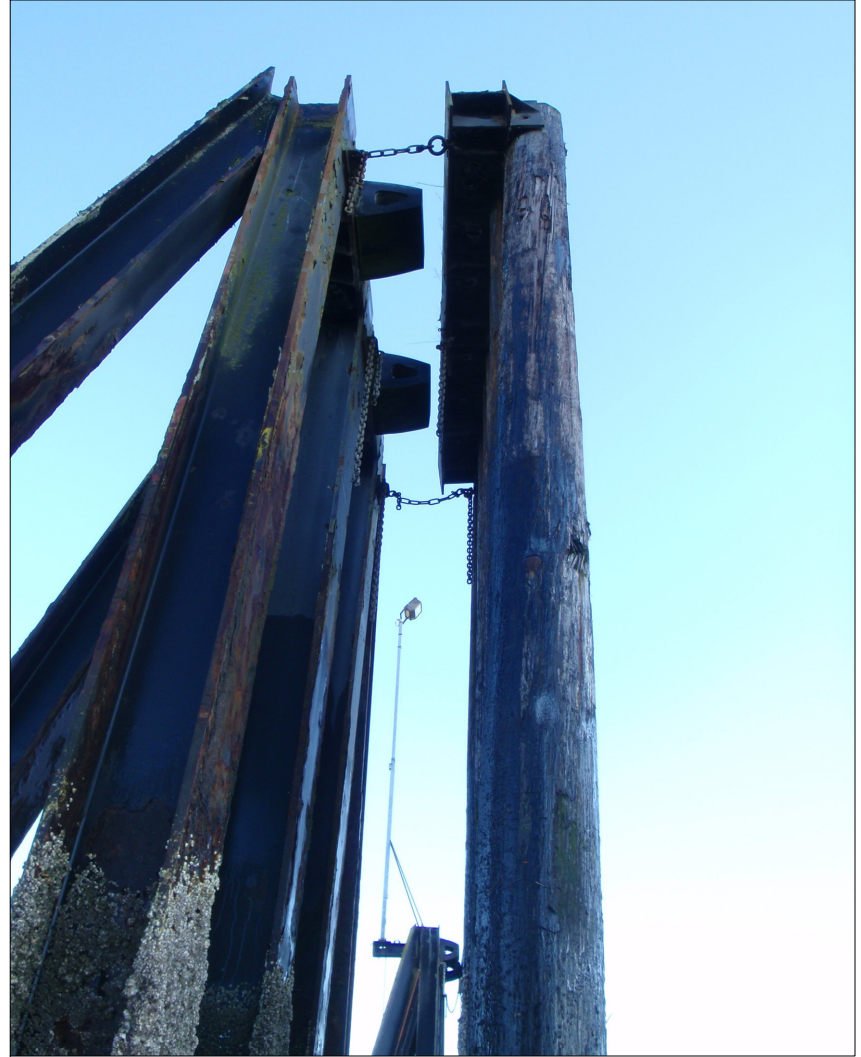
Broken stay chains at Dolphin "C".

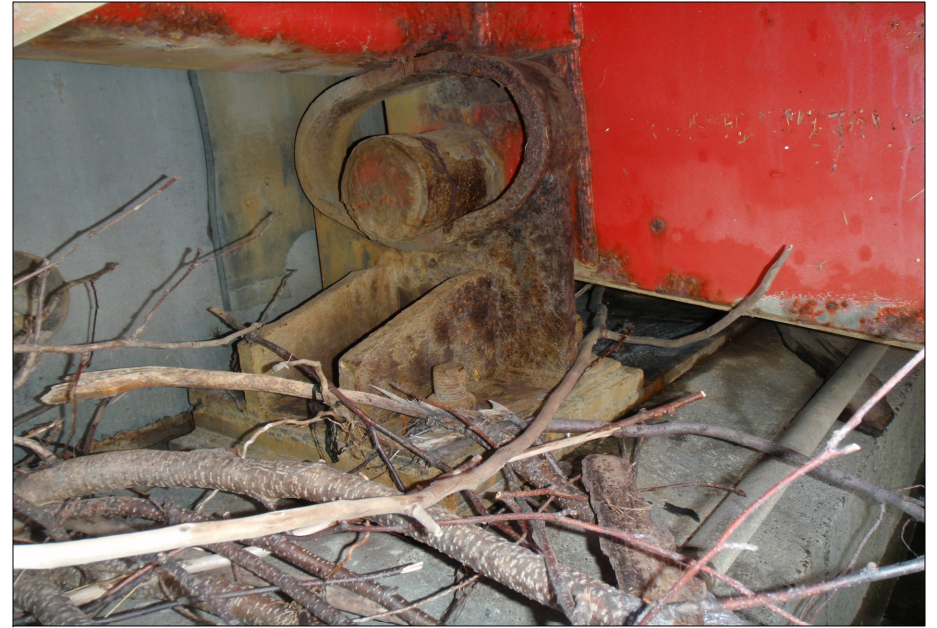
- Abutment - The steel bridge bearing assemblies are still structurally adequate; however, the protective paint coating is in poor condition. The north bearing assembly has significant mechanical wear such that the bridge sets approximately an inch lower on the north side. Minor erosion exists along the base of the concrete abutment's front face.

North bearing assembly, debris and worn steel; coating failure on all steel components.

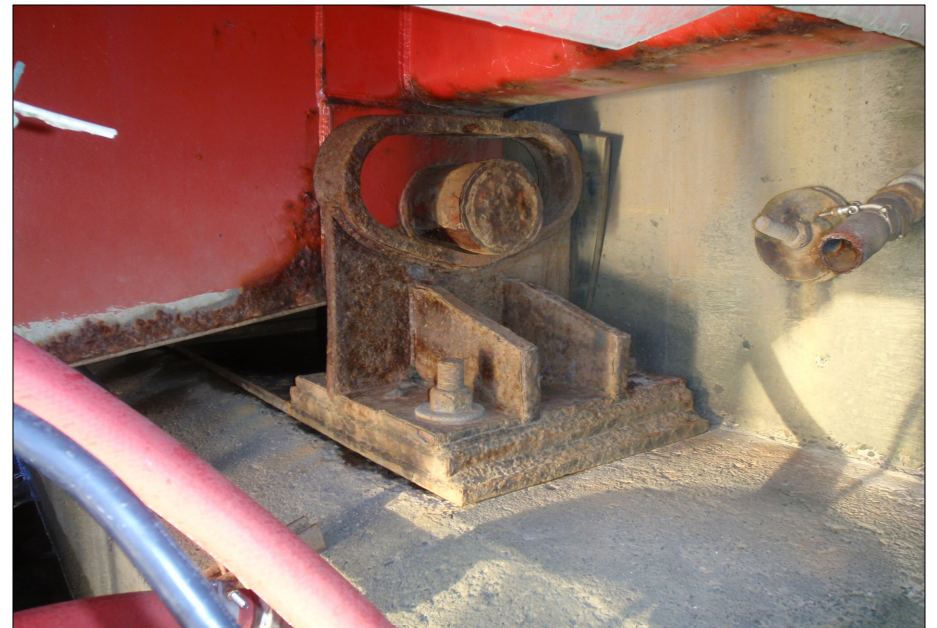
South bearing assembly; coating failure on all steel components.

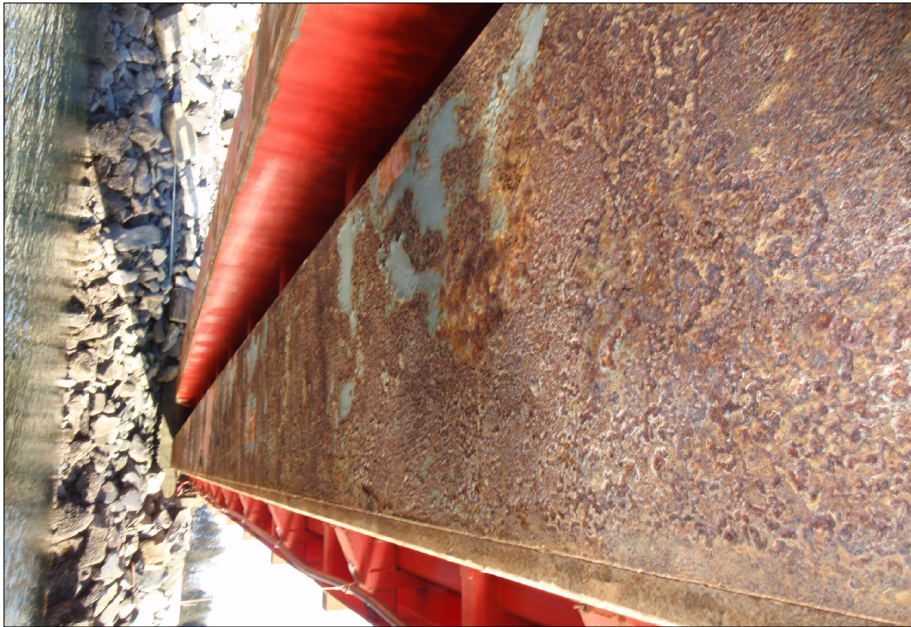
Ramp box-girder bottom flange corrosion.

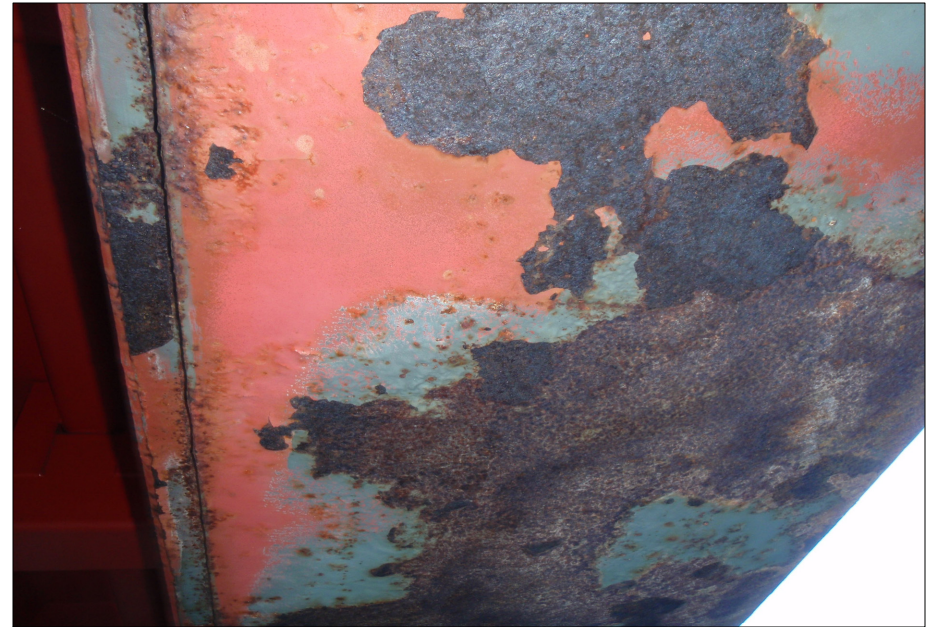
Typical coating failure/corrosion of girder bottom flange.

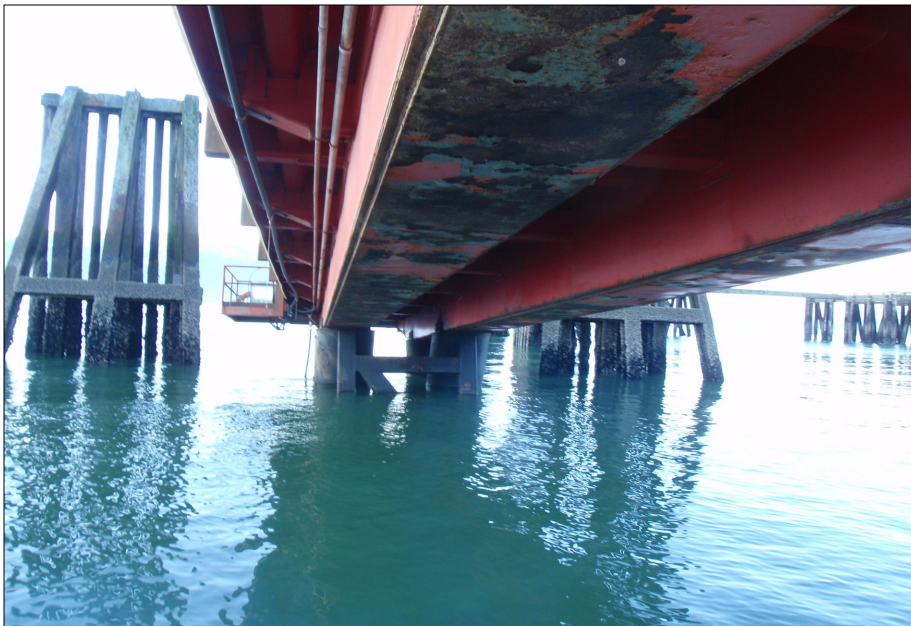
Ramp box-girder bottom flanges; coating failure, minor corrosion, typical.

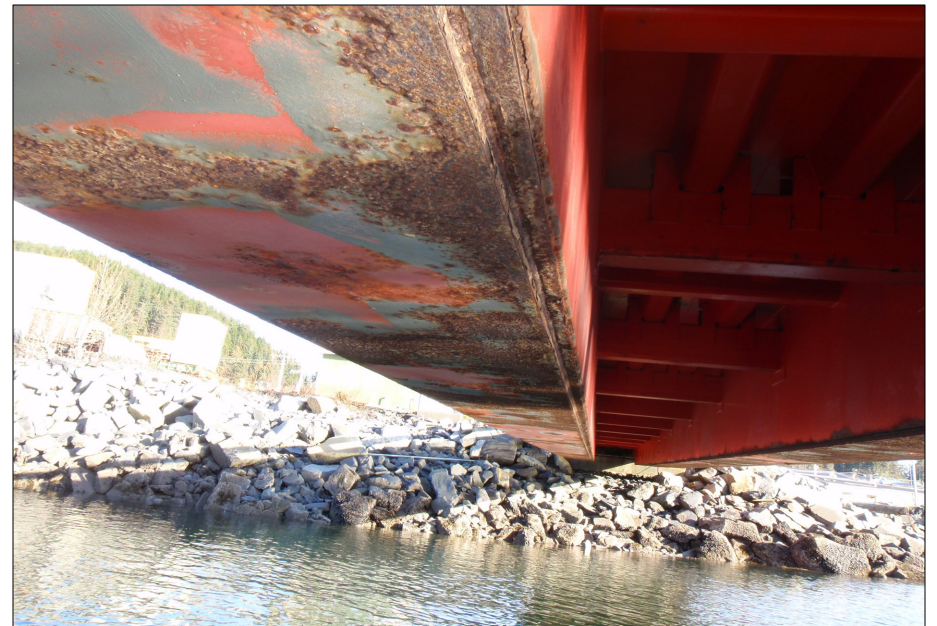
Ramp box-girder bottom flanges; coating failure, minor corrosion, typical.

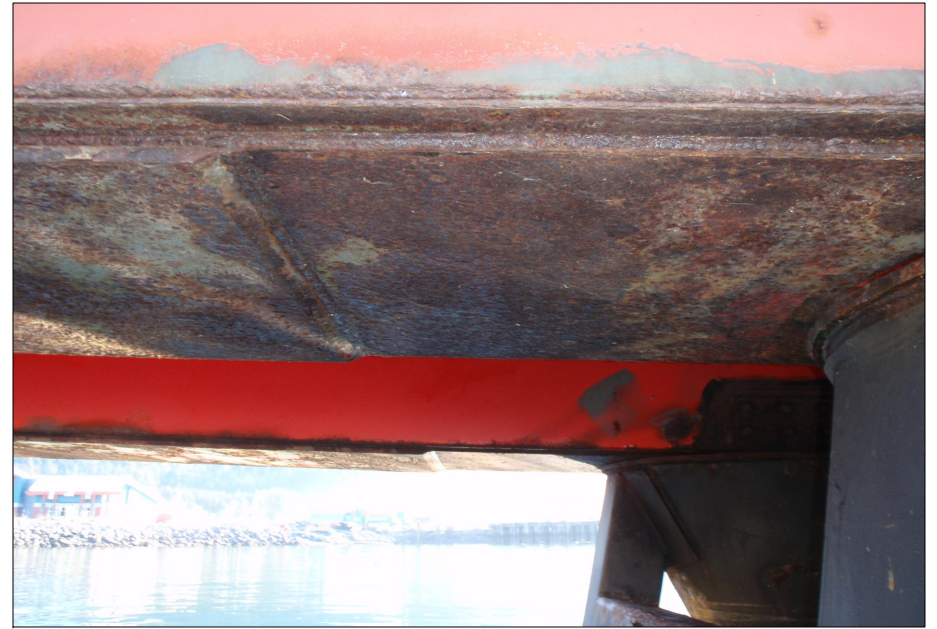
Typical minor corrosion of ramp girder bottom flange.

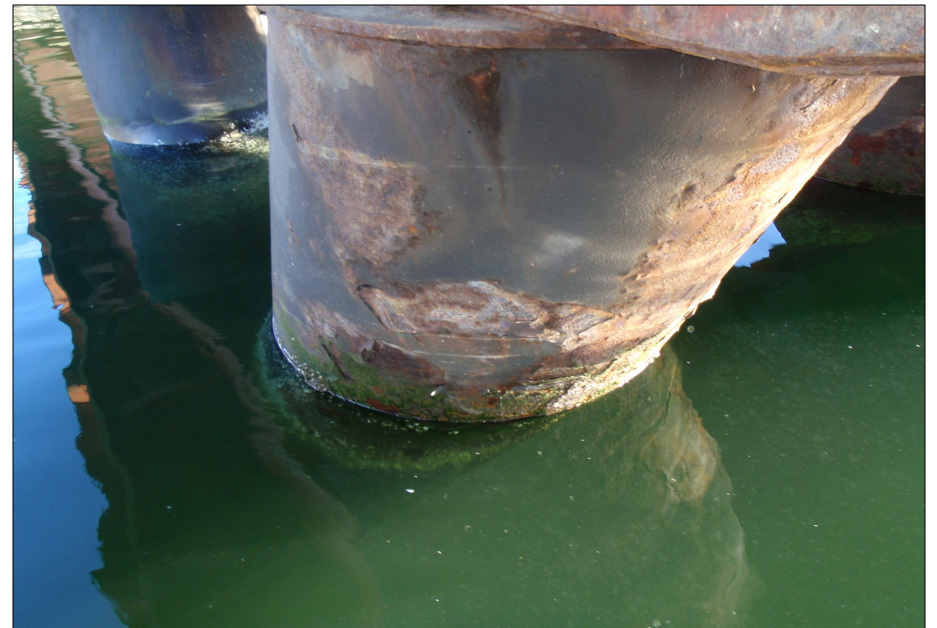
Typical coating failing/minor corrosion of ramp tank support strut.

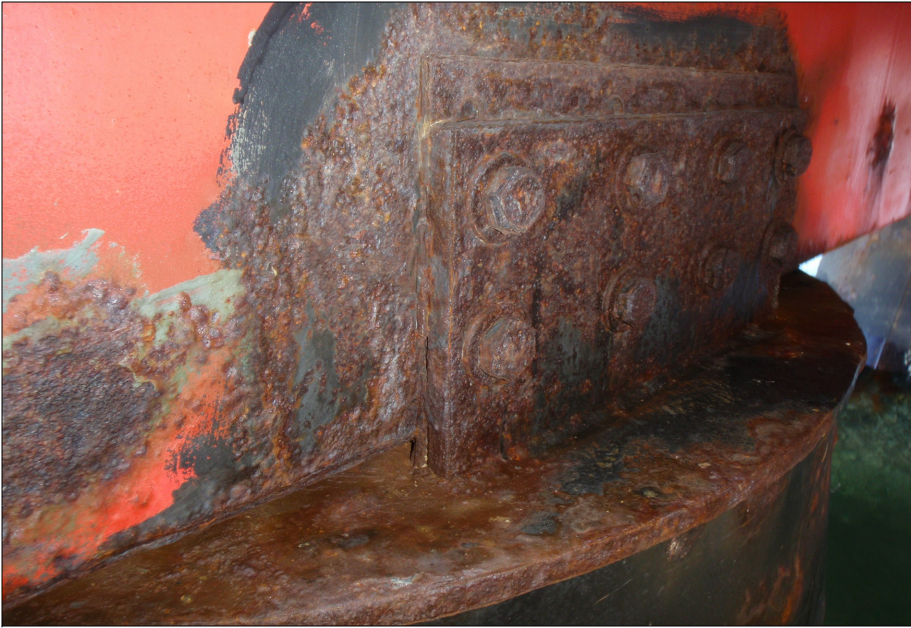
Coating failure/corrosion at ramp/support tank connection assemblies.

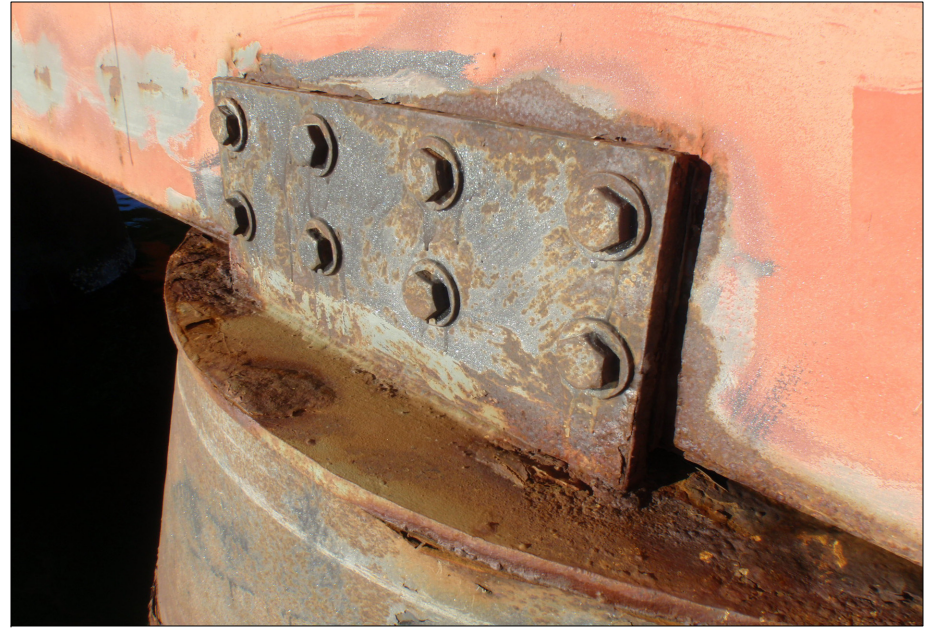
Coating failure/corrosion at ramp/support tank connection assemblies.

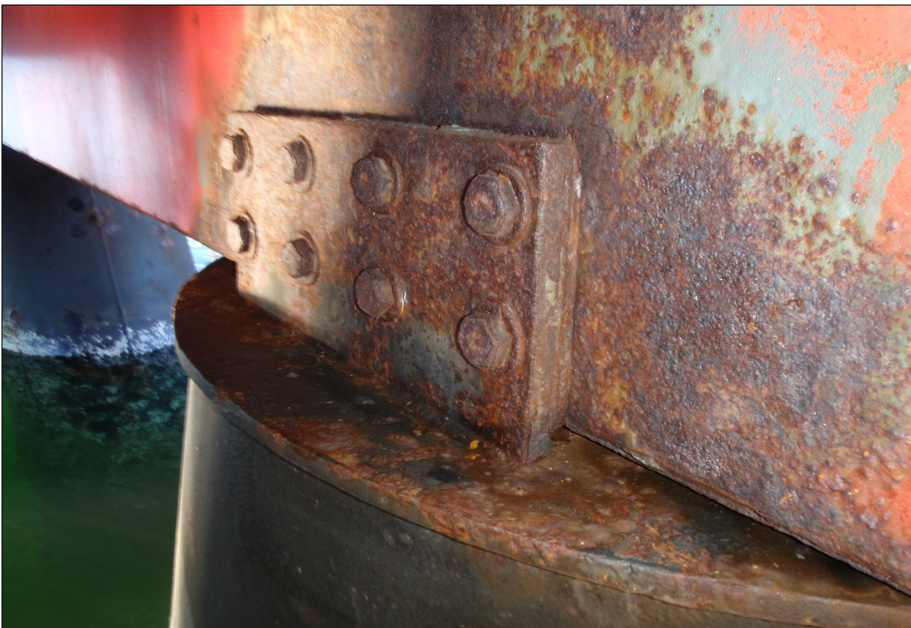
Coating failure/corrosion at ramp/support tank connection assemblies.

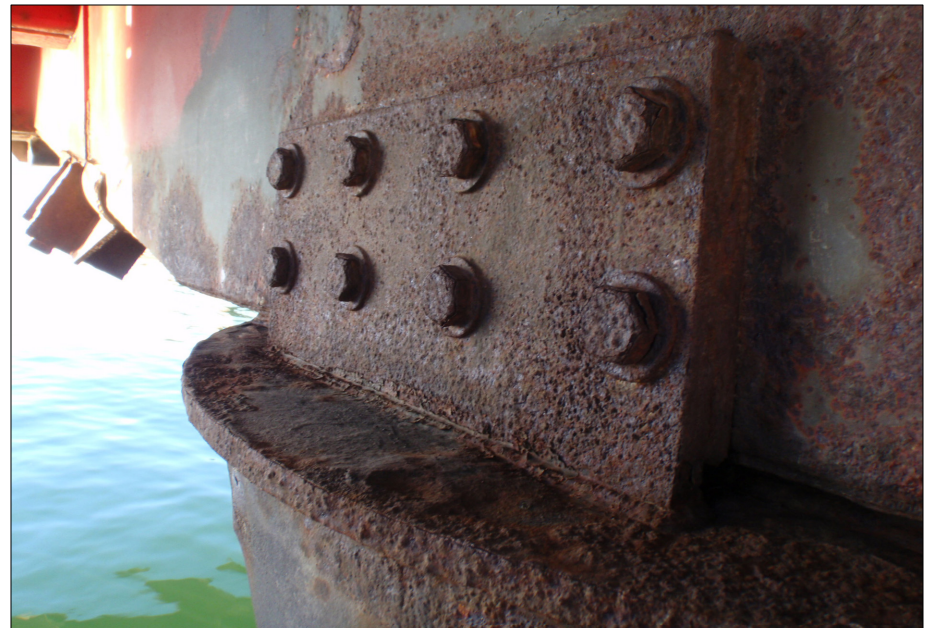
Coating failure/corrosion at ramp/support tank connection assemblies.

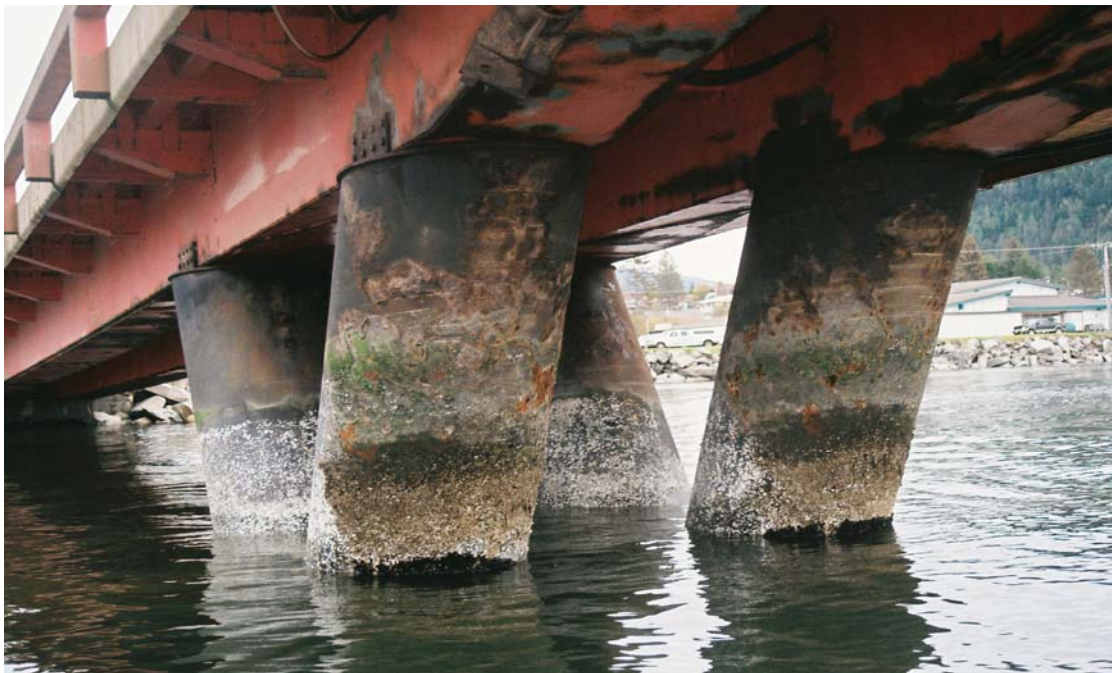
75-90% remaining intact. Inspection of the members in the above water splash zone noted significant deterioration of the protective coating system with an estimated 50% of the coating noted to be intact. Refer to Photo No.s 4 – 10.

**PHOTO No. 4:** Floatation Tank Pipe Struts – Note the deterioration and failure of the protective black epoxy coating on these members in the splash zone.

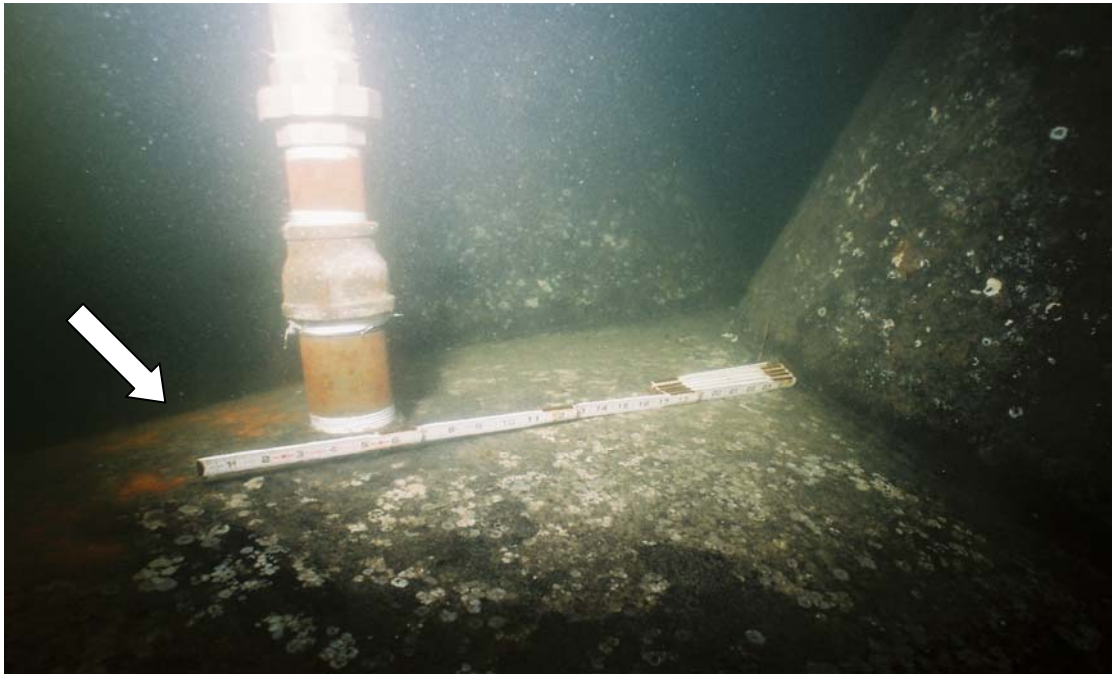
8. Investigation of the inlet / exhaust system found it to be in good condition. No apparent damage or deterioration of the inlet was identified and the three exhaust ports (~3 ft' Ø) located on the bottom of the 9 ft. tank were found to be clear and free of significant marine fouling or obstruction. Refer to Photo No.s 7 and 8.

**PHOTO No. 7:** Floatation Tank, Air Inlet Port – Note the good condition of the air inlet port located at the south end at the crown of the 9 ft. dia. tank. Also note the good condition of the coating on the two pipe struts and the minor coating deterioration in the vicinity of the inlet.

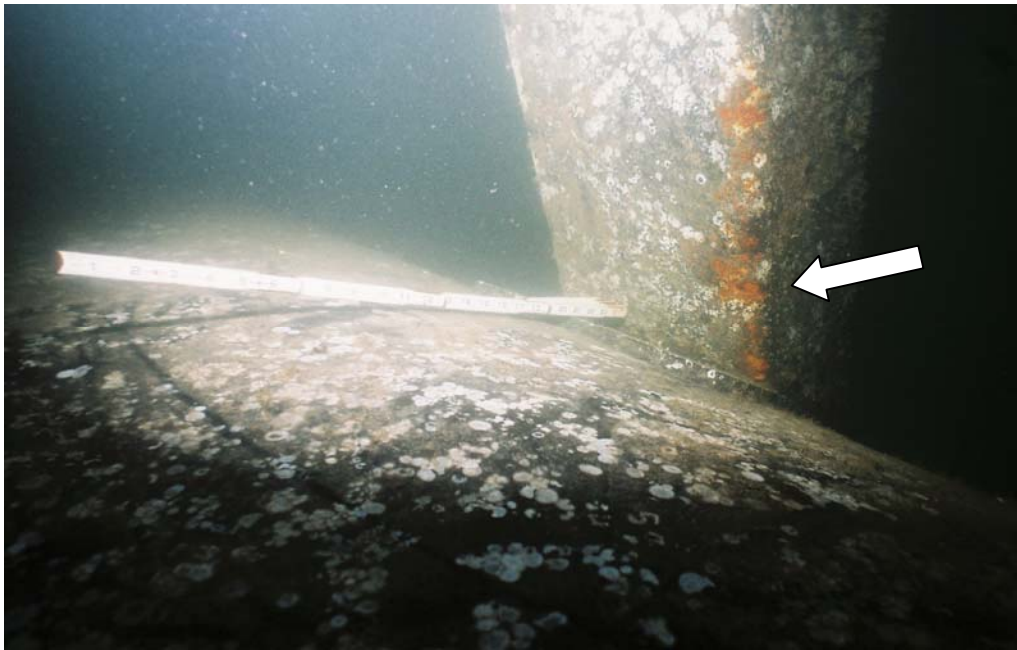
**PHOTO No. 9:**  
Seven Foot  
Diameter Floatation  
Tank – Note the  
good condition of  
the welded  
connection  
between the square  
tubular strut and  
the floatation tank.  
Also note the good  
condition of the  
epoxy coating on  
the top of the  
pontoon and the  
localized coating  
failure on the strut.

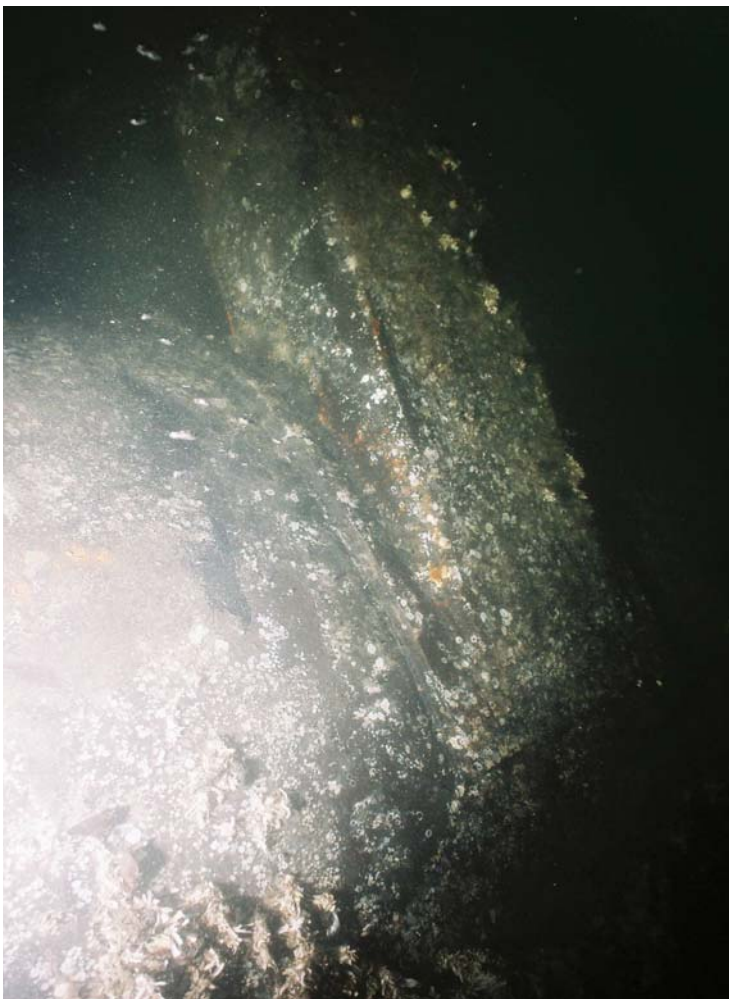
**PHOTO No. 10:** Seven Foot Diameter  
Floatation Tank – Note the  
good condition of the welded  
connection between the  
square tubular strut and the  
eastern side of the floatation  
tank. Also note the general  
good condition of the epoxy  
coating.

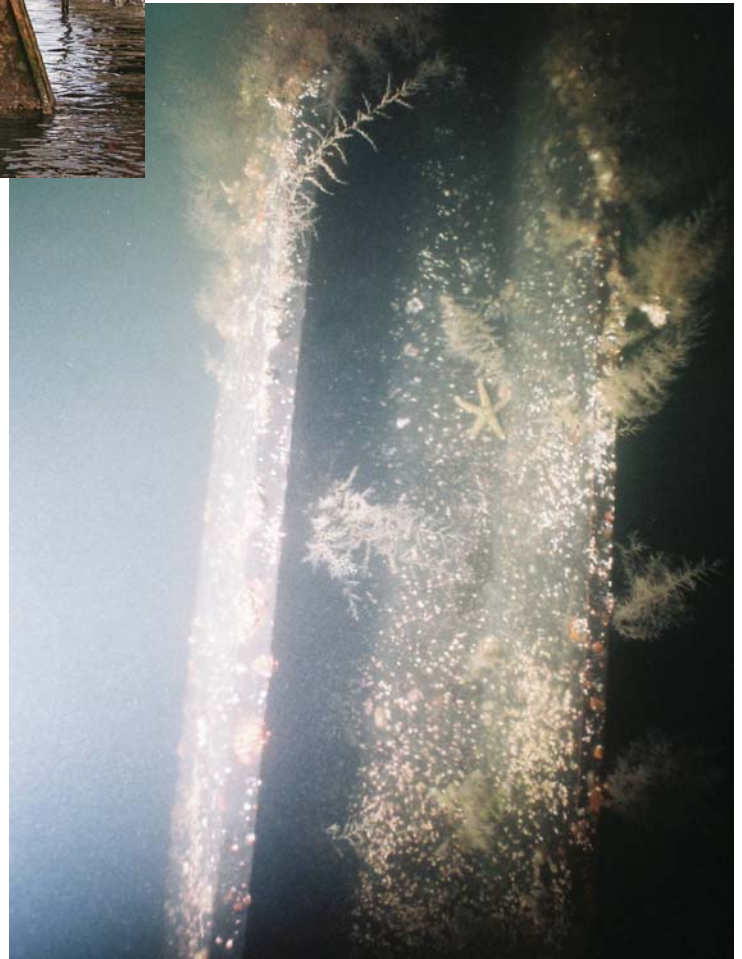
**PHOTO No. 12:** Breasting Dolphin C, Pile 3 Batter – Note the general good condition of the epoxy coating in the upper portion of the submerged zone. The coating at this elevation has been estimated to be 90% remaining overall.

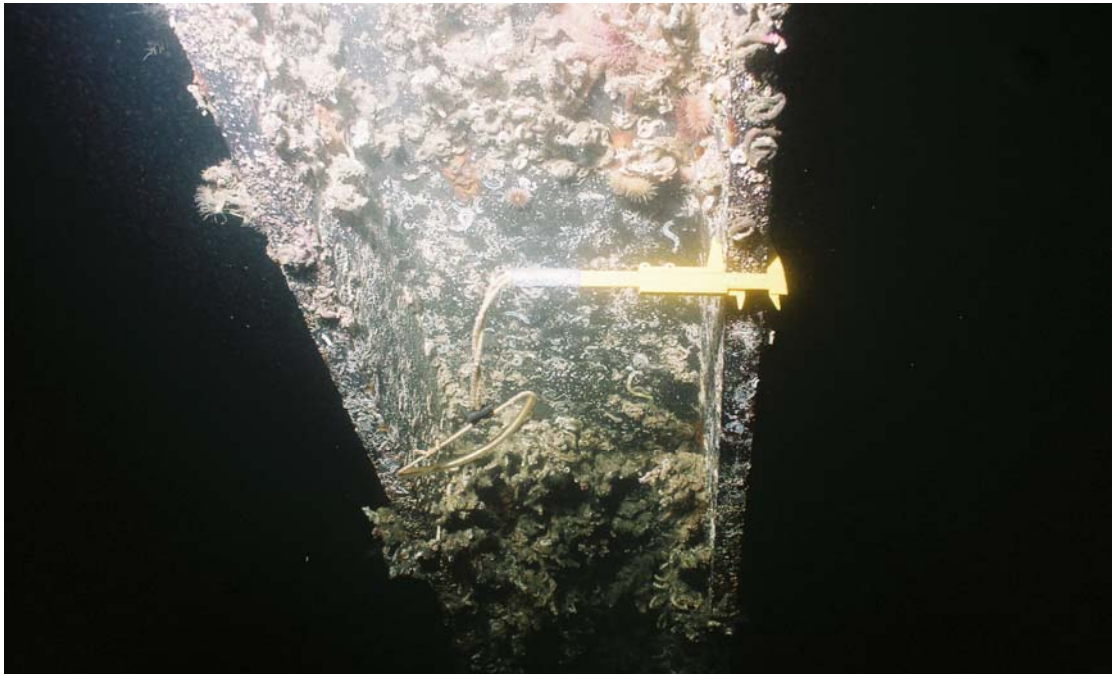
**PHOTO No. 13:** Breasting Dolphin C, Pile 3 Batter – Note the yellow caliper on the flange at this Level II cleaned site and the good condition of the epoxy coating in the submerged zone.

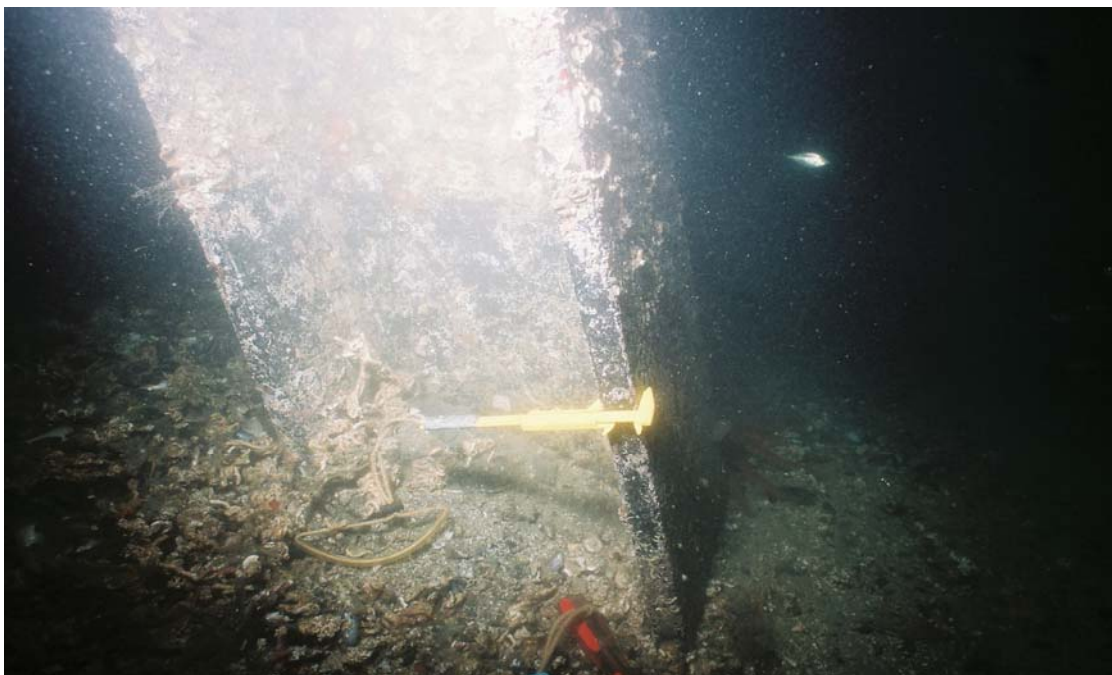
**PHOTO No. 14:** Breasting Dolphin C, Pile 3 Batter – Level II cleaning of this pile at the mudline found it to be in good condition with an estimated 90% of the epoxy coating intact at the mudline.

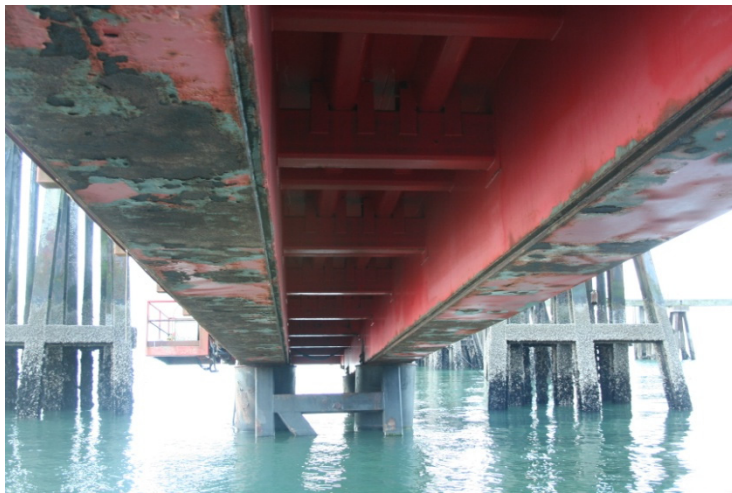
Figure 3 - coating failure along the barge ramp girder soffits

Since it is a floating structure, much of the length of the two box girder flanges constantly sit in or near the splash zone, causing accelerated corrosion on these areas. The coating has largely deteriorated in this area (see Figure 3). The nominal thickness of the box girder flange is 0.75" in most areas with a small reinforced
