**STABILITY STUDY  
UPPER AND LOWER WATER SUPPLY DAMS  
WRANGELL, ALASKA**

**May 1993**

**City of Wrangell  
P.O. Box 531  
Wrangell, Alaska 99929**

**RE: STABILITY STUDIES FOR WRANGELL UPPER AND LOWER DAMS,  
WRANGELL, ALASKA**

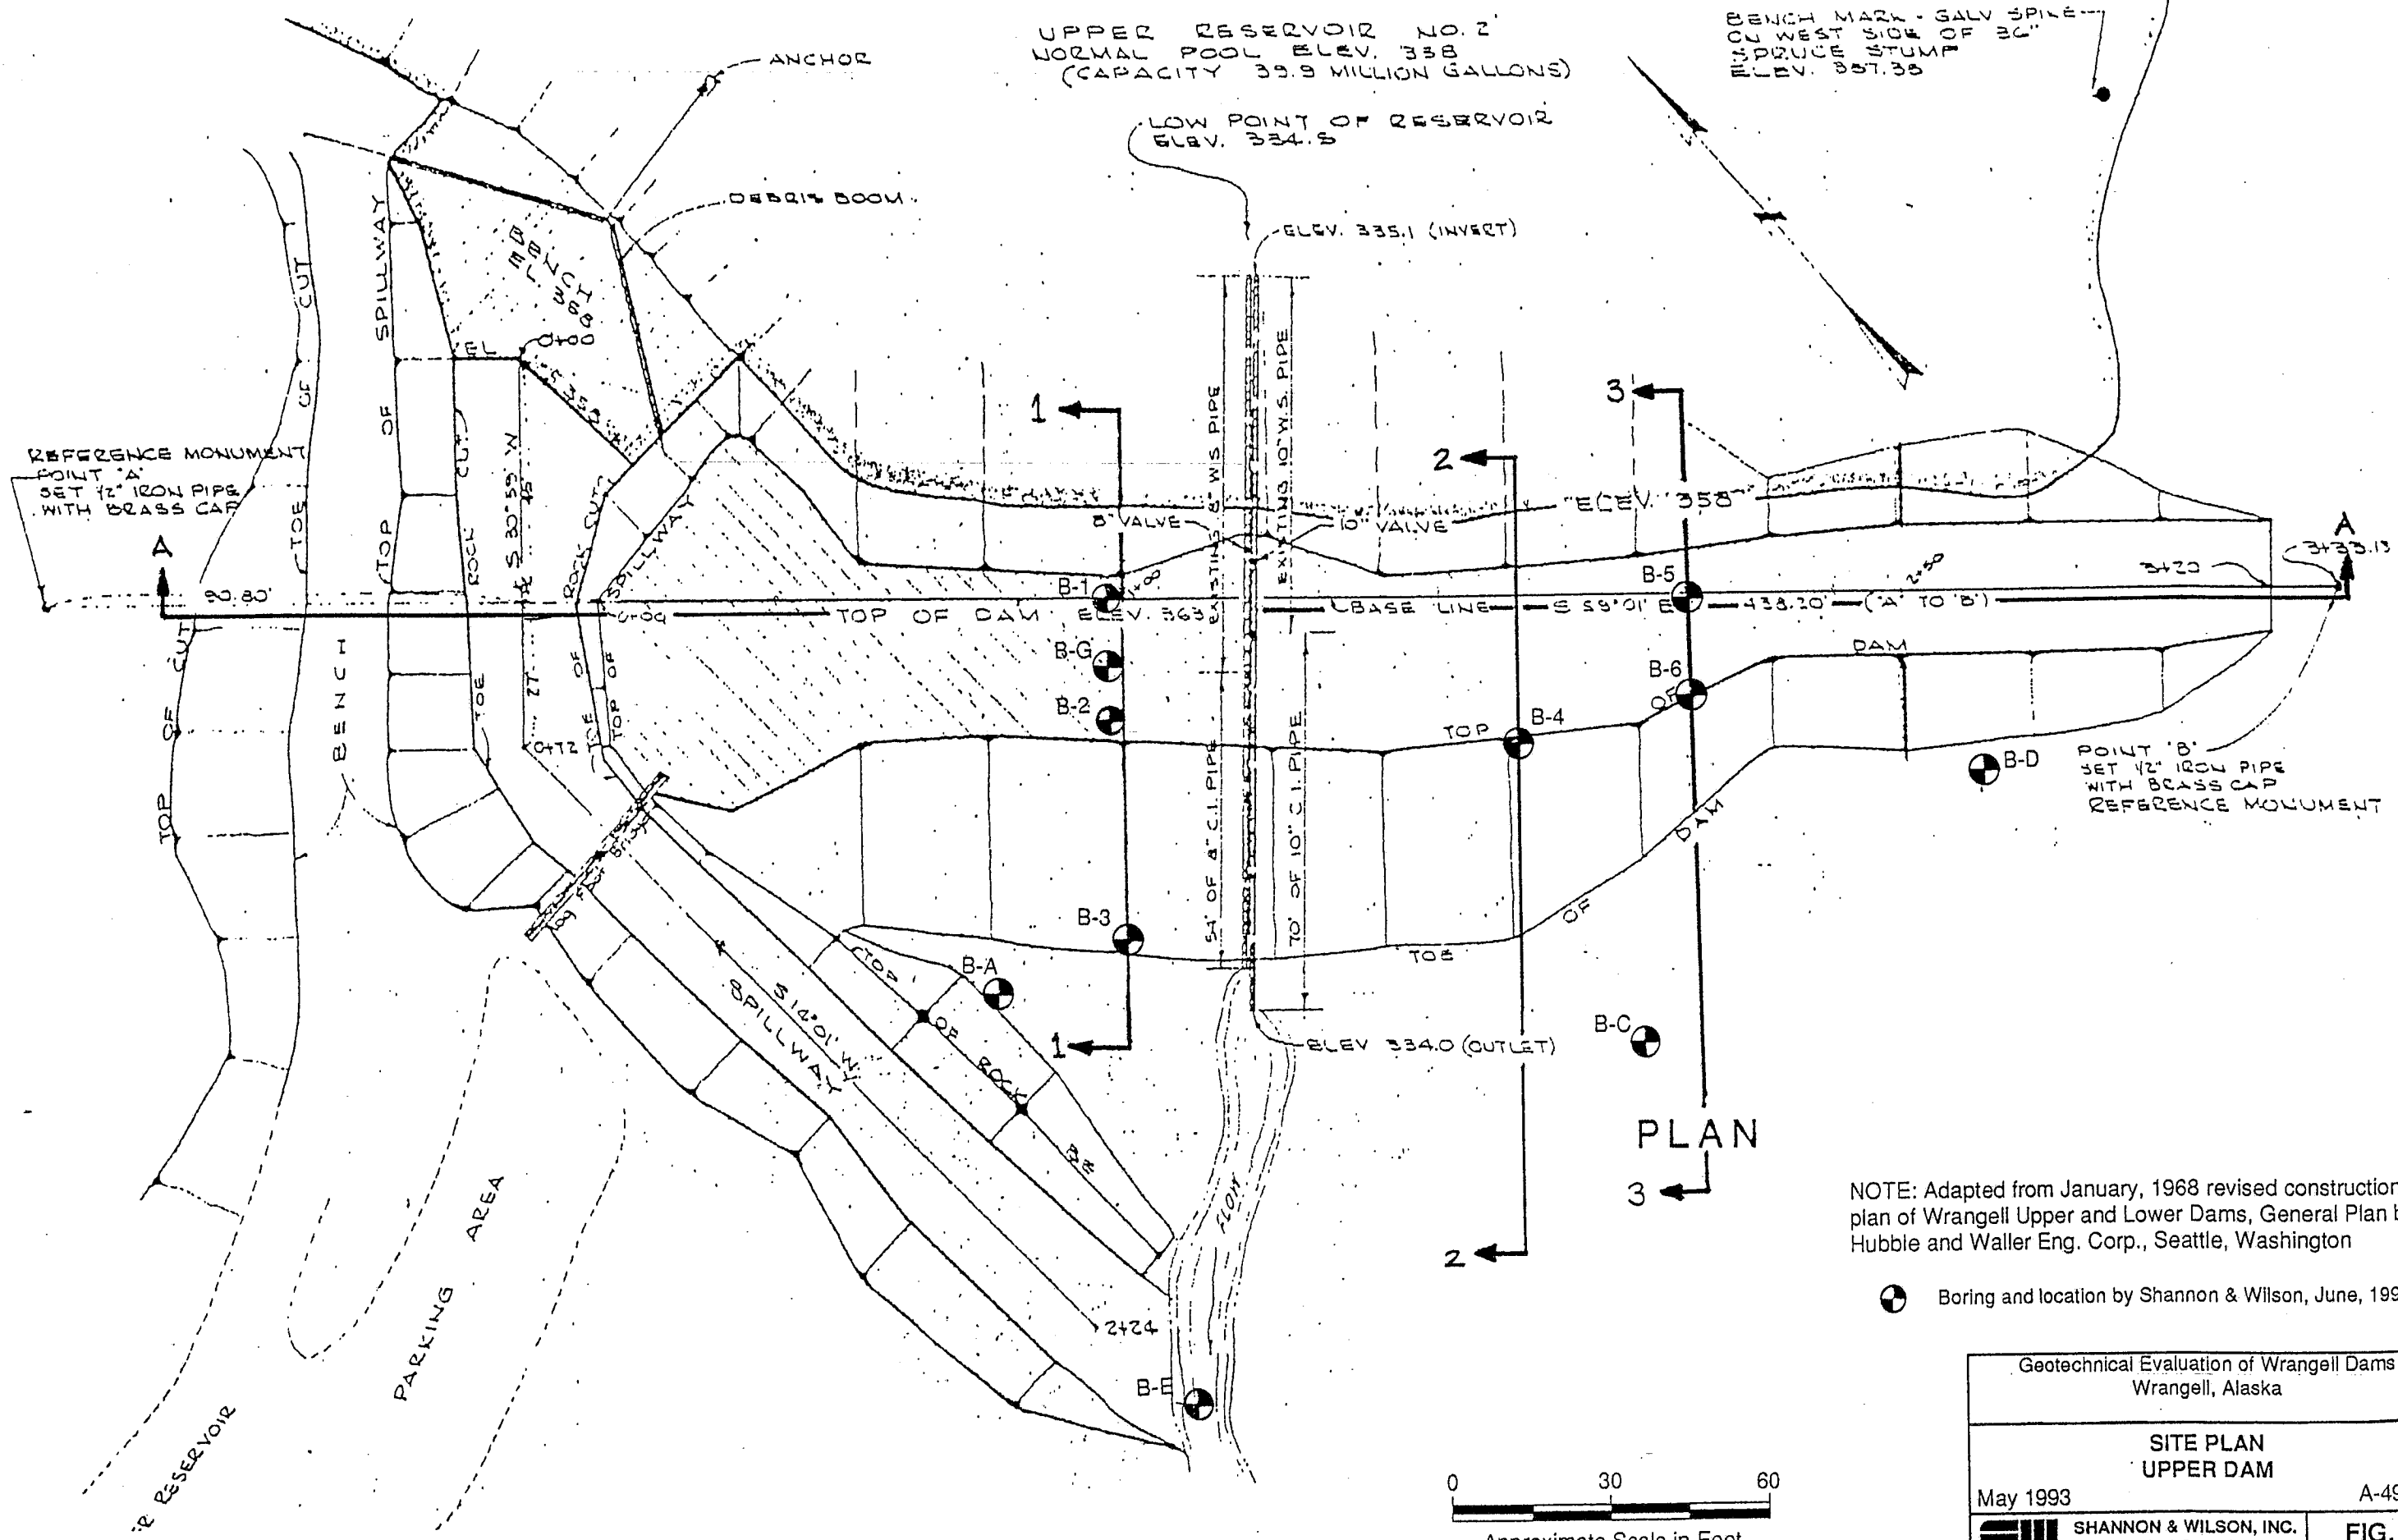
Geotechnical Evaluation of Wrangell Dams Wrangell, Alaska	
SITE PLAN UPPER DAM	
May 1993	A-494
SHANNON & WILSON, INC. Geotechnical Consultants	FIG. 2

The two dams are both approximately 28 feet high, 315 to 320 feet long earth structures located on the same stream. The elevation difference between the two dams is 64 feet. The upper dam has a 25 to 33 foot wide crest, coarse granular slopes on both the up and downstream sides, and retains water via an internal crib core which prior to 1958 was it's own water retention structure, but leaked excessively and held little or no water. Available records suggest that in about 1958 it was covered with fill on both the up and downstream slopes to support water and then raised again in about 1967 with additional fill to create it's current shape. The approximate current shape of the dam is shown in Figure 2.

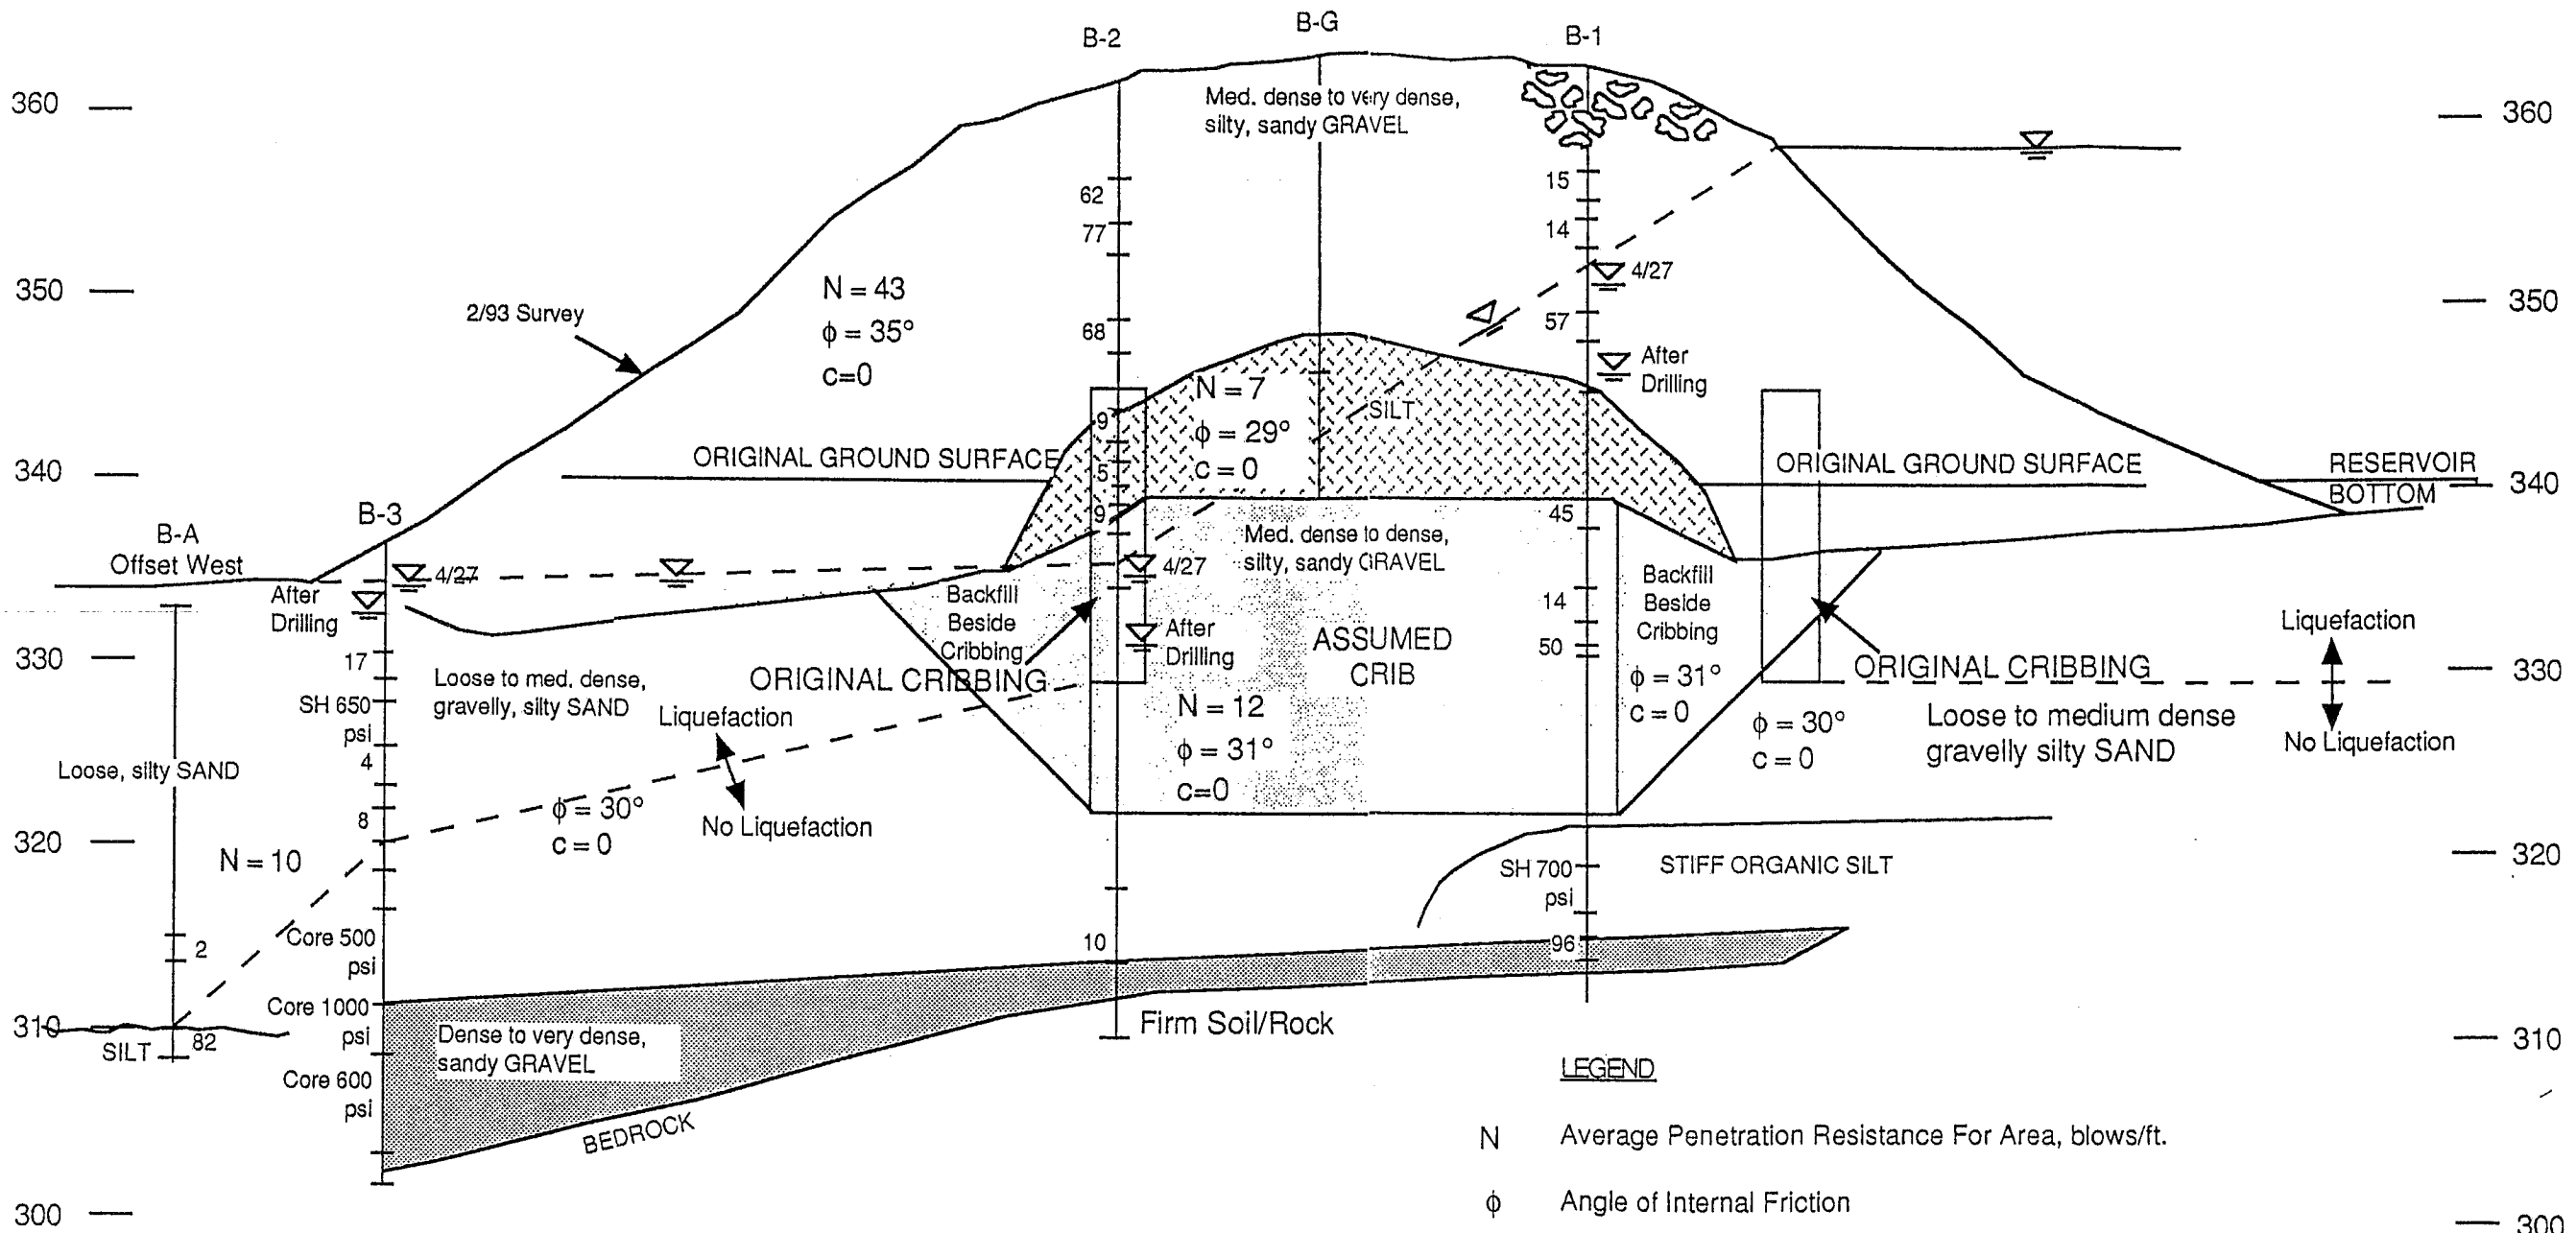
Upper Wrangell Dam Wrangell, Alaska	
Section 1	
May, 1993	A-494
SHANNON & WILSON, INC. Geotechnical Consultants	FIG. 6

Directly on top of the wood crib, a low plasticity silt unit was encountered in all three borings drilled in Section 1 of the Upper Dam (Figure 6). This silt was locally gravelly and sandy and three penetration tests produced an average driving resistance of 7 blows per foot. This corresponds to a medium stiff cohesive material or a loose granular soil. For purposes of analysis, this material is treated as a cohesionless ( $c = 0$ ) material or the more conservative of the two possible assumptions. The top of this unit is thought to represent the sloping and flat top zone of material depicted on the as built documents. The documents suggest that this silt was likely placed here as an extension of the impervious core as part of early (pre 1967) attempts to seal the leaking Upper Dam and raise the water level. These documents also suggest that sloping fills were placed on each side of the crib and at the higher elevations to form what is referred to as the top of old dam in Figure 4. The survey information and current observations suggest that this dam was later covered with another granular shell to create the current slopes in Figures 6, 7 and 8.

Referring to Figure 6, it is our opinion that the risk of piping of loose crib materials from the Upper Dam is low for the following reasons.

1. The gravelly silty sands in the foundation are too well graded and while loose have too many fines for migration below the dam.
2. The dam is not a rockfill dam, but rather an embankment dam with 60 to 70 percent sand and silt size particles with little or no apparent cohesion. The void space or porosity of this material is small or low compared to a rockfill material, providing limited paths for piping. As long as the flow or seepage through these materials is not large, excessive internal piping cannot occur. Before internal piping can occur, the fines at the toe would have to be washed out first causing signs of ground subsidence in this region as an early warning sign.

**NOTE**  
 1. See Fig. 2 for location of section  
 2. Liquefaction boundary assumed for dynamic stability studies only. In liquefaction zone, strength was reduced to residual value of  $c=200\text{psf}$

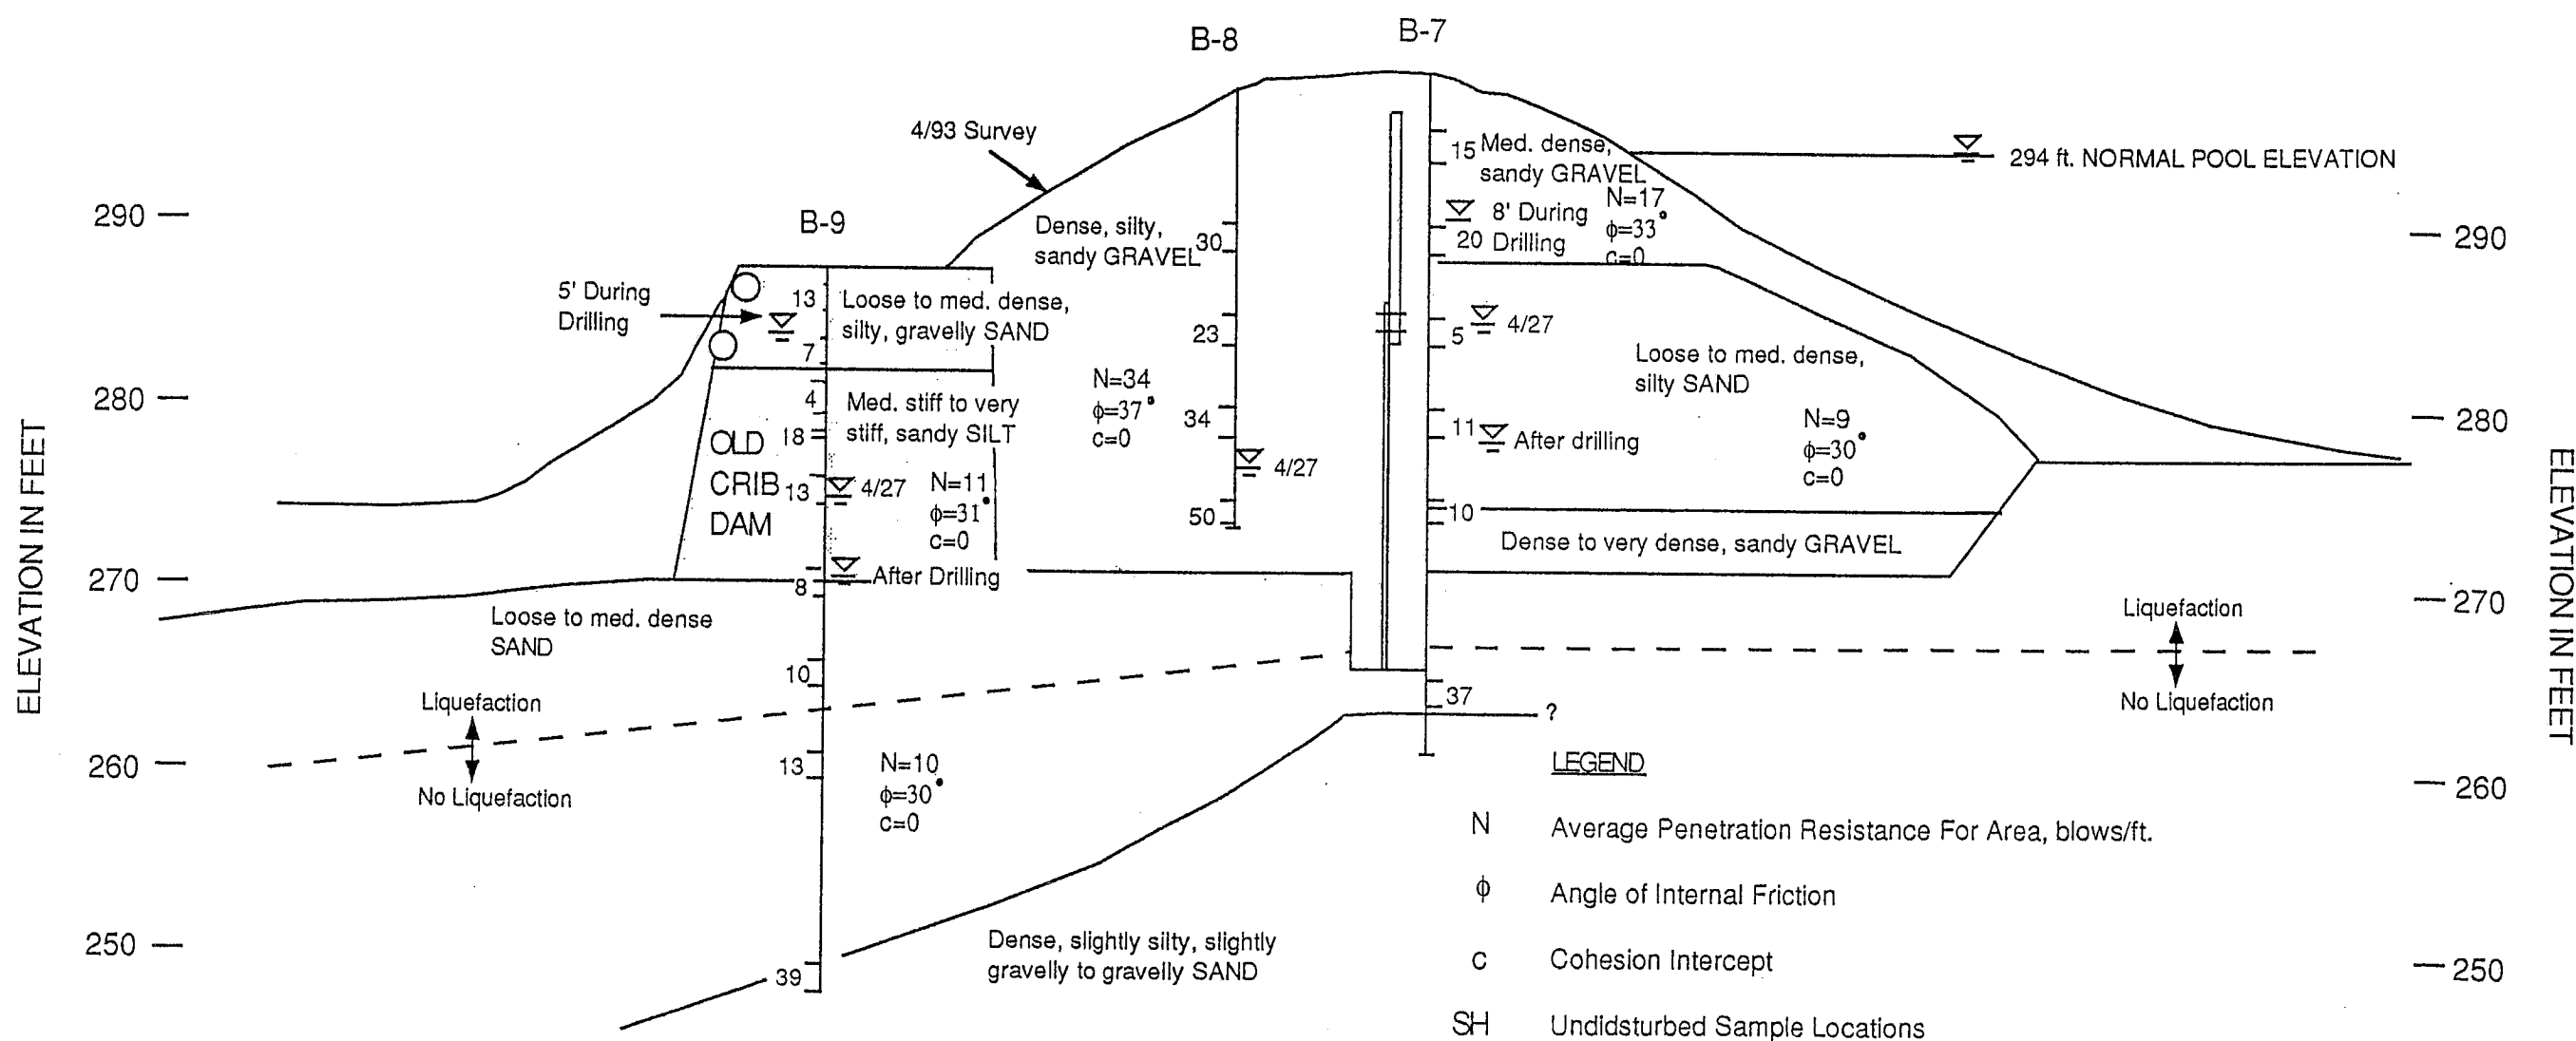
Lower Wrangell Dam Wrangell, Alaska	
<b>Section 4</b>	
May, 1993	A-494
SHANNON & WILSON, INC. Geotechnical Consultants	<b>FIG. 9</b>

The sheet pile wall in the Lower Dam presumably falls between borings B-7 and B-8 in Figure 9. It's integrity cannot be evaluated by boring explorations nor was it considered necessary as it's effectiveness at sealing off water should be reflected in the piezometers and signs of toe seepage. In both instances, low water levels in the dam and no apparent seepage suggest that hydrostatic pressures are not large in this dam. The sheet piles structural integrity was ignored in the follow-on stability analysis.
