# City and Borough of Wrangell, Alaska

## REQUEST FOR PROPOSALS REAL ESTATE BROKER SERVICES

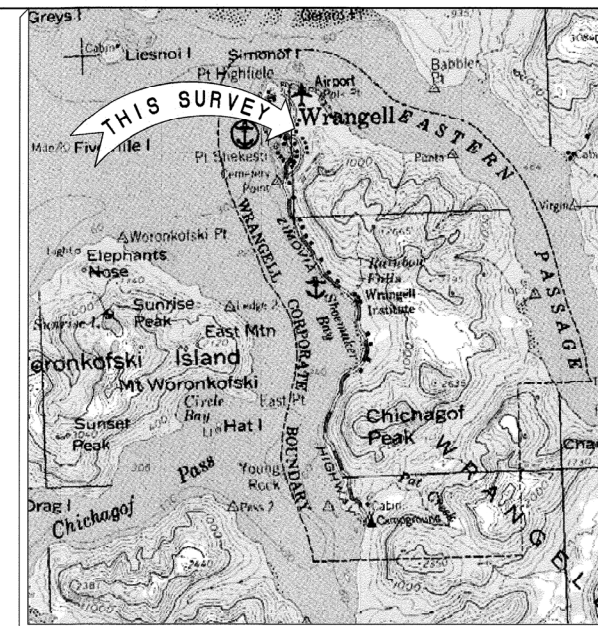
VICINITY MAP:  
SCALE: NOT TO SCALE

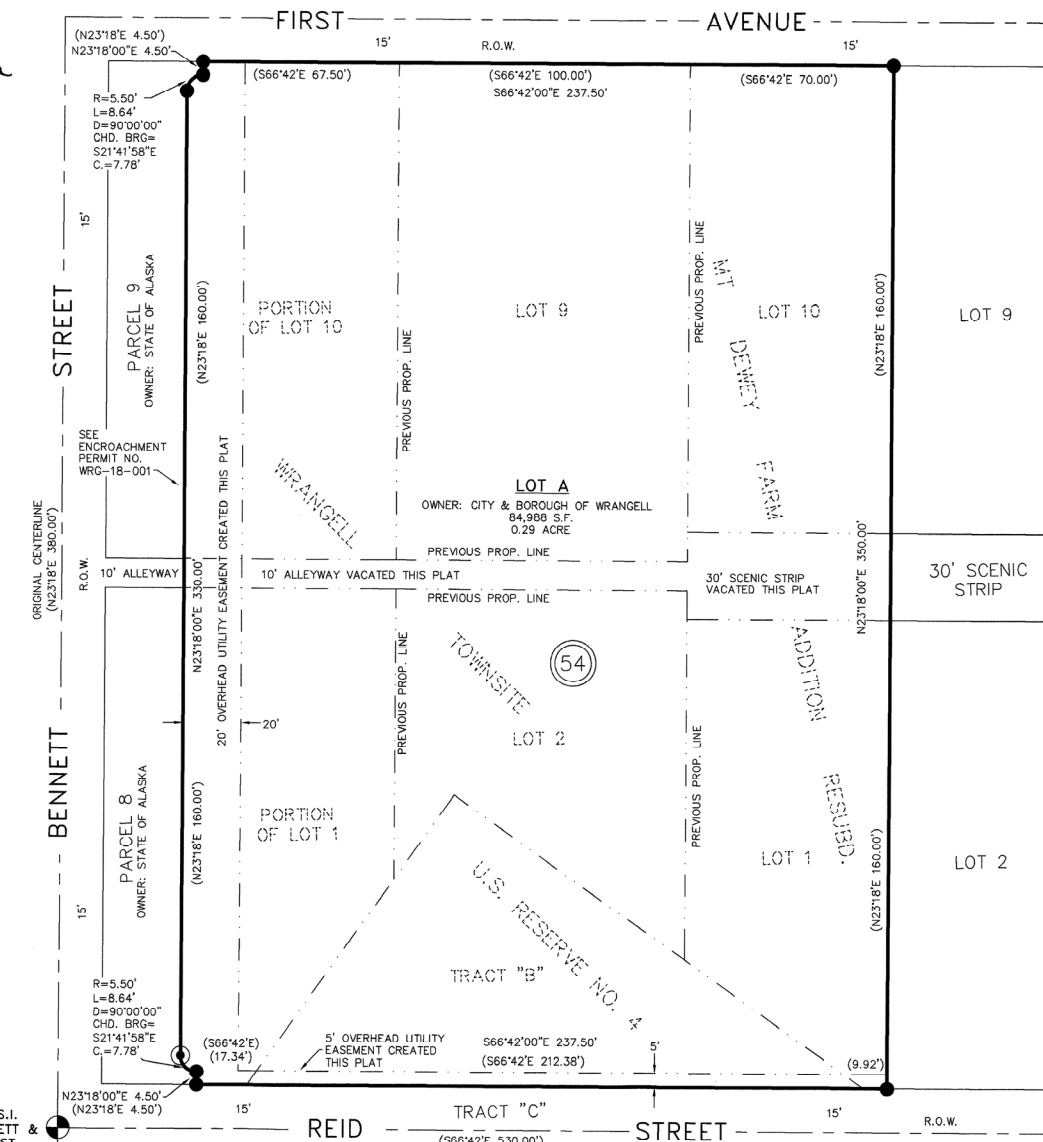
CLIENT: CITY & BOROUGH OF WRANGELL  
P.O. BOX 541  
WRANGELL, ALASKA 99929

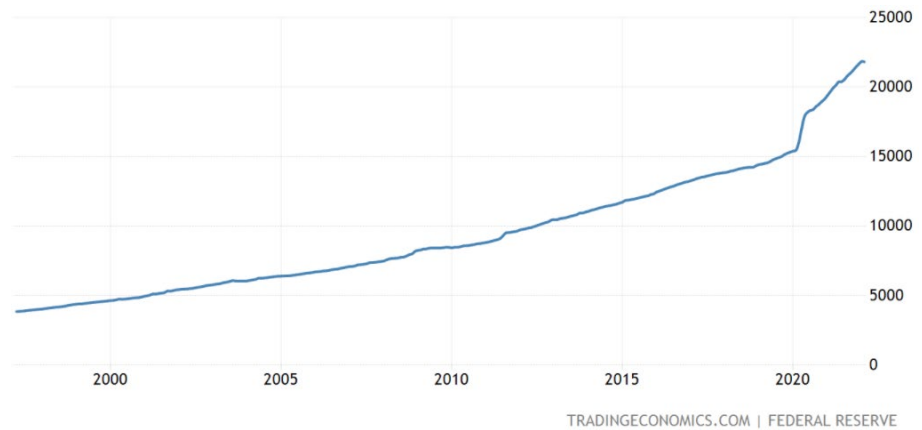
Since 2004, the money supply has gone up nearly 500%. As shown, however, it sharply increased during COVID-19 and increased from \$15,000 billion to nearly \$22,000 billion in roughly two years. Most market participants, including the Federal Reserve itself, are now anticipating a period of inflation and higher interest rates to combat it.

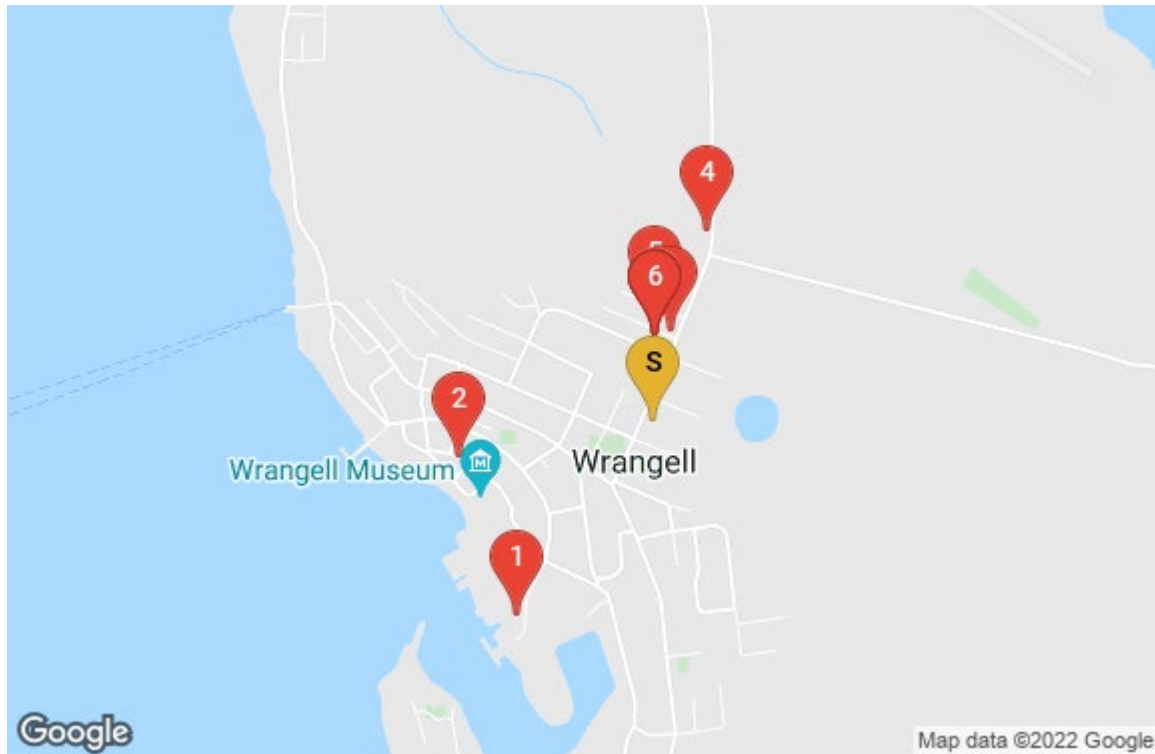
**Description of Data**

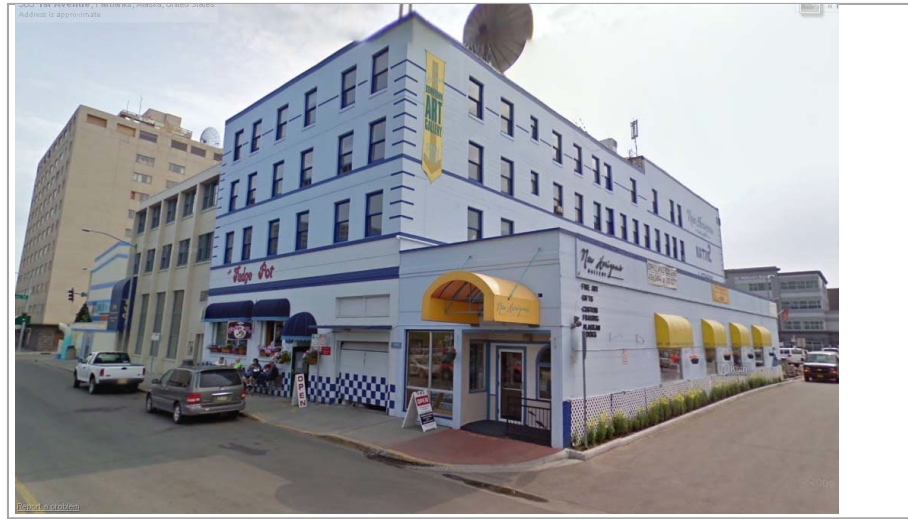
This older building was foreclosed on by Wells Fargo in 2009. The listing was originally priced at \$1,200,000 but has been reduced to \$575,000. As an older building, the improvements are compromised with contained asbestos, estimates to cure range from \$106.92/sq ft. to \$160.38/sq ft.

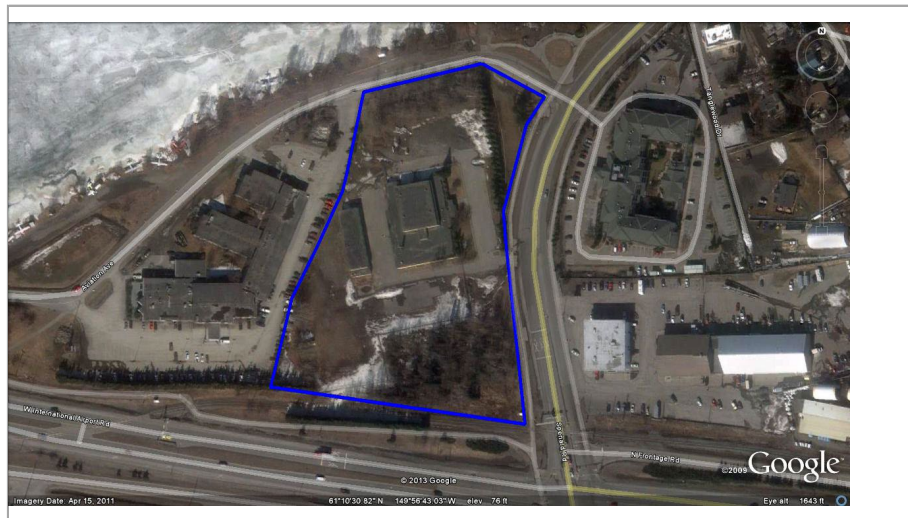
This is the sale of the former National Guard Armory located at the northwest corner of Spenard Road and West International Airport Road. The site is influenced by both the midtown and airport markets, and is just across Aviation Avenue from Spenard Lake. The site was improved with a 28,433 sq ft concrete block building originally built in 1962. The property was auctioned off by the MOA and the successful bid was \$4,500,000. There was prior known contamination on the property, however, a no further action letter had been issued and no impact on the sale was noted. Post sale expenditures include demolition of the existing building, which includes small amounts of asbestos, at an estimated cost of \$269,000 (based on the accepted bid). The property was sold with deed restrictions requiring an aviation theme, meeting space and gift shop that negatively impacted the sale

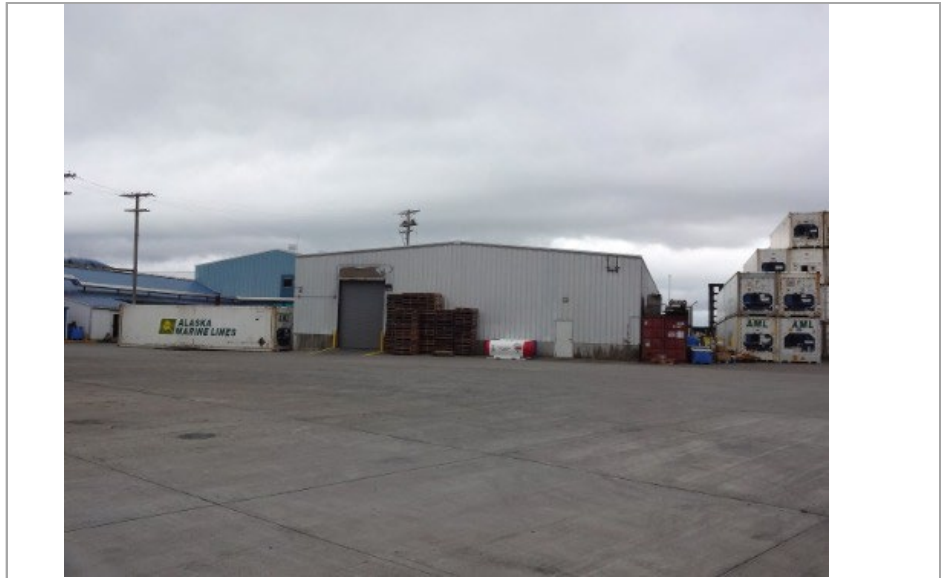
**Sale Information**

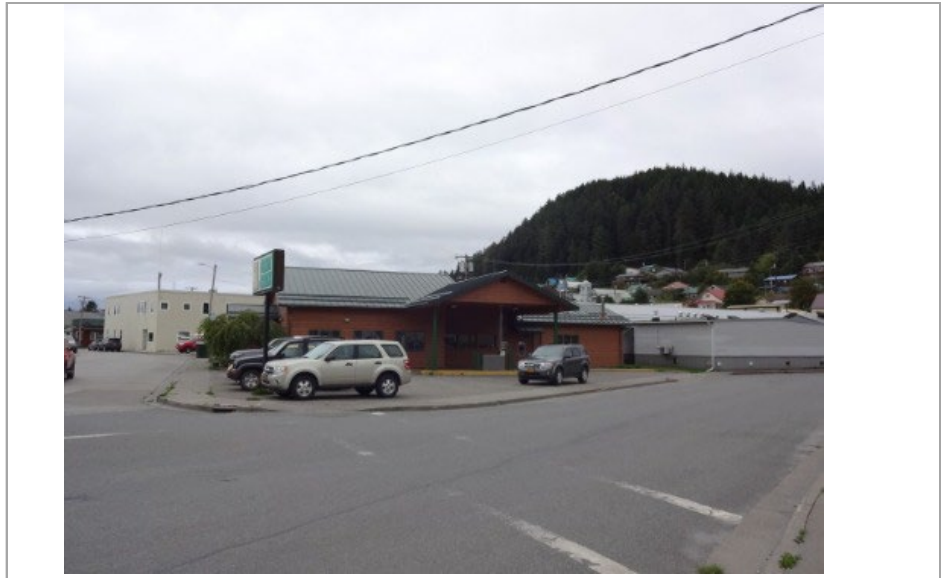
**Legal Description**

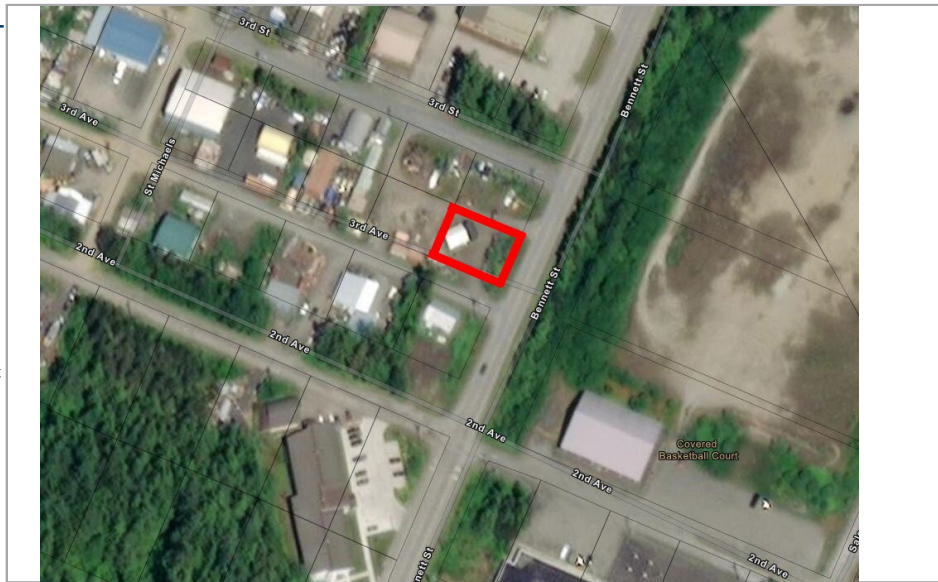
Lot 5, Block 59B, Industrial Subd Plat 85-8, Wrangell RD, State of Alaska

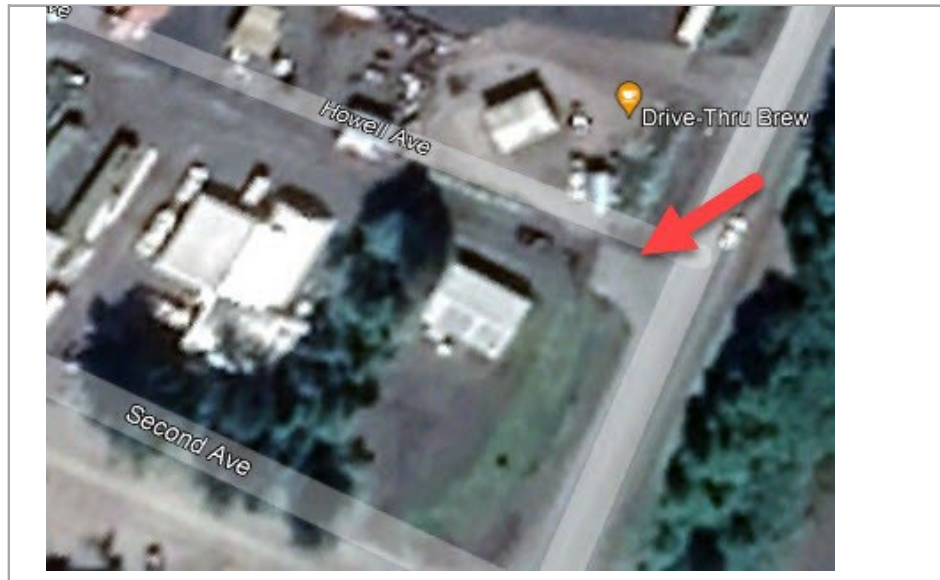
Transaction			
<b>Actual Price</b>	\$70,000	<b>Date</b>	7/30/2020
<b>Price</b>	\$37,300	<b>Transaction Type</b>	Closed Sale
<b>Price Per Land SF</b>	\$5.16	<b>Property Rights</b>	Fee Simple
<b>Price Per Usable Land SF</b>	\$5.16	<b>Financing</b>	Cash
<b>Price Per Acre</b>	\$224,983.41	<b>Conditions of Sale</b>	Arm's Length
<b>Grantor</b>	Bernard Massin	<b>Sale Verification Source</b>	Mike Renfrow
<b>Grantee</b>	Sara Gadd

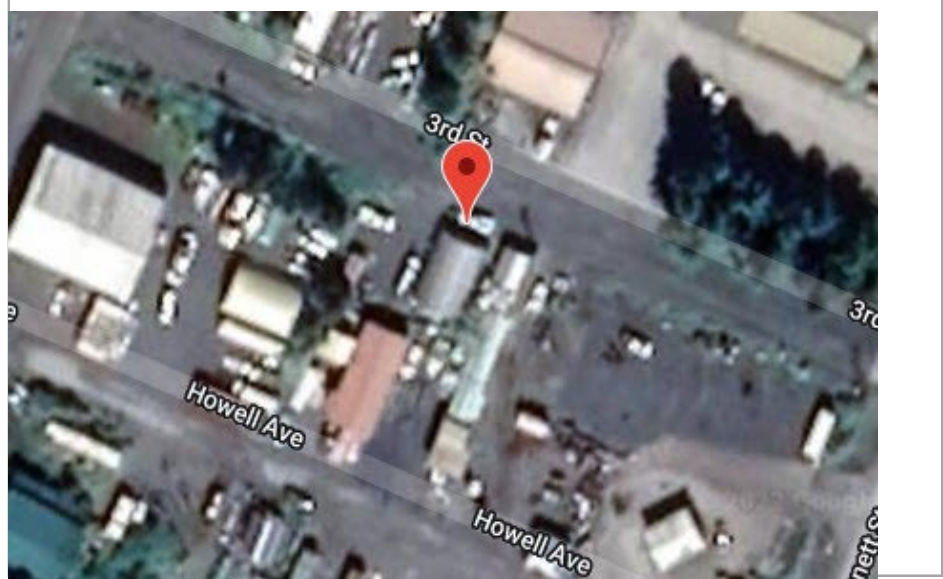
**Legal Description**  
Lot 8A, Block 59B, Plat 2018-5

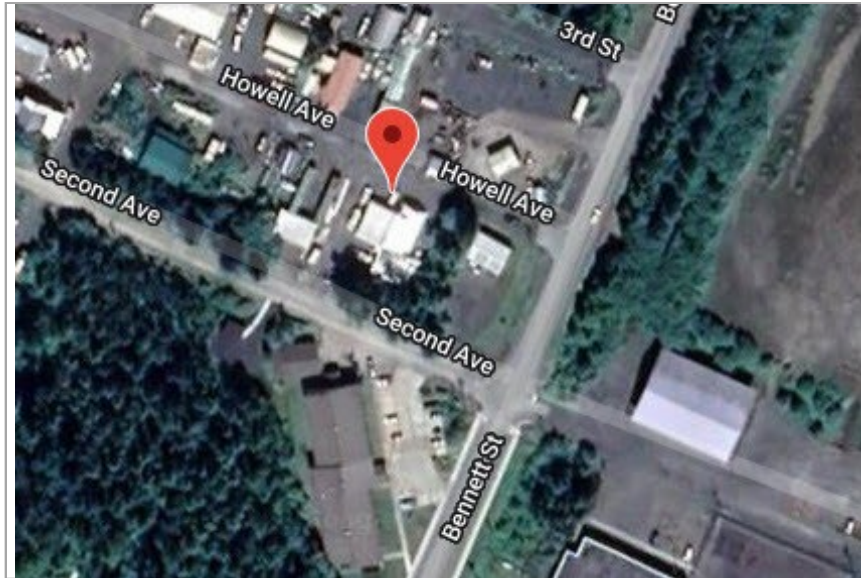
**Legal Description**  
Lot 4A, Block 59B, Massin/Industrial  
Subdivision, Plat 2018-5.

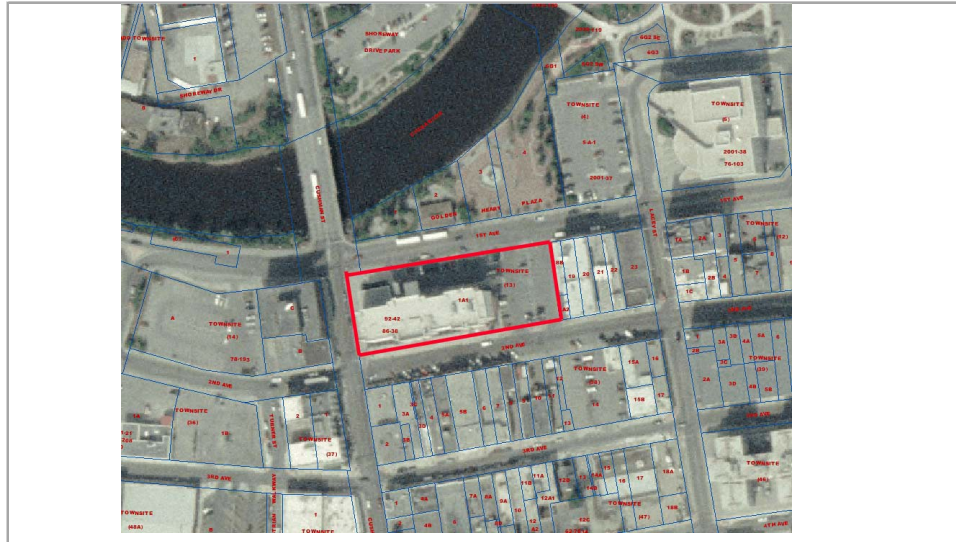
**Sale Information**

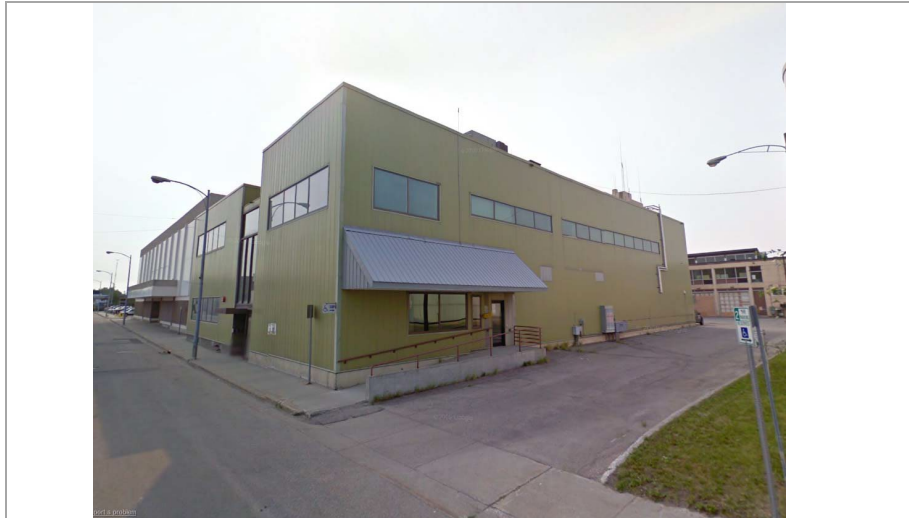
**Legal Description**  
Lot 5, Block 86A, Fairbanks  
Townsite

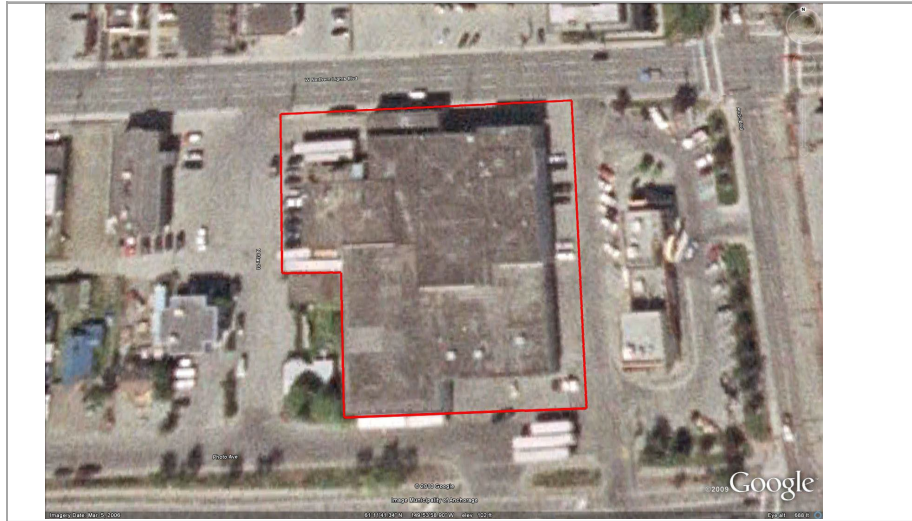
**Legal Description**  
 Lot 1-5, 7-10, Block 4, Frank Dickson SD, Plat 135-A

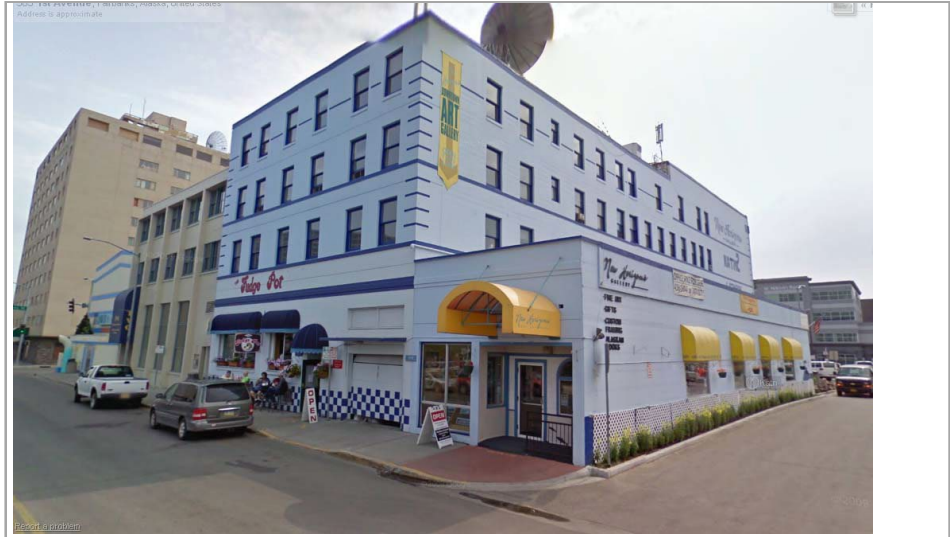
**Legal Description**  
Lt 18, except S. 45' and Lts 19 & 20  
BLK 13 Fairbanks Townsite

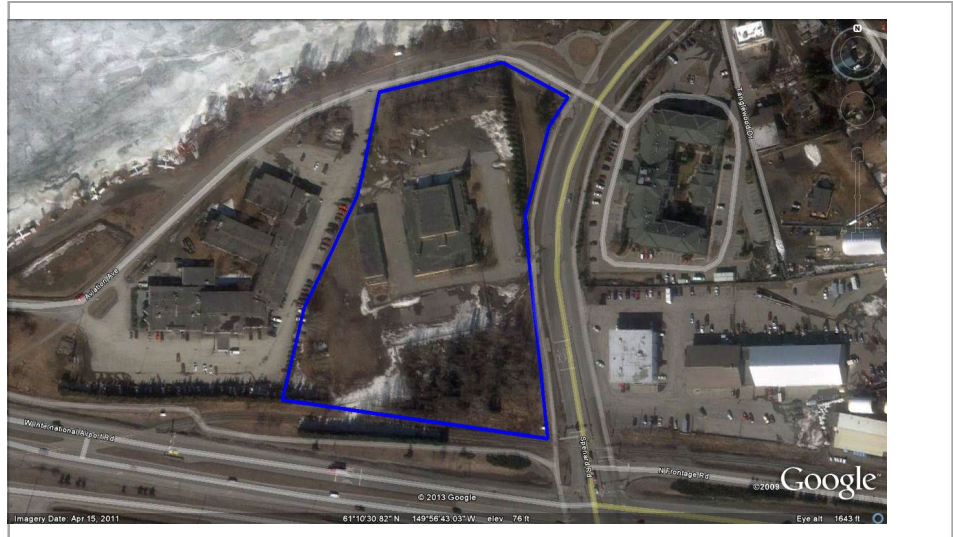
**Legal Description**  
Lot 2, AIRPORT GATEWAY  
SUBDIVISION, according to Plat No.  
2003-136

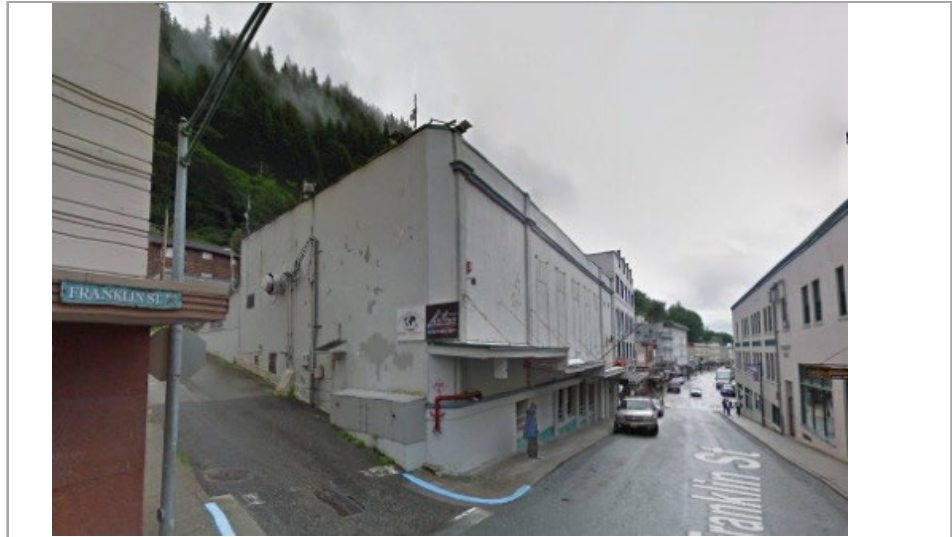
Fr. Lot 6, Lots 7 and 8, Block 13, Juneau Townsite

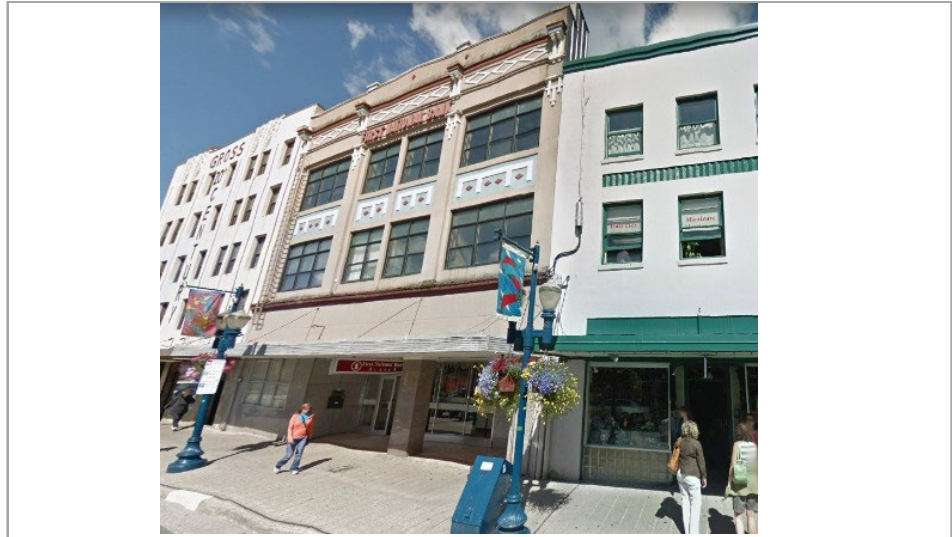
Lot 3 and Por Lot 2 Block G, and  
Lot 4 Block 3, Juneau Townsite

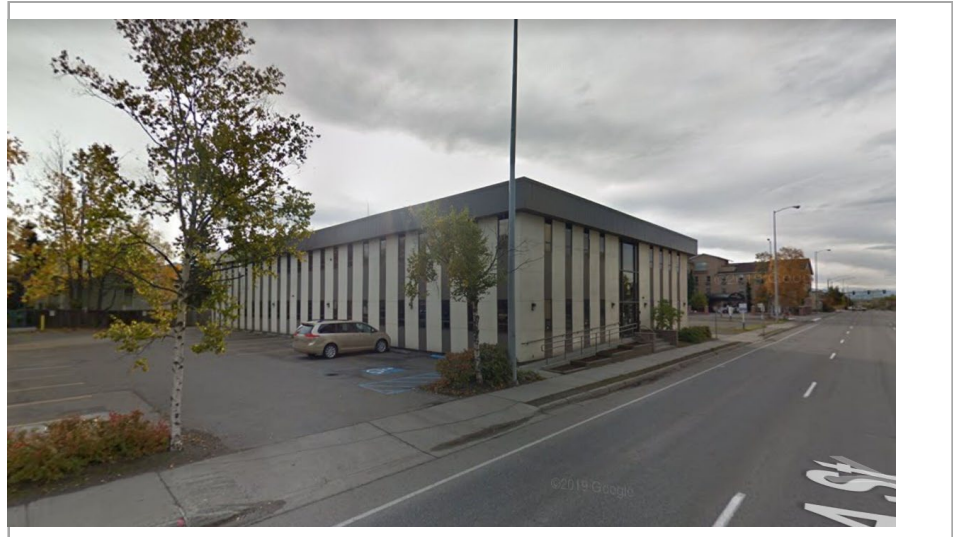
**Legal Description**  
Lots 4,5,and 6 Block 109 Original  
Townsite of Anchorage

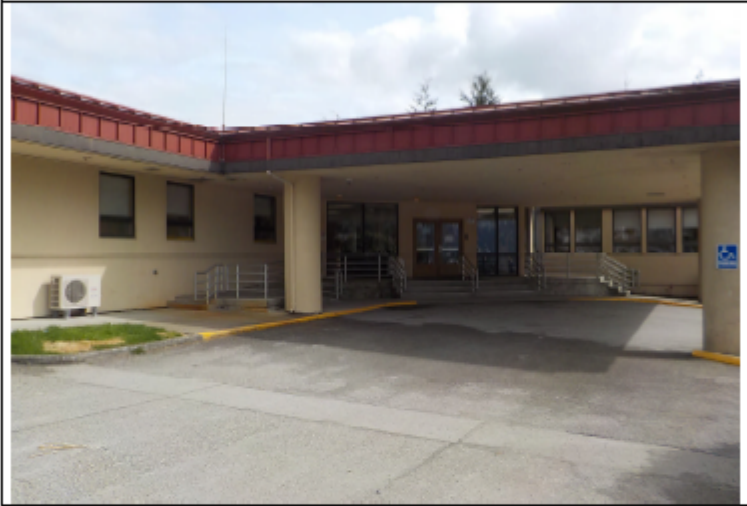
**Wrangell Medical Center Building Condition Survey**  
**Structural, Building Envelope and Interior Finishes**  
(15 Pages)

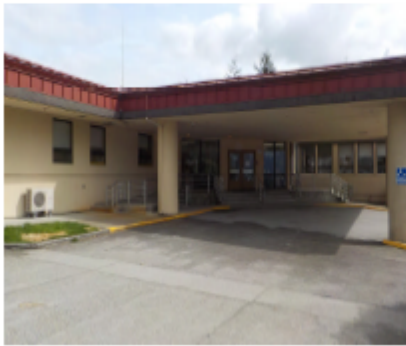
Main Entry – Southwest Elevation

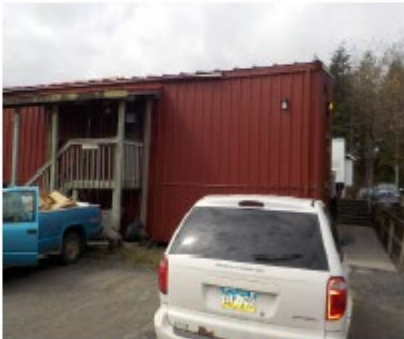
East Elevation - Shop  
1994 Addition

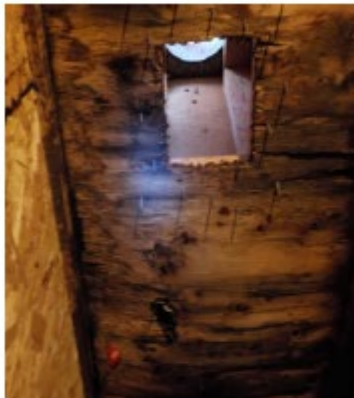
Deficiency Item S01. Decayed plywood roof sheathing typical at (2) roof ventilation turrets. Nontypical condition of framing.

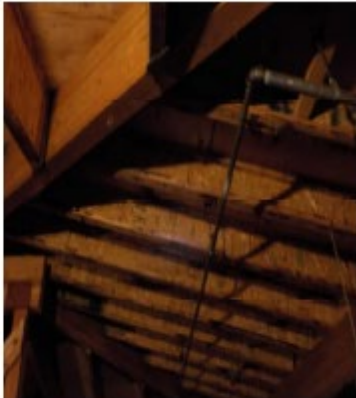
Typical structural roof framing in good condition. 1988 roof over-framing addition.

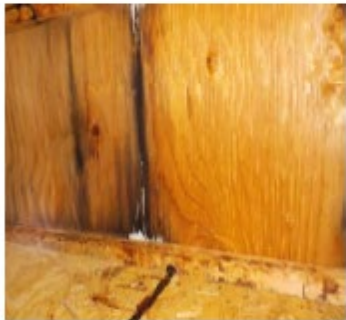
Deficiency Item S01. Minor roof leak creating moist condition for mildew growth (white).

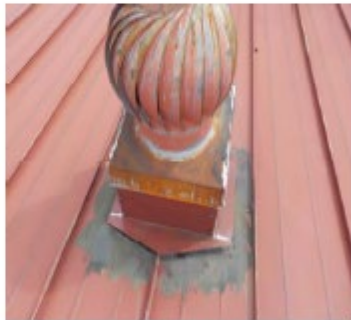
Deficiency Item S01. Example roof ventilation turret above major roof leak.

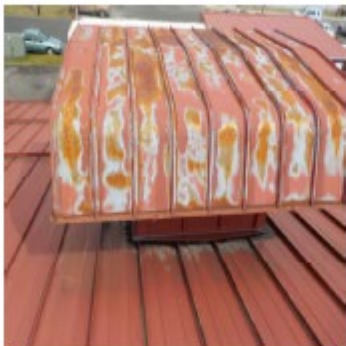
Deficiency Item S03. Air handler hood with corrosion.

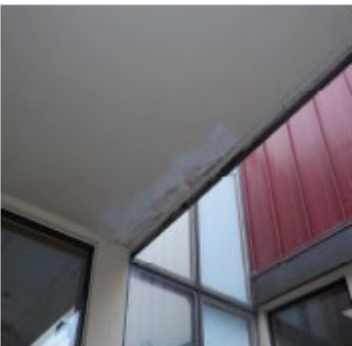
Deficiency Item S04. Example water damaged roof soffit sheathing.

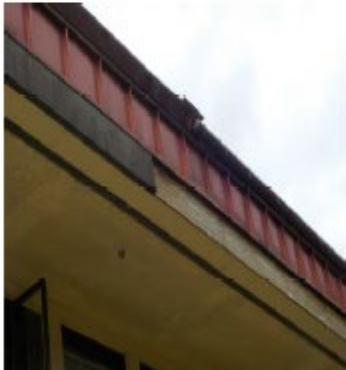
Deficiency Item S05. Missing EIFS fascia.

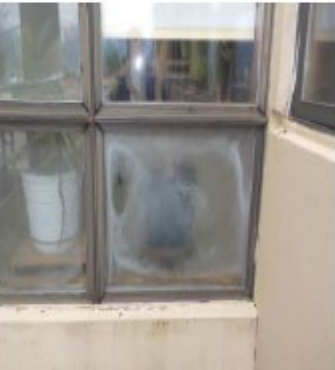
Deficiency Items S06, S07 and S08. Example damaged EIFS (freeze-thaw), fogged window, caulking sealant failure, siding in need of exterior paint

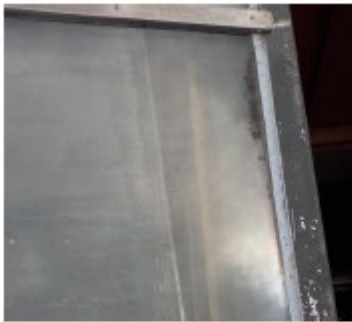
Deficiency Item S09. Broken skylight glazing.

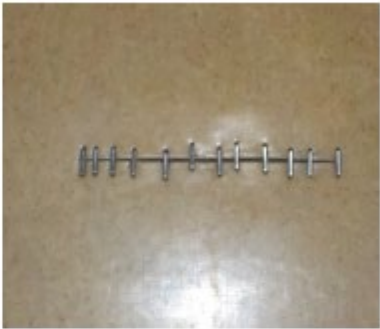
Deficiency Item S11. Example of existing vinyl flooring repair.

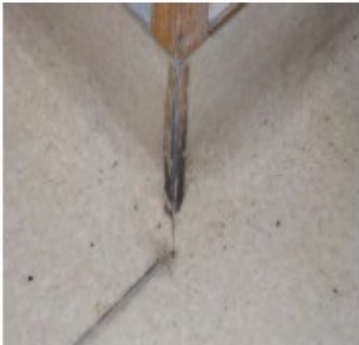
Deficiency Item S11. Example vinyl Flooring seam failure.

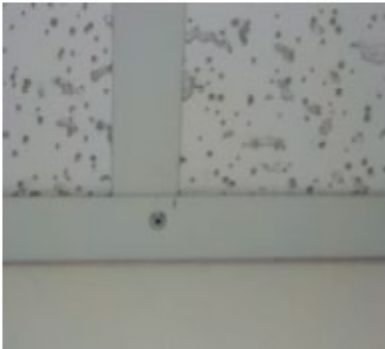
Deficiency Item S12. Rooms over 144 sf, metal grid runners are fastened to angle on all four sides of ceiling. Only one side shown in photo.

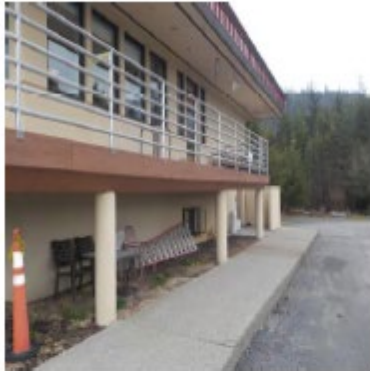
Deficiency Item S15. Note dip in deck rim board. Guardrails non-code compliant. Space between horizontal rails exceeds 4". Connection to deck not capable or resisting a force of 200 pounds.

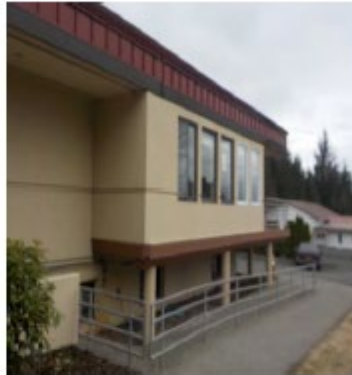
Deficiency Item S16. Addition bump out to activities room. Water runs down beneath the wall sole plate and runs across the floor. Foundation piers have settled.

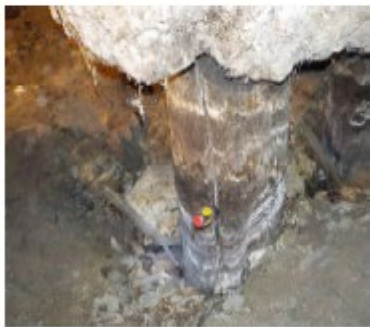
Deficiency Item S17. Decayed creosote treated timber piling. Nontypical condition, not representative of average piling condition. Most pilings were found to be in good condition.

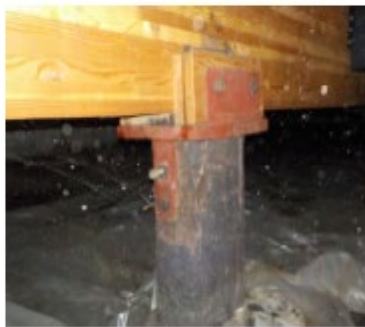
Typical creosote treated timber piling beneath 1988 addition, below emergency room. In good condition.

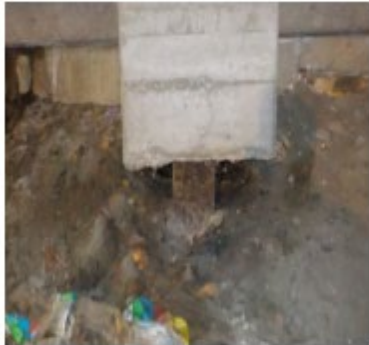
Typical creosote treated timber piling beneath 1968 Construction, beneath kitchen. In good condition. Reinforced concrete pile cap and grade beams in good condition.

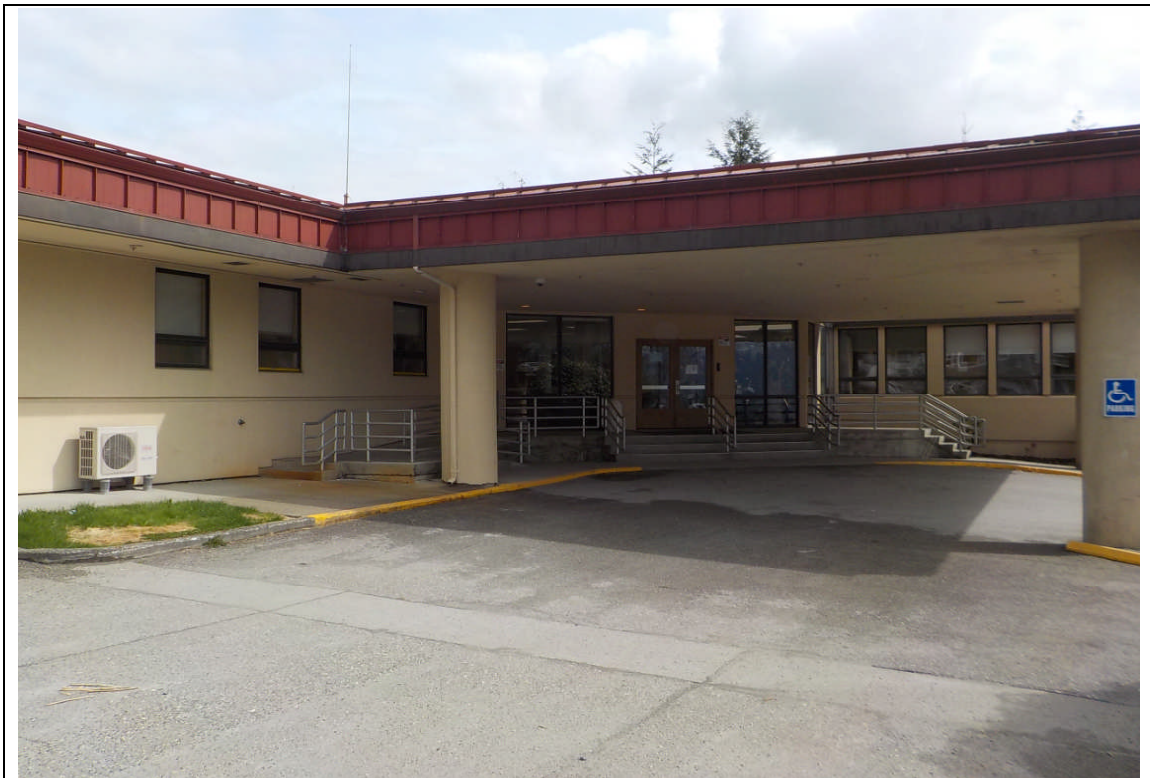
### **Wrangell Medical Center Building Condition Survey Structural, Building Envelope and Interior Finishes (15 Pages)**

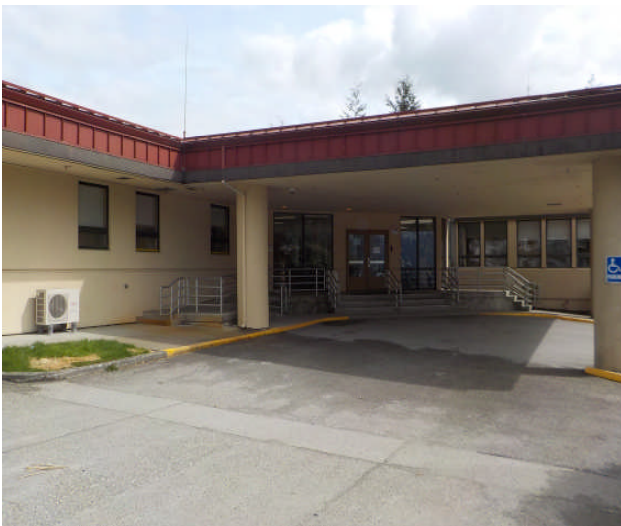
**Main Entry – Southwest Elevation**

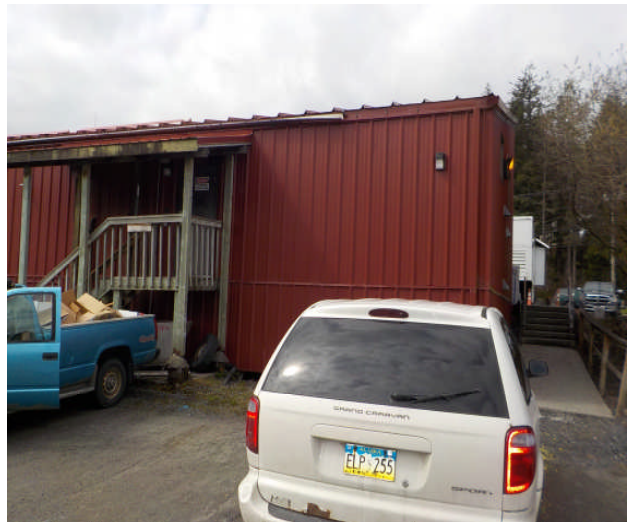
**East Elevation - Shop  
1994 Addition**

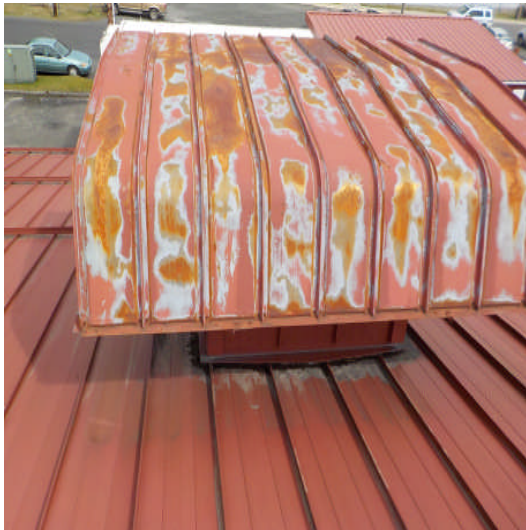
Deficiency Item S03. Air handler hood with corrosion.

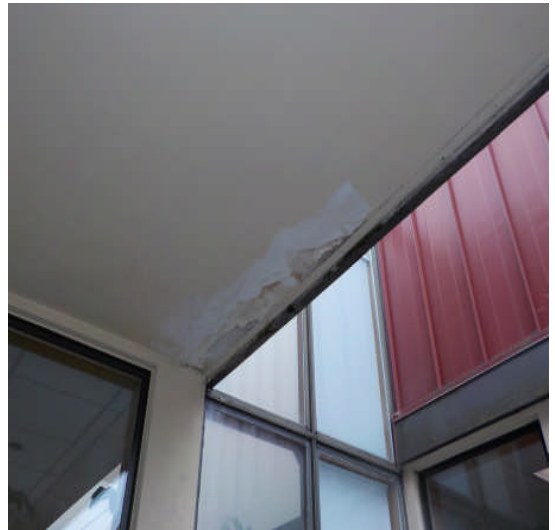
Deficiency Item S04. Example water damaged roof soffit sheathing.

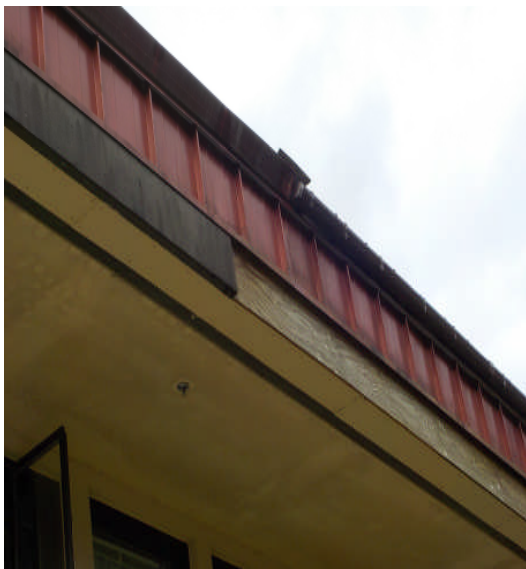
Deficiency Item S05. Missing EIFS fascia.

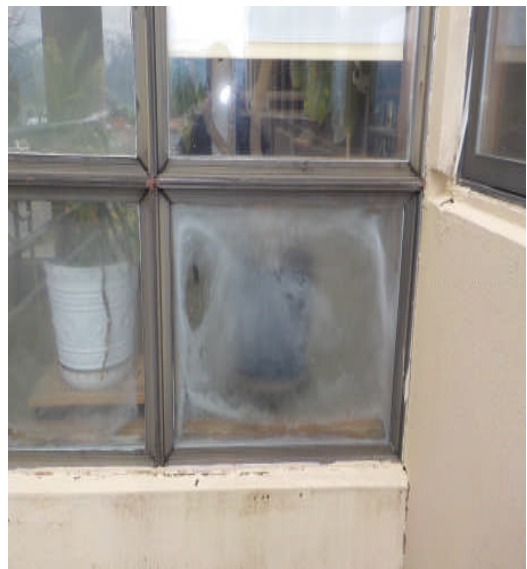
Deficiency Items S06, S07 and S08. Example damaged EIFS (freeze-thaw), fogged window, caulking sealant failure, siding in need of exterior paint

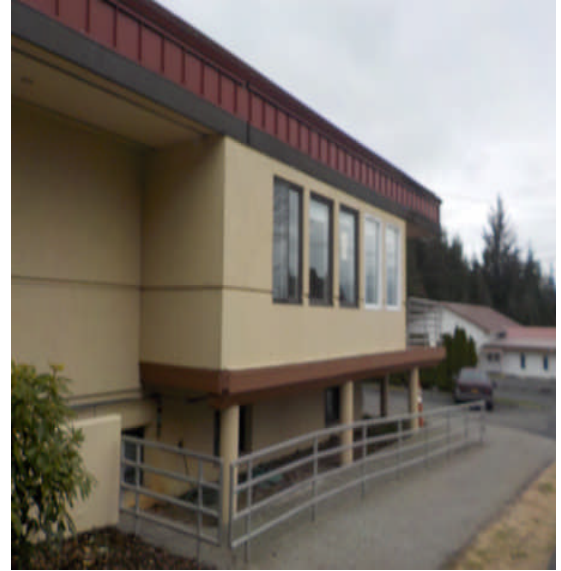
Deficiency Item S16. Addition bump out to activities room. Water runs down beneath the wall sole plate and runs across the floor. Foundation piers have settled.

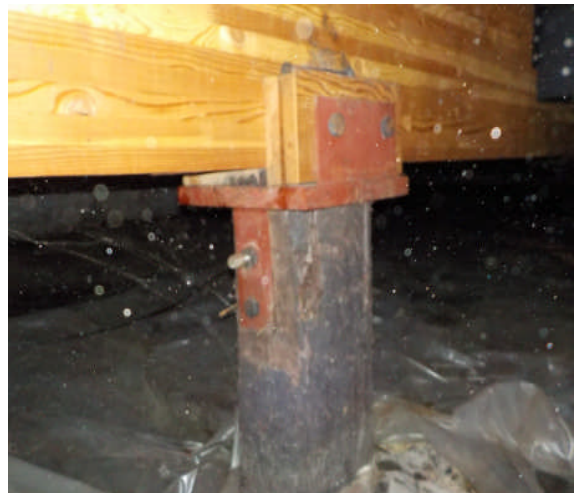
Typical creosote treated timber piling beneath 1988 addition, below emergency room. In good condition.

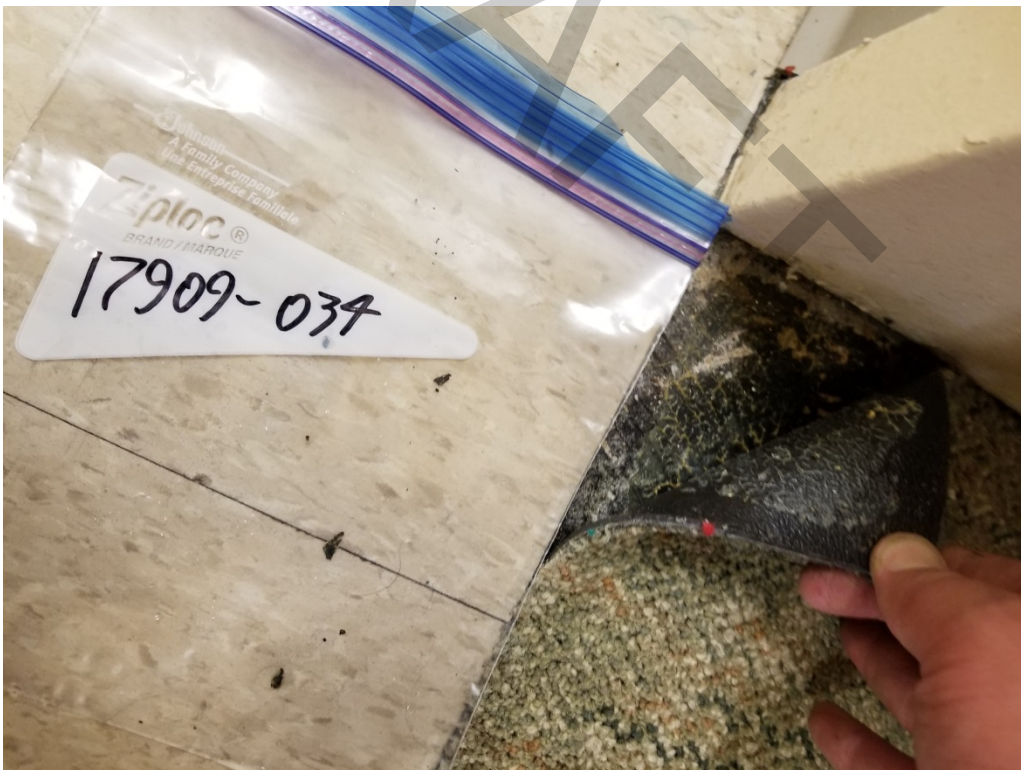
**Photo 4:** Black mastic beneath found beneath floor tiles and green carpet in the basement. (May 22, 2018)

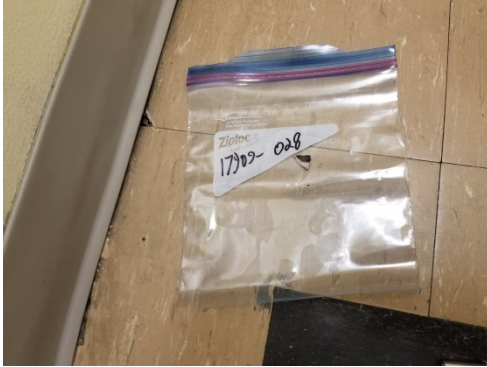
**Photo 5:** Pink floor tiles in the upper landing of the stairway were ACM, and had a black ACM mastic. Tile appears beige in this photograph; appeared pink when sampled. (May 22, 2018)

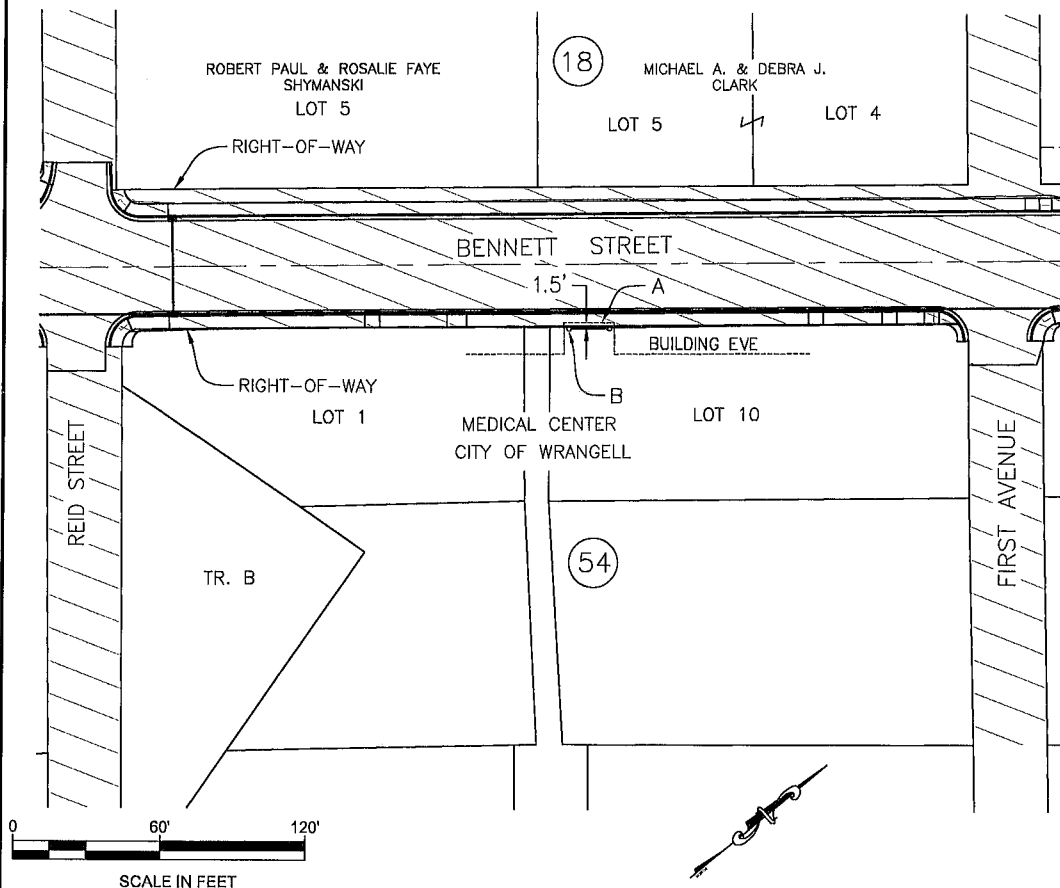
**DESCRIPTION:** LOT 10, BLOCK 54, USS 1119 distances listed below extend into Right of Way  
**ENCROACHMENT:** BUILDING ROOF LINE extends 1.5'.  
**DATE:** 07/12/2017 **PROJECT #** SFHWY00067

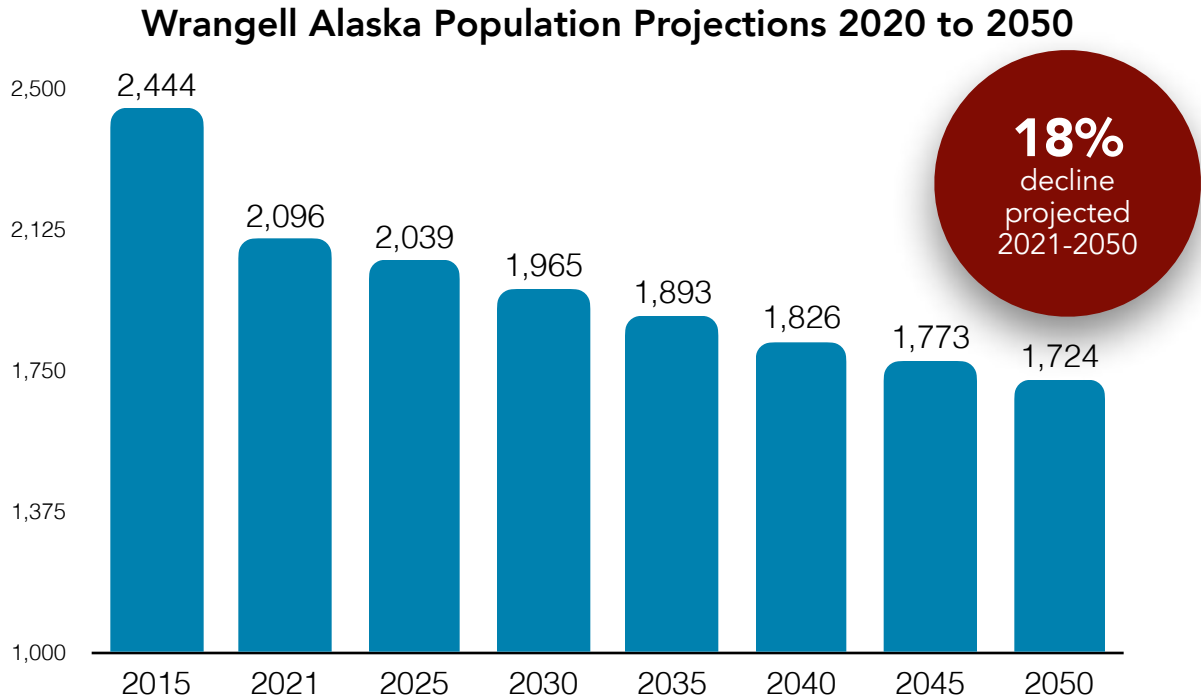
<sup>3</sup> Alaska Department of Labor and Workforce Development. The population projections are based on the current population and historical birth, death, and migration trends, and were developed after the analysis of COVID-19s impact on population levels. <https://live.laborstats.alaska.gov/pop/projections.cfm>

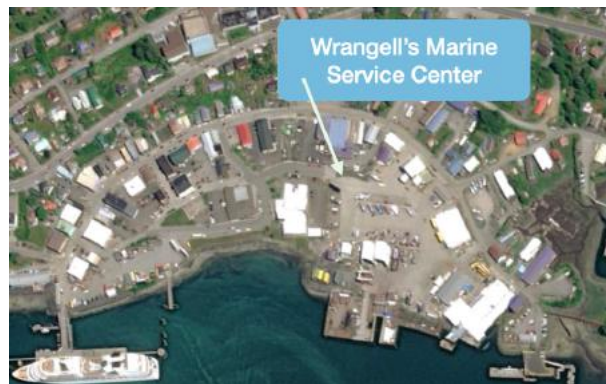
After the demise of the regional timber industry, Wrangell began to focus on providing maritime industrial services to southern Southeast Alaska. Wrangell is centrally-located in Southeast Alaska, allowing fishermen to access emergency repairs while remaining close to fishing grounds. Southeast Alaska vessel owners are taking advantage of the ability to have their repairs completed close to home.
