**APPRAISAL REPORT  
REAL ESTATE APPRAISAL**

**Of  
Armory Building**

101 Second Ave, Wrangell  
AK, 99923

**As of**  
April 28, 2021

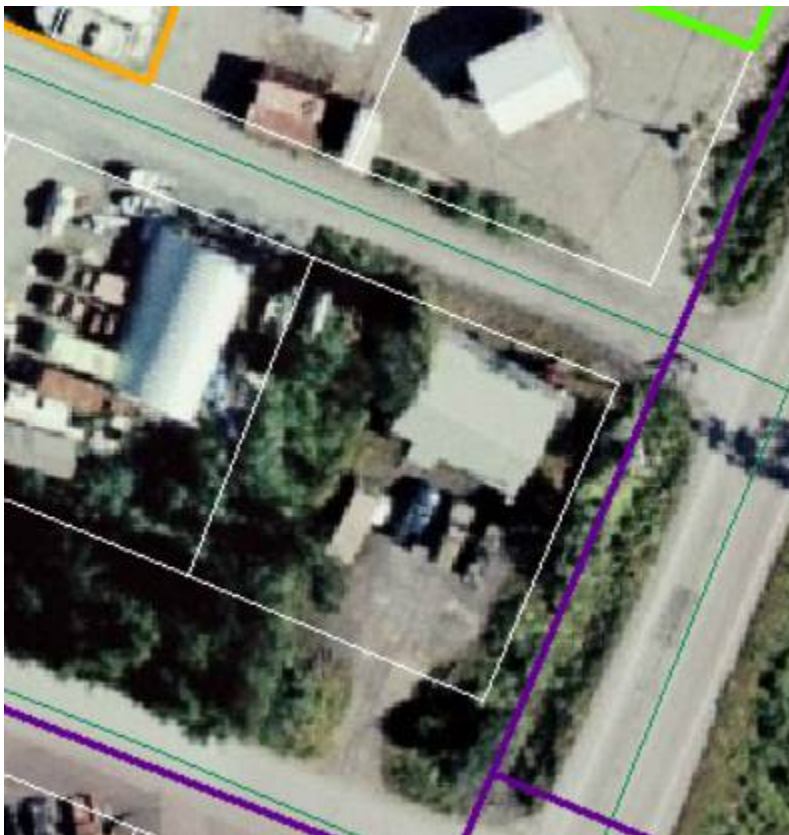
An older aerial of the subject site. As can be seen, the driveway is constructed through the area which is designated as green space.

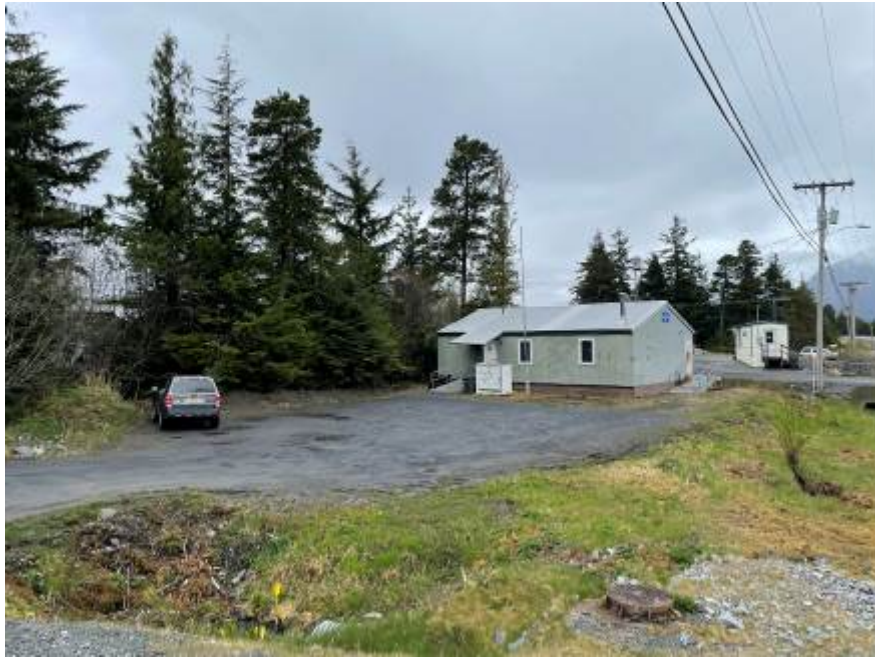
Pictured above is the front of the subject property as viewed from the corner of Second Ave and Airport Road.

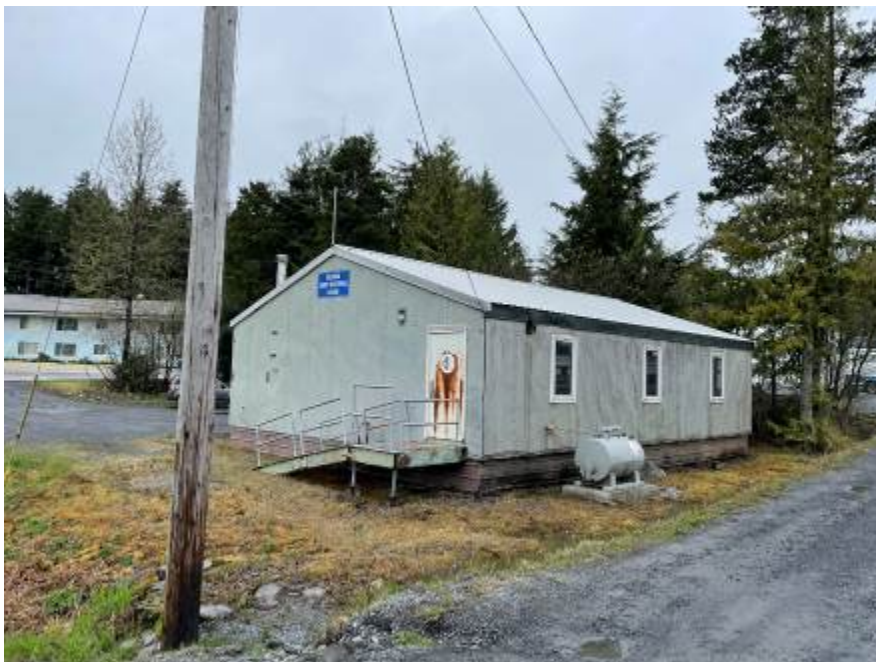
Above is a view of the rear of the subject building as viewed from Third Ave and Airport Rd

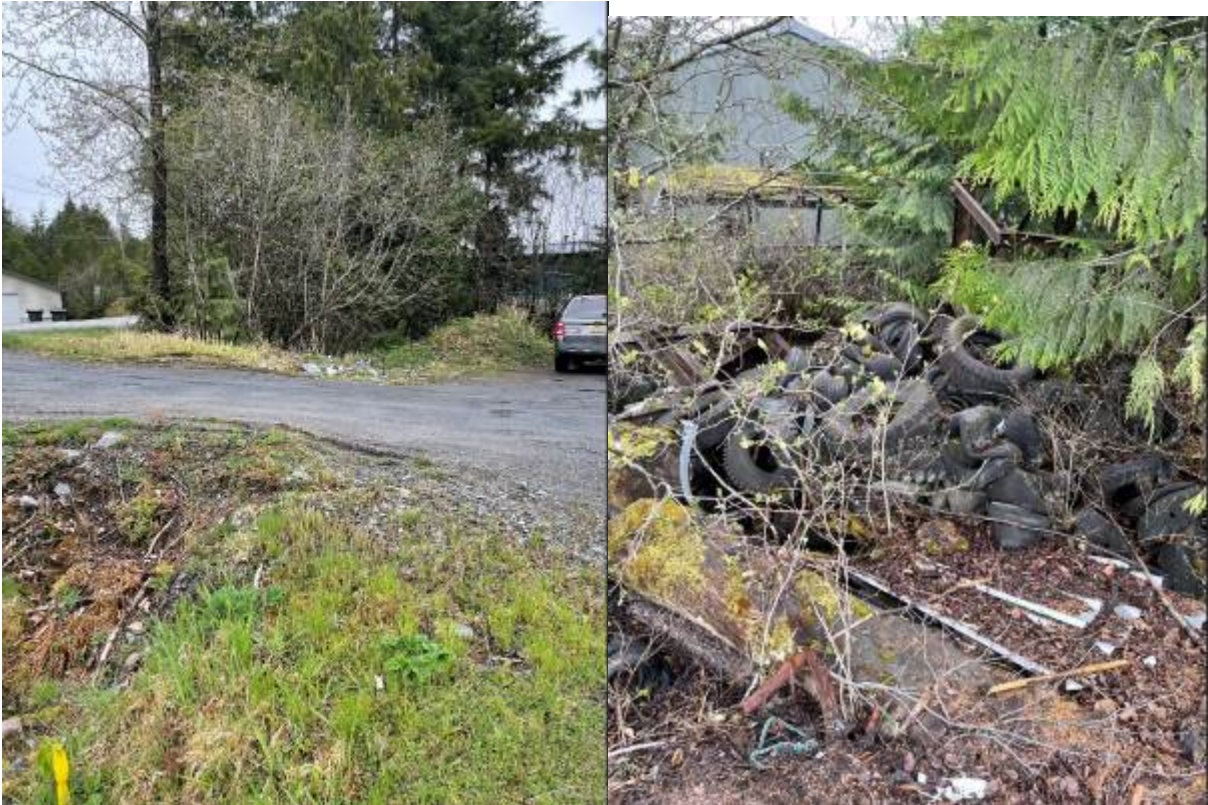
Pictured above left is the easement area reserved as a green belt easement in the plat. Pictured right is the NW corner of the subject site which has significant junk stored there.

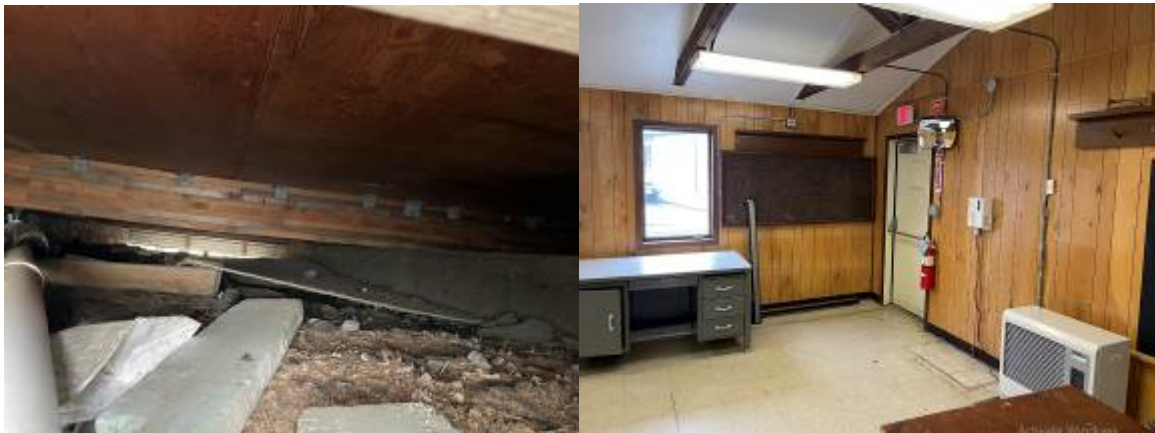
Above left is the underside of the building and as can be seen the subject is sitting on wood grade beams. Above right is a view of the interior looking at the NE corner. The oil fired Toyo heater is viewers right.

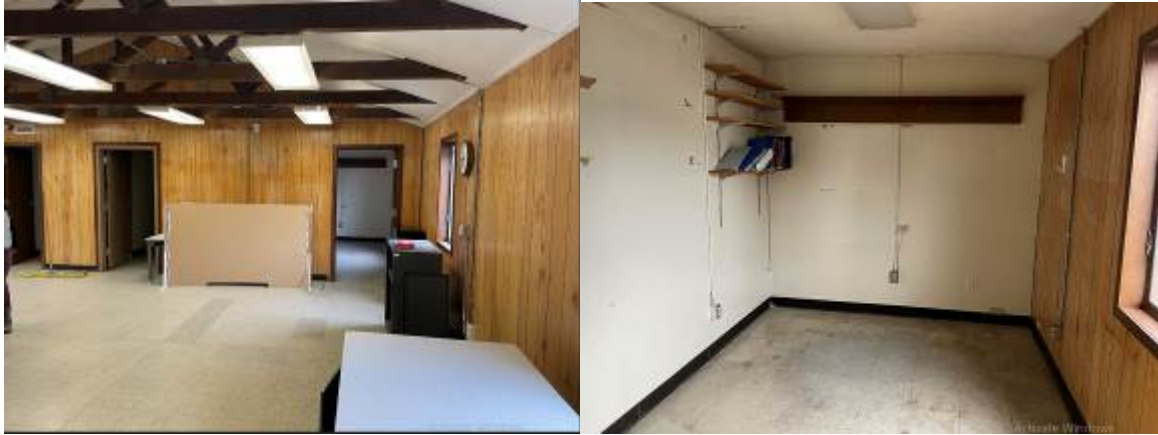
Pictured above left is the main hall which can be used for larger gatherings. Pictured right is an office with an outside window.

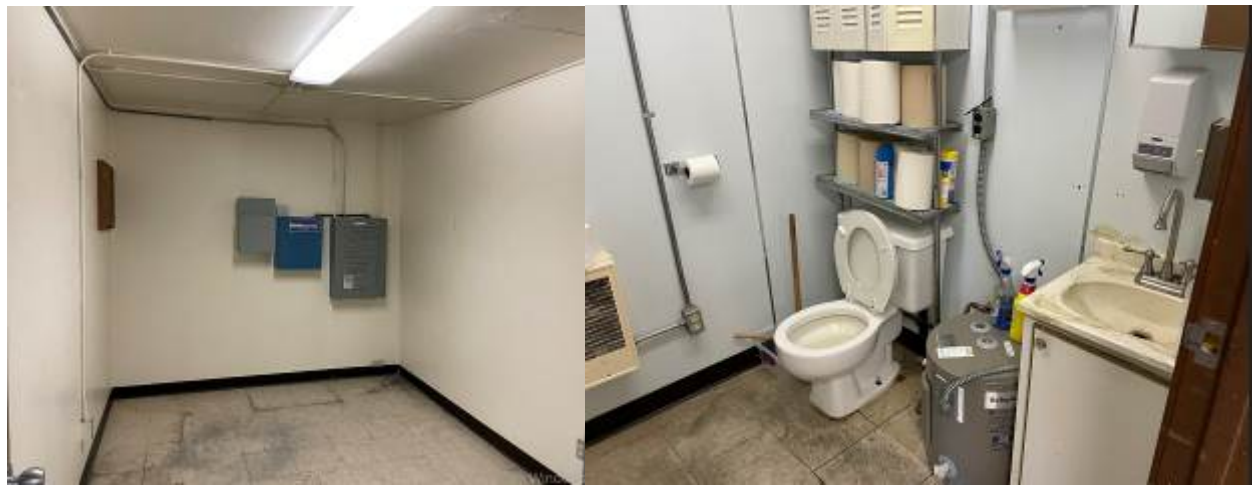
Pictured left above is a interior room with no windows. Pictured right above is the bathroom.
