POST-LANDSLIDE ELEVATION CHANGES DETECTED FROM MULTI-TEMPORAL LIDAR SURVEYS OF THE NOVEMBER 2023 WRANGELL, ALASKA, LANDSLIDES

Preliminary Interpretive Report 2024-2

Landslides identified by lidar data after the November 20, 2023, precipitation event in Wrangell, Alaska.

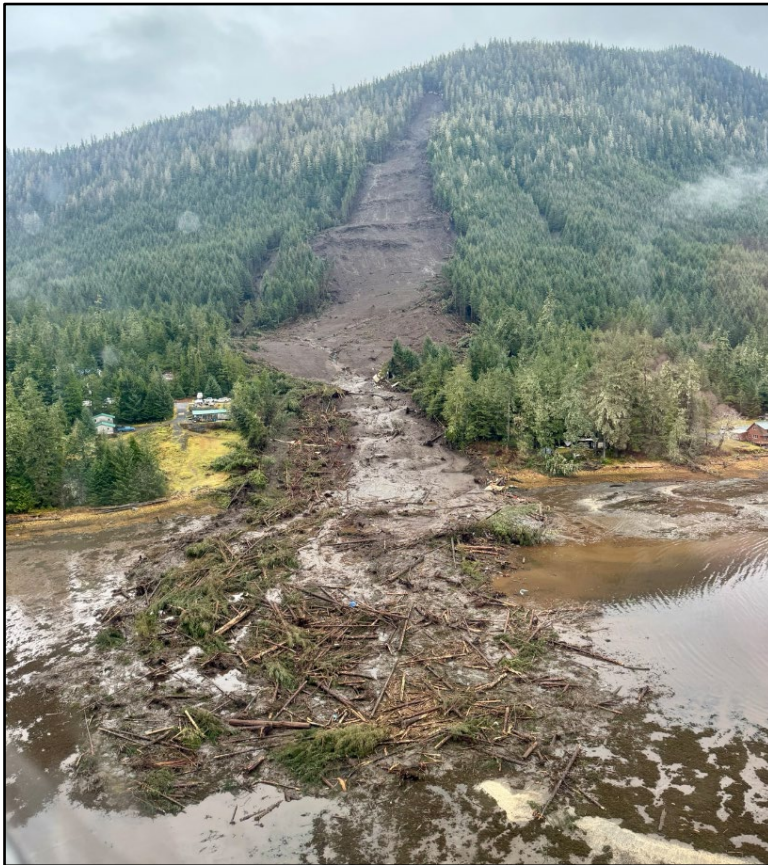
Figure 5. Zimovia Highway milepost 11.2 landslide (photo taken looking east by Barrett Salisbury, November 22, 2023).

DGGs geologists flew helicopter reconnaissance over the MP11.2 landslide on November 22 and 26 to document and assess the landslide source area and flow path. There is a distinct head scarp at 1,490 ft (450 m) asl and several bedrock benches at various elevations that trend roughly perpendicular to the path of the landslide. The soil cover in the steep source area is thin, with potential for thicker soil development in the flat areas above the bedrock benches. The landslide debris is primarily comprised of saturated soils and large wood debris, with minimal rock material. The landslide spanned approximately 3,750 ft (1,140 m) from head scarp to shoreline, with roughly an additional 500 ft (152 m) extending into Zimovia Straight

(fig. 5). The landslide was approximately 350 ft (106 m) wide where it crossed the highway, wider in other sections further upslope, and it tapered to about 100 ft (30 m) at the head scarp.

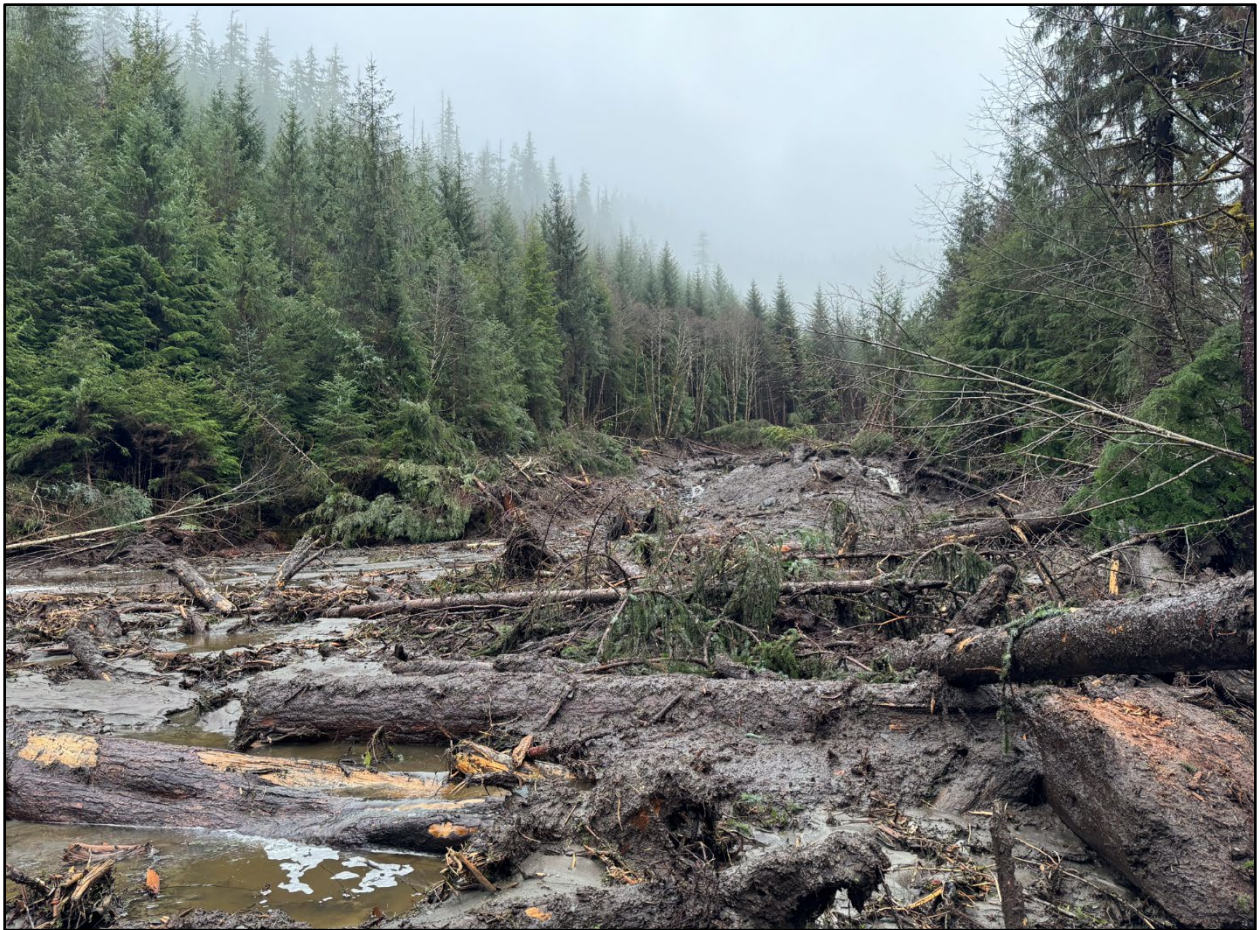
Figure 6. Toe of the Middle Ridge Road landslide where it covers the road (photo looking south by Barrett Salisbury, November 24, 2023).

The Middle Ridge Road landslide occurred within one to two hours after the MP11.2 landslide, based on information given by the resident who was temporarily trapped by this landslide. DGGs geologists accessed the toe of the landslide to document and assess the debris composition. This lower section of the landslide was estimated to be approximately 150 ft (50 m) wide and covered approximately 600 ft (180 m) of Middle Ridge Road (fig. 6). The Southeast Power Authority flew a drone survey over the landslide on November 24, 2023, which helped determine the location of the source area and the flow path downhill. The landslide crossed Middle Ridge Road in three places and followed an already established stream channel resulting in significant erosion and entrainment of material in the V-shaped channel. From head scarp to toe, the landslide was approximately 3,600 ft (1,100 m) long and more than 100 ft (30 m) wide, with similar composition to the MP11.2 landslide: primarily large wood debris and saturated soils with very little rock.

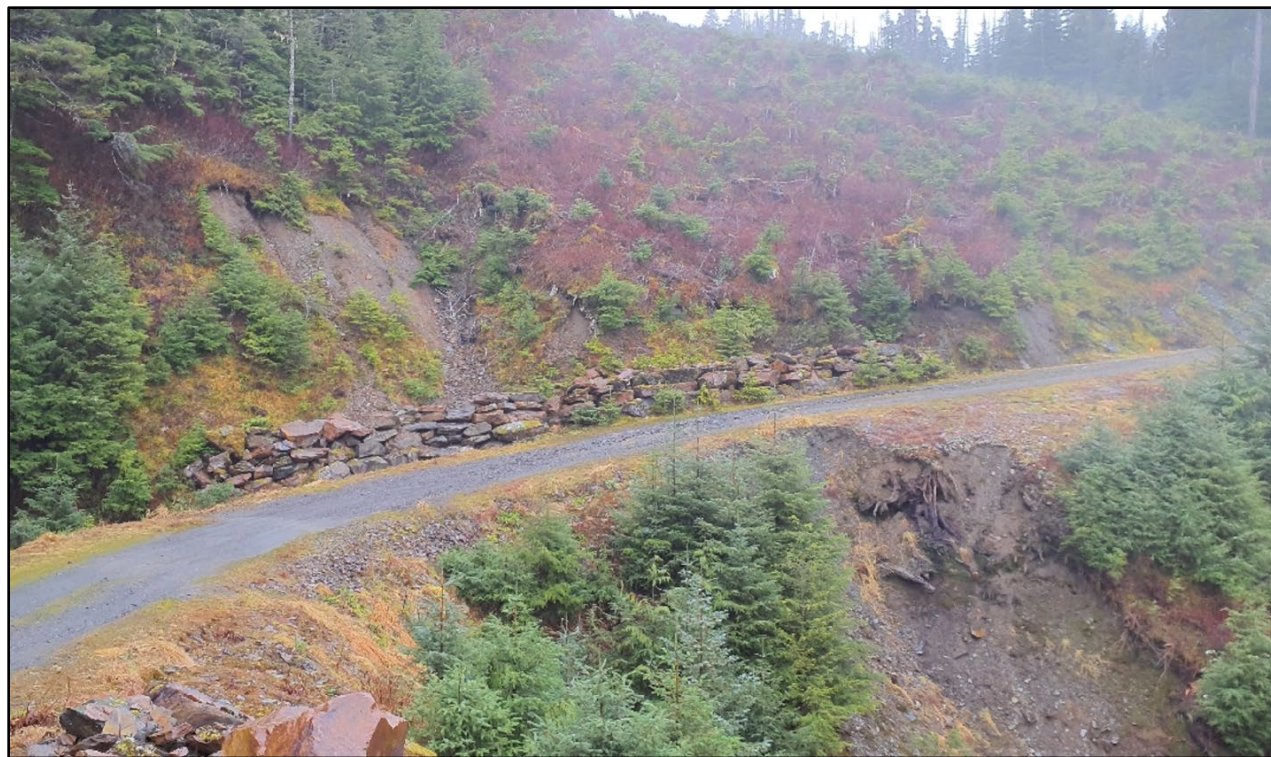
Figure 8. Existing landslide on forestry road 50052 (photo by Jillian Nicolazzo, November 25, 2023).

We joined a U.S. Forest Service officer to investigate additional landslide activity along the logging road network accessible north of the MP11.2 landslide road closure (forestry roads 50051, 50052, and 50055 [fig. 1]). The higher elevations were cloud-covered so visibility was limited, but no new landslides were identified near the roads. An existing landslide originating at forestry road 50052 and crossing forestry road 50051 was visited to investigate for possible reactivation (fig. 8).

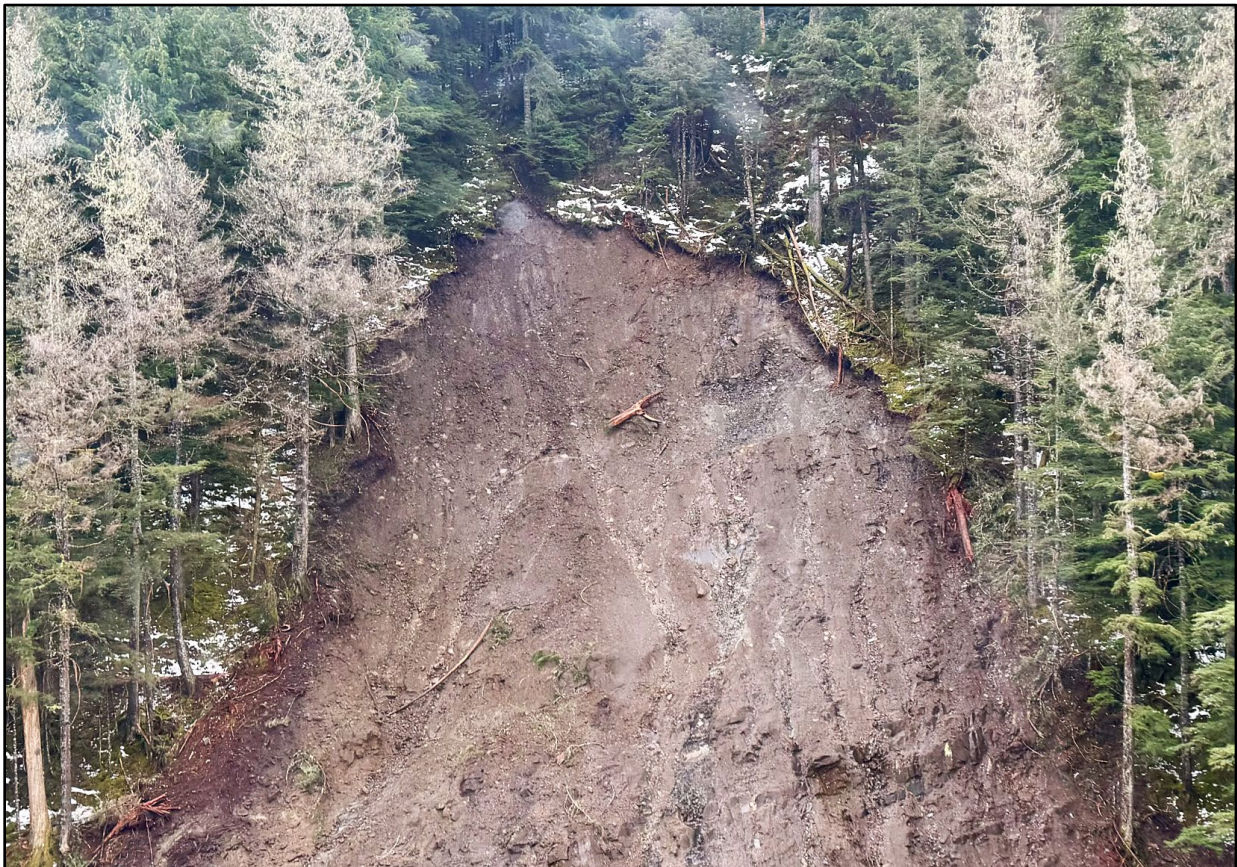
Figure 12. MP11.2 landslide head scarp (photo by Barrett Salisbury, November 23, 2023).

A 150-ft- (45-m-) long head scarp shaped like an inverted “U” is visible at the top of the MP11.2 landslide (fig. 12) at approximately 1,500 ft (455 m) asl. The lidar differencing suggests that roughly 2.8 million ft³ (80,000 m³) of material was released/eroded and approximately 1.7 million ft³ (48,000 m³) was deposited by the landslide (fig. 13). The DOT&PF had already removed debris from the road at the time of the November lidar survey and that removed volume is not part of the deposited volume stated here. In addition, this landslide ran into the ocean and deposited sediment in the water. Additional bathymetric lidar or sonar is necessary to calculate this deposition volume (not currently planned).
