# Facility Overview

| School District: | Wrangell Public School District |
| Facility: | Stikine Middle School |
| Inspection Date(s): | May 16-19, 2023 |

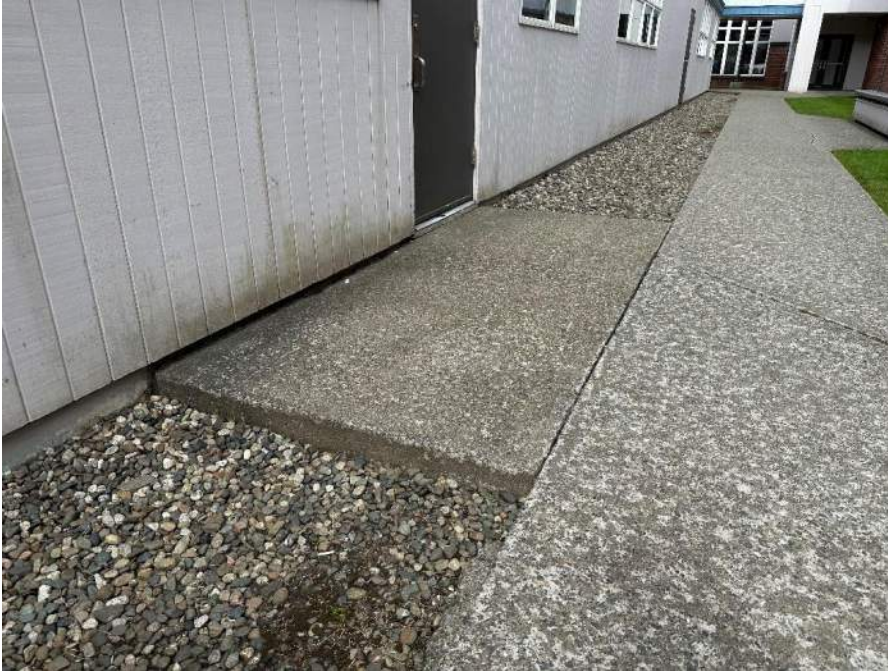
*Replacing existing 10'x5' concrete stoop at door exiting building*

**C-4:** Priority #3 Consider replacing existing 10'x5' concrete stoop at door exiting building on northeast side.

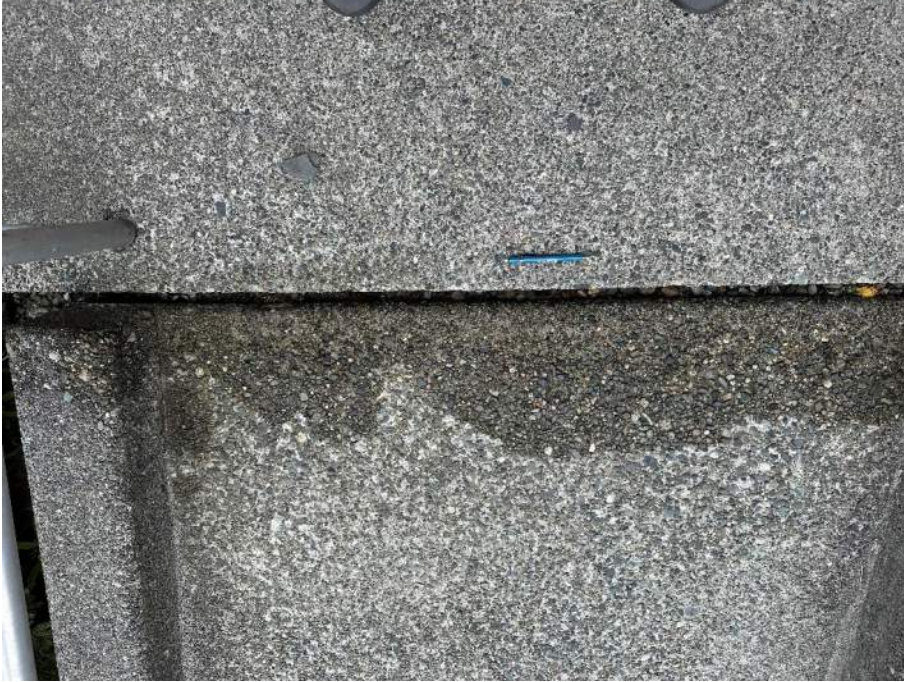
**C-7:** A gap at the construction joint at the top of the concrete access ramp is wider than the ADA maximum.

*A gap at the construction joint at the top of the concrete access ramp is wider than the ADA maximum.*

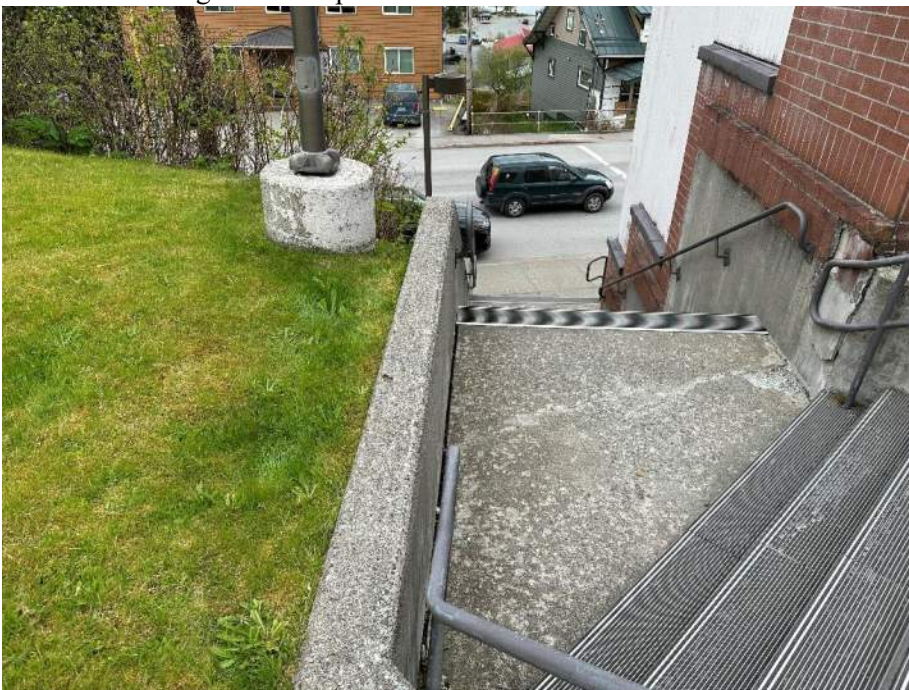
**C-8:** The elevation difference between the lawn and stair landing at the northwest staircase is greater than 30" and no guardrail is present.

*Elevation difference between the lawn and stair landing at the northwest staircase is greater than 30" and no guardrail is present.*

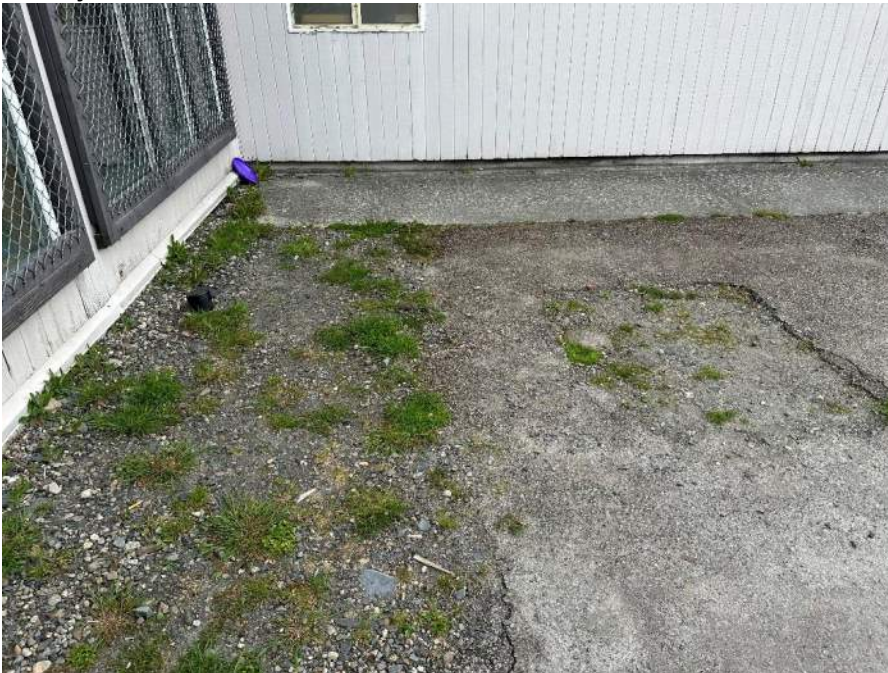
*Remove weeds along building and pavement edges*

**C-11:** Priority #2 Remove weeds along building and at concrete/ACP joint to prolong surfacing life. Priority #2

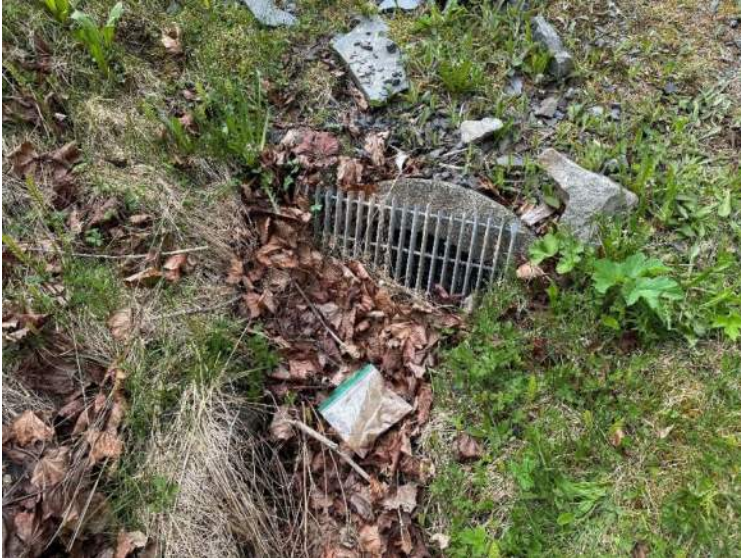
*Inlet and pipe near east building corner*

**C-16:** Priority #1 Clean pipe adjacent to east building corner (size, length and discharge point unknown).

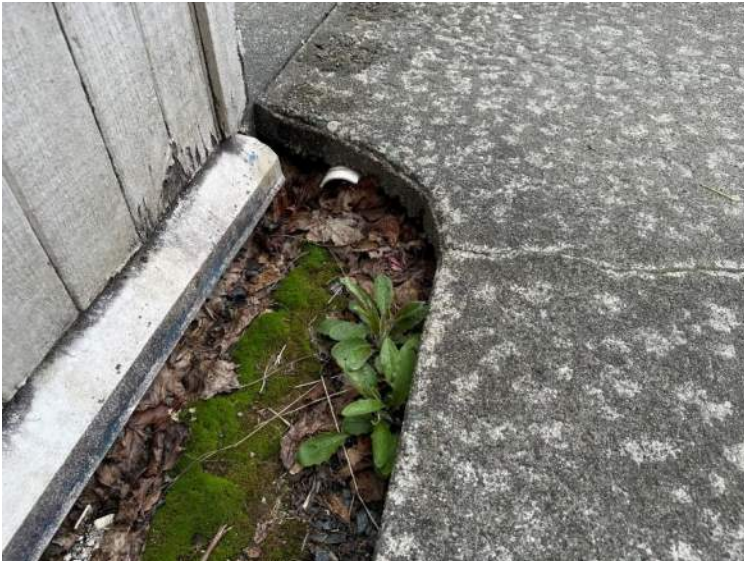
*Drain pipe immediately northwest of building entrance on Church Street*

**C-17:** Priority #1 Clean 4" drain pipe (approximately 15 LF) immediately northwest of entrance on Church Street.

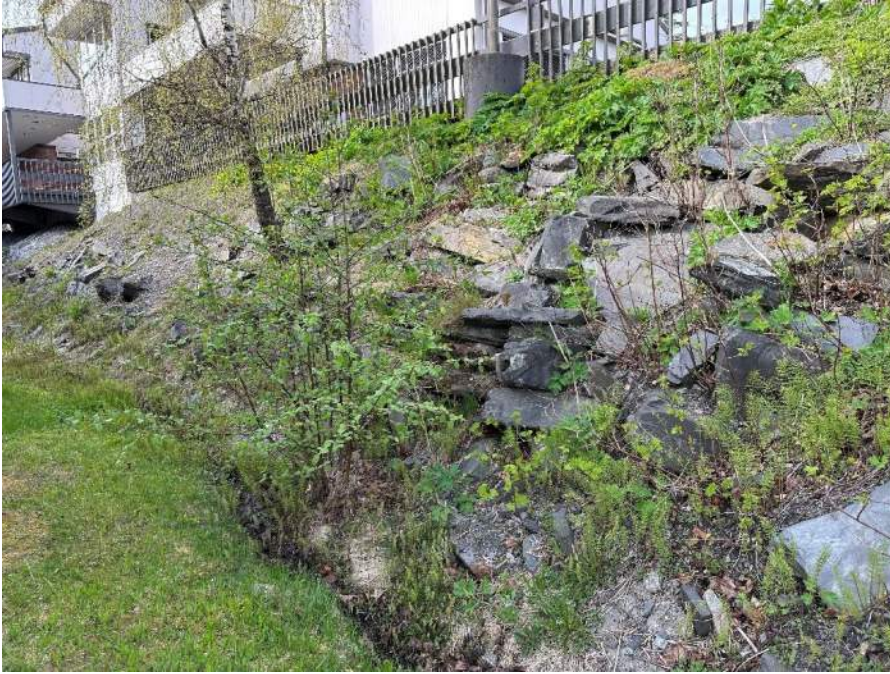
*Saturation and standing water in vegetated area northeast of vocational wing*

**C-18:** Priority #1 Consider a 4" perforated CPP underdrain (approximately 80 LF) in the grass area northeast of the vocational wing. Connect to existing catch basin in St. Michael Street with 40 LF of 4" PVC.

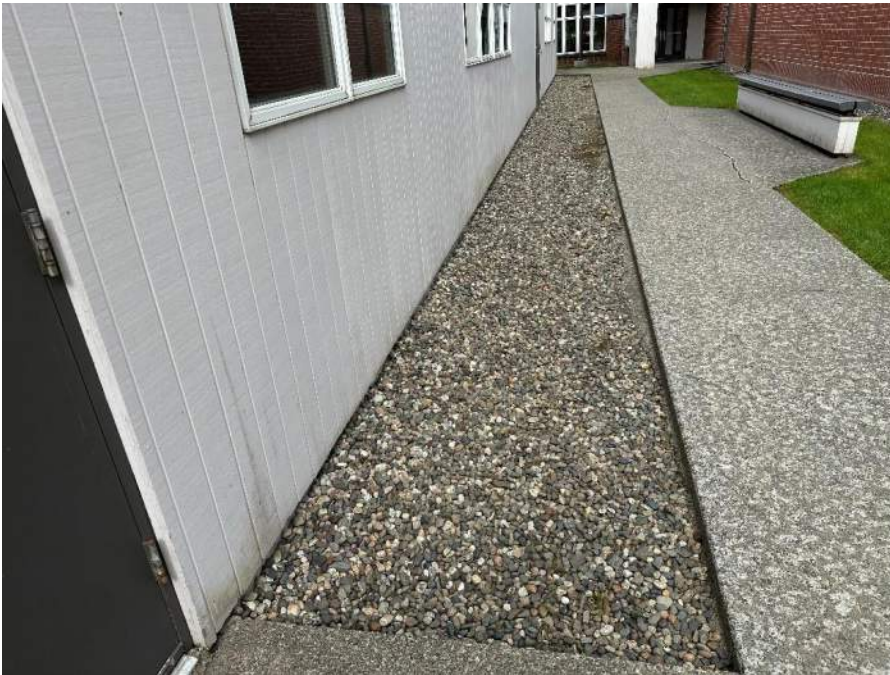
*Buffer on northeast side of building, top level*

**C-19:** Priority #1 Consider a 4" perforated CPP underdrain (approximately 100 LF) in the rock mulch buffer on the northeast side of the building. Connect to existing High School catch basin with 20 LF of 4" PVC.

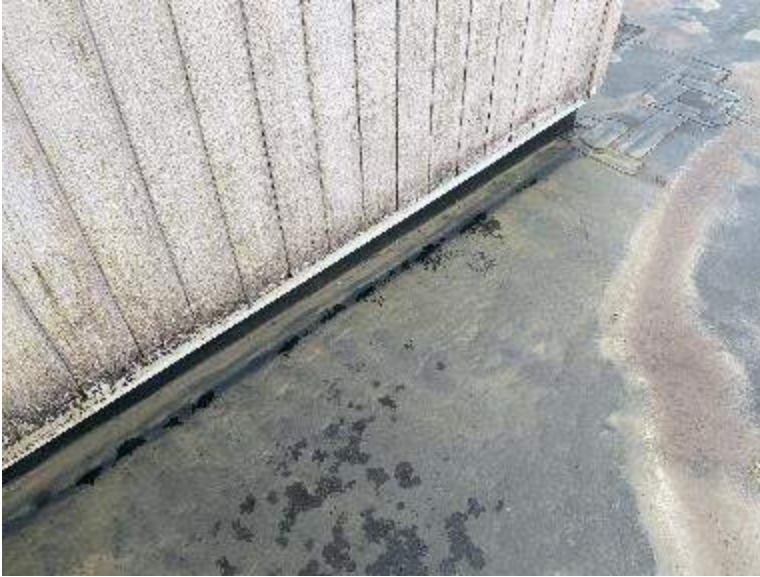
*Water intrusion behind siding*

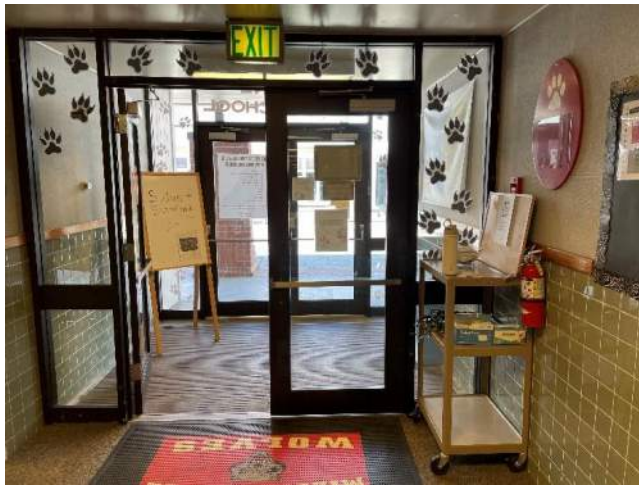
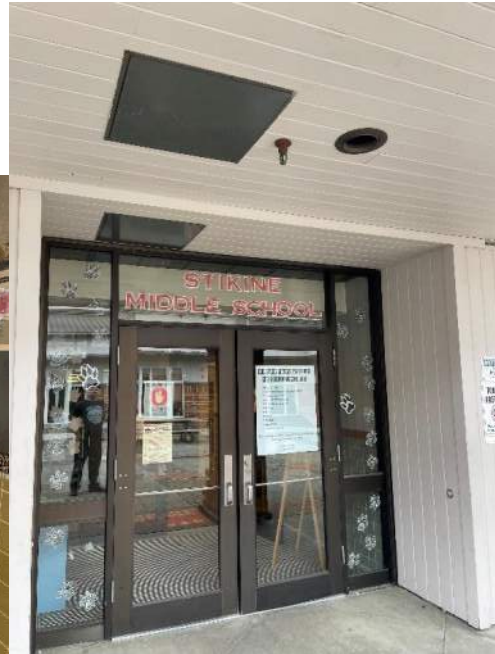
All doors are maintained in good operating condition. The bar type panic hardware is antiquated but functional. Some weather seals are worn, most of the entrances are in otherwise serviceable condition.

The steel frame at the aluminum entrances exhibit some corrosion at the frame and are clearly subject to harder use, and therefore exhibit greater signs of wear.

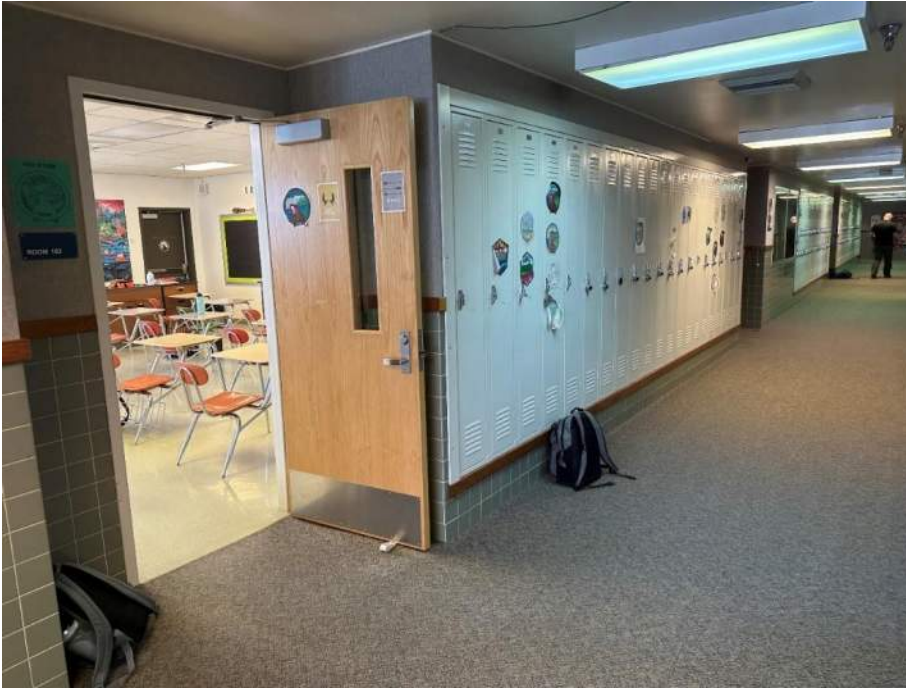
*Main hallway illustrates typical classroom door, signage, and lockers.*

Metal lockers are located on the north side of the main hallway are in good condition, with two latch mechanisms noted as missing - score 3.

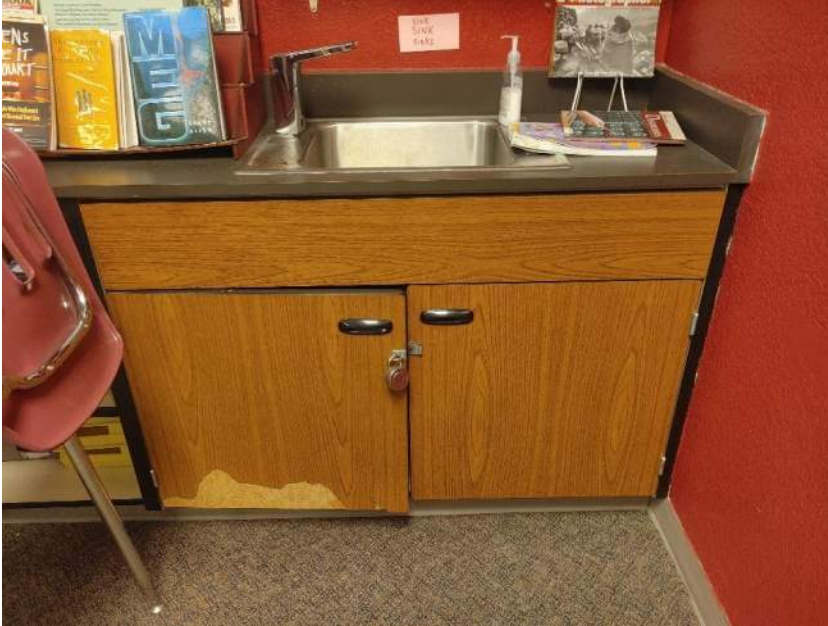
The commercial cabinet boxes and shelves appear sound and design configuration seem functional, but door and drawer faces are chipped and damaged in numerous locations.

**ID-10:** Millwork Repairs. Priority #1:

- Remove and replace sink base with accessible assembly at 4 locations; remove box and provide new configuration to afford accessible clearance and plumbing guard. The existing stainless-steel sink and touch free faucet may be salvaged and reinstalled.
- Remove all drawer and door faces that are damaged and replace with new to match, 14 locations.
- Remove and replace five science classroom lab countertops (each is 12' x 30"). Salvage undermount sink and touch free faucet. Provide new black solid surfaces countertops to receive reinstall of sinks and faucets.

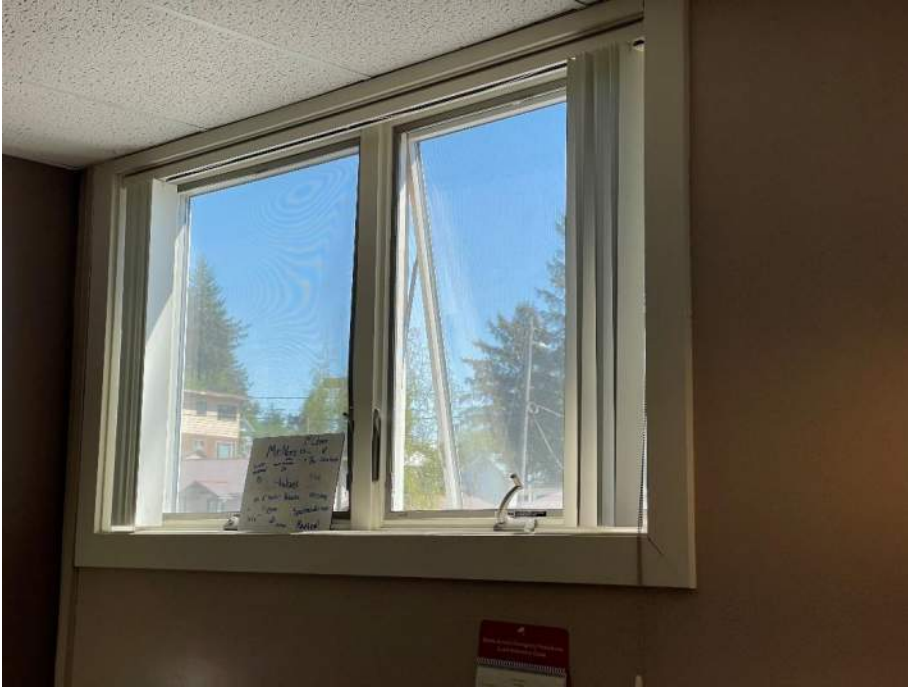
Vertical louver slat blinds, PVC, retractable to sides.

Mostly intact and operational but not functional. Operation requires sill and mullions be cleared, spaces commonly used as shelves for plants and other classroom related items that must be moved to deploy the blinds. Rapid deployment of blinds is not possible in an emergency.

**ID-11:** Remove and replace existing blinds with new roller shades at 20 installation locations. Priority #1

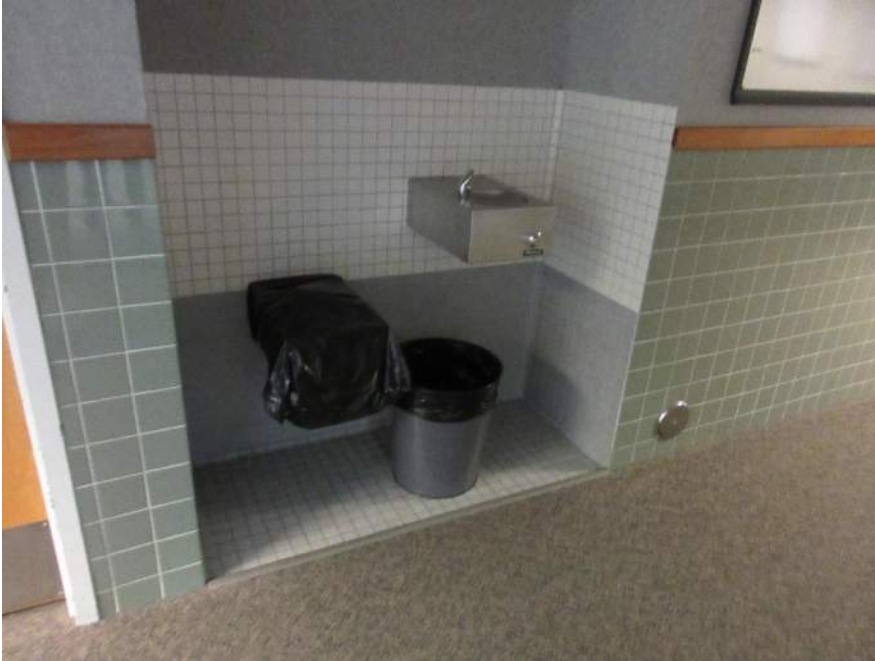
Fixtures are generally in adequate condition. Faucets are in poor to good condition. Flush valves are in good to almost new condition. The service sink in the Janitor's closet is in adequate condition. The second floor drinking fountains are from 1991, with one of them out of order. The drinking fountain / bottle filler in the first floor commons is like new. The drinking fountain and wash fountain in the wood shop are adequate condition.

**MP-1:** None of the lavatories are equipped with an ASSE 1070 compliant tempering valve, as required by section 407.3 of the Uniform Plumbing Code.

**MP-2:** The existing toilets and urinals are older designs not engineered for use with low consumption flush valves. Consequently, the flush valves have been adjusted to a higher flow for proper flushing action. If saving water is a concern, it is recommended these fixtures be changed out for modern versions that can better utilize the capability of the low consumption flush valves. Replace the two second floor drinking fountains with a single high-low unit equipped with a bottle filler. Any ADA compliance issues should be addressed. Priority #2.

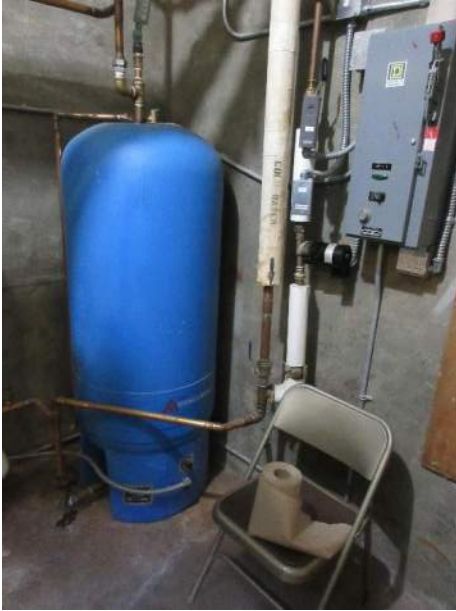
The age of the Amtrol hot water storage tank is not known, but it looks to be in adequate condition. Both the tank heating circulation pump and the HWC pump are not new but are in adequate condition.

**MP-5:** The Amtrol storage tank is not either strapped to the wall or anchored to the floor to prevent overturning, which is a violation of section 507.2 of the Uniform Plumbing Code and Chapter 13 of ASCE/SEI Standard 7-2016 (Minimum Design Loads for Buildings and Other Structures).

**MP-5:** Prior to replacement, recommend the Amtrol tank be anchored to the floor or be strapped to the wall. Priority #1.

**MP-6:** Even though the age of the Amtrol storage tank is unknown, it is known that Amtrol has not manufactured these units for quite a while. Also, given the age of the boiler and its need for replacement (see heating equipment section of this report), it is recommended planning for this tank to be replaced at the same time as the heating system replacement work. Priority #1 See boiler replacement.

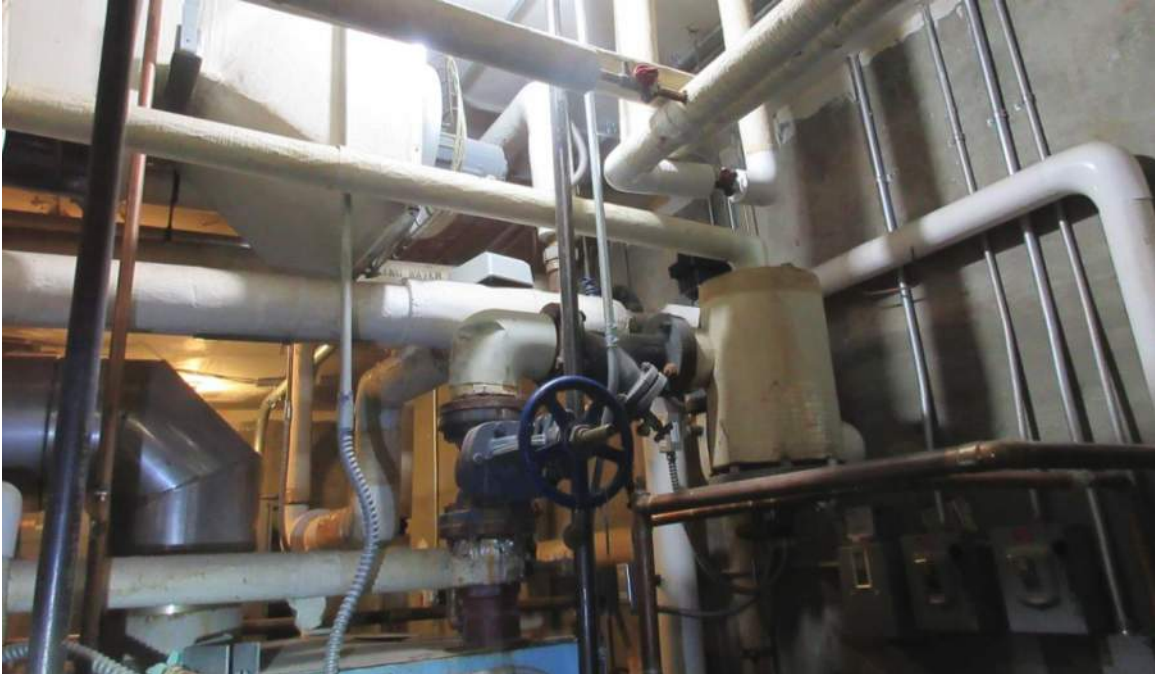
Heating system and heating terminal devices are overall in good to adequate condition. Control valves are properly functioning. Some of the pipe insulation needs to be repaired or replaced. The two science classroom convectors have damaged grilles.

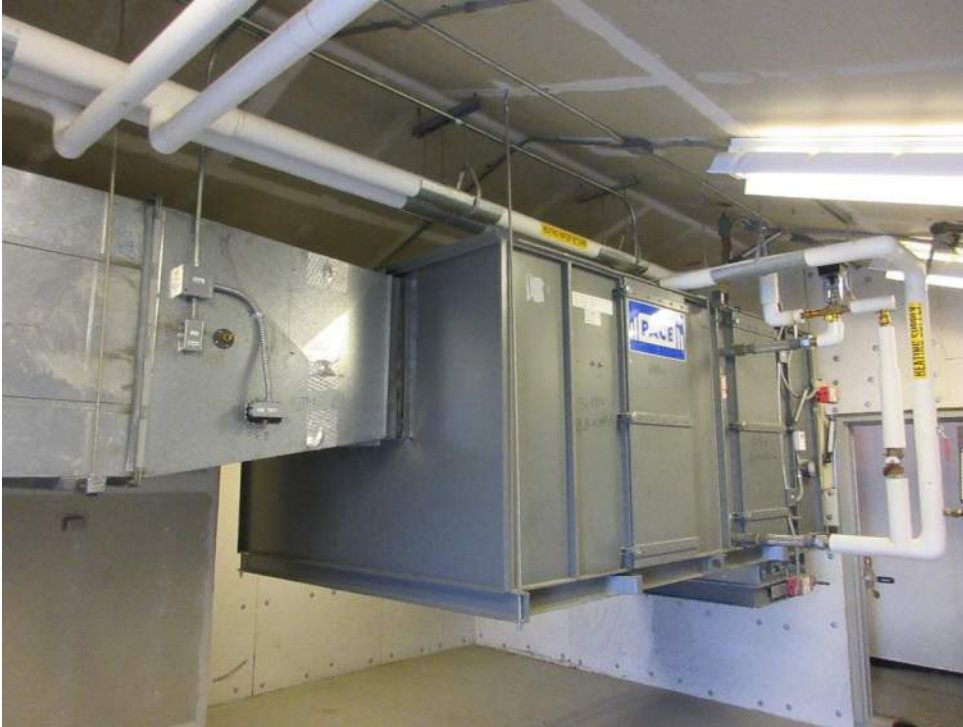
Despite their age and being beyond or well beyond their expected useful life, the main AHUs are generally in adequate to good condition due to good maintenance practices. The relief hoods for AHU-1 and AHU-2 are showing extensive rust on the top surface.

In general, the various exhaust fan range in condition from broken or worn out to good condition. Except for the Rupp Air fan fan, the rest of the fans are at or beyond their expected useful life. However, the Rupp Air fan is very noisy and should be replaced soon.

**MP-12:** All the AHUs are not properly anchored against seismic events per section 1613 of the International Building Code and Chapter 13 of ASCE/SEI Standard 7-2016 (Minimum Design Loads for Buildings and Other Structures).

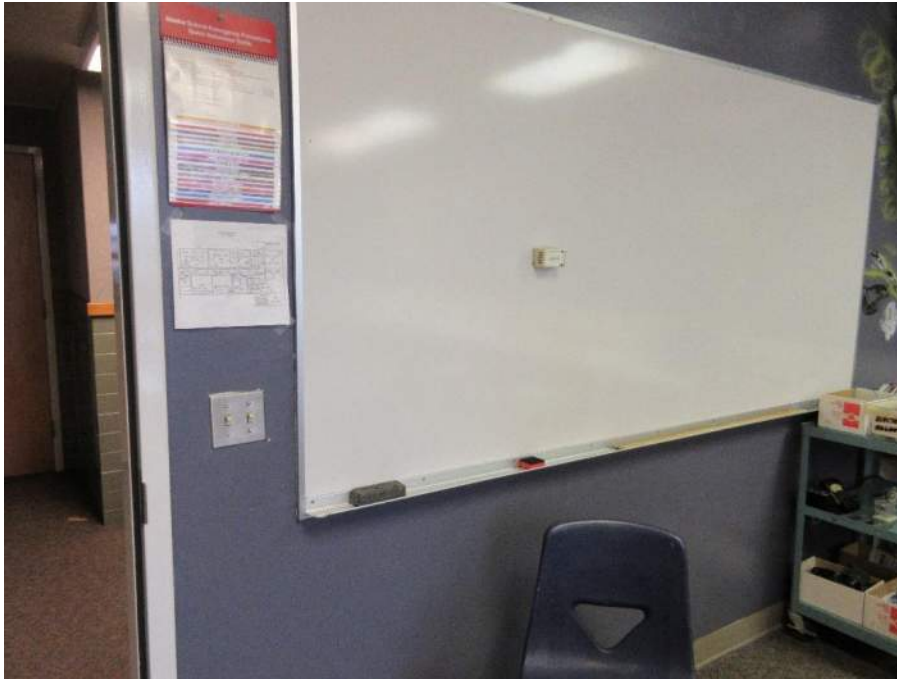
DDC portion of the system for both buildings is in very good condition. There are some programming items to clean up and miscellaneous control glitches to sort out. The pneumatic portion

of the system in both buildings is in poor to very poor condition. See the Air compressor section of this report. Classroom 105 has a thermostat located in the middle of a white board.

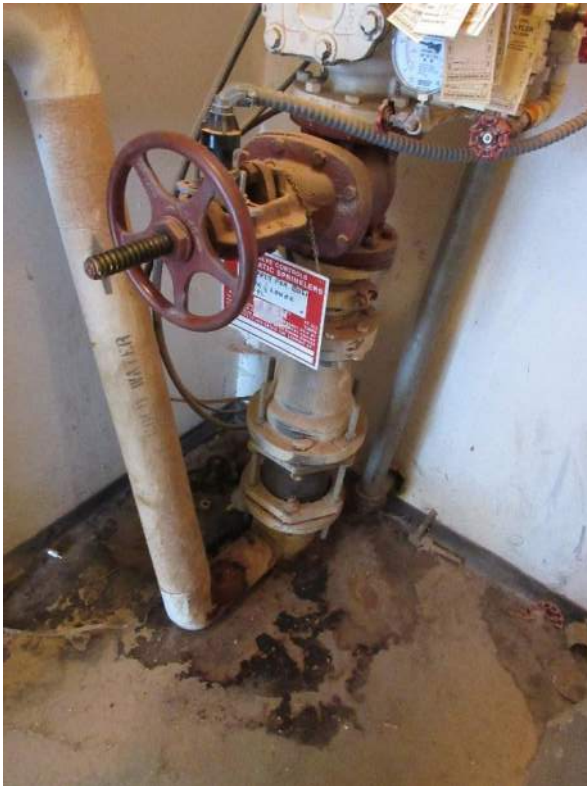
The sprinkler system is generally in good condition and is certified annually.

**MP-25:** The system does not have a double check valve assembly, so there is no backflow protection for the domestic system, in violation of section 603 of the Uniform Plumbing Code. This needs to be installed right away.

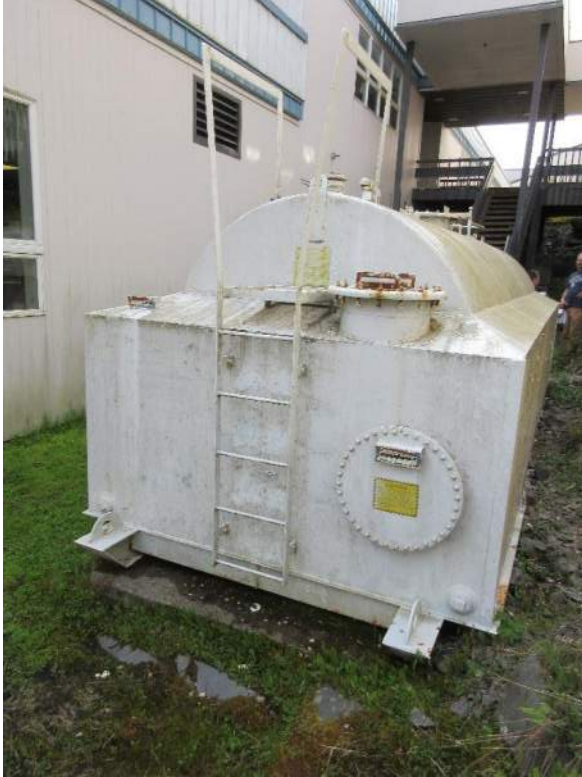
The AST was installed in 1990 is in adequate condition. Piping within the boiler room is in good condition. The boiler burner does not have a drip pan to contain any oil leakage.

**MP-27:** The AST vent does not extend a minimum of 12 feet above grade, as required by NFPA 30, section 27.8.1.

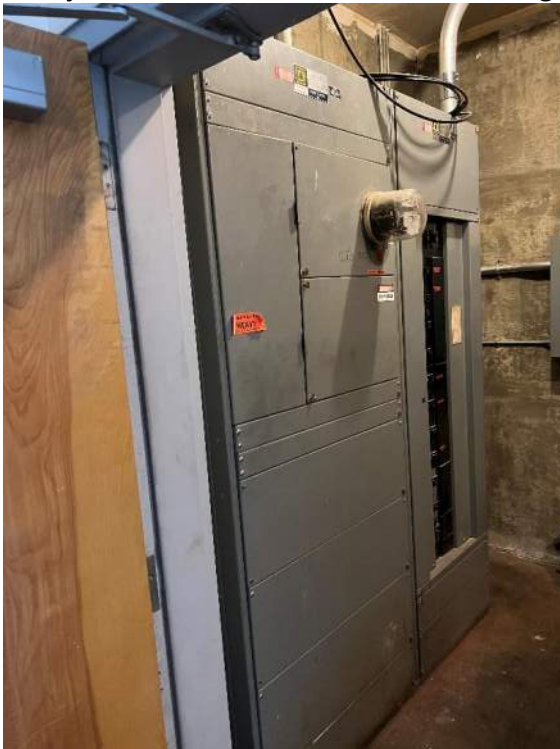
The system condition is determined to be marginal due to the system exceeding its useful life.

**E-8:** Feeder breakers in main distribution panel are not labeled in accordance with NEC 408.4.

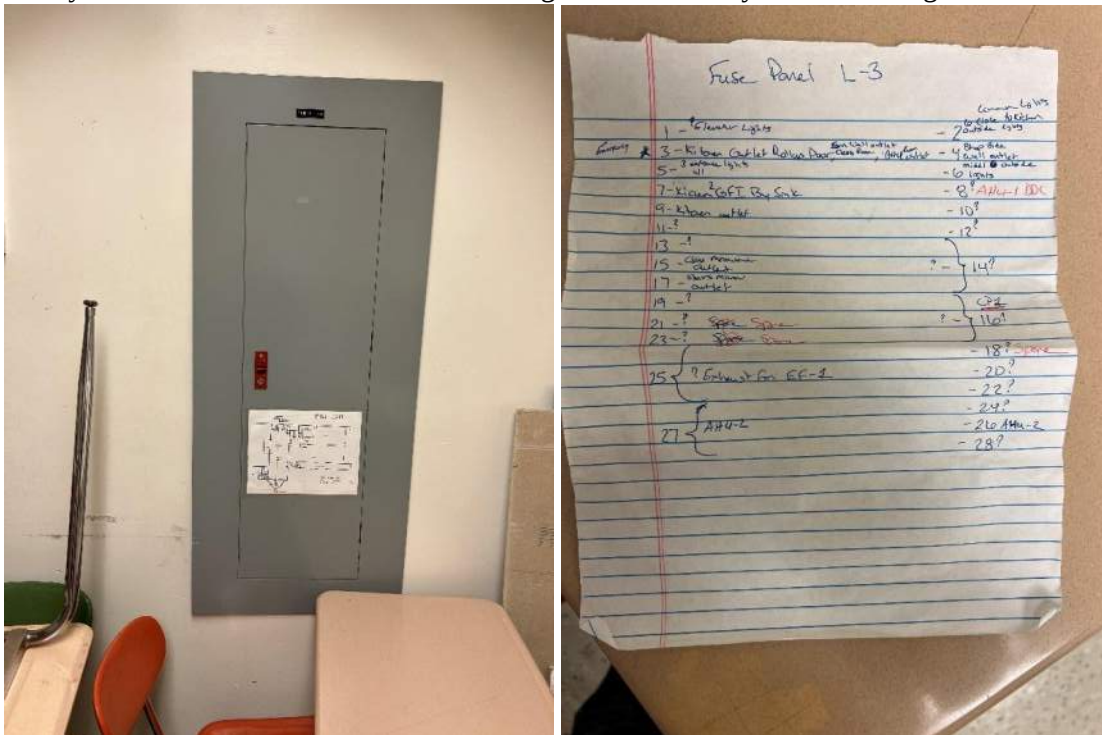
The system condition is determined to be marginal due to the system exceeding its useful life.

**E-9:** Panel schedules in branch circuit panelboards are not wholly accurate and require relabeling in accordance with NEC 408.4.

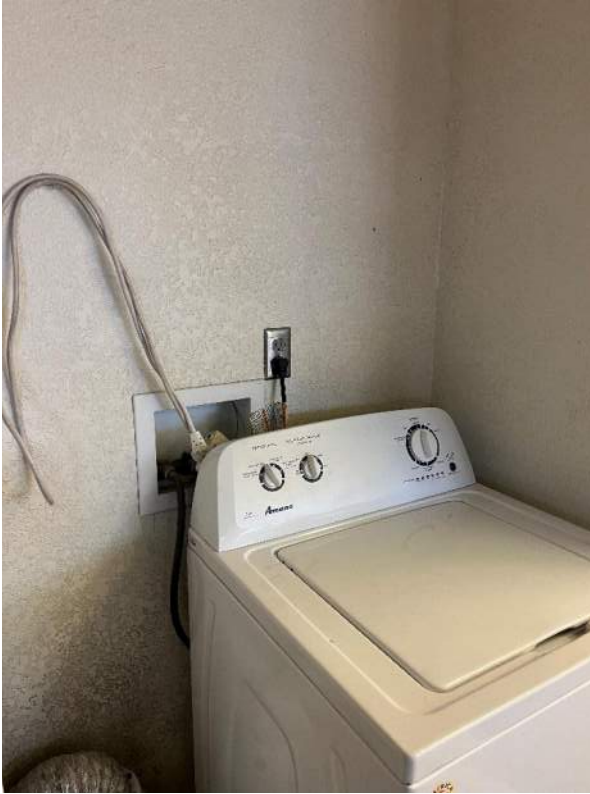
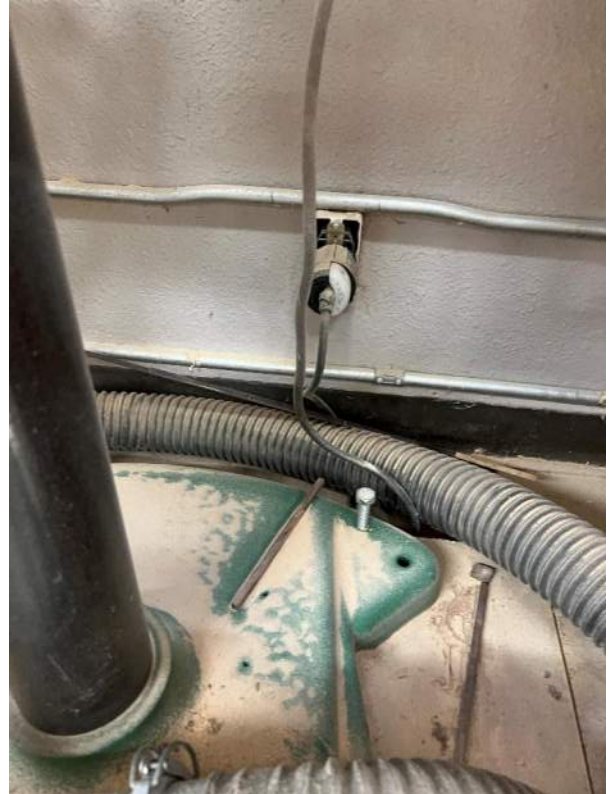
Receptacles appear to be original equipment and are classified as marginal due to exceeding useful life.

- E-19:** Receptacle for laundry washer in Classroom 265 is not GFCI per NEC 210.8(B)(11).
- E-20:** Receptacle for garbage disposals in Classroom 265 is not GFCI per NEC 210.8(B)(5).
- E-21:** Some floor receptacles in Classroom 265 missing device covers.
- E-22:** Receptacle in Girls 252 and Boys 253 is not GFCI per NEC 210.8(B)(1).
- E-23:** Two receptacles in Snack 157 are not GFCI per NEC 210.8(B)(5).
- E-24:** Numerous device plates missing for receptacles in Shop 113 and Shop 114.
- E-25:** Roof heat trace is not ground fault protected for equipment (GFPE) per NEC 427.22.
- E-26:** No receptacle within 25' of exhaust fan on upper room and exhaust fan on lower roof per NEC 210.63.

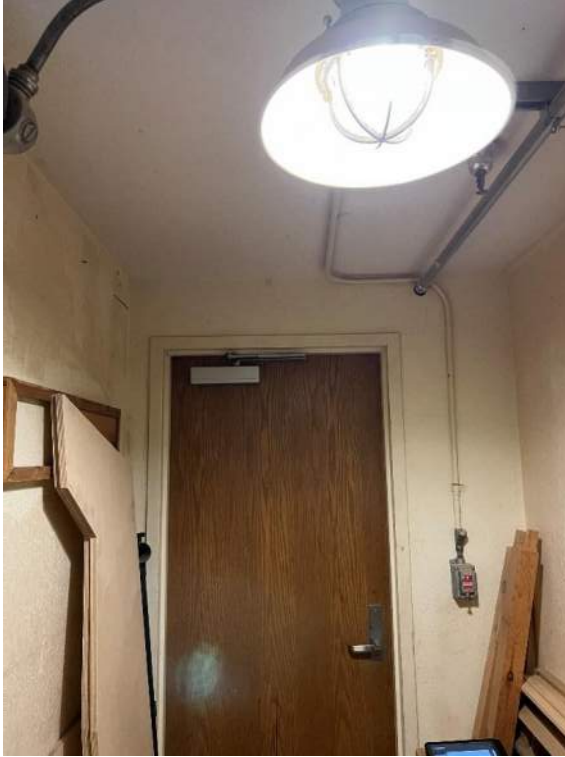
In general, the conduit and wiring systems in use are in good condition.

**E-30:** Conduit in Paint Room 113A requires sealing at room penetration.

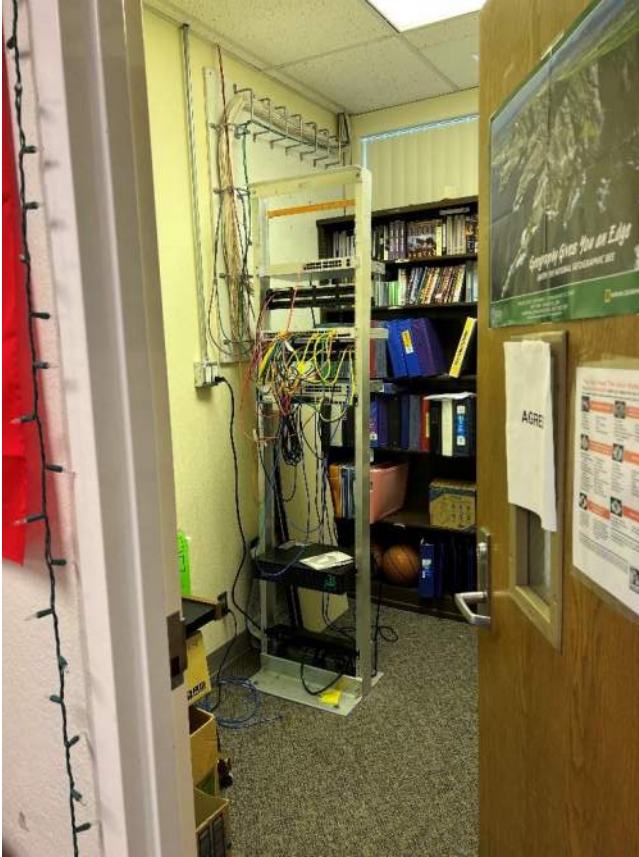
The cabling is considered marginal as it has exceeded its useful life.

**E-32:** Abandoned cables that are accessible require removal per NEC 725.25 and 800.25.

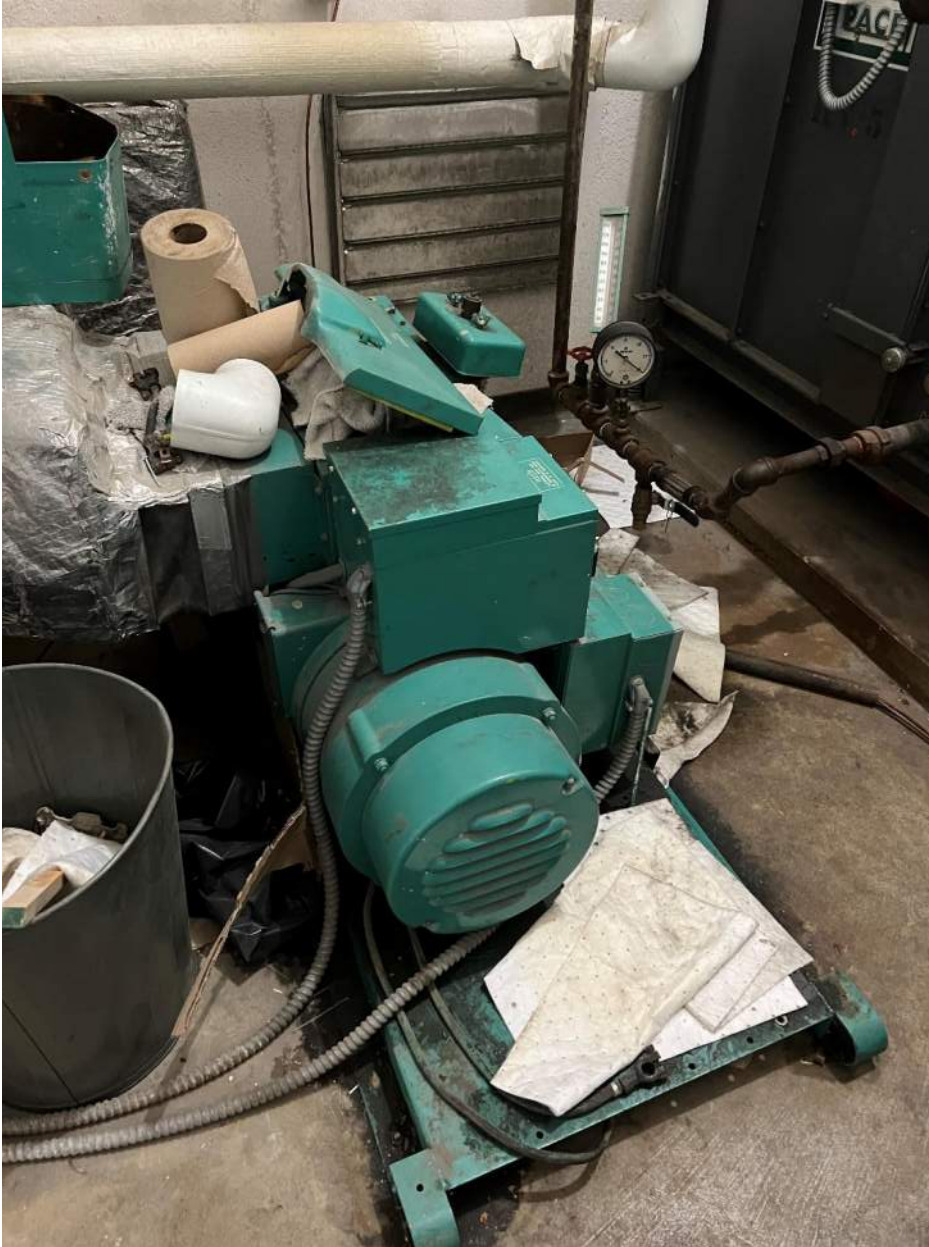
Abandoned equipment.

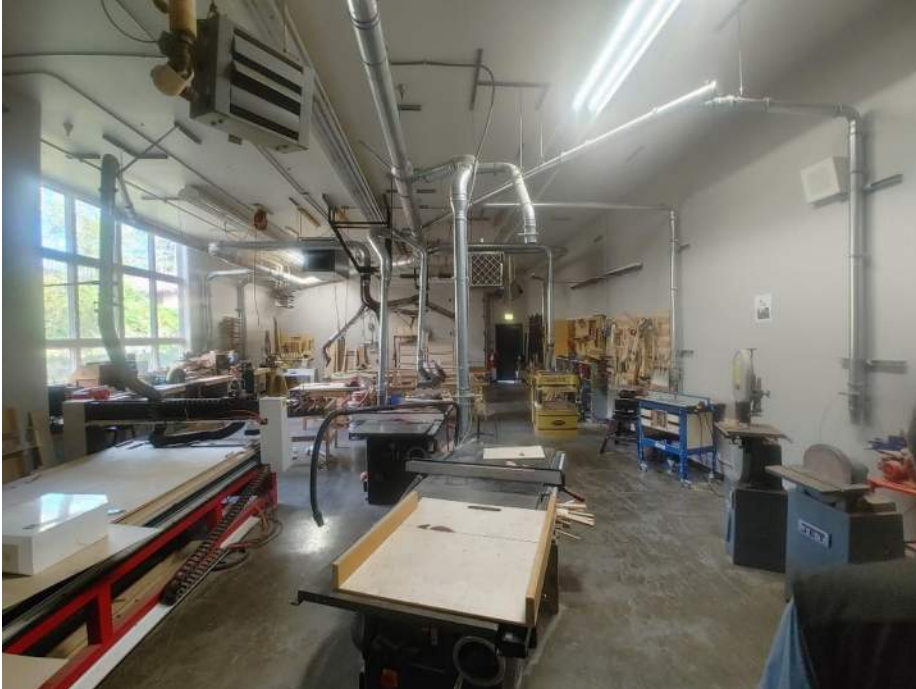
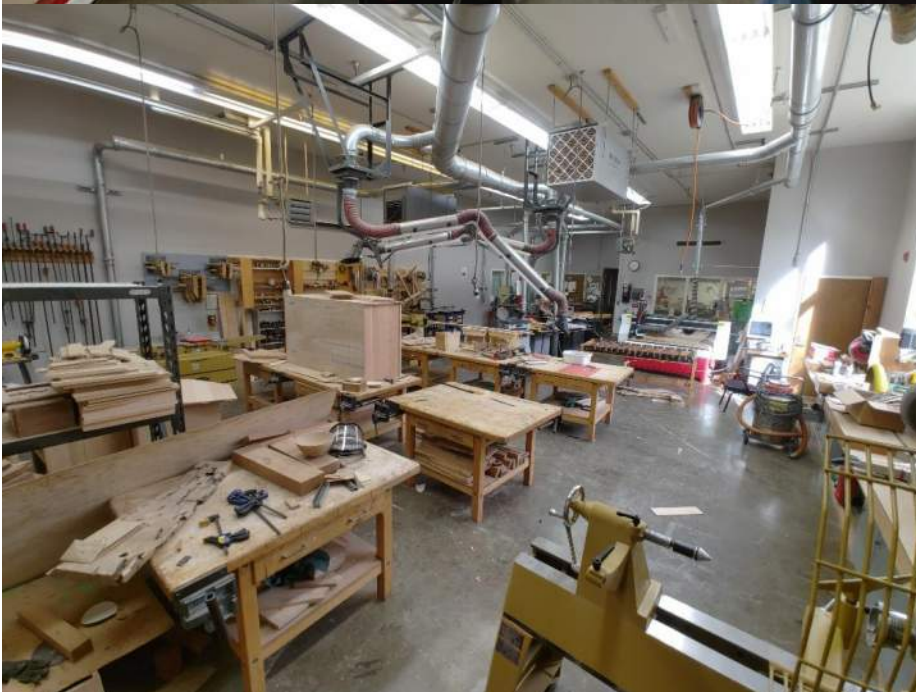
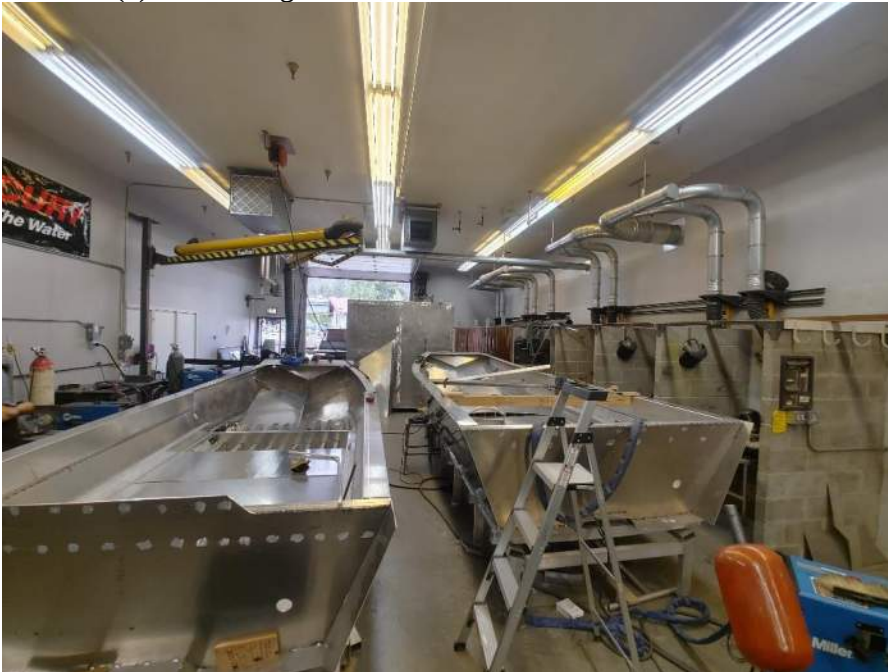
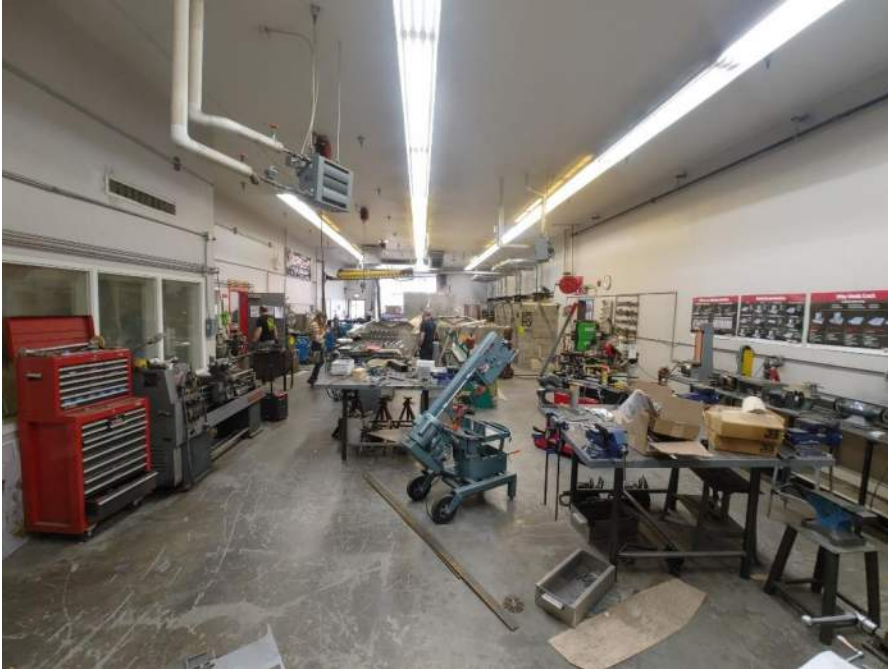
All equipment appears to be in working order. [4]. The shop spaces are crowded with projects and equipment but appear to be functional.
