Wrangell Public Safety Building Assessment

Final Report

23 February 2021

Wrangell Public Safety Building Assessments

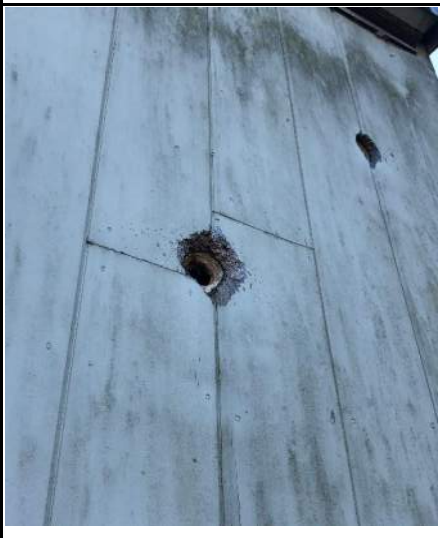
Ref.	Orientation	Observations	Quantity	Recommendations	Photos
3	North Elev.	Woodpecker holes through into stud cavities, grid C, between 6 and 8. mechanical mezzanine level. Suspecting they are after an insect infestation in the wall framing.	three noted	Investigate framing, sheathing and gypsum board overlay as part of siding replacement.

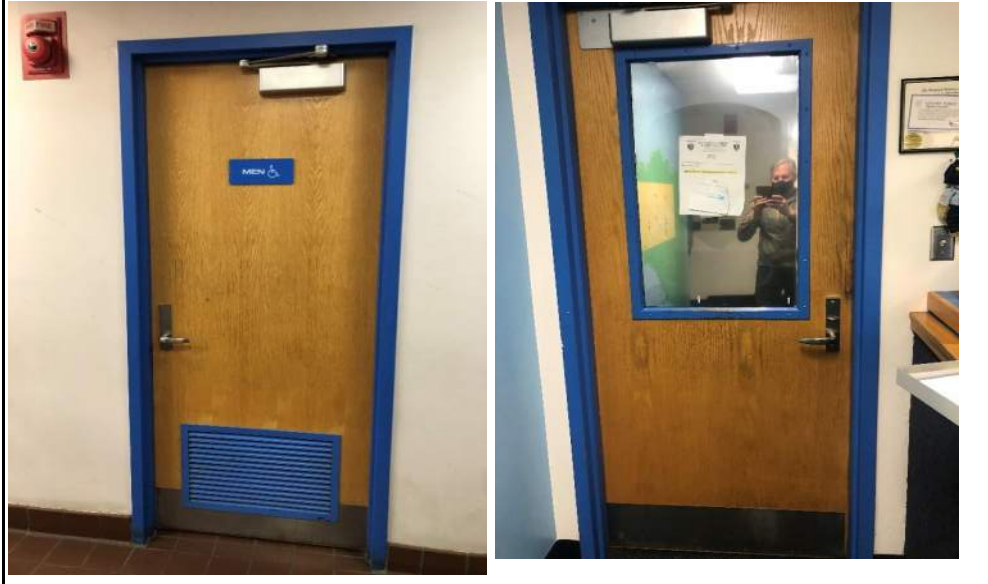
Ref.	Item	Observations	Quantity	Recommendations	Photos
5	Interior Doors	Solid Core Wood in commercial hollow metal frames	82	Good condition, typ. Repaint frames. Painted wood doors in basement, clear finish typical elsewhere. 1-1/2hr fire ratings typ.

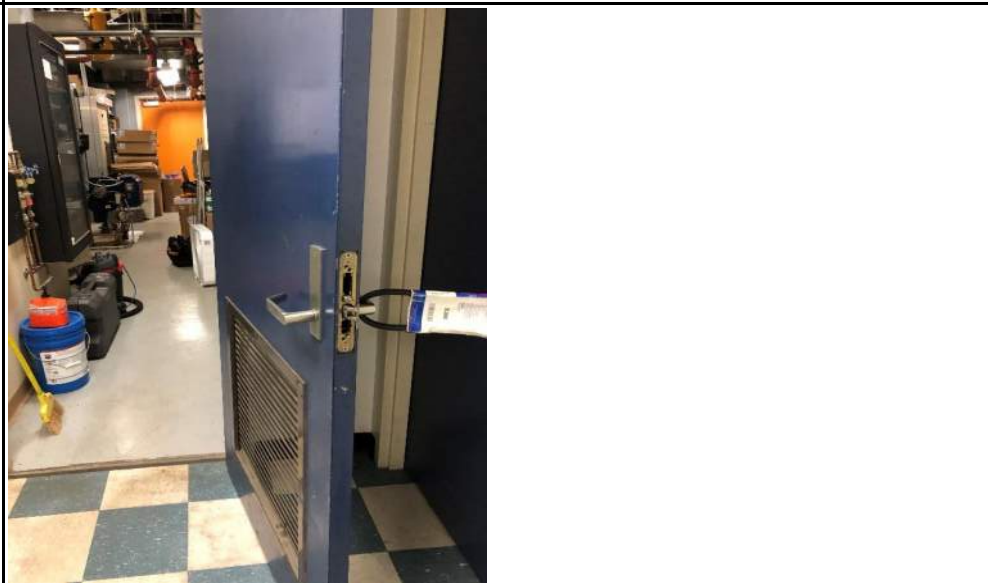
6	Interior Doors	Commercial hollow metal	4	Good condition, at mechanical/electrical rooms, typ. Fire rated to 1-1/2Hr

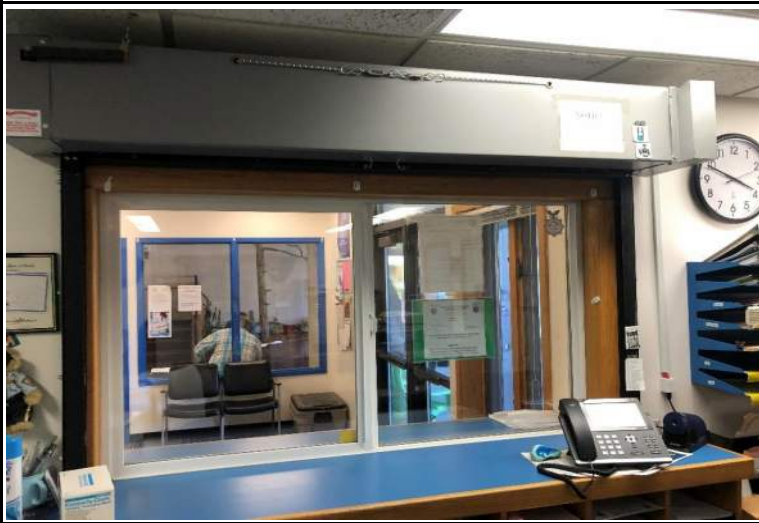
9	Interior Doors	Overhead coiling fire shutter	1	At police Department: Good Condition with fused link. Manual operation.

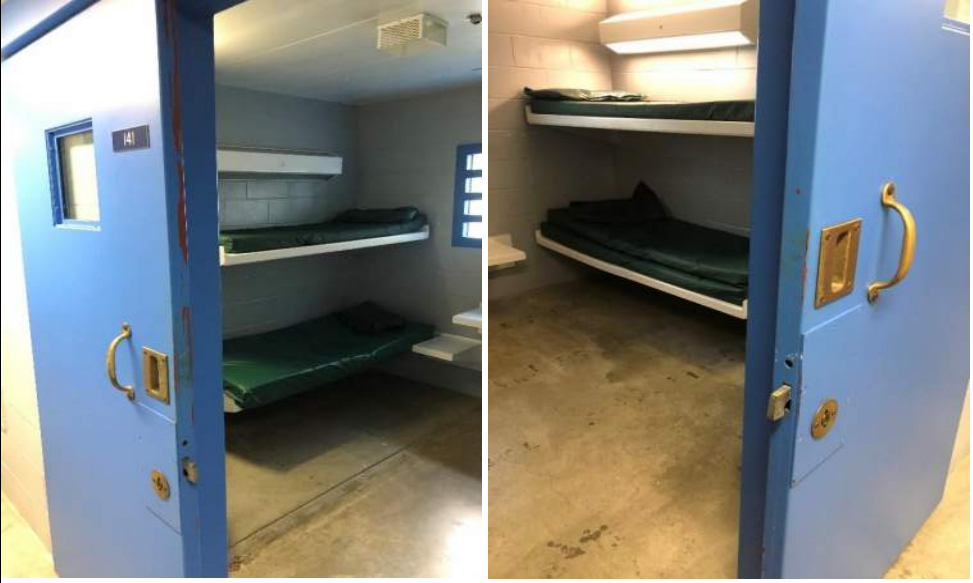
Ref.	Item	Observations	Quantity	Recommendations	Photos
10	Interior Doors	Detention hollow metal slide	3	Detention HM, sliding assemblies with hardware fair to good condition

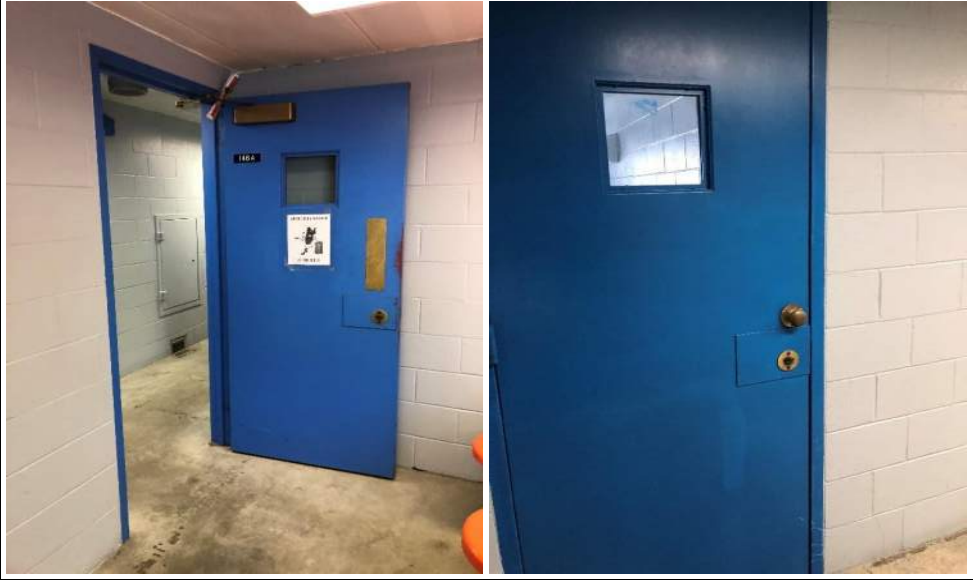
11	Interior Doors	Detention Hollow metal hinged	8	Detention HM, doors and solid grouted frames hardware, fair to good condition.

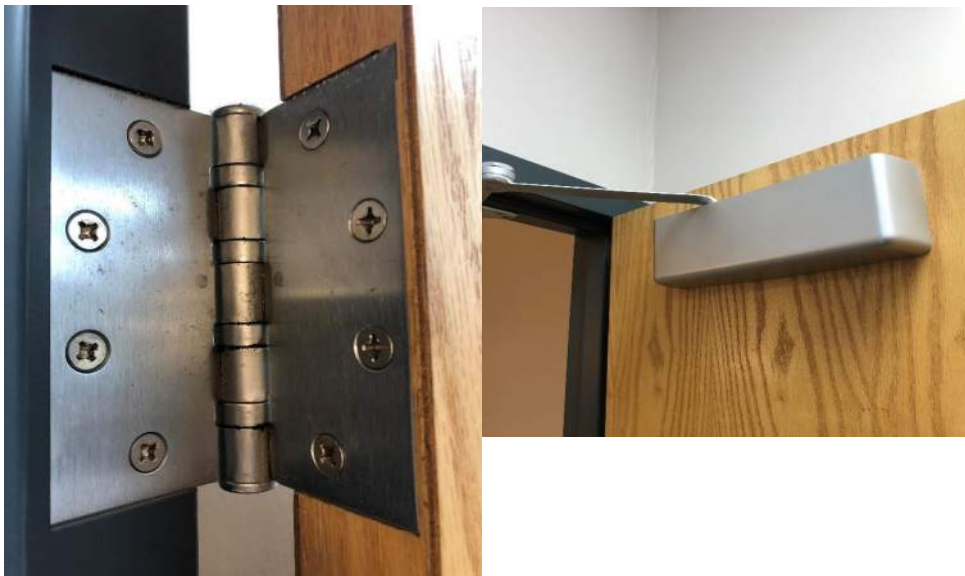
14	Commercial Door Hardware	Mortice locksets, ball bearing hinges, closers typical.	91 sets	Schlage mortise locksets with ADA levers and Stanly 5-knuckle ball bearing hinges in stainless steel, typical throughout. KABA mechanical code locksets at three exterior doors and two interior doors into equipment bay and at one interior door into second floor training room. Panic hardware is provided at all primary egress points from the Courtroom and Training room to grade (9 locations, three of which are in pairs, total of 12 Precision panic hardware sets). LCN closers at 87 locations.

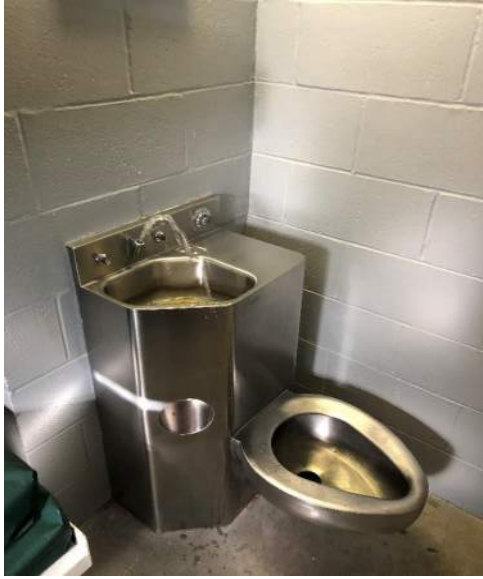
Ref.	Item	Observations	Quantity	Recommendations	Photos
15	Detention Fixtures: Combination toilet/sink units , SS	Noted all of these need valve replacement for sink units.	5	Detention toilet valves function. Sink valves do not all work.

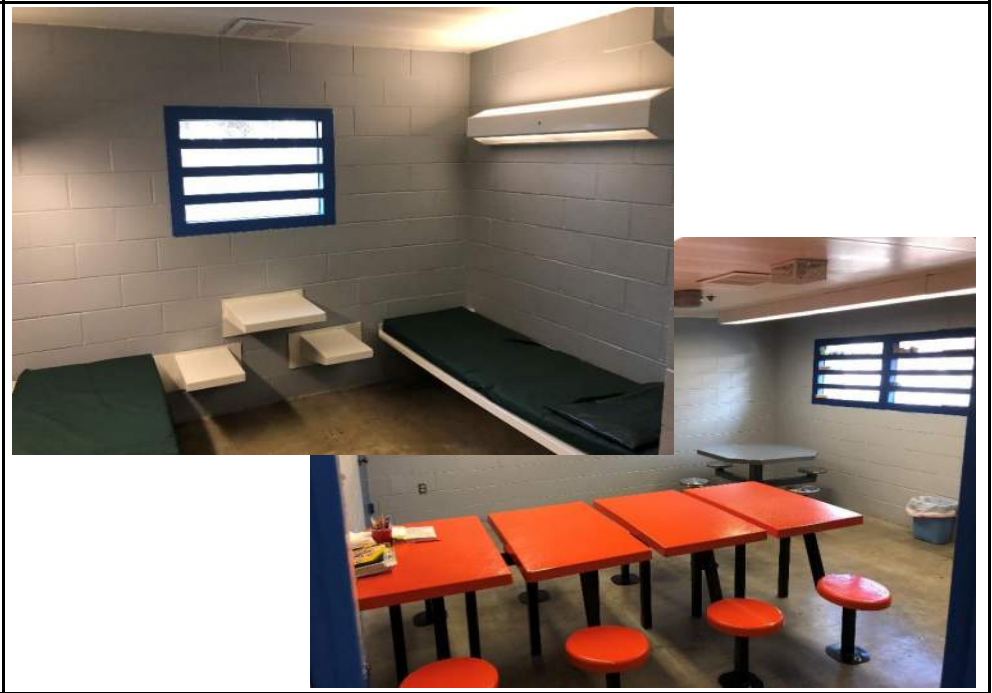
Ref.	Item	Observations	Quantity	Recommendations	Photos
17	Detention furnishings	Each Cell is equipped with welded steel bunks and shelves mounted to walls and vinyl mattresses. Day room is equipped with detention table stool sets permanently affixed to floor.

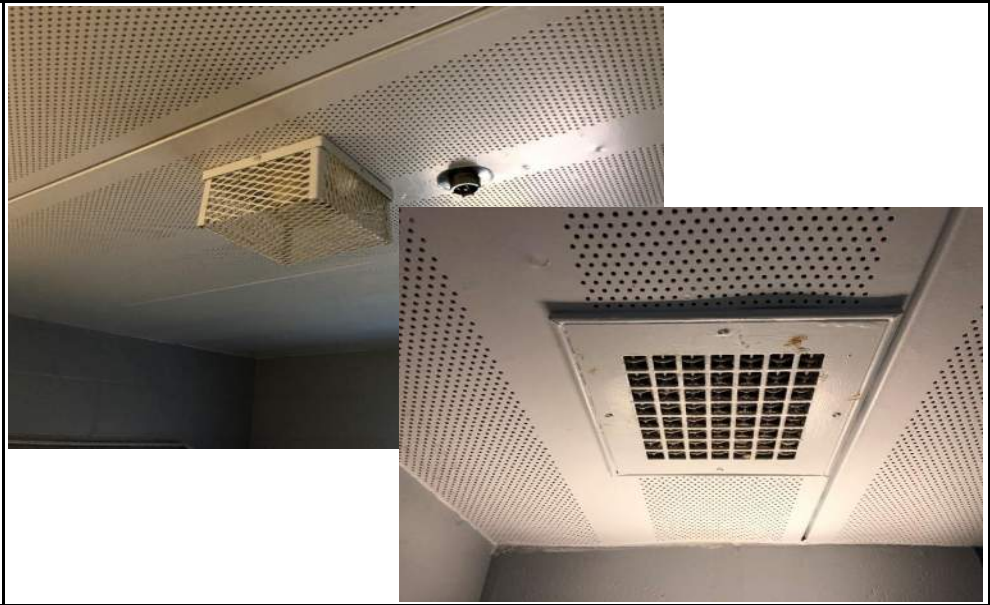
<i>Ref.</i>	<i>Item</i>	<i>Observations</i>	<i>Quantity</i>	<i>Recommendations</i>	<i>Photos</i>
18	Detention M&E	Light fixtures are detention grade and ligature resistant.		Mechanical grills are secure but have larger openings than expected. Must verify for ligature resistance.

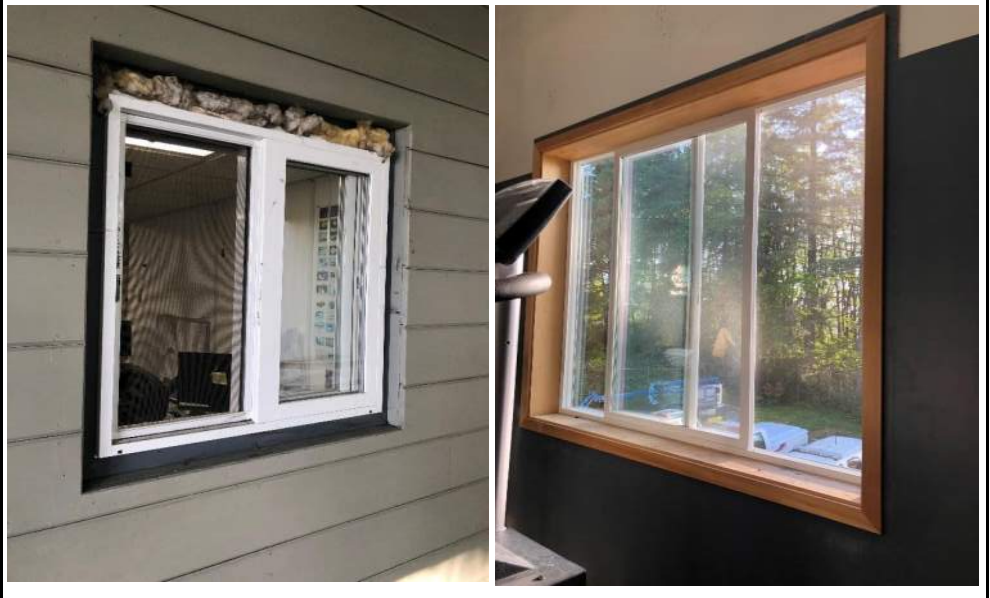
Ref.	Item	Observations	Quantity	Recommendations	Photos
20	Exterior Windows	Vinyl window replacements.	3	New insert at Equipment Bay, older insert at Police Dispatch area.

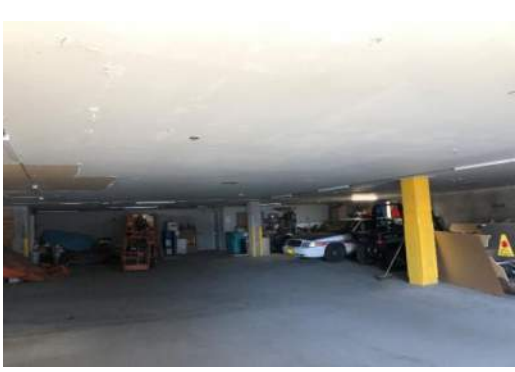
Ref.	Level Room Number	Room Name	Observations	Gross SF	Net SF	Fire/Life Safety Deficiencies and Repairs	Accessibility, ANSI 117.1 and IBC Chapter 11; Deficiencies and Repairs	Maintenance Repairs	Photos
	Basemen			10534					
1	B000	Parking	Does not meet 40% open area required for natural ventilation (calculates at 34% open area). No ventilation system present. Gypsum board soffit and insulation below equipment bays has been damaged by water leakage.		4589	1) Remove 20 lf of non-structural wood framed wall on grid 3, between girds A and A.1. this brings open area up from 34% to 44%. This opening increase mitigates ventilation requirements. 2) Restore gypsum board soffit assembly where damaged or missing (approximately 250sf) include 12" batt insulation, vapor retarder and WR gwb, painted.		Strip and repaint whole ceiling after completing repairs.

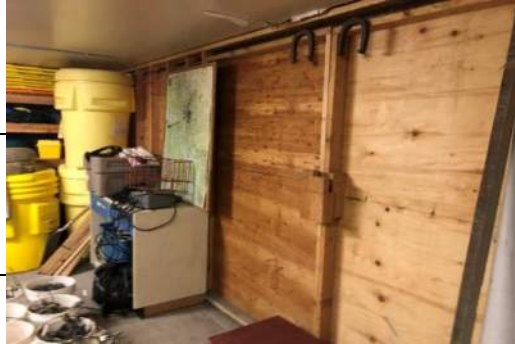
2	B000.1	Storage	No fire rated enclosure or door. Not conditioned space, not load bearing walls and sprinklered as garage.		523	Apply Type X GWB to exposed framing and plywood paneling, fire tape and ensure sprinkler coverage is sufficient.

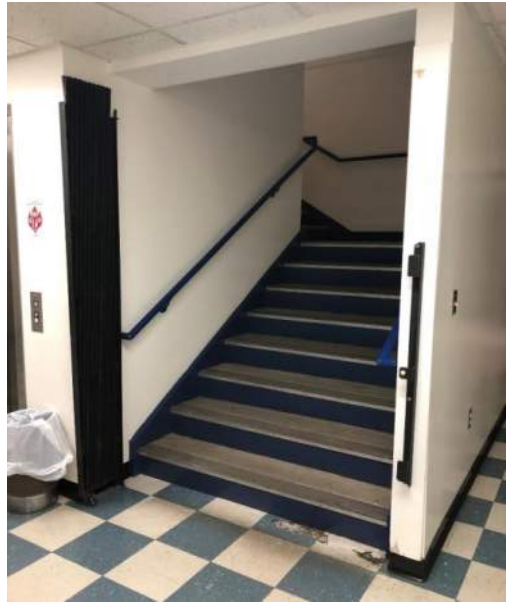
Ref.	Level Room Number	Room Name	Observations	Gross SF	Net SF	Fire/Life Safety Deficiencies and Repairs	Accessibility, ANSI 117.1 and IBC Chapter 11; Deficiencies and Repairs	Maintenance Repairs	Photos
5	B100	Stair	Noted manual gate at bottom of stair for after hours security separation from upstairs. Concrete fill metal pans, abrasive insert nosing. 7":11" rise:run, good condition. 1.75" diameter pipe handrails both sides, painted.		87		No handrail extensions at bottom of stairs. Wal mounted handrails are installed at 33" above nosing rather than the 34" minimum required. Reinstall at correct elevation, and correct extension deficiency.

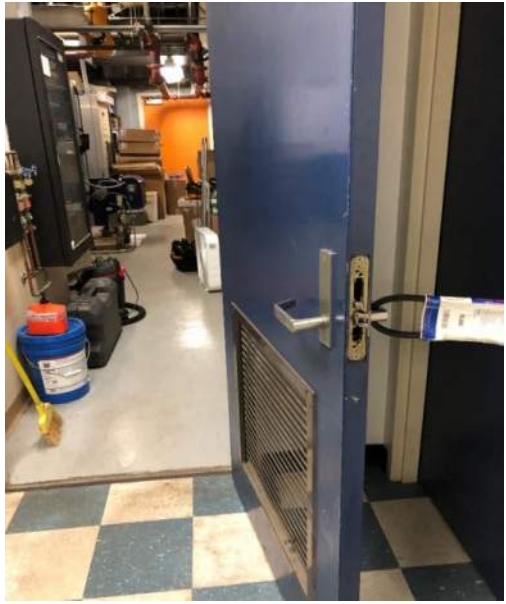
Ref.	Level Room Number	Room Name	Observations	Gross SF	Net SF	Fire/Life Safety Deficiencies and Repairs	Accessibility, ANSI 117.1 and IBC Chapter 11; Deficiencies and Repairs	Maintenance Repairs	Photos
7	B102	Mechanical	No Observations - see M/E/P		772	Missing portions of door latching hardware in UL rated door assembly. Repair mortice lockset.

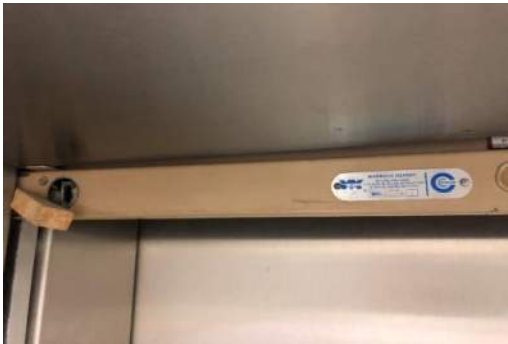
8	B103	Elevator	3-stop Dover hydraulic elevator. Cab in good condition. Elevator operation is very slow, maintenance should be verified. Inspection certificate dated 06/2019, expires 06/2021. 52" x 69" clear cab dimensions, meets ADA		44	Automatic overhead fire shutter at cab portal is not functioning, jammed open with wood wedges. Repair.	Elevator controls, signals and numerical signage are not accessibility compliant. No braille, no visible on hall side. Update controls and signals.

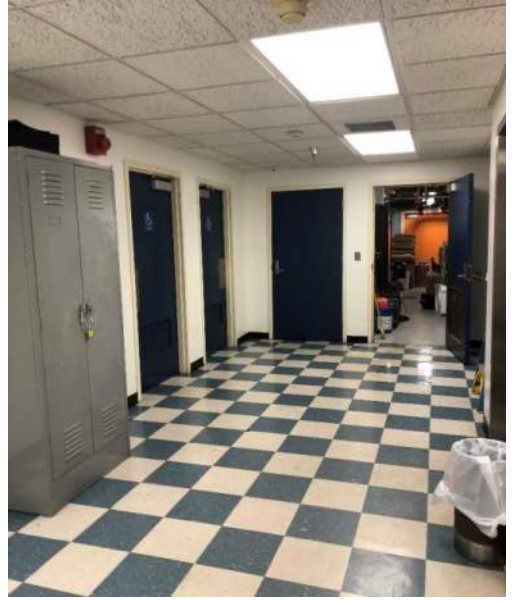
Ref.	Level Room Number	Room Name	Observations	Gross SF	Net SF	Fire/Life Safety Deficiencies and Repairs	Accessibility, ANSI 117.1 and IBC Chapter 11; Deficiencies and Repairs	Maintenance Repairs	Photos
9	B104	Lobby	ACT Ceiling: fair. Paint at walls: good. 12x12 vct flooring: poor - failing in multiple locations. Rubber base: fair. Metal lockers: good.		380		Drinking fountain does not meet accessibility requirements; height, operator. Replace with new.	Strip and repaint walls, replace flooring and rubber base. Note the original finish schedule referred to the VCT flooring as "Vinyl asbestos". Test to determine if it is ACM.

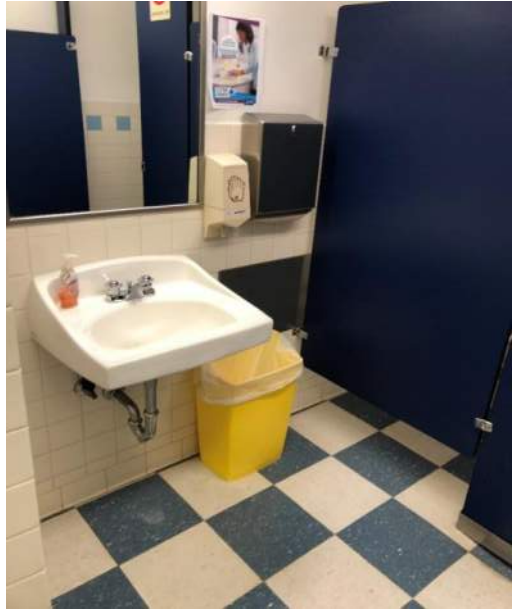
Ref.	Level Room Number	Room Name	Observations	Gross SF	Net SF	Fire/Life Safety Deficiencies and Repairs	Accessibility, ANSI 117.1 and IBC Chapter 11; Deficiencies and Repairs	Maintenance Repairs	Photos
11	B106	Women	Painted gypsum board walls and ceiling: poor. Tile wainscot: good. 12x12 vct flooring: poor. Rubber base: good. Plastic laminate faces partitions: good. Fixtures: serviceable. Accessibility issues would necessitate renovation of bathroom.		83		Accessible clearance at door into bathroom is constricted; 54" clear for egress approach required, 42" provided. Reconfiguration requires relocation of plumbing wall serving lavatory. Accessible clearances in stall constricted: Reconfigure to gain additional 9" of clearance, will require new partitions. Lavatories do not have scald guard: install. Missing vertical grab bar at toilet: install. relocate toilet such it meets accessibility requirements (too far from wall with grab bar.)	Strip and repaint walls and ceiling. Remove existing flooring, seal slab, install new flooring. Replace damaged solid core hood door. Note the original finish schedule referred to the VCT flooring as "Vinyl asbestos". Test to determine if it is ACM.

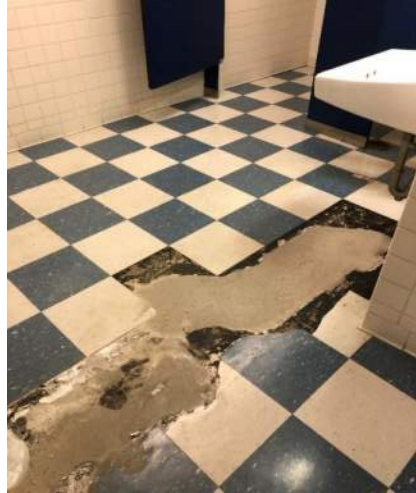
12	B107	Men	Painted gypsum board walls and ceiling: Alligatored surfaces - poor. Tile wainscot: good. 12x12 vct flooring: poor, failing apparently due to moisture under slab in vicinity of underground waste piping that may be compromised. Plastic laminate faces partitions: good. Fixtures: serviceable. Accessibility issues would necessitate renovation of bathroom.		126		Accessible clearance at door into bathroom is constricted; 54" clear for egress approach required, 42" provided. Reconfiguration requires relocation of plumbing wall serving lavatory. Accessible clearances in stall constricted: Reconfigure to gain additional 9" of clearance, will require new partitions. Lavatories do not have scald guard: install. Missing vertical grab bar at toilet: install.	Strip and repaint walls and ceiling. Remove existing flooring, investigate water source, seal slab, install new flooring. Note the original finish schedule referred to the VCT flooring as "Vinyl asbestos". Test to determine if it is ACM.

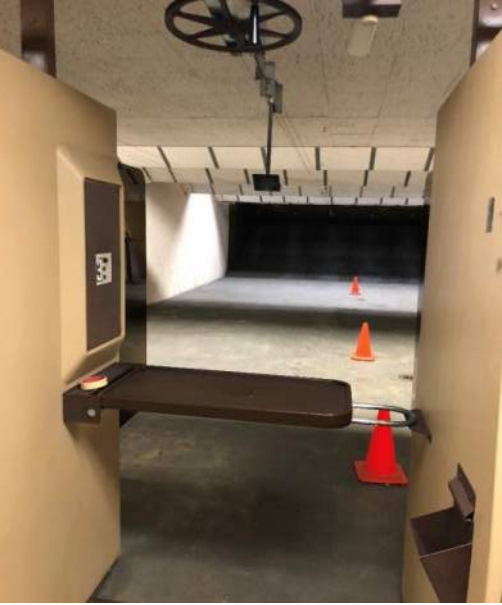
Ref.	Level Room Number	Room Name	Observations	Gross SF	Net SF	Fire/Life Safety Deficiencies and Repairs	Accessibility, ANSI 117.1 and IBC Chapter 11; Deficiencies and Repairs	Maintenance Repairs	Photos
13	B108	Shooting Range	Equipment is aging but in serviceable condition.		1434			Clean range and lead collection area.

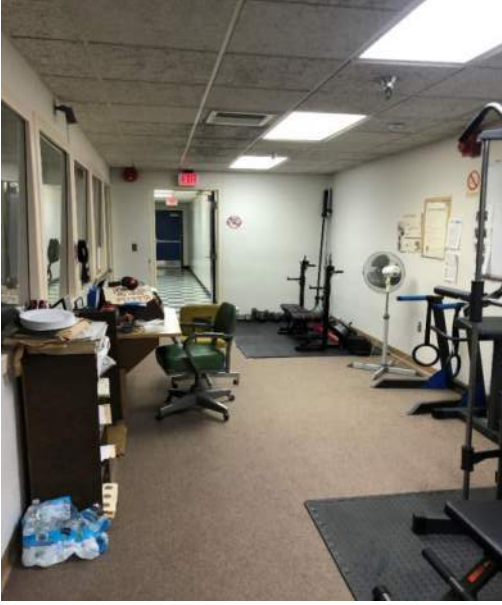
14	B109	Observation	Older carpet and rubber base, ACT, painted finishes.		259			Provide new carpet and rubber base. Paint walls, doors and hollow metal frames.

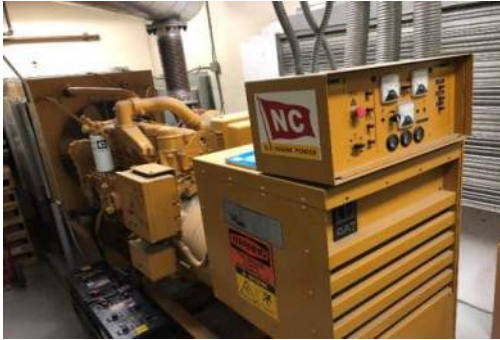
Ref.	Level Room Number	Room Name	Observations	Gross SF	Net SF	Fire/Life Safety Deficiencies and Repairs	Accessibility, ANSI 117.1 and IBC Chapter 11; Deficiencies and Repairs	Maintenance Repairs	Photos
17	B112	Generator	No Architectural Observations - see M/E/P. Generator: CAT 3408DT, approximately 375 hours.		258

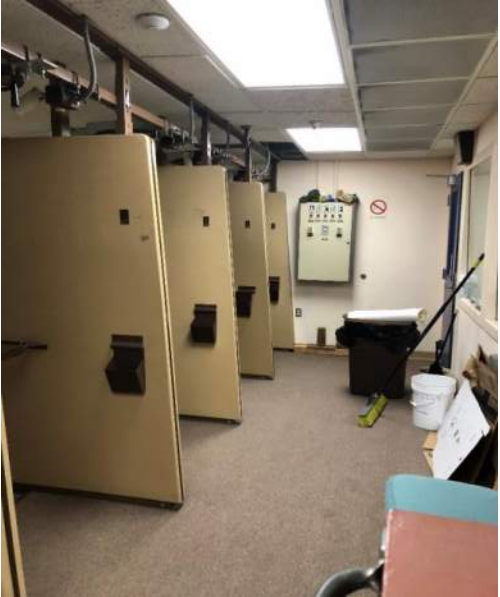
18	B113	Firing area	Older carpet and rubber base, ACT, painted finishes.		188			Provide new carpet and rubber base. Paint walls, doors and hollow metal frames.

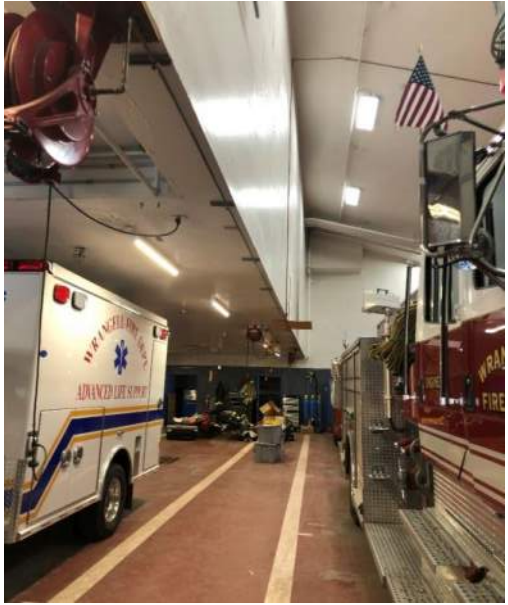
Ref.	Level Room Number	Room Name	Observations	Gross SF	Net SF	Fire/Life Safety Deficiencies and Repairs	Accessibility, ANSI 117.1 and IBC Chapter 11; Deficiencies and Repairs	Maintenance Repairs	Photos
	Floor 1			11780					
20	100	Apparatus Bay	Alligatored paint at all painted gypsum board walls and ceilings. 8' painted plywood wainscot, all walls: good condition. Floor is painted concrete in worn condition. Overhead doors maintained in good operational condition. Noted water infiltration at northeast corner, likely corresponding to broken rake flashing at roof above this area. Painted wood doors in hollow metal frames from equipment bay into Public Safety facility (x3) fire rated 1.5hr, good condition.		4977			Remove all alligatored paint, fill and sand surface, patch damaged areas of wallboard (north wall), prime and paint all surfaces above 8' AFF. Prep and repaint all floors areas.

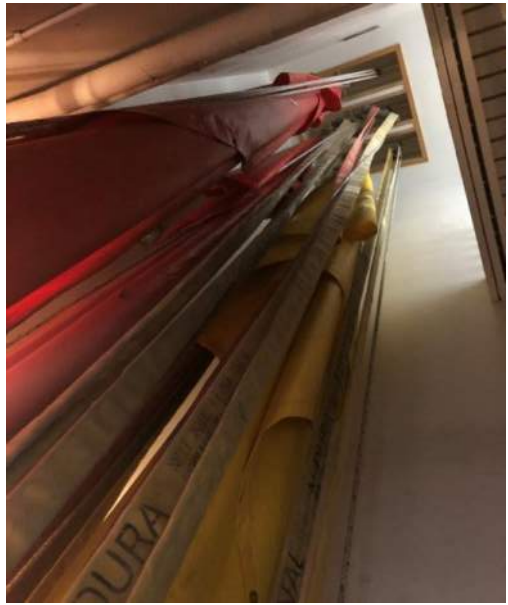
Ref.	Level Room Number	Room Name	Observations	Gross SF	Net SF	Fire/Life Safety Deficiencies and Repairs	Accessibility, ANSI 117.1 and IBC Chapter 11; Deficiencies and Repairs	Maintenance Repairs	Photos
21	101	Hose Tower	Alligatored paint at all painted gypsum board walls and ceilings. Painted wood door in hollow metal frame, fair condition.		72			Remove all alligatored paint, fill and sand surface, prime and paint.

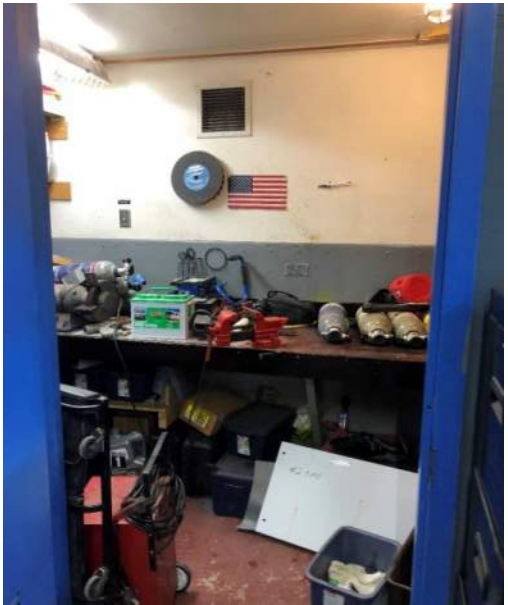
22	102	Extinguisher Refill	Alligatored paint at all painted gypsum board walls and ceilings. Wainscot and workbench in serviceable condition. Painted wood door (pair) in hollow metal frame, fair condition.		55			Remove all alligatored paint, fill and sand surface, prime and paint. Paint workbench and wainscot.

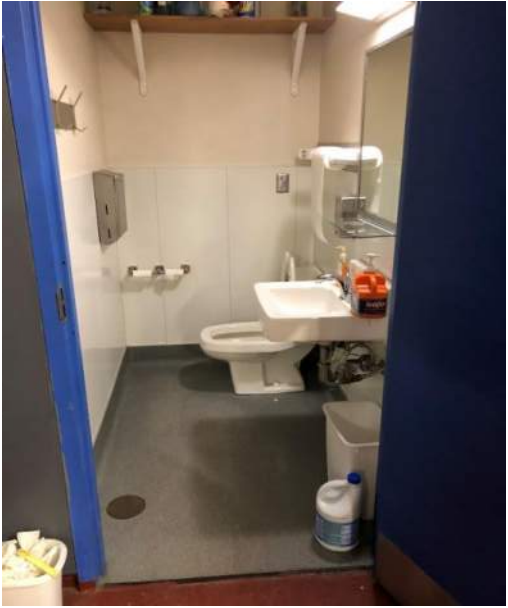
Ref.	Level Room Number	Room Name	Observations	Gross SF	Net SF	Fire/Life Safety Deficiencies and Repairs	Accessibility, ANSI 117.1 and IBC Chapter 11; Deficiencies and Repairs	Maintenance Repairs	Photos
23	103	Air Comp	Alligatored paint at all painted gypsum board walls and ceilings. Painted wood door in hollow metal frame, fair condition.		57			Remove all alligatored paint, fill and sand surface, prime and paint.	
24	104	Toilet	Alligatored paint at all painted gypsum board walls above enameled hardboard wainscot (good condition), and ceilings. Sheet vinyl flooring with integral cove base: good conditions. Painted wood door in hollow metal frame, fair condition; missing silencers.		28		Not Accessible by IBC or ADA. As a part of the active fire station area it may be expected all personnel be physically fit and not need accessible bathroom.	Remove all alligatored paint, fill and sand surface, prime and paint.

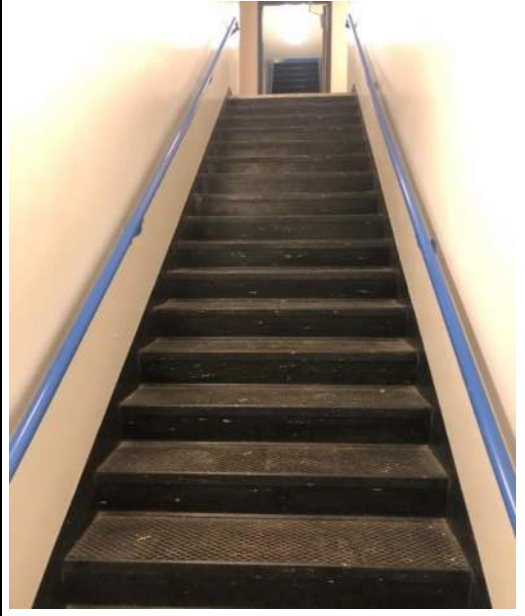
Ref.	Level Room Number	Room Name	Observations	Gross SF	Net SF	Fire/Life Safety Deficiencies and Repairs	Accessibility, ANSI 117.1 and IBC Chapter 11; Deficiencies and Repairs	Maintenance Repairs	Photos
25	105	Stair	Alligatored paint at all painted gypsum board walls and ceilings. 7:11 rise run, rubber treads and nosing in good condition. Steel pipe handrails set below 34" minimum height for Accessibility.		80		Remove and reinstall pipe handrails to elevation 34" .	Remove all alligatored paint, fill and sand surface, prime and paint.

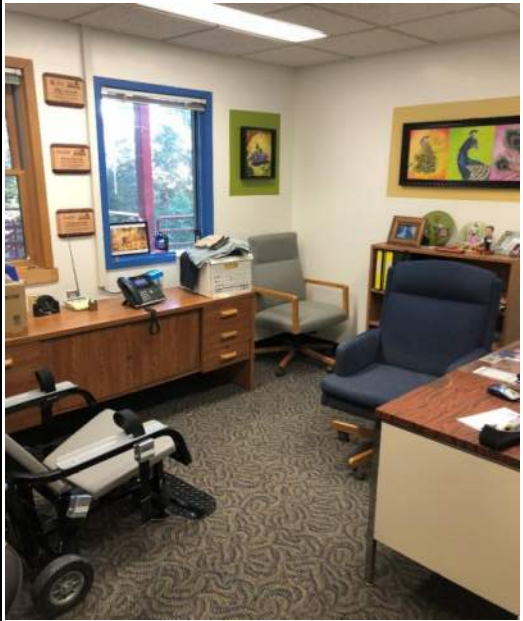
Ref.	Level Room Number	Room Name	Observations	Gross SF	Net SF	Fire/Life Safety Deficiencies and Repairs	Accessibility, ANSI 117.1 and IBC Chapter 11; Deficiencies and Repairs	Maintenance Repairs	Photos
26	106	Office	Relatively new 18"x18" commercial carpet tile and carpet base. ACT ceiling: fair condition. Walls more recently refinished. Clear finished wood door in hollow metal frame, good condition. Louver blinds at exterior windows: fair condition.		116	Noted wire glass in hollow metal frame originally in exterior window was replaced with a vinyl operable unit.

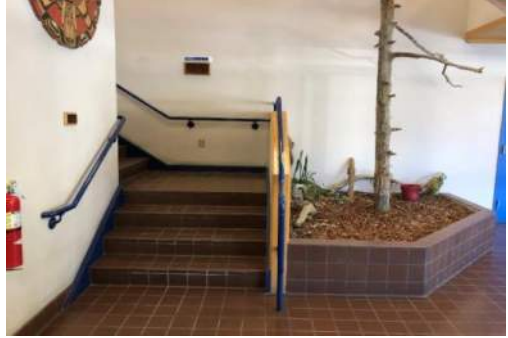
Ref.	Level Room Number	Room Name	Observations	Gross SF	Net SF	Fire/Life Safety Deficiencies and Repairs	Accessibility, ANSI 117.1 and IBC Chapter 11; Deficiencies and Repairs	Maintenance Repairs	Photos
29	110	Stairs	6x6 terracotta tile flooring in lobby and at main stairway up is in good condition. Vinyl wall covering at main stairway delaminating from substrate. Wood slat ceiling in good condition. Handrails only have extensions as required by code on one side. 7" step rise and 11" tread run meets code.					Replace vinyl wall covering at stairs and adjacent display wall. Repaint stair railings.

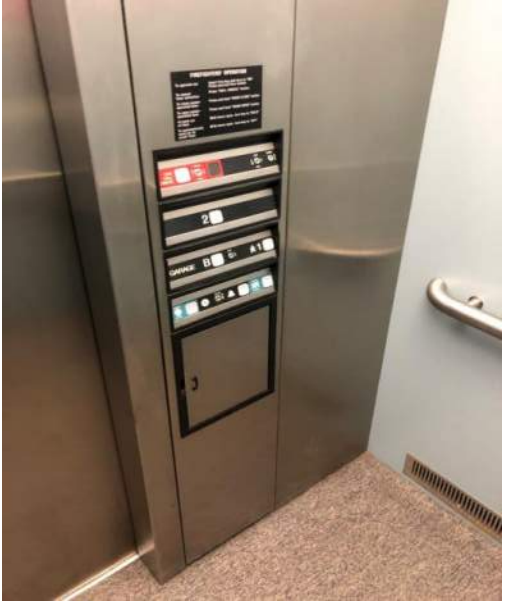
30	111	Elevator	See notes in B103		40	Automatic overhead fire shutter at cab portal is not functioning, jammed open with wood wedges. Repair.	Elevator controls, signals and numerical signage are not accessibility compliant. No braille, no visible on hall side. Update controls and signals.

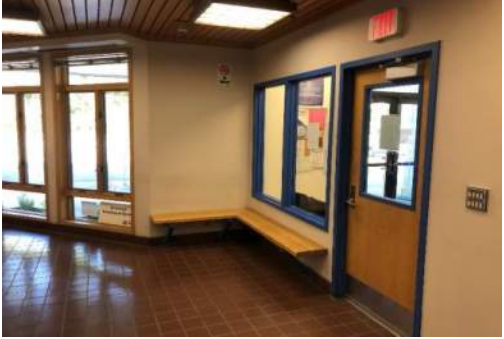
Ref.	Level Room Number	Room Name	Observations	Gross SF	Net SF	Fire/Life Safety Deficiencies and Repairs	Accessibility, ANSI 117.1 and IBC Chapter 11; Deficiencies and Repairs	Maintenance Repairs	Photos
31	112	Lobby	6x6 terracotta tile flooring in lobby is in good condition. Wood slat ceiling in good condition. Horizontal louver blinds in fair condition. Interior doors are clear finished wood with painted hollow metal frames, fair condition.		452		Drinking fountain does not meet Accessibility requirements - replace.	Replace vinyl wall covering at stairs and adjacent display wall. Repaint door frames.

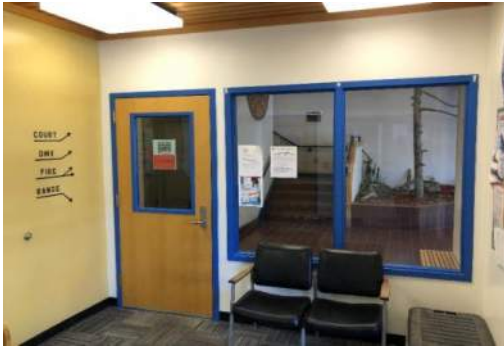
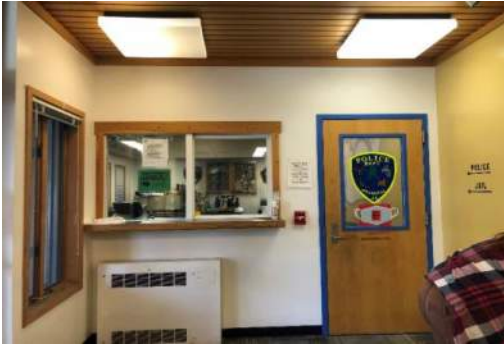
32	113	Vestibule	Walk off carpet older but in fair condition. Doors and hardware in good condition. Painted gypsum board walls in good condition. Wood slat ceiling in good condition.		155		Entry doors not equipped with motor operator for accessibility. Services counter at police station not at accessible height.

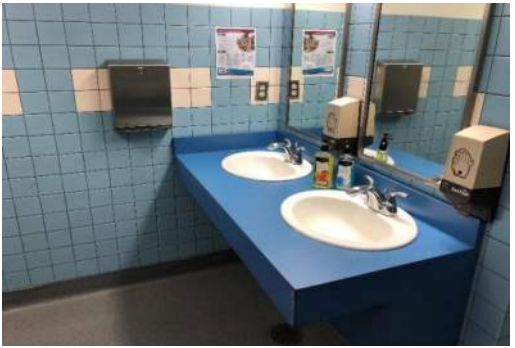
Ref.	Level Room Number	Room Name	Observations	Gross SF	Net SF	Fire/Life Safety Deficiencies and Repairs	Accessibility, ANSI 117.1 and IBC Chapter 11; Deficiencies and Repairs	Maintenance Repairs	Photos
33	114	Men	Sheet vinyl flooring with rubber base in good condition. Ceramic tile wainscot to 60" in good condition. Gypsum board walls and ceilings in good condition. Plastic laminate partitions in good condition. Plastic laminate lavatory in fair condition. Estimated renovation in early 2000's.		138		42" clearance on pull side of door with closer does not meet accessibility requirements and will require significant bathroom renovation to accomplish. Missing vertical grab bar at toilet - install.

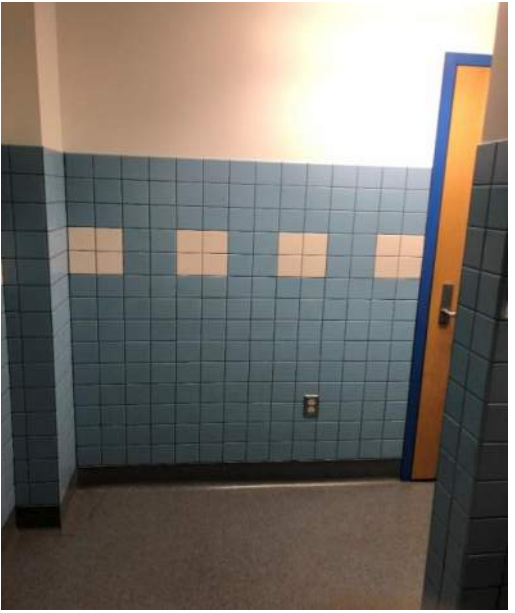
34	115	Women	Sheet vinyl flooring with rubber base in good condition. Ceramic tile wainscot to 60" in good condition. Gypsum board walls and ceilings in good condition. Plastic laminate partitions in good condition. Plastic laminate lavatory in fair condition. Estimated renovation in early 2000's.		148		42" clearance on pull side of door with closer does not meet accessibility requirements and will require significant bathroom renovation to accomplish. Missing vertical grab bar at toilet - install.

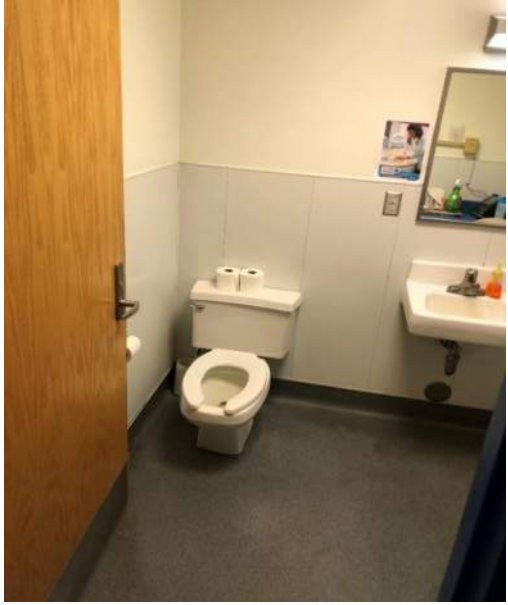
Ref.	Level Room Number	Room Name	Observations	Gross SF	Net SF	Fire/Life Safety Deficiencies and Repairs	Accessibility, ANSI 117.1 and IBC Chapter 11; Deficiencies and Repairs	Maintenance Repairs	Photos
	116	Bathroom	Alligatored paint at all painted gypsum board walls above enameled hardboard wainscot (poor condition, some damage), and ceilings. Sheet vinyl flooring with integral cove base: poor condition. Painted wood door in hollow metal frame, fair condition.		46		Bathroom is large enough to meet spatial requirements under ADA, but does not have grab bars and other compliant fixtures.	Remove all alligatored paint, fill and sand surface, prime and paint. Remove and replace wainscot. Remove and replace sheet vinyl flooring with suitable finish. Replace all fixtures hardware with items compliant with ADA and IBC Chapter 11.

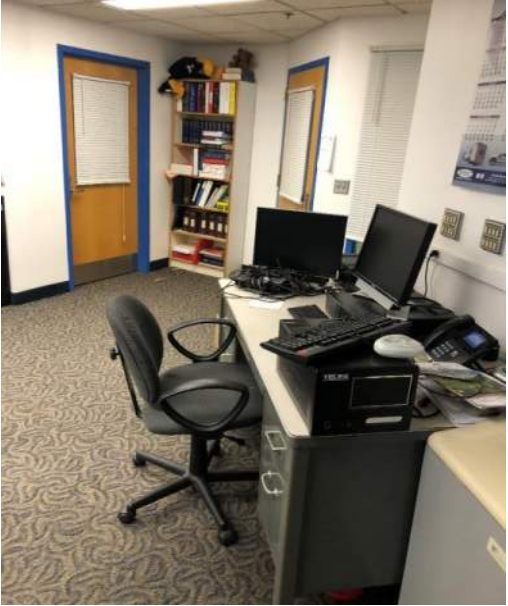
35	118	Dispatch	Relatively new 18"x18" commercial carpet tile and carpet base. ACT ceiling: fair condition. Walls more recently refinished. Clear finished wood door in hollow metal frame, good condition. Louver blinds at exterior windows: fair condition.		250

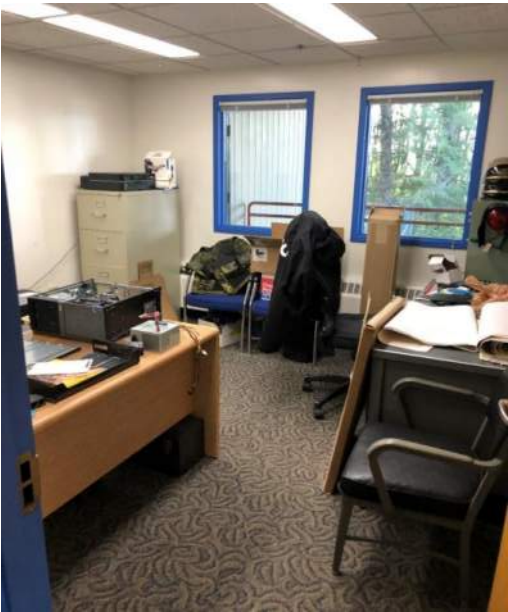
Ref.	Level Room Number	Room Name	Observations	Gross SF	Net SF	Fire/Life Safety Deficiencies and Repairs	Accessibility, ANSI 117.1 and IBC Chapter 11; Deficiencies and Repairs	Maintenance Repairs	Photos
36	119	Office	Relatively new 18"x18" commercial carpet tile and carpet base. ACT ceiling: fair condition. Walls more recently refinished. Clear finished wood door in hollow metal frame, good condition. Louver blinds at exterior windows: fair condition.		140

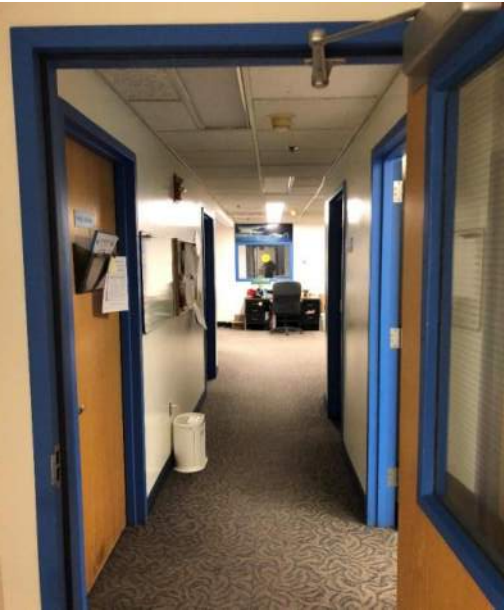
Ref.	Level Room Number	Room Name	Observations	Gross SF	Net SF	Fire/Life Safety Deficiencies and Repairs	Accessibility, ANSI 117.1 and IBC Chapter 11; Deficiencies and Repairs	Maintenance Repairs	Photos
39	122	Corridor	Relatively new 18"x18" commercial carpet tile and carpet base. ACT ceiling: fair condition. Walls more recently refinished.		250

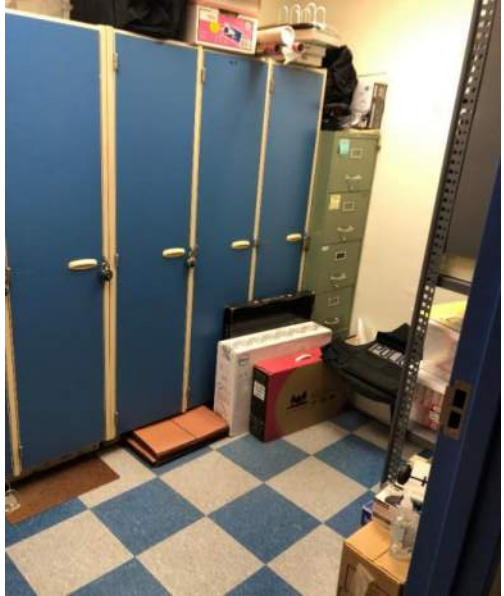
40	123	Storage	Gypsum board walls and ceiling in fair condition. 12x12 vct flooring in fair condition. Plastic Laminate lockers, fair condition.		63			Note the original finish schedule referred to the VCT flooring as "Vinyl asbestos". Test to determine if it is ACM.

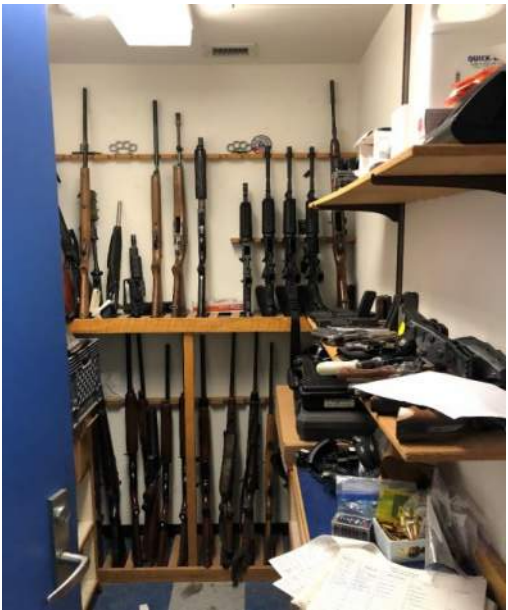
Ref.	Level Room Number	Room Name	Observations	Gross SF	Net SF	Fire/Life Safety Deficiencies and Repairs	Accessibility, ANSI 117.1 and IBC Chapter 11; Deficiencies and Repairs	Maintenance Repairs	Photos
41	124	Armory	Gypsum board walls and ceiling in fair condition. 12x12 vct flooring in fair condition.		38			Note the original finish schedule referred to the VCT flooring as "Vinyl asbestos". Test to determine if it is ACM.

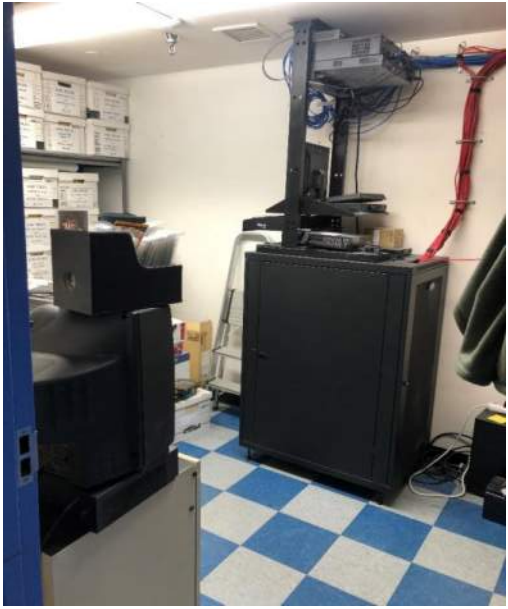
42	125	Evidence Storage/Server	Gypsum board walls and ceiling in fair condition. 12x12 vct flooring in fair condition.		115			Note the original finish schedule referred to the VCT flooring as "Vinyl asbestos". Test to determine if it is ACM.

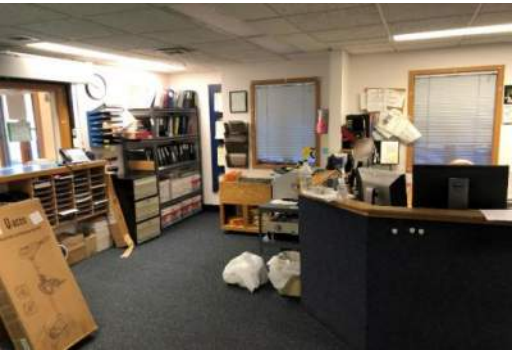
Ref.	Level Room Number	Room Name	Observations	Gross SF	Net SF	Fire/Life Safety Deficiencies and Repairs	Accessibility, ANSI 117.1 and IBC Chapter 11; Deficiencies and Repairs	Maintenance Repairs	Photos
43	126	Corridor	Renovations removed this corridor and made it part of combined Office and Squad Room.		54				
44	127	Office	Renovations combined Office and Squad Room. Commercial carpet tile and rubber base in worn condition. Built-in partial height walls with wall carpet finishes and wood caps in fair condition. ACT ceiling in fair condition. Reception service window configured as single height, not meeting ADA compliance. Plastic laminate casework in fair condition. Louver blinds at exterior windows are in fair condition.		107	Install automatic fire rated shutter assembly at service window. The existing is not automatic and serves as a nigh security shutter.	Renovate service counter window to meet Accessibility requirements for height and depth. This will require relocation of cabinet unit heater in lobby/vestibule.	Refinish wood caps at partial height walls. Refinish wood entry door from vestibule, repaint associated metal frames. Replace commercial carpet tile.

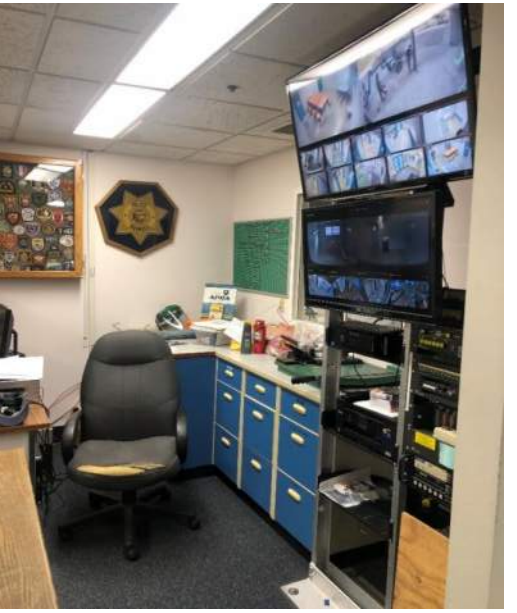
45	128	Squad room	Renovations combined office and squad room. Commercial carpet tile and rubber base in worn condition. Built-in partial height walls with wall carpet finishes and wood caps in fair condition. ACT ceiling in fair condition. Plastic laminate casework in fair condition. Louver blinds at exterior windows are in fair condition.		211			Refinish wood caps at partial height walls. Replace commercial carpet tile. Noted this area houses two workstations and is very cluttered. Consider alternative consolidated file storage in another portion of building.

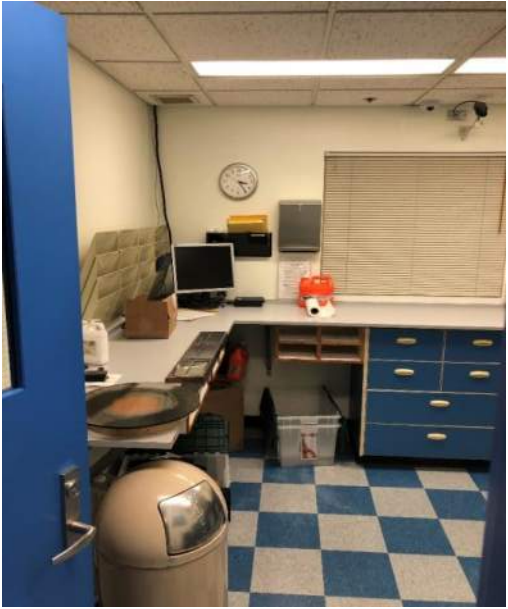
Ref.	Level Room Number	Room Name	Observations	Gross SF	Net SF	Fire/Life Safety Deficiencies and Repairs	Accessibility, ANSI 117.1 and IBC Chapter 11; Deficiencies and Repairs	Maintenance Repairs	Photos
46	129	Booking	Gypsum board walls and ACT ceiling in fair condition. 12x12 vct flooring in fair condition. Plastic laminate casework in fair condition.		122		Laminate countertop extends in to required clear area on pull-side of door. Evaluate accessibility requirements for staff working this area of the facility, as casework is deficient in terms of height and knee-space.	Note the original finish schedule referred to the VCT flooring as "Vinyl asbestos". Test to determine if it is ACM.

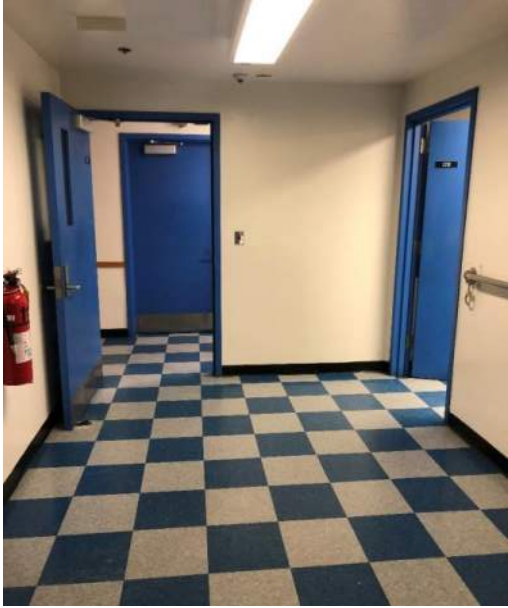
47	130	Sallyport	Gypsum board walls and ceiling in fair condition. 12x12 vct flooring and rubber base in fair condition.		144	Noted doors propped open with wedges. Magnetic holders should be installed in two locations so in the event of a fire the fire rated separations can be maintained.		Note the original finish schedule referred to the VCT flooring as "Vinyl asbestos". Test to determine if it is ACM.

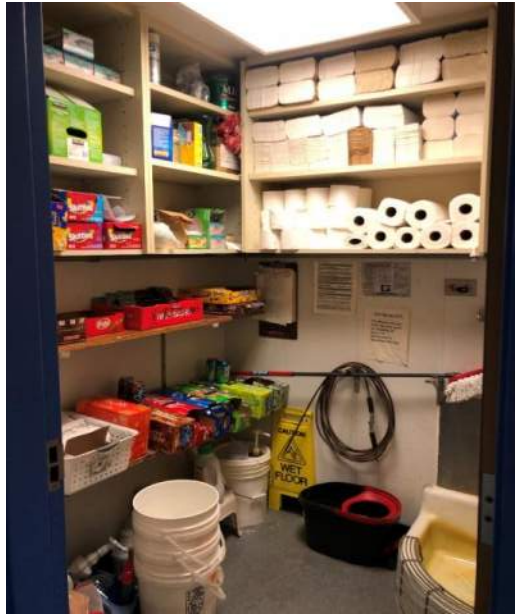
Ref.	Level Room Number	Room Name	Observations	Gross SF	Net SF	Fire/Life Safety Deficiencies and Repairs	Accessibility, ANSI 117.1 and IBC Chapter 11; Deficiencies and Repairs	Maintenance Repairs	Photos
48	131	storage	Used for linen storage. Gypsum board walls and ceiling in fair condition. 12x12 vct flooring and rubber base in fair condition.		28			Note the original finish schedule referred to the VCT flooring as "Vinyl asbestos". Test to determine if it is ACM. Commercial mortice lockset damaged - replace.	
49	132	Jan	Painted gypsum board walls alligatored, above enameled hardboard wainscot (poor condition, some damage), and ceilings. Sheet vinyl flooring with rubber base: poor condition. Clear finished wood door in hollow metal frame, fair condition.		31	Noted food products (snacks foods) stored in same space as janitorial cleaning products. This may be considered a health concern.		Replace wainscot, flooring and wall base. Strip and repaint gypsum board surfaces.

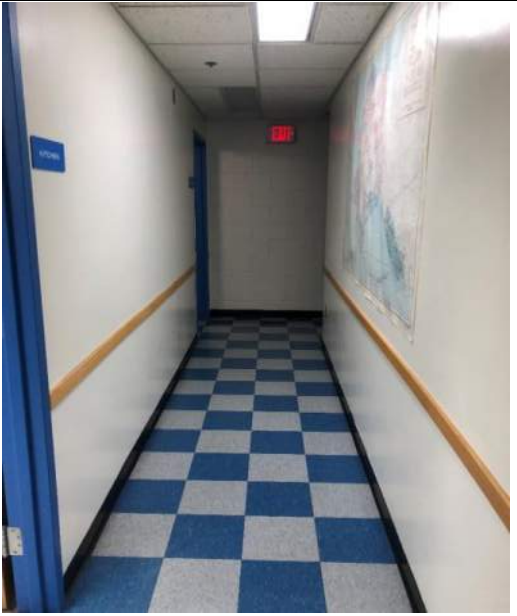
Ref.	Level Room Number	Room Name	Observations	Gross SF	Net SF	Fire/Life Safety Deficiencies and Repairs	Accessibility, ANSI 117.1 and IBC Chapter 11; Deficiencies and Repairs	Maintenance Repairs	Photos
50	133	Corridor	Gypsum board walls and ACT ceiling in fair condition. 12x12 vct flooring and rubber base in fair condition.		258			Note the original finish schedule referred to the VCT flooring as "Vinyl asbestos". Test to determine if it is ACM.
