Wrangell Public Safety Building Assessment

Final Report

23 February 2021

Wrangell Public Safety Building Assessments

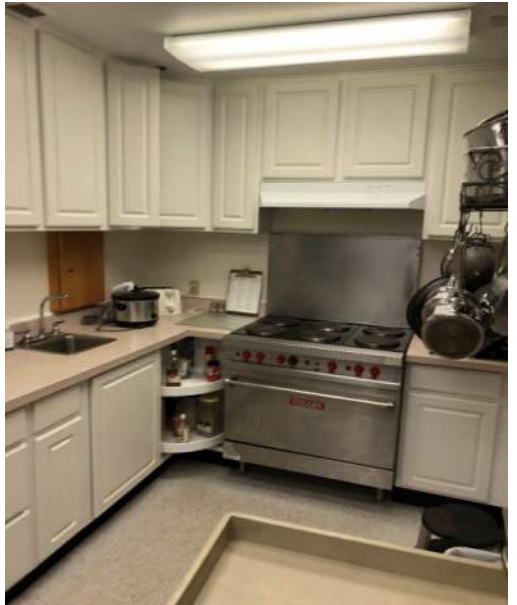
51	134	Kitchen	Recently renovated absorbing adjacent Darkroom in original plan. Painted gypsum walls and ceiling in good condition. Sheet vinyl flooring in good condition. Residential grade cabinets and plastic laminate countertops in good condition. Commercial cookstove (Vulcan 6-burner electric with single oven) in good condition. Commercial Dishwasher (Hobart) in good condition. Commercial refrigerator (Frigidaire) in good condition.		141	Range hood over commercial range is residential type, not type I as required in a commercial application. There is no type 2 hood installed over the commercial dishwasher.	This kitchen is not accessible.	There is no type 2 hood installed over the commercial dishwasher. The flooring transition between hallway VCT and kitchen sheet vinyl is missing. The sheet vinyl is damaged at this threshold. Install flooring transition between sheet vinyl flooring and VCT.

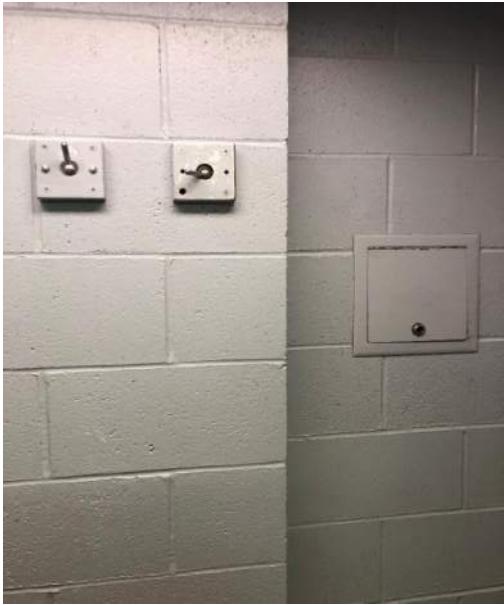
Ref.	Level Room Number	Room Name	Observations	Gross SF	Net SF	Fire/Life Safety Deficiencies and Repairs	Accessibility, ANSI 117.1 and IBC Chapter 11; Deficiencies and Repairs	Maintenance Repairs	Photos
52	135	Shower	The shower is off the main Circulation space in the secured area. Walls are painted CMU and ceiling is painted metal decking. The door is conventional painted hollow metal with commercial hardware. The shower unit is a detention-type, stainless steel with 6" raised curb. Floor is concrete with an anti-slip coating. All finishes in fair condition.		22		This detention area shower is not accessible, and should be replaced with a shower facilitating roll-in use. Floor plan does not meet prescribed dimensional accessibility requirements.	One of the two anti-ligature robe hooks is damaged and should be replaced. The locking access panel over the temperature control valve is damaged and can not be secured.

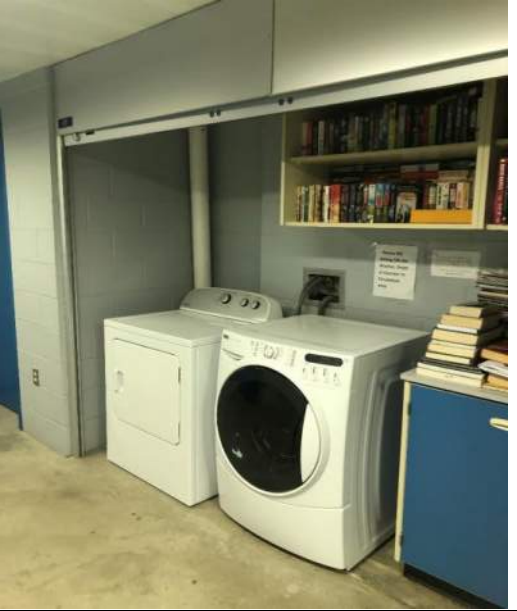
Ref.	Level Room Number	Room Name	Observations	Gross SF	Net SF	Fire/Life Safety Deficiencies and Repairs	Accessibility, ANSI 117.1 and IBC Chapter 11; Deficiencies and Repairs	Maintenance Repairs	Photos
53	137	Linen	The linen/laundry area is a niche off the main Circulation space in the secured area, and is securable with an aluminum overhead coiling shutter. Walls are painted CMU and ceiling is painted metal decking. The washer and dryer are conventional residential types in good condition. Plastic laminate countertops and cabinets are in fair condition. Floor is sealed concrete. All finishes in fair condition.		29			Plumbing hook-up box for clothing washer is rusting and should be refinished or replaced.

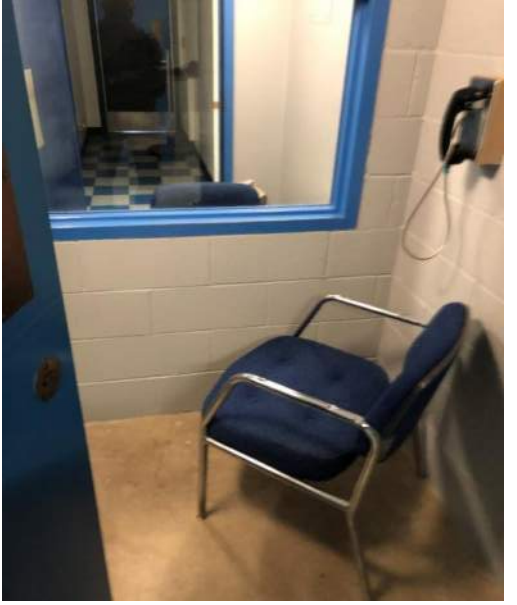
54	138	Prisoner Visit	Walls are painted CMU and ceiling is painted metal decking. Floor is sealed concrete. Detention metal relight frame needs touchup painting and plastic glazing is in good condition. Door is detention hollow metal and hardware. All finishes in good condition.		27			Repaint detention hollow metal relight frame.

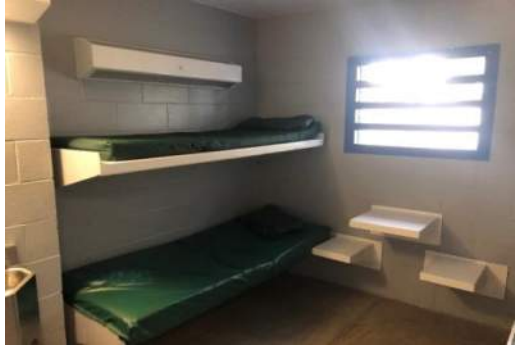
Ref.	Level Room Number	Room Name	Observations	Gross SF	Net SF	Fire/Life Safety Deficiencies and Repairs	Accessibility, ANSI 117.1 and IBC Chapter 11; Deficiencies and Repairs	Maintenance Repairs	Photos
55	139	Civilian Visit	Walls are painted CMU and ceiling is painted gypsum board. Floor is ACT. Door is painted wood in hollow metal frame. All finishes in good condition.		28			Note the original finish schedule referred to the VCT flooring as "Vinyl asbestos". Test to determine if it is ACM.	
56	140	Cell	Walls are painted CMU and ceiling is painted metal decking. Floor is sealed concrete. Detention furnishings (beds, benched, desks) are welded steel, wall-mounted. Door is a sliding detention hollow metal unit, all hardware functional. All finishes in good condition. Detention stainless steel combi (toilet/lavatory) unit in fair condition. Cell area meets ACA's Core Jail standards. This cell supervised via security camera.		81	There are no electronic door controls or monitoring devices, or means of triggering immediate release in emergency situations, per ACA Core Jail standards. Cover at ceiling mounted equipment has holes greater than that recommended for ligature prevention, per ACA.

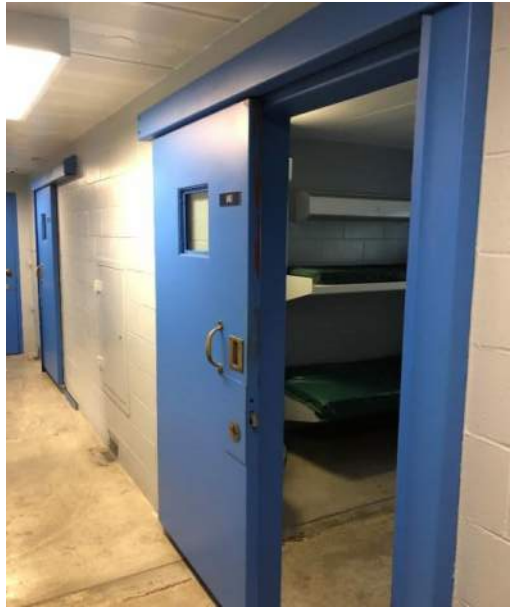
Ref.	Level Room Number	Room Name	Observations	Gross SF	Net SF	Fire/Life Safety Deficiencies and Repairs	Accessibility, ANSI 117.1 and IBC Chapter 11; Deficiencies and Repairs	Maintenance Repairs	Photos
57	141	Cell	Walls are painted CMU and ceiling is painted metal decking. Floor is sealed concrete. Detention furnishings (beds, benched, desks) are welded steel, wall-mounted. Door is a sliding detention hollow metal unit, all hardware functional. All finishes in good condition. Detention stainless steel combi (toilet/lavatory) unit in fair condition. Cell area meets ACA's Core Jail standards.		85	There are no electronic door controls or monitoring devices, or means of triggering immediate release in emergency situations, per ACA Core Jail standards. Cover at ceiling mounted equipment has holes greater than that recommended for ligature prevention, per ACA.		Replace water valves at combi unit lavatory - minimal flow.

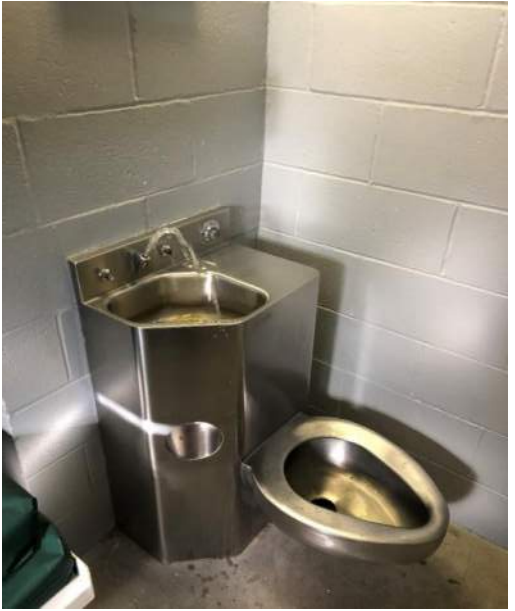
58	142	Cell	Walls are painted CMU and ceiling is painted metal decking. Floor is sealed concrete. Detention furnishings (beds, benched, desks) are welded steel, wall-mounted. Door is a sliding detention hollow metal unit, all hardware functional. All finishes in good condition. Detention stainless steel combi (toilet/lavatory) unit in fair condition. Cell area meets ACA's Core Jail standards.		85	There are no electronic door controls or monitoring devices, or means of triggering immediate release in emergency situations, per ACA Core Jail standards. Cover at ceiling mounted equipment has holes greater than that recommended for ligature prevention, per ACA.		Inspect plumbing at combi unit - brown water comes out of tap when first running. Water pressure is high - adjust such it does not overshoot basin.

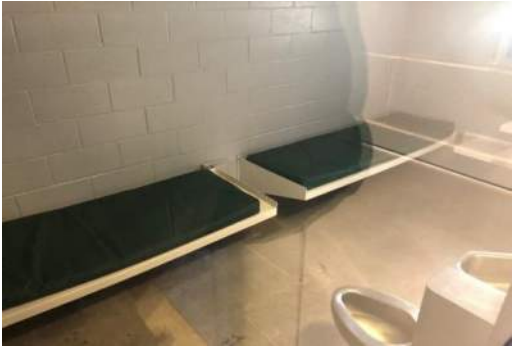
Ref.	Level Room Number	Room Name	Observations	Gross SF	Net SF	Fire/Life Safety Deficiencies and Repairs	Accessibility, ANSI 117.1 and IBC Chapter 11; Deficiencies and Repairs	Maintenance Repairs	Photos
59	143	Cell	Walls are painted CMU and ceiling is painted metal decking. Floor is sealed concrete. Detention furnishings (beds, benched, desks) are welded steel, wall-mounted. Door is a hinged detention hollow metal unit, all hardware functional. All finishes in good condition. Detention stainless steel combi (toilet/lavatory) unit in fair condition. Cell area meets ACA's Core Jail standards.		118	There are no electronic door controls or monitoring devices, or means of triggering immediate release in emergency situations, per ACA Core Jail standards. Cover at ceiling mounted Cover at ceiling mounted equipment has holes greater than that recommended for ligature prevention, per ACA.		Replace water valves at combi unit lavatory - no flow.

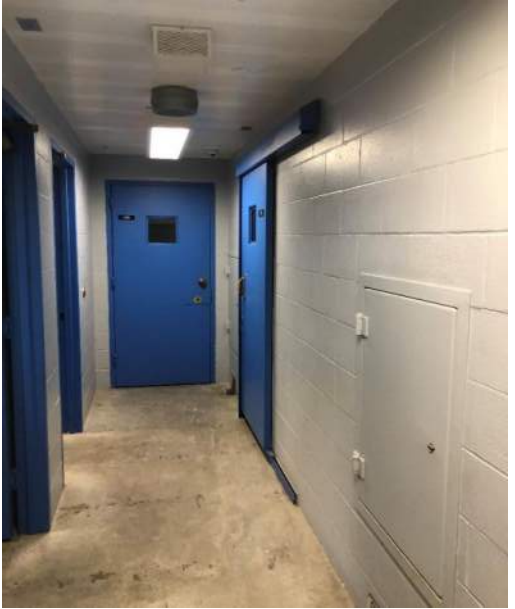
60	144	Secure Corridor	Walls are painted CMU and ceiling is painted metal decking. Floor is sealed concrete. Plumbing chase access panels are hinged detention metal unit, all security hardware functional. Finishes in fair condition.		124			Touchup paint detention metal frame and doors

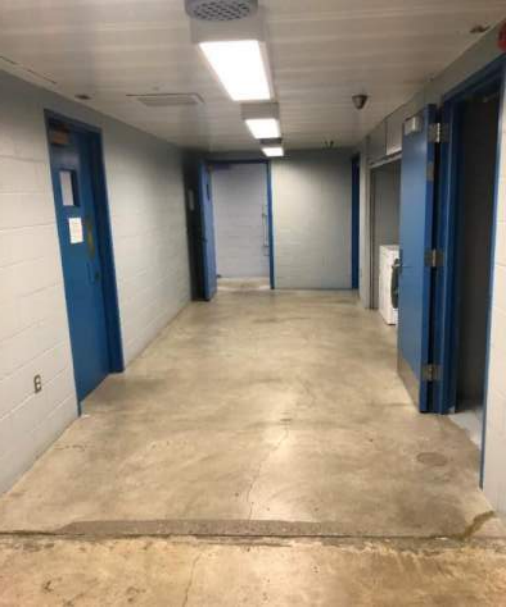
Ref.	Level Room Number	Room Name	Observations	Gross SF	Net SF	Fire/Life Safety Deficiencies and Repairs	Accessibility, ANSI 117.1 and IBC Chapter 11; Deficiencies and Repairs	Maintenance Repairs	Photos
61	145	Secure Circulation	Walls are painted CMU and ceiling is painted metal decking. Floor is sealed concrete. Some patching at concrete floor is necessary. Finishes in fair condition. Supervised via security cameras.		222			Clean and patch/fill joint at concrete floor with epoxy grout.

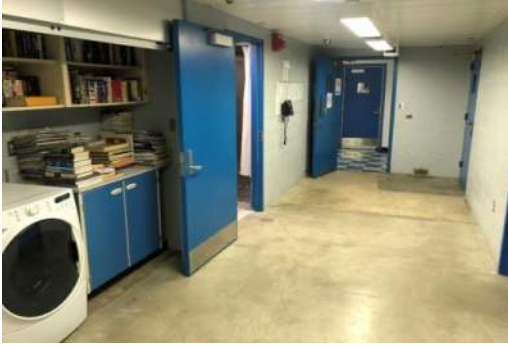
62	146	Day Room	Walls are painted CMU and ceiling is painted metal decking. Floor is sealed concrete. Detention furnishings (tables and stools) are welded steel, floor-mounted. Doors are hinged detention hollow metal units, all hardware functional. All finishes in fair condition. Supervised via security cameras.		259	There are no electronic door controls or monitoring devices, or means of triggering immediate release in emergency situations, per ACA Core Jail standards. Cover at ceiling mounted equipment has holes greater than that recommended for ligature prevention, per ACA.

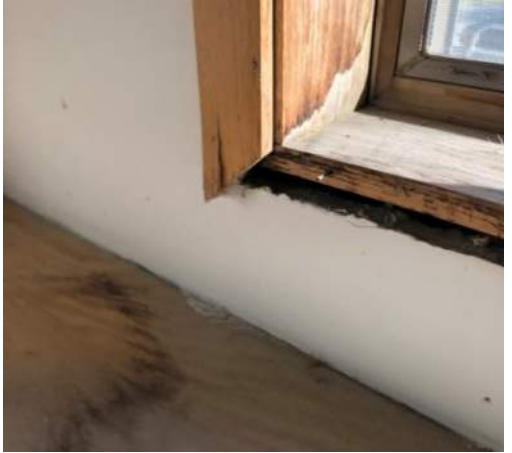
Ref.	Level Room Number	Room Name	Observations	Gross SF	Net SF	Fire/Life Safety Deficiencies and Repairs	Accessibility, ANSI 117.1 and IBC Chapter 11; Deficiencies and Repairs	Maintenance Repairs	Photos
63	147	Stair	No entry from stairs to the detention area on this level. Alligatored paint on all gypsum board walls. Exterior window trim partially removed and shows evidence of water damage.		103			Strip and repaint all gypsum board surfaces. Repair window trim.

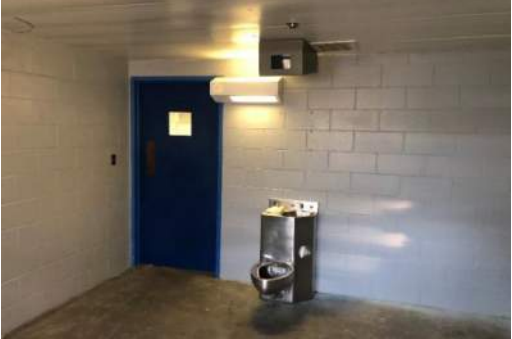
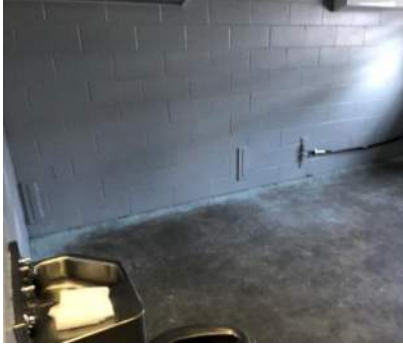
64	148	Holding	Walls are painted CMU and ceiling is painted metal decking. Floor is sealed concrete. Detention furnishings (beds, benches, desks) are welded steel, wall-mounted. Door is a hinged detention hollow metal unit, all hardware functional. All finishes in fair condition. Detention stainless steel combi (toilet/lavatory) unit in fair condition. Holding area meets ACA's Core Jail standards in terms of sf per occupant. Supervised via security cameras.		190	Call button is missing. Cover at ceiling mounted equipment has holes greater than that recommended for ligature prevention, per ACA.

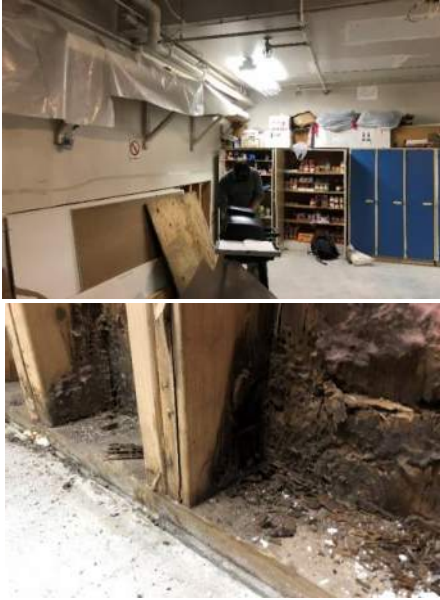
Ref.	Level Room Number	Room Name	Observations	Gross SF	Net SF	Fire/Life Safety Deficiencies and Repairs	Accessibility, ANSI 117.1 and IBC Chapter 11; Deficiencies and Repairs	Maintenance Repairs	Photos
65	149	Garage	Two-car vehicular garage currently being utilized as storage area. This is a semi-secure police vehicle sallyport with direct access to police station. Water damage at the south wall is evident, with interior gypsum board panels removed exposing extensive rot and insect damage at wall framing, base of wall. Ceiling has multiple holes in the gypsum board panels, temporarily covered with plastic sheeting.		677	The ceiling is part of a fire rated assembly. Holes in the ceiling must be repaired as soon as possible to maintain separation between floors and between garage and offices above.		Rotten 2x6 wall framing to be removed and replaced with new from elevation 6' aff to and including the sill plate for a length of wall approximately 20' . This is a bearing wall on grid H

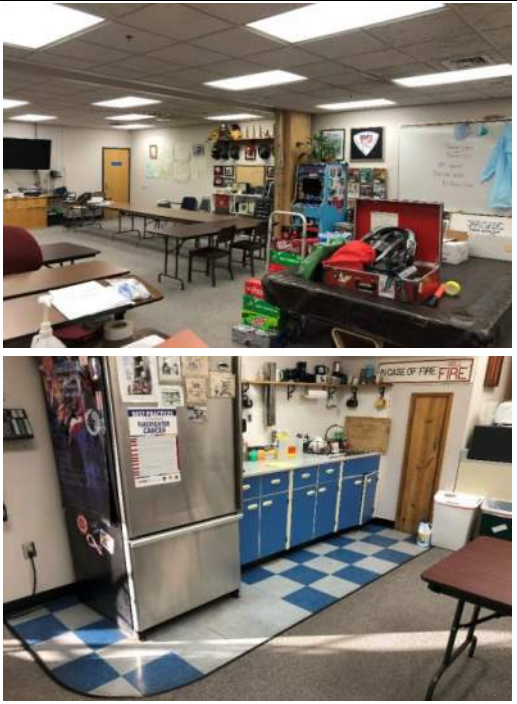
Ref.	Level Room Number	Room Name	Observations	Gross SF	Net SF	Fire/Life Safety Deficiencies and Repairs	Accessibility, ANSI 117.1 and IBC Chapter 11; Deficiencies and Repairs	Maintenance Repairs	Photos
	Floor 2			10362					
66	200	Training	Large room with two exists and Modern Fold "accordion" type acoustic partition to divide into two separate spaces. Provided with kitchenette, large screen TV and three 4'x8' white boards (good condition). Commercial carpet and rubber base in worn condition. VCT flooring around kitchenette in fair condition. plastic laminate cabinets at kitchenette in poor condition. Vinyl wall covering in poor condition. Commercial style refrigerator in good condition.		1200		Kitchenette sink is not accessible - upgrade with replacement.	Replace flooring, replace plastic laminate kitchenette. Replace vinyl wall covering. Note the original finish schedule referred to the VCT flooring in kitchenette as "Vinyl asbestos". Test to determine if it is ACM.

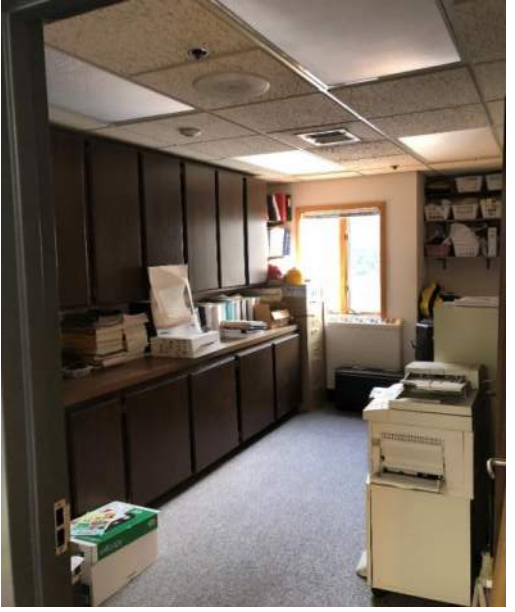
Ref.	Level Room Number	Room Name	Observations	Gross SF	Net SF	Fire/Life Safety Deficiencies and Repairs	Accessibility, ANSI 117.1 and IBC Chapter 11; Deficiencies and Repairs	Maintenance Repairs	Photos
69	203	Records Work	Office-sized space with lower and upper cabinets full length of room. Carpet and base in fair condition. Cabinets in functional condition.		143			Space appears underutilized. Reassess function in renovation and anticipate removing all plastic laminate cabinets and refinishing all walls, with replacement of carpet.

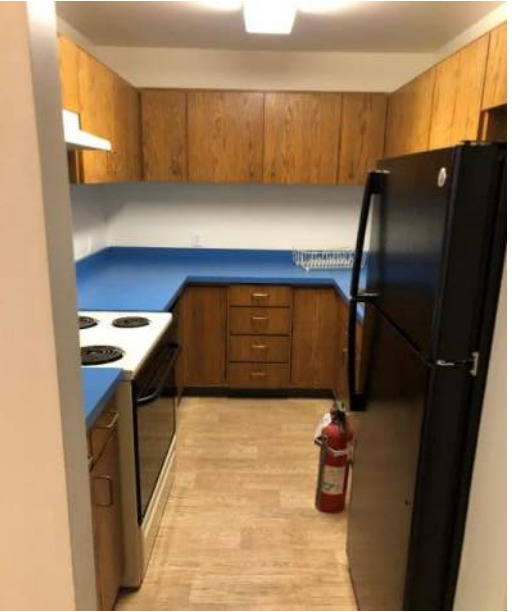
70	204	Kitchen	Aging finishes, casework but in fair condition. LVT Flooring.		68		Space is not large enough to meet accessibility requirements.	Upgrade countertops and appliances; Range, Hood, Refrigerator (provide counter-depth unit), dishwasher. Repaint all walls and ceilings.

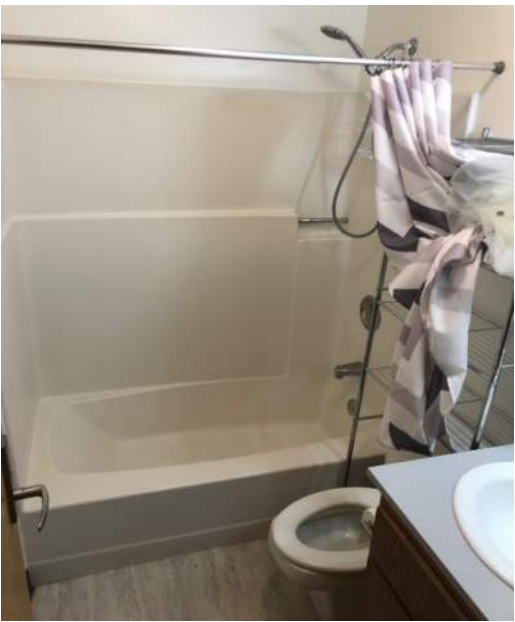
Ref.	Level Room Number	Room Name	Observations	Gross SF	Net SF	Fire/Life Safety Deficiencies and Repairs	Accessibility, ANSI 117.1 and IBC Chapter 11; Deficiencies and Repairs	Maintenance Repairs	Photos
71	205	Bathroom	Aging finishes, casework but in fair condition.		39		Space is not large enough to meet accessibility requirements.	Upgrade countertop at vanity and repaint all walls and ceilings.

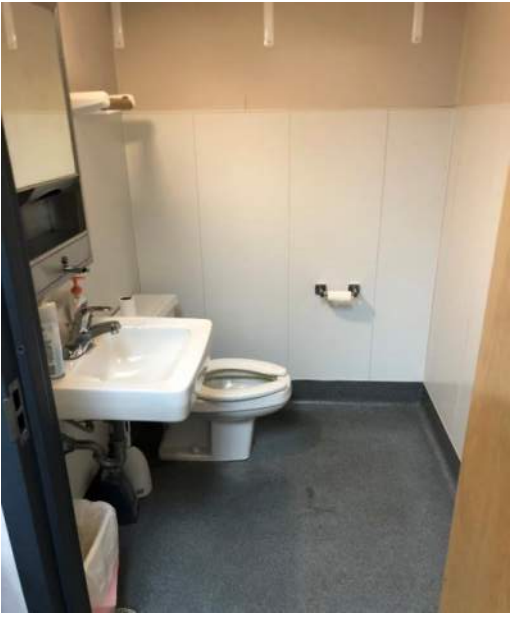
Ref.	Level Room Number	Room Name	Observations	Gross SF	Net SF	Fire/Life Safety Deficiencies and Repairs	Accessibility, ANSI 117.1 and IBC Chapter 11; Deficiencies and Repairs	Maintenance Repairs	Photos
72	206	Toilet	Bathroom that opens into Training 200. Sheet vinyl floor and integral base, poor condition. Vinyl wall covering above wainscot, poor condition. Enameled hardboard wainscot- fair condition. No ADA equipment.		17		Bathroom is not large enough to meet accessibility requirements.	Strip and repaint gypsum board ceiling surfaces. Replace vinyl wall covering. Replace sheet vinyl flooring with integral cove base.

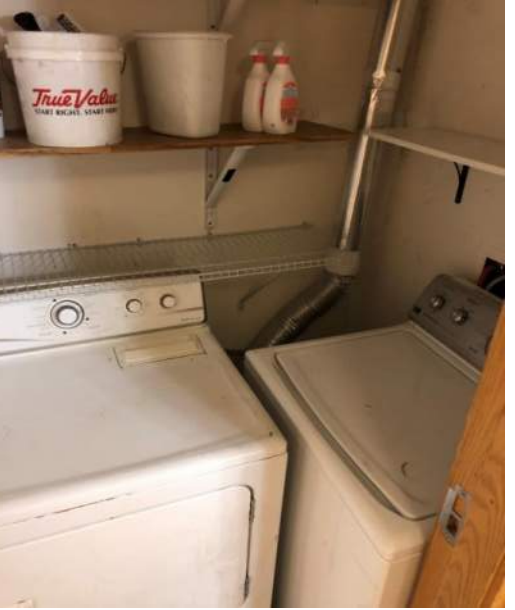
73	207	Storage	Converted to laundry room. Alligatored paint at walls, ceiling. worn flooring.		22			Remove side-by-side washer and dryer, replace with a stacking unit. Refinish all walls and ceiling. Install new flooring.

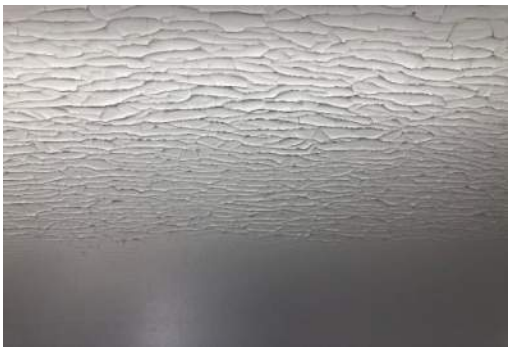
Ref.	Level Room Number	Room Name	Observations	Gross SF	Net SF	Fire/Life Safety Deficiencies and Repairs	Accessibility, ANSI 117.1 and IBC Chapter 11; Deficiencies and Repairs	Maintenance Repairs	Photos
74	208	Hose Tower	Upper level - painted wall finishes alligating.		0			Strip and repaint all gypsum board wall and ceiling surfaces.

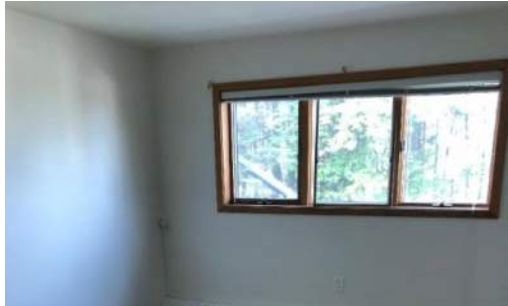
75	209	Bedroom	Aging finishes, no egress window. Wood door, frame and trim in fair condition. LVT Flooring.		116	Install egress window.		Repaint all wall and ceiling surfaces.

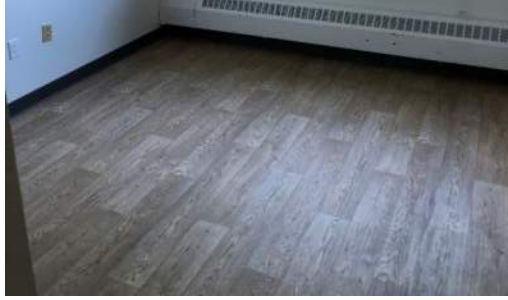
76	210	Bedroom	Aging finishes, no egress window. Wood door, frame and trim in fair condition. LVT Flooring.		122	Install egress window.		Repaint all wall and ceiling surfaces.

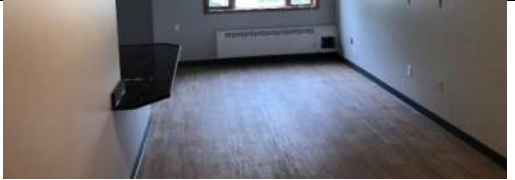
Ref.	Level Room Number	Room Name	Observations	Gross SF	Net SF	Fire/Life Safety Deficiencies and Repairs	Accessibility, ANSI 117.1 and IBC Chapter 11; Deficiencies and Repairs	Maintenance Repairs	Photos
78	212	Dining	Aging finishes. Plastic laminate bar in poor condition. LVT Flooring.		96			Repaint all wall and ceiling surfaces. Replace plastic laminate bar.

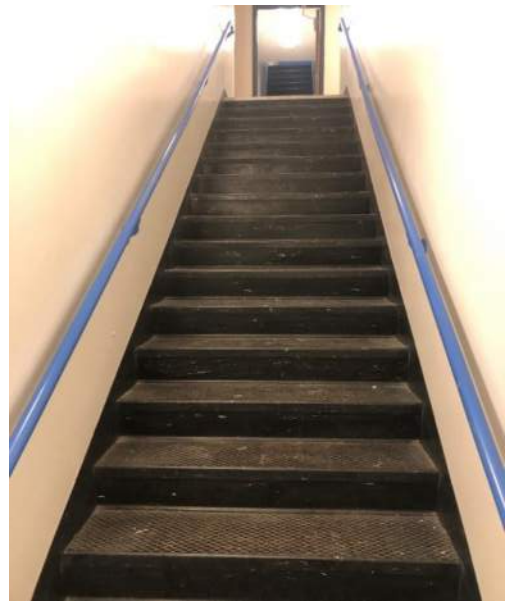
79	213	Stair	Stair down to equipment bay and back exterior mezzanine. Alligatored paint on gypsum board walls. 7" rise and 11" run meets code. Handrails both sides, rubber treads and risers. Good condition.		120			Strip and repaint all walls.

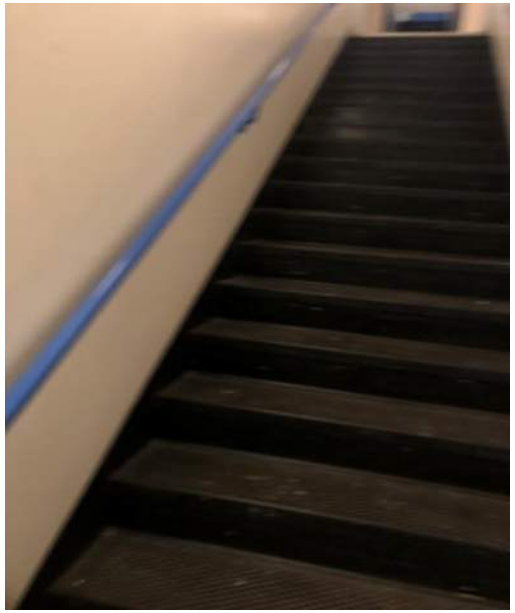
Ref.	Level Room Number	Room Name	Observations	Gross SF	Net SF	Fire/Life Safety Deficiencies and Repairs	Accessibility, ANSI 117.1 and IBC Chapter 11; Deficiencies and Repairs	Maintenance Repairs	Photos
80	214	Stair	Stair up to mechanical loft/mezzanine. Alligatored paint on gypsum board walls. 9" rise and 8.5" run does not meet OSHA for equipment access, but has handrails both sides, rubber treads and is otherwise in good condition.		71			Strip and repaint all walls.

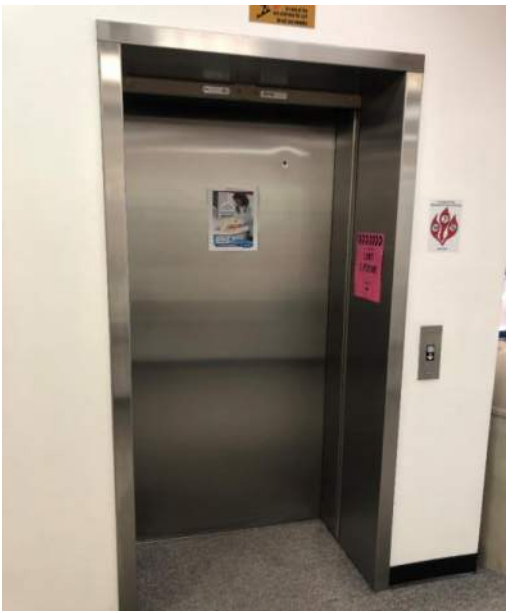
81	215	Elevator	See notes in B103		40	Automatic overhead fire shutter at cab portal is not functioning, jammed open with wood wedges. Repair.	Elevator controls, signals and numerical signage are not accessibility compliant. No braille, no visible on hall side. Update controls and signals.

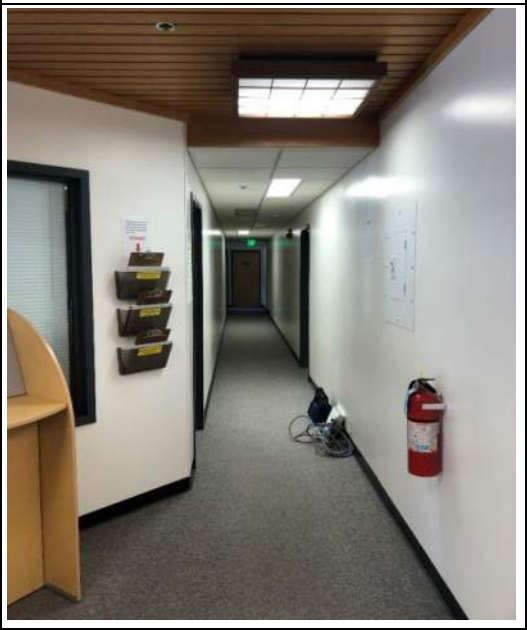
Ref.	Level Room Number	Room Name	Observations	Gross SF	Net SF	Fire/Life Safety Deficiencies and Repairs	Accessibility, ANSI 117.1 and IBC Chapter 11; Deficiencies and Repairs	Maintenance Repairs	Photos
82	216	Hallway	Alligatored paint on gypsum board walls. ACT ceiling in good condition. Commercial carpet and rubber base older, in fair condition.		300			Strip and paint walls, replace carpet and rubber base. Touch up painted hollow metal door frames. Replace carpet and rubber base.

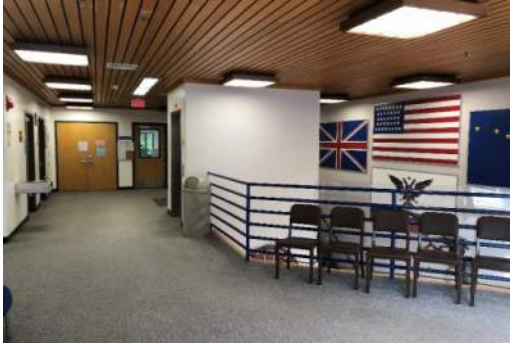
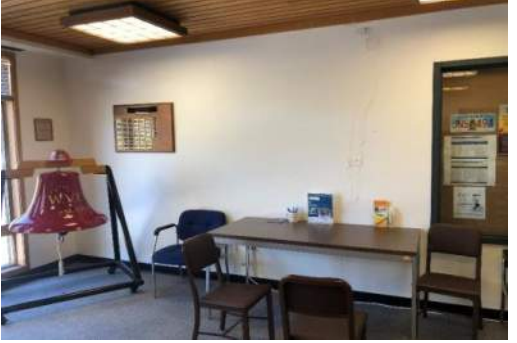
Ref.	Level Room Number	Room Name	Observations	Gross SF	Net SF	Fire/Life Safety Deficiencies and Repairs	Accessibility, ANSI 117.1 and IBC Chapter 11; Deficiencies and Repairs	Maintenance Repairs	Photos
83	217	Lobby	Paint on south wall damaged due to water leak. Wood slat ceiling in fair condition , with some water damage in areas of roof leaks. Painted pipe guardrail has larger than 4" openings, and is less that code required 42" height in some areas. Commercial carpet is older, fair condition. Horizontal louver blinds at exterior windows in fair condition.		816	Modify guard rail height as required for compliance. Add panels or modify railing to narrow openings to code requirement.		After roof/wall leak is resolved, repair at gypsum wall and wood slat ceiling where damaged. New paint at all walls, new carpet and rubber base.

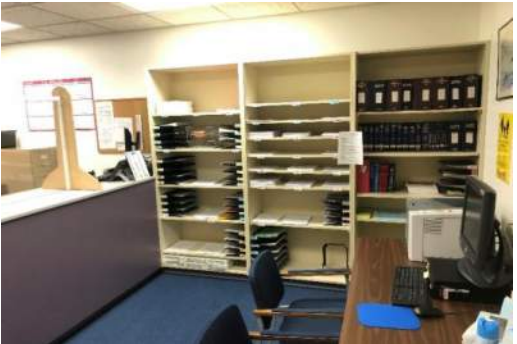
84	218	Public Records	Floor = 24x24 commercial carpet tile with rubber base, good condition. ACT ceiling, good condition. Walls , painted gypsum board, good condition. Clear finished wood doors in hollow metal frames, good condition. Plastic laminate casework, good condition.		532		Service counter not configured for accessibility. Modify for 30" high service area.

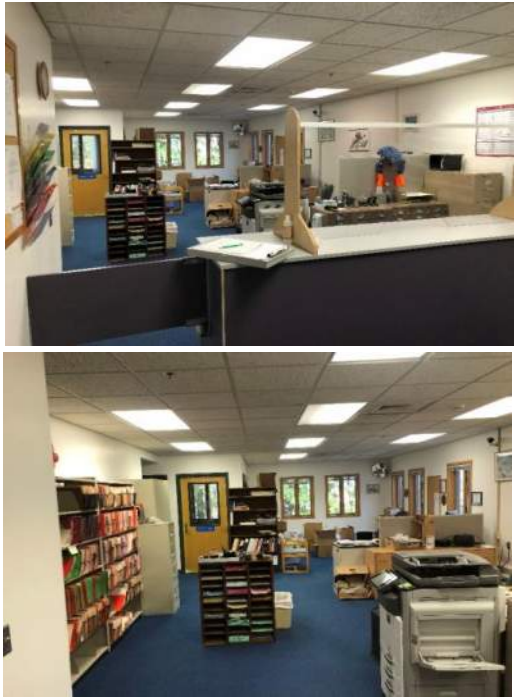
Ref.	Level Room Number	Room Name	Observations	Gross SF	Net SF	Fire/Life Safety Deficiencies and Repairs	Accessibility, ANSI 117.1 and IBC Chapter 11; Deficiencies and Repairs	Maintenance Repairs	Photos
85	219	Clerks Office	Floor = 24x24 commercial carpet tile with rubber base, good condition. ACT ceiling, good condition. Walls, painted gypsum board, good condition (poor condition at exterior walls). Clear finished wood doors in hollow metal frames, good condition.		153	The exterior (west and north) walls in this space display significant water damage from leaking parapet and scupper above. Water damage is evident at the wood window unit and can be seen where gypsum board wall is "swelling" into the room around the window. Area is noted in exterior investigations for significant shoring and reconstruction.		Long term water infiltration and humidity cause significant occupant discomfort and deteriorating affect on interior finishes. Anticipate all finishes for this room shall be removed and reinstalled new. Exterior wall is substantially deteriorated due to water infiltration and shall be reconstructed with new framing, insulation vapor retarder sheathing and siding. Coordinate with exterior notes and structural notes.

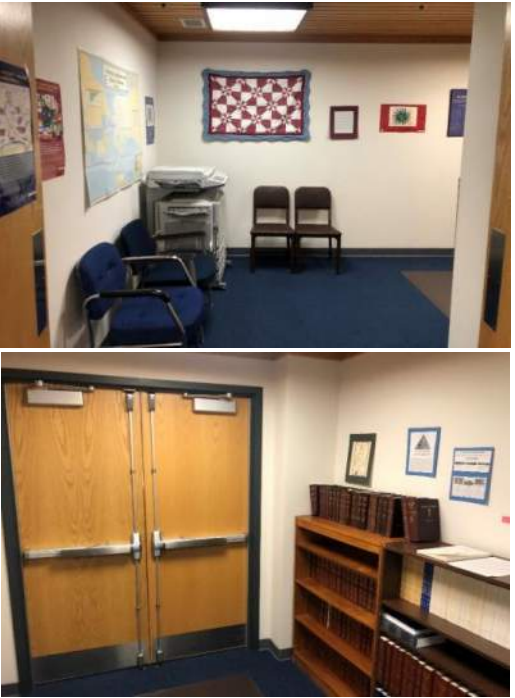
Ref.	Level Room Number	Room Name	Observations	Gross SF	Net SF	Fire/Life Safety Deficiencies and Repairs	Accessibility, ANSI 117.1 and IBC Chapter 11; Deficiencies and Repairs	Maintenance Repairs	Photos
86	220	Entry	Floor = 24x24 commercial carpet tile with rubber base, good condition. ACT ceiling, good condition. Walls, painted gypsum board, fair condition with some alligatoring. Clear finished wood doors in hollow metal frames, good condition.		121		Paired doors: each leaf is narrower than required so both leaf must be open to meet 34" clear width. Provide motor operator and push button controls to open each pair of doors at two locations, or replace both pairs of doors with new single panels doors with sidelight.

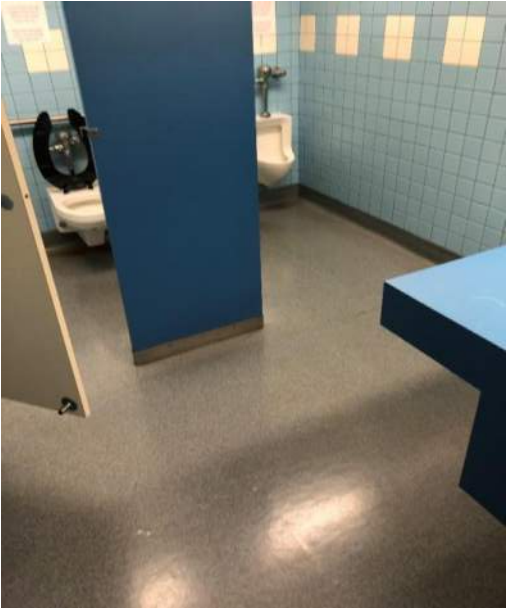
Ref.	Level Room Number	Room Name	Observations	Gross SF	Net SF	Fire/Life Safety Deficiencies and Repairs	Accessibility, ANSI 117.1 and IBC Chapter 11; Deficiencies and Repairs	Maintenance Repairs	Photos
88	223	Men	Sheet vinyl flooring with rubber base in fair condition. Ceramic tile wainscot to 60" in good condition. Gypsum board walls and ceilings in good condition. Plastic laminate partitions in fair condition. Plastic laminate lavatory in fair condition. Estimated renovation in early 2000's.		137		42" clearance on pull side of door with closer does not meet accessibility requirements and will require significant bathroom renovation to accomplish. Missing vertical grab bar at toilet - install.

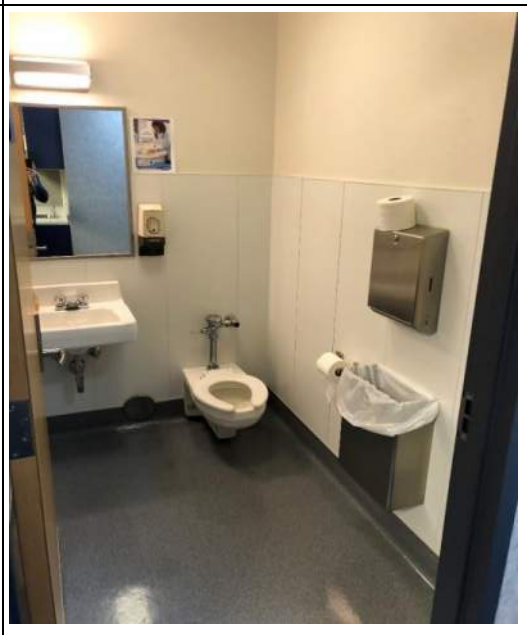
Ref.	Level Room Number	Room Name	Observations	Gross SF	Net SF	Fire/Life Safety Deficiencies and Repairs	Accessibility, ANSI 117.1 and IBC Chapter 11; Deficiencies and Repairs	Maintenance Repairs	Photos
90	225	Toilet	Alligatored paint on all gypsum board walls above wainscot, and ceilings. Sheet vinyl flooring with integral cove base, in fair condition. Clear finished wood doors with painted hollow metal frames, in good condition. Stainless steel washroom accessories in good condition. Wainscot in fair condition.		30		Not accessible; limited clearances, no grab bars, scald-guards.	Strip and paint gypsum board walls and ceiling. Replace vinyl flooring and cove base.

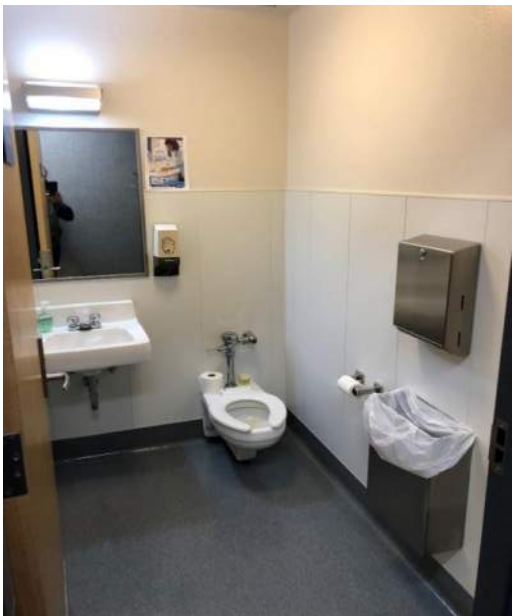
Ref.	Level Room Number	Room Name	Observations	Gross SF	Net SF	Fire/Life Safety Deficiencies and Repairs	Accessibility, ANSI 117.1 and IBC Chapter 11; Deficiencies and Repairs	Maintenance Repairs	Photos
91	226	Toilet	Alligatored paint on all gypsum board walls above wainscot, and ceilings. Sheet vinyl flooring with integral cove base, in fair condition. Clear finished wood doors with painted hollow metal frames, in good condition. Stainless steel washroom accessories in good condition. Wainscot in fair condition.		30		Not accessible; limited clearances, no grab bars, scald-guards.	Strip and paint gypsum board walls and ceiling. Replace vinyl flooring and cove base.

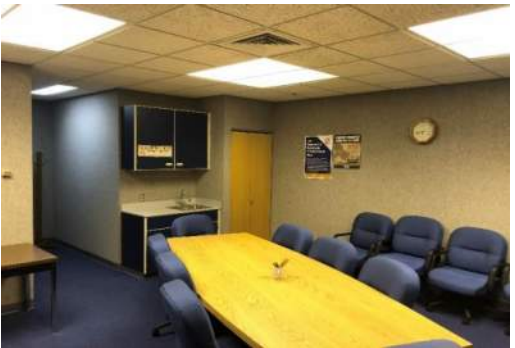
92	227	Jury Room	ACT ceiling, good condition. Carpet wall covering, good condition. 24x24 commercial carpet tile and rubber base, good condition. Plastic laminate casework and top (with sink) good condition - meets side reach requirements for ADA. Clear finished wood doors, good condition.		383		Jury room is not provided with accessible bathroom. While not explicitly required in the IBC, this is a functional breach in operations, as the only accessible bathrooms are on the public side, outside the Jury sequester space.

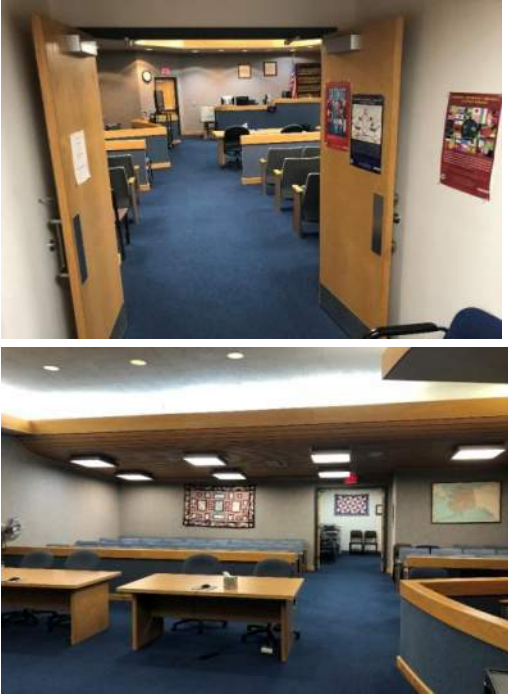
Ref.	Level Room Number	Room Name	Observations	Gross SF	Net SF	Fire/Life Safety Deficiencies and Repairs	Accessibility, ANSI 117.1 and IBC Chapter 11; Deficiencies and Repairs	Maintenance Repairs	Photos
93	228	Court Room	12x12 adhered acoustic ceiling tile, good condition. Wood slat ceiling soffit, good condition. Alligatored paint on all gypsum board soffits soffits (25% floor area). Carpet wall covering, good condition. 24x24 commercial carpet tile and rubber base, good condition. Clear finish wood trim at partial height walls and fixed wood veneer faced and topped casework in good condition. Clear finished wood doors, good condition. Clear finished wood trim at Judge, jury and witness boxes in good condition. Two means of egress provided and clearly marked.		1136		Jury box is not accessible (elevated with steps) and has no space for wheelchair, required per IBC 1108.4.1.1. wheelchair seating in the Gallery is not provided per 1108.4.1.2. Employee work stations and Judge's bench not accessible as required by 1108.4.1.4 (one step up). Reconfiguration remodel required.	All gypsum wall bord ceilings/soffit areas to be stripped and repainted. (25% floor area)

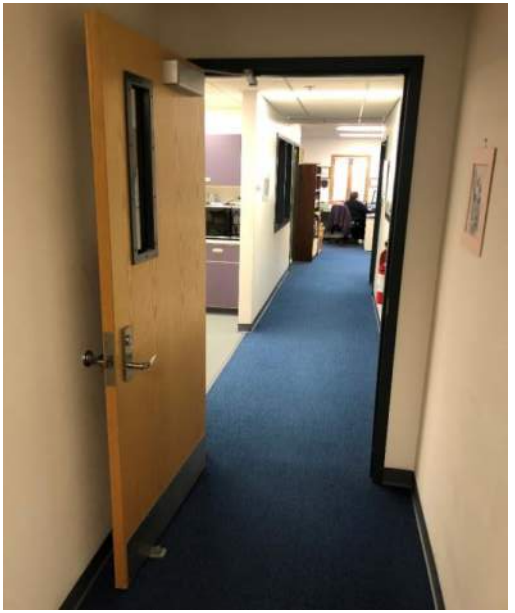
Ref.	Level Room Number	Room Name	Observations	Gross SF	Net SF	Fire/Life Safety Deficiencies and Repairs	Accessibility, ANSI 117.1 and IBC Chapter 11; Deficiencies and Repairs	Maintenance Repairs	Photos
	229	Corridor	Alligatored paint on gypsum board walls. ACT ceiling in good condition. t 24x24 commercial carpet tile and rubber base in good condition.		107	Provide magnetic door holder at corridor door - it is a fire rated separation and is propped open with wedges.		Strip and paint walls. Touch up painted hollow metal door frames.

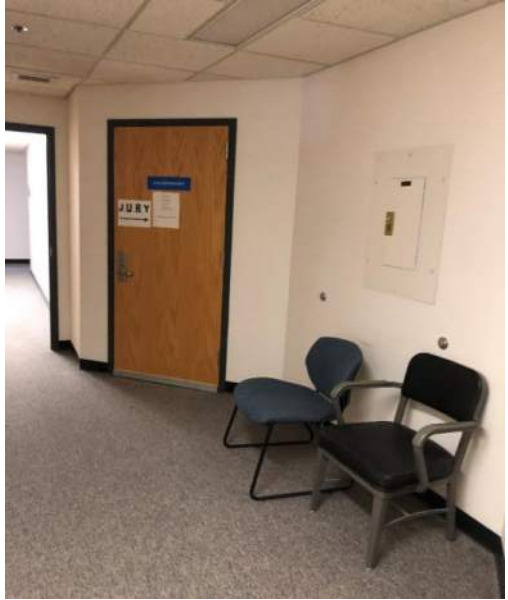
94	230	Vestibule	Alligatored paint on gypsum board walls. ACT ceiling in good condition. Commercial carpet and rubber base older, in fair condition. Clear finished wood doors in fair condition.		125	Provide magnetic door holder at corridor doors to 231 and 216 - fire rated separations propped open with wedges.		Strip and paint walls, replace carpet and rubber base. Touch up painted hollow metal door frames. Replace carpet and rubber base.

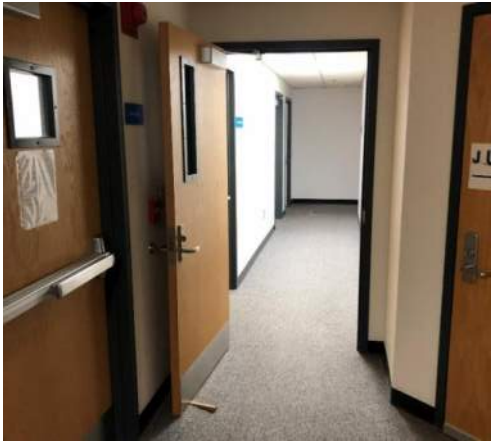
Ref.	Level Room Number	Room Name	Observations	Gross SF	Net SF	Fire/Life Safety Deficiencies and Repairs	Accessibility, ANSI 117.1 and IBC Chapter 11; Deficiencies and Repairs	Maintenance Repairs	Photos
95	231	Corridor	Alligatored paint on gypsum board walls. ACT ceiling in good condition. Commercial carpet and rubber base older, in fair condition. Clear finished wood doors in fair condition.		79	Provide magnetic door holder at corridor door - it is a fire rated separation and is propped open with wedges.		Strip and paint walls, replace carpet and rubber base. Touch up painted hollow metal door frames. Replace carpet and rubber base.

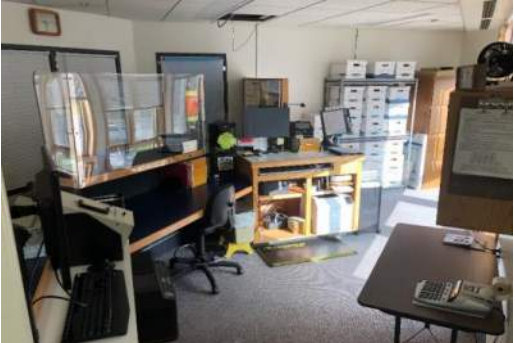
96	232	DMV	More recent renovation evident in this space. Exterior window operator problems. Commercial carpet and carpet base in fair condition. Replace missing ACT (one piece, 2x2). Plastic Laminate counter and half height partitions in fair condition. horizontal louver blinds in fair condition.		521			Replace missing ceiling tile (2x2), replace carpet, refinish wood trim on plastic laminate casework. Paint walls.

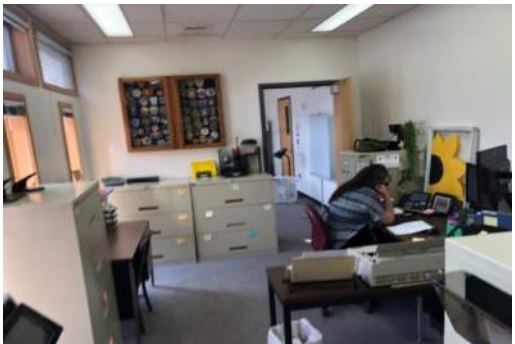
97	232A	Records	More recent renovation evident in this space; new wall and door subdividing from 232.		137			Replace commercial carpet. Paint walls.

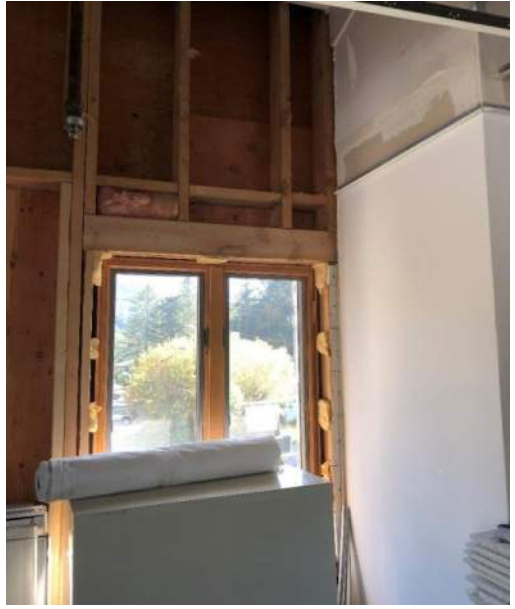
Ref.	Level Room Number	Room Name	Observations	Gross SF	Net SF	Fire/Life Safety Deficiencies and Repairs	Accessibility, ANSI 117.1 and IBC Chapter 11; Deficiencies and Repairs	Maintenance Repairs	Photos
98	233	Interview	Room sustained damage from a leak in the dry pipe sprinkler system in the roof cavity. ACT ceiling and gird is 80% removed. Gypsum panels and insulation have been removed from exterior wall. Gypsum panels and insulation have been removed from the roof assembly. Window trim and blinds have been removed.		134	The wall and roof assemblies are fire rated, and must be closed up with insulation and gypsum panels per the fire rated design.		With the completion of the gypsum board, insulation and vapor retarder installation, paint all surfaces. Install window trim. Install ACT ceiling system and lighting. Replac dammaged carpet area.

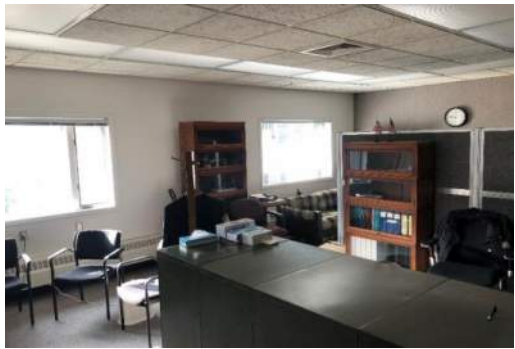
100	235	Customs	Space more recently renovated, likely when exterior wall work was done. Carpet is older but in fair condition. Exterior gypsum wall board in good condition, exterior clad wood windows painted rather than clear finish as seen elsewhere. ACT ceiling in good condition. Carpet finished walls in good condition.		390			Replace carpet and base when connecting hallway carpet is replaced. Exterior wall, may be subject to reconstruction due to resolve water infiltration and internal deterioration. Repairs will require removal and reinstallation of full length baseboard heat unit.

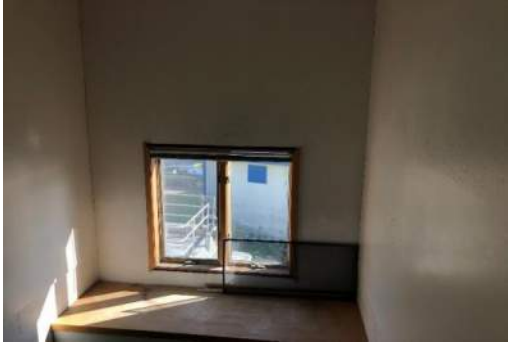
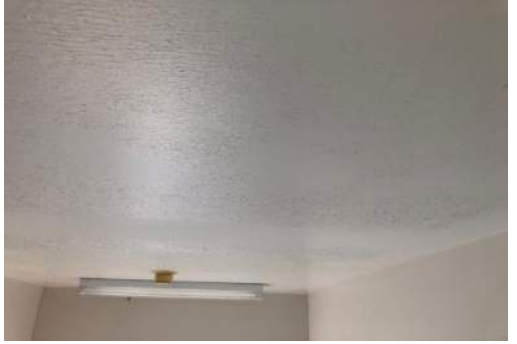
Ref.	Level Room Number	Room Name	Observations	Gross SF	Net SF	Fire/Life Safety Deficiencies and Repairs	Accessibility, ANSI 117.1 and IBC Chapter 11; Deficiencies and Repairs	Maintenance Repairs	Photos
101	236	Stair	Door at top of stairs missing latch. Alligatored paint on all gypsum board walls severe. Exterior window trim partially removed and shows evidence of water damage.		103	Install missing hardware at fire rated door and frame (latch catch for panic hardware).		Strip and repaint all gypsum board surfaces. Repair window trim. Paint interior window trim and window.

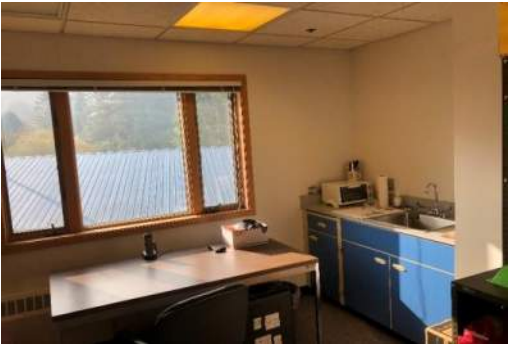
102	237	Break	Carpet is older but in fair condition. Exterior gypsum wall board in poor condition, cracked with evidence of water infiltration. ACT ceiling in good condition. Plastic laminate casework and countertops with sink in fair condition - meets side reach requirements for ADA. Clear finished wood doors, good condition.		166			Replace carpet and base when connecting hallway carpet is replaced. Exterior wall, may be subject to reconstruction due to resolve water infiltration and internal deterioration. Repairs will require removal and reinstallation of full length baseboard heat unit.

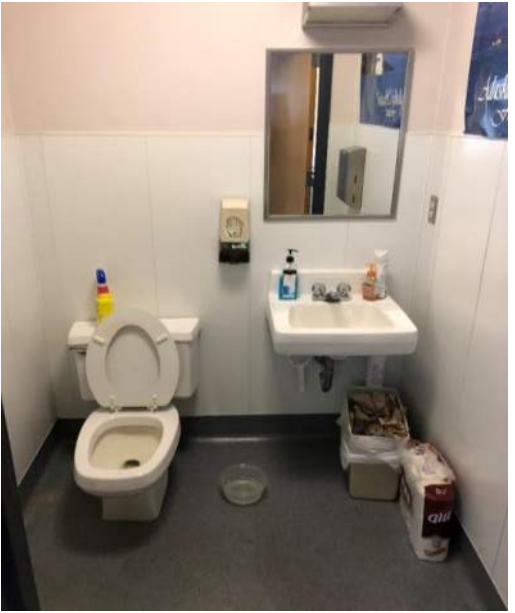
Ref.	Level Room Number	Room Name	Observations	Gross SF	Net SF	Fire/Life Safety Deficiencies and Repairs	Accessibility, ANSI 117.1 and IBC Chapter 11; Deficiencies and Repairs	Maintenance Repairs	Photos
104	239	Toilet	Alligatored paint on all gypsum board walls above wainscot, and ceilings. Sheet vinyl flooring with integral cove base, in fair condition. Clear finished wood doors with painted hollow metal frames, in good condition. Stainless steel washroom accessories in good condition. Wainscot in fair condition.		28		Not accessible; limited clearances, no grab bars, scald-guards.	Strip and paint gypsum board walls and ceiling. Replace vinyl flooring and cove base.

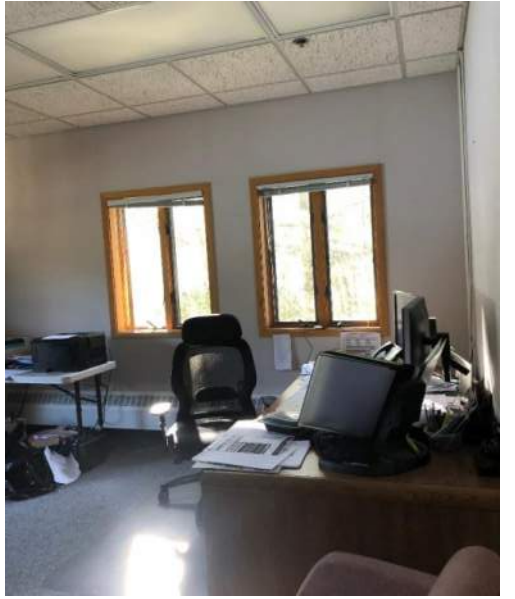
105	240	Police Chief	Carpet is older but in fair condition. Exterior gypsum wall board in good condition. ACT ceiling in good condition. Carpet faced wall in good condition. Clear finished wood doors, good condition.		244			Replace carpet and base when connecting hallway carpet is replaced. Exterior wall, may be subject to reconstruction due to resolve water infiltration and internal deterioration. Repairs will require removal and reinstallation of partial length baseboard heat unit.

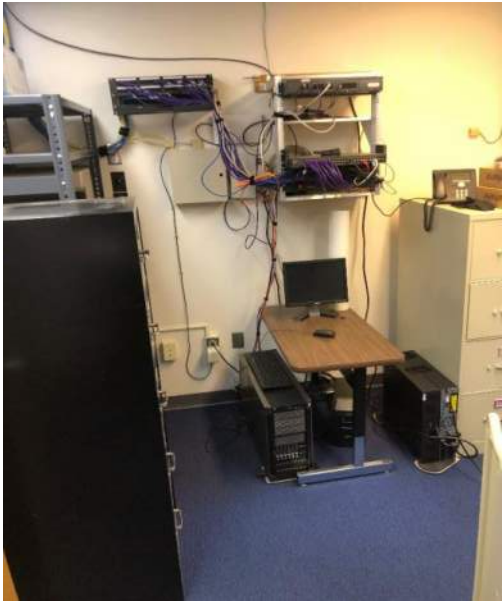
Ref.	Level Room Number	Room Name	Observations	Gross SF	Net SF	Fire/Life Safety Deficiencies and Repairs	Accessibility, ANSI 117.1 and IBC Chapter 11; Deficiencies and Repairs	Maintenance Repairs	Photos
106	241	Server	24x24 commercial carpet tile with rubber base, good condition. ACT ceiling, good condition. Walls, painted gypsum board, good condition. Clear finished wood doors in hollow metal frames, good condition.		153			Exterior wall, may be subject to reconstruction due to resolve water infiltration and internal deterioration. Repairs will require removal and reinstallation of partial length baseboard heat unit.

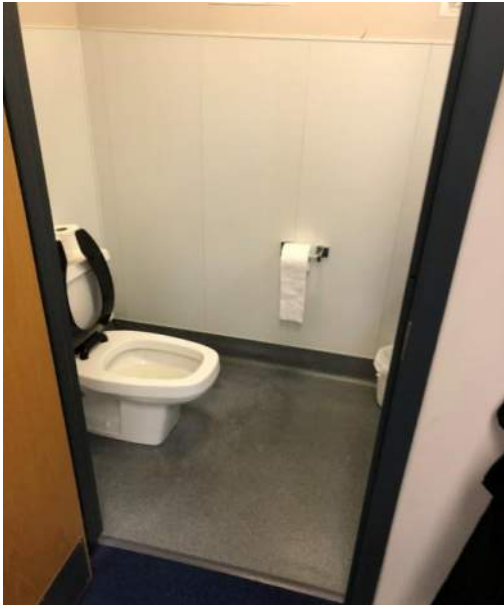
107	242	Toilet	Alligatored paint on all gypsum board walls above wainscot, and ceilings. Sheet vinyl flooring with integral cove base, in poor condition. Clear finished wood doors with painted hollow metal frames, in good condition. Stainless steel washroom accessories in good condition. Wainscot in fair condition. Plastic laminate casework and counter lavatory in fair condition.		27		Not accessible; limited clearances, no grab bars, scald-guards.	Strip and paint gypsum board walls and ceiling. Replace vinyl flooring and cove base.
