Wrangell Public Safety Building Assessment

Final Report

23 February 2021

Wrangell Public Safety Building Assessments

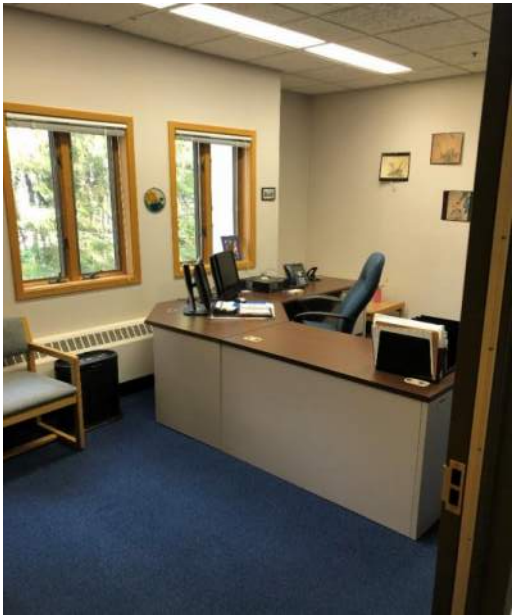
Ref.	Level Room Number	Room Name	Observations	Gross SF	Net SF	Fire/Life Safety Deficiencies and Repairs	Accessibility, ANSI 117.1 and IBC Chapter 11; Deficiencies and Repairs	Maintenance Repairs	Photos
108	243	Magistrate's Office	24x24 commercial carpet tile with rubber base, good condition. ACT ceiling, good condition. Walls, painted gypsum board, good condition. Carpet wall covering at one wall, poor condition. Clear finished wood doors in hollow metal frames, good condition.		182			Exterior wall, may be subject to reconstruction due to resolve water infiltration and internal deterioration. Repairs will require removal and reinstallation of partial length baseboard heat unit. Replace carpet wall finish with new.

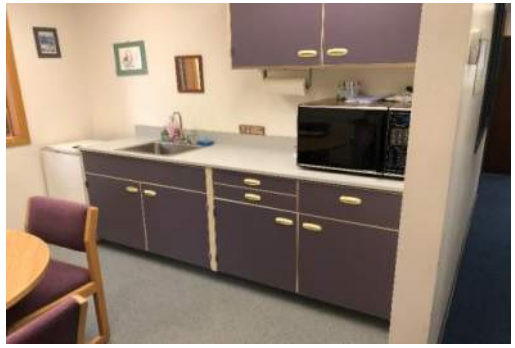
109	244	Lounge	Alligatored paint on all gypsum board walls. Sheet vinyl flooring with rubber base, good condition. Plastic laminate casework and counter in fair condition. Sink accessible via side reach, but basin is too deep.		196	Temporary shoring for roof structure shall be installed through this space, necessitating removal of casework and ACT grid.	Replace stainless steel sink with shallow basin unit.	Anticipate all finishes for this room shall be removed and reinstalled new. Exterior wall is substantially deteriorated due to water infiltration and shall be reconstructed with new framing, insulation vapor retarder sheathing and siding. Coordinate with exterior notes and structural notes.

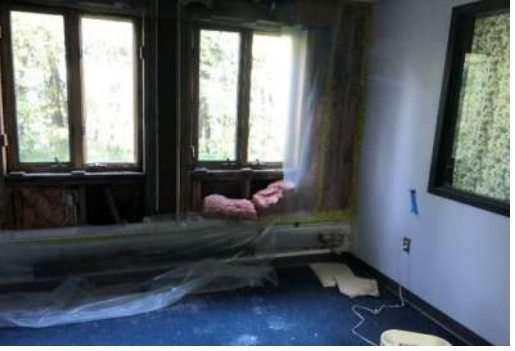
Ref.	Level Room Number	Room Name	Observations	Gross SF	Net SF	Fire/Life Safety Deficiencies and Repairs	Accessibility, ANSI 117.1 and IBC Chapter 11; Deficiencies and Repairs	Maintenance Repairs	Photos
110	245	Court Clerk	All exterior wall panels have been removed an the room sealed due to mold. Will undergo significant reconstruction.		109	Temporary shoring for roof structure will be installed through this space, necessitating removal of casework and ACT grid.		Anticipate all finishes for this room shall be removed and reinstalled new. Exterior wall is substantially deteriorated due to water infiltration and shall be reconstructed with new framing, insulation vapor retarder sheathing and siding. Coordinate with exterior notes and structural notes.

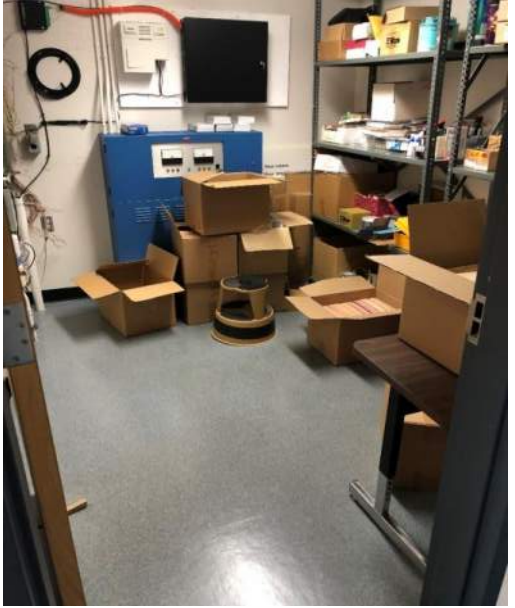
111	246	Storage	ACT ceiling in good condition. Sheet vinyl flooring and rubber base in good condition. Gypsum board walls display some alligatoring.		80			Strip and repaint gypsum board walls

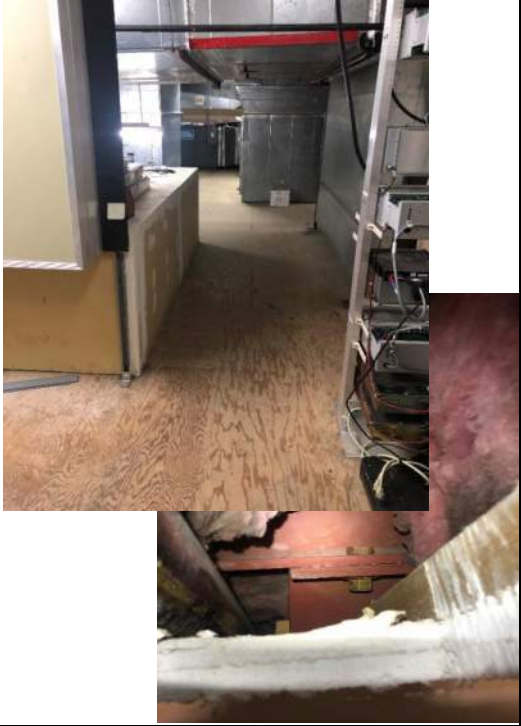
Ref.	Level Room Number	Room Name	Observations	Gross SF	Net SF	Fire/Life Safety Deficiencies and Repairs	Accessibility, ANSI 117.1 and IBC Chapter 11; Deficiencies and Repairs	Maintenance Repairs	Photos
	Mech. Loft			2168					
112	M300	Mechanical	Unfinished areas for equipment, attics, and roof access.		2015	Patch all gypsum board cut-away required for investigations. All are in fire protection assemblies and need to be fire taped. 6-8 locations totaling 15 sf.		Replace seals at exterior access doors.

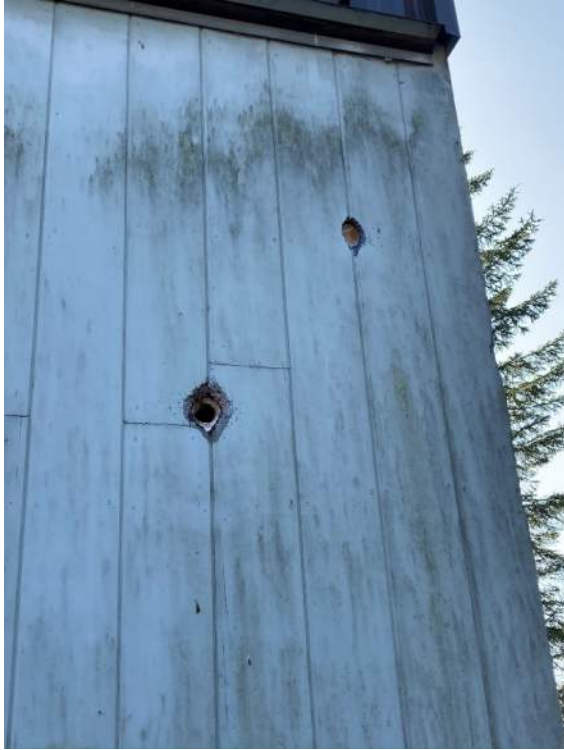
Photo 21 – Woodpecker holes in exterior wall
