**Department of Environmental
Conservation**

Re: Decision Document: Wrangell Sawmill
Cleanup Complete Determination

Wrangell Sawmill
7 Mile Zimovia Highway
Wrangell, Alaska 99929

File No: 1529.38.022
Hazard ID: 25786

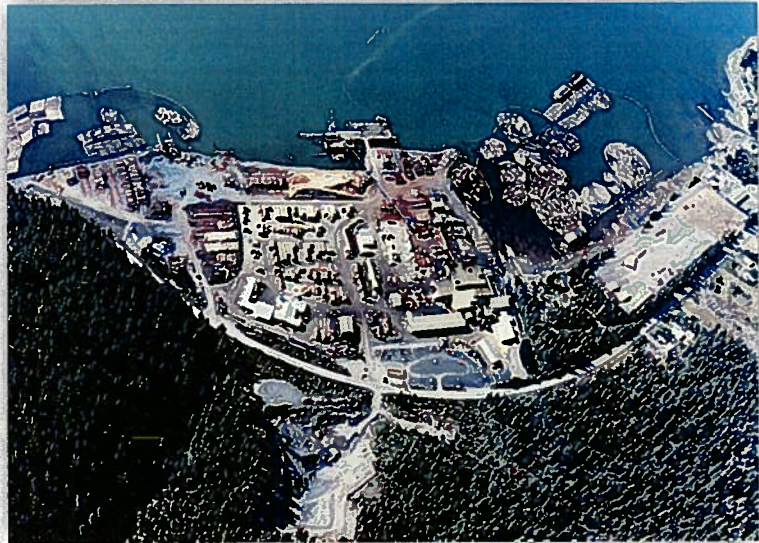
Figure 1: Alaska Pulp Corporation: circa 1950's - estimated date (Photo: by Frank Roppel)

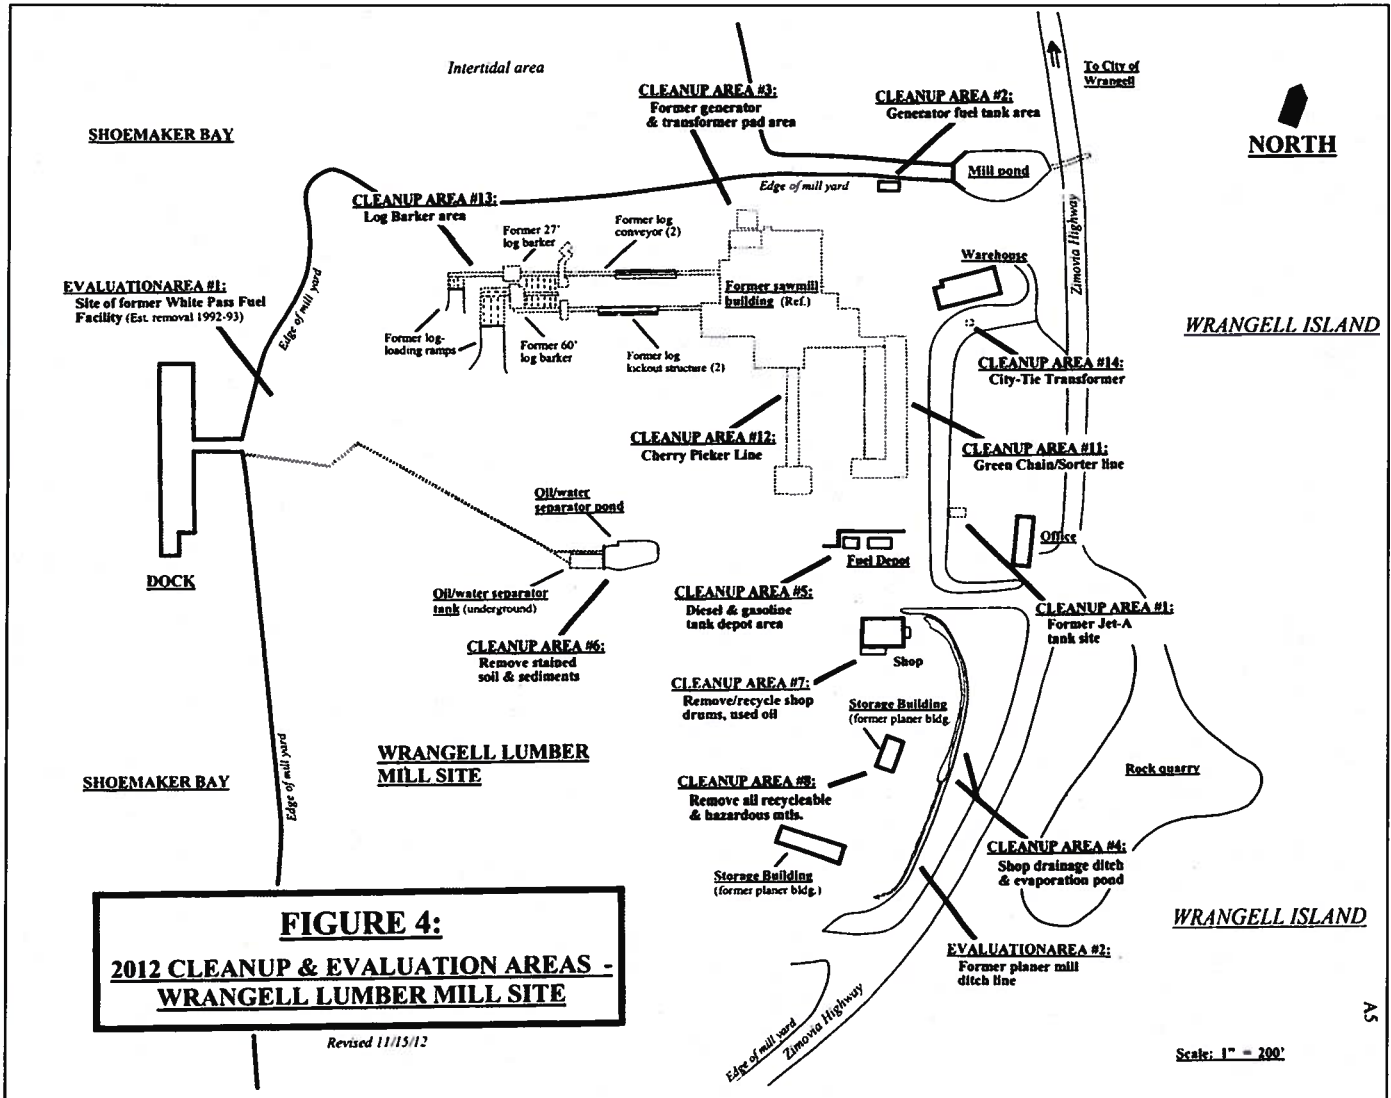
The following sections detail the cleanup work done at multiple areas identified across the Wrangell Sawmill property. Figure 4 below depicts these areas.

Area 1 - Office Jet-A tank site: The site was excavated on 7/1/12, leaving an 8'x30'x4.5' hole directly under the tank location. Sample results of the excavated stockpile showed low detections of DRO and RRO, 11-120 mg/kg and 52-110 mg/kg respectively. The stockpiled material was then used as backfill and the area was confirmed to meet cleanup criteria. No soils were removed for bioremediation.

Area 2- Generator tank site: The site was excavated on 5/17/12 once the concrete foundation was moved back. After excavating 12"-18" directly under the tank's former discharge pipe location, little contamination was found. Confirmation samples for DRO and RRO were below cleanup levels at 160-180mg/kg and 220-440 mg/kg, respectively. The area was confirmed to meet cleanup criteria and no soil was removed for bioremediation.

Area 3- Emergency generator/ transformer pad site: Initial excavations began on 5/15/12. After an 8' wide space was opened between the foundations of the generator building and sawmill transformer, a significant amount of contamination was found almost immediately. By 5/19/12, the excavation had extended to nearly 100' x 80' x 14' and eventually revealed four possible source areas. High levels of DRO and RRO directed the excavations early on but high concentrations of DRO drove the excavation and characterization until 8/22/12. Confirmation samples eventually revealed DRO levels that ranged from 31-3000 mg/kg. The emergency/ transformer pad site was also evaluated for GRO, BTEX, PCB's, and nine semi-volatile organic compounds (SVOCs). All GRO and BTEX samples were non-detect. One PCB analyte (Aroclor 1260) and the nine SVOCs were detected but all below DEC cleanup criteria.

Area #5- Fuel Depot: The fuel depot bulkhead was removed on 6/4/12. Considerable diesel-contaminated soil was found and excavated to 2.5' below the concrete surface until clean soil appeared. As the excavation continued toward the gasoline tanks location, high PID readings were encountered at a depth of 4-5 feet bgs. Characterization samples showed GRO concentrations were above DEC cleanup criteria. As a result, GRO and the gasoline compounds, BTEX, were added as potential COCs for this location. Excavations continued over the course of the summer. After a July 20, 2012 site visit, DEC recommended the evaluation of SVOCs and RCRA-8 metals for this area. On 9/16/12 the final excavations took place. An additional 10'-15' section of the concrete surface was removed and soil was excavated to 12' depths. Along the embankment DRO levels were 3,900-4,400mg/kg. All other COC confirmation samples confirmed RRO, GRO, BTEX, SVOCs, and RCRA-8 metals also were below cleanup levels. Approximately, 1,090 c.y. of contaminated soil was removed for treatment.
