**STABILITY STUDY  
UPPER AND LOWER WATER SUPPLY DAMS  
WRANGELL, ALASKA**

**May 1993**

**City of Wrangell  
P.O. Box 531  
Wrangell, Alaska 99929**

**RE: STABILITY STUDIES FOR WRANGELL UPPER AND LOWER DAMS,  
WRANGELL, ALASKA**

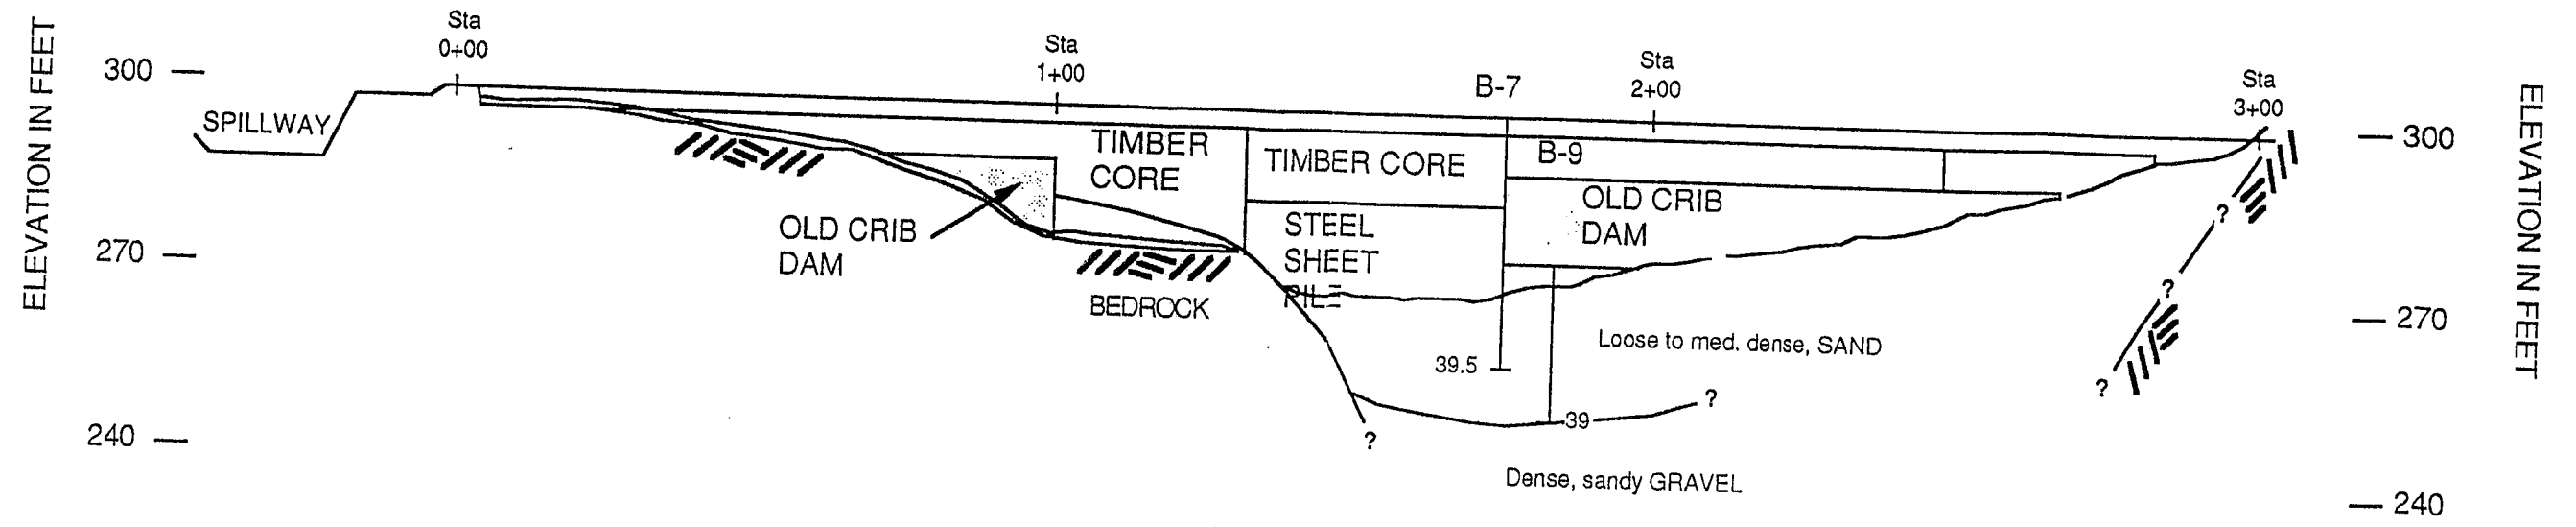
As there is no evidence that the crib extended below the groundline in the Lower Dam (Figure 9), this wedge was not added to Section 4.

The granular materials at the Lower Dam have similar gradation and compaction properties to the Upper Dam only they are less dense and therefore have slightly lower in place wet unit weights and higher water contents. Based on limited boring data, the section in Figure 9 reflects three basic shell units differentiated largely by density. The upstream shallow and deep embankment materials have average uncorrected penetration resistance values of 17 and 9 blows/foot respectively. The lower upstream zone also contains less gravel and is mostly a silty sand. The downstream embankment is more compact with average uncorrected penetration values of 34 blows per foot.

The sheet pile wall in the Lower Dam presumably falls between borings B-7 and B-8 in Figure 9. It's integrity cannot be evaluated by boring explorations nor was it considered necessary as it's effectiveness at sealing off water should be reflected in the piezometers and signs of toe seepage. In both instances, low water levels in the dam and no apparent seepage suggest that hydrostatic pressures are not large in this dam. The sheet piles structural integrity was ignored in the follow-on stability analysis.

saturated materials (i.e. below the water table). Based on Figure 9 the water level encompasses only the lower third of the crib structure and is in an area where the N-values are somewhat higher.

A second area identified where liquefaction may occur is the upstream fill of the Lower Dam, Figure 9. Only one data point fell into this range, suggesting local loose pockets, however, the overall database in this region is weak. For lack of more definitive information and the fact that the hazard rating is thought to be low for this dam, we have assumed that it would not liquefy.
